Re: November 2023 Monthly Progress Report
Administrative Settlement Agreement and Order on Consent for Removal Action
EPA Region 10 Docket No. CERCLA 10-2009-0255
Gasco Sediments Site Within the Portland Harbor Superfund Site

Attachment A Monthly Visual Monitoring Report for Pilot Cap Vicinity

Project: NW Natural – Gasco

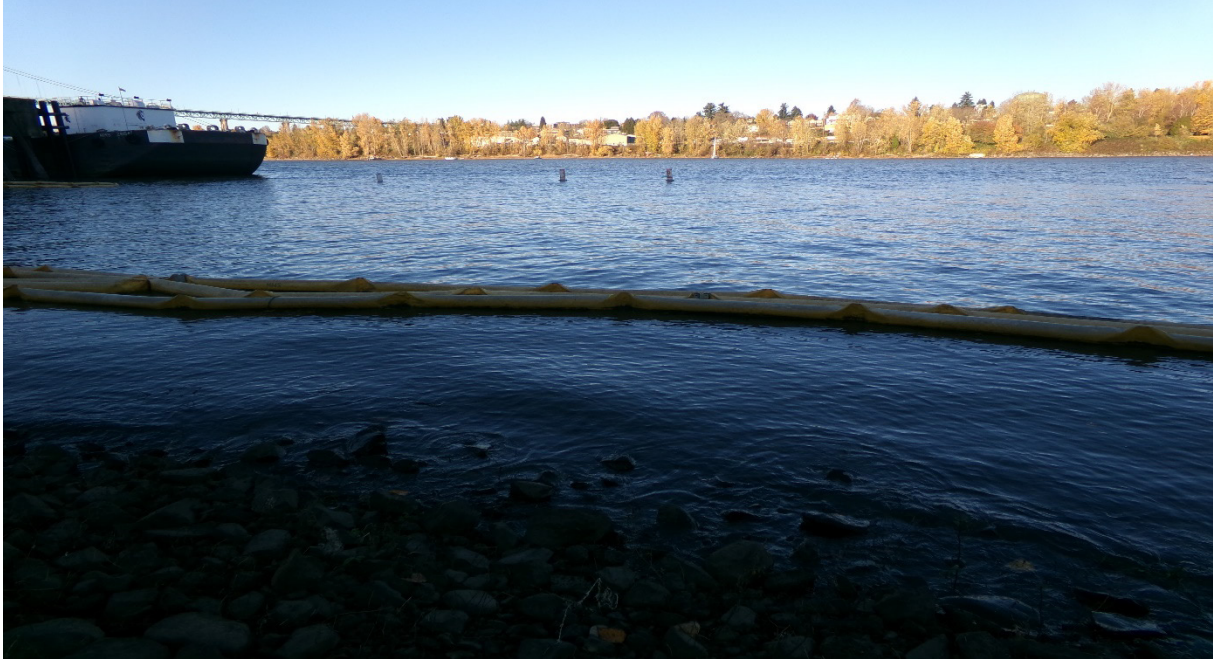
During the observation, a barge was moored at the Centerline Logistics (Centerline) ship dock. The Centerline containment boom was in place, from dock to the upriver containment boom. The three buoys identifying the cap area to mariners were in place as installed. The positions of the warning buoys and Centerline boom are shown in Photo 1.

Photo 1
Three Mariner Warning Buoys and Centerline Containment Boom at Pilot Cap Area
(11/27/2023)

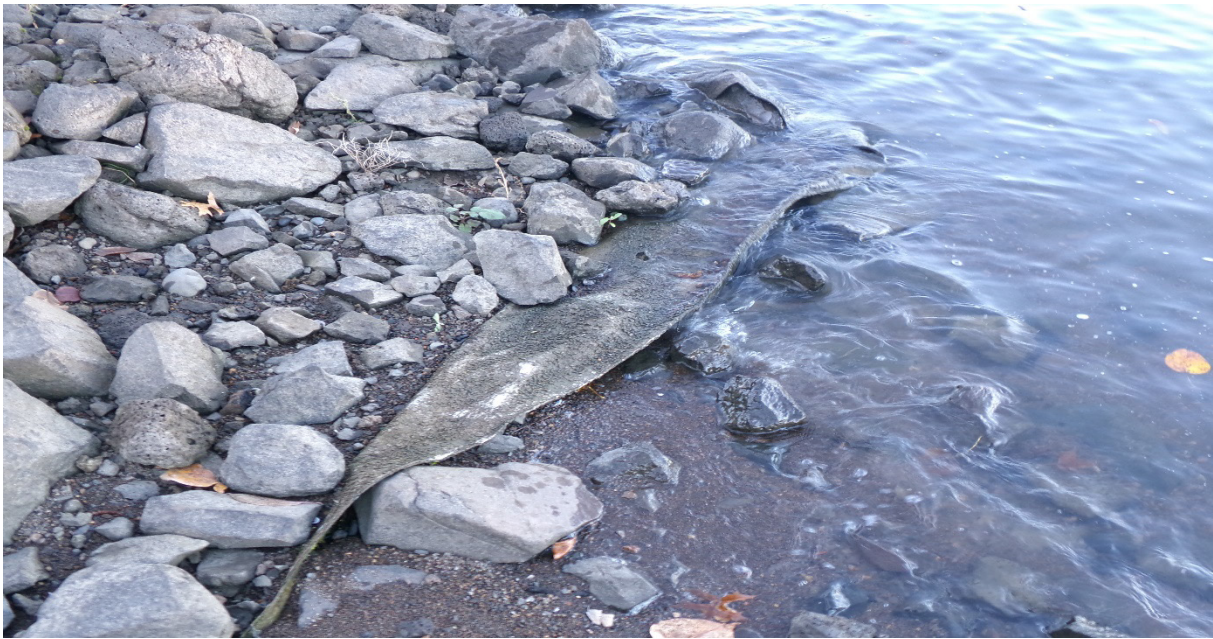
All exposed organoclay mat material segments were underwater except for a 5-foot section along the water’s edge at the lateral midpoint of the cap area (Photo 2). The visible, exposed segments of organoclay mat were in visually good condition.

Photo 2
Organoclay Mat Material at the Midpoint of the Pilot Cap Area (11/27/2023)

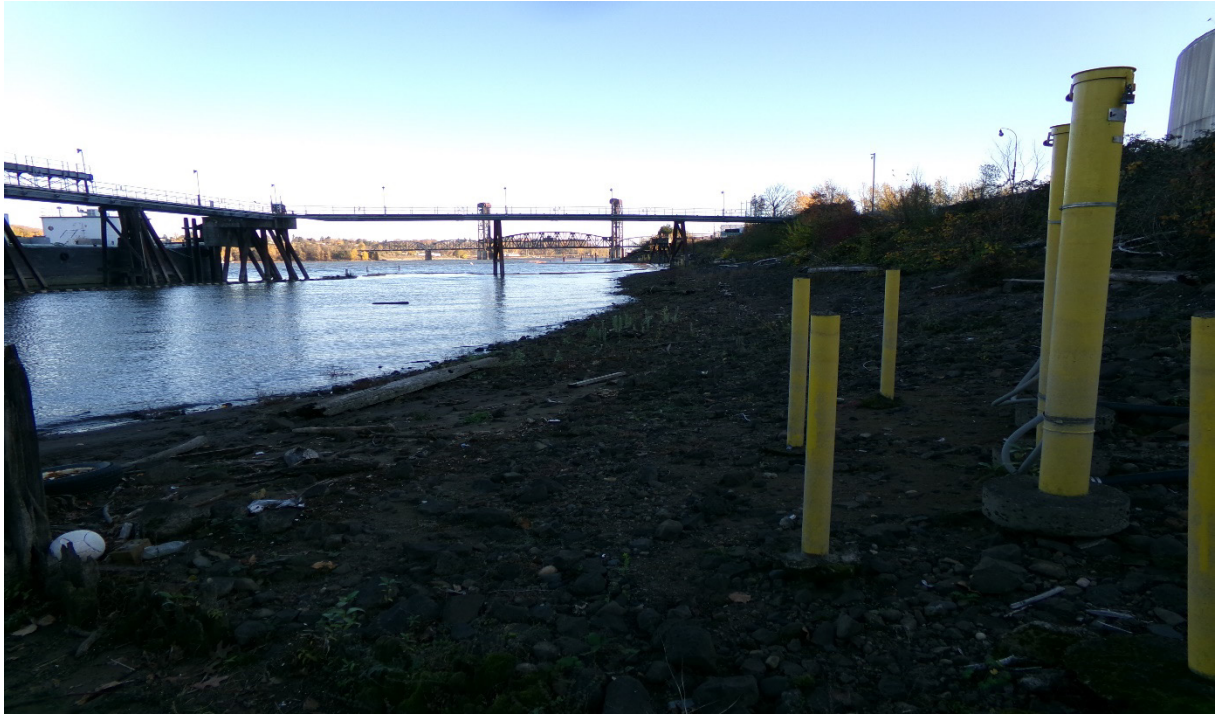
Photo 3 shows the water surface and shoreline immediately downriver of the sediment cap. No sheen was observed within the vicinity of the cap area.

Photo 3
Conditions Downriver of Pilot Cap Area Looking Upriver (11/27/2023)
