Re: October 2023 Monthly Progress Report
Administrative Settlement Agreement and Order on Consent for Removal Action
EPA Region 10 Docket No. CERCLA 10-2009-0255
Gasco Sediments Site Within the Portland Harbor Superfund Site

Attachment A Monthly Visual Monitoring Report for Pilot Cap Vicinity

Visual Observations Log Form

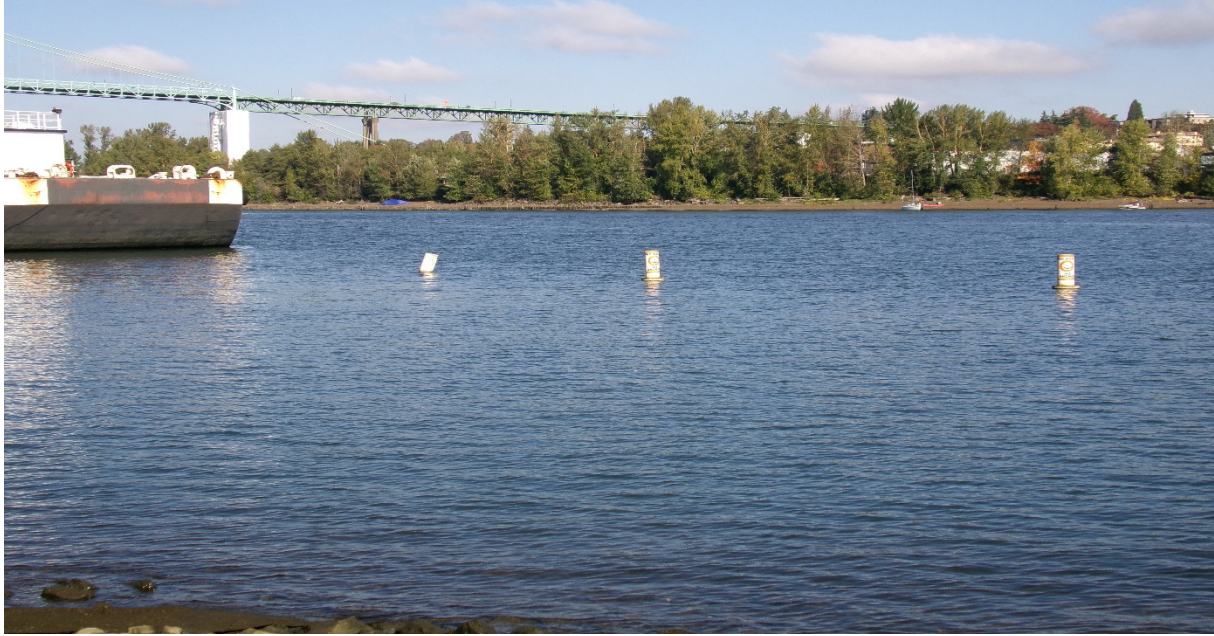
During the observation, a barge was moored at the Centerline Logistics (Centerline) ship dock. The Centerline containment boom was staged along the dock. The three buoys identifying the cap area to mariners were in place as installed. The positions of the warning buoys are shown in Photo 1.

Photo 1
Three Mariner Warning Buoys at Pilot Cap Area (10/27/2023)

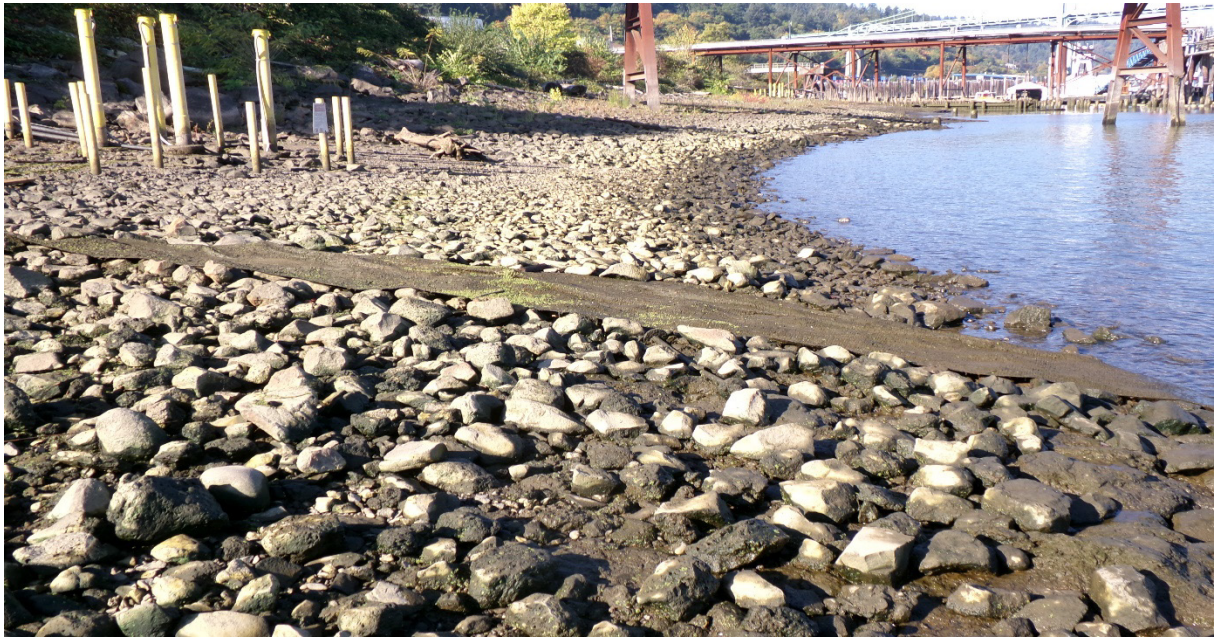
All exposed organoclay mat material segments were visible and exposed above the waterline (Photo 2). The visible, exposed segments of organoclay mat were in visually good condition.

Photo 2
Organoclay Mat Material at the Upriver Extent of the Cap Area (10/27/2023)

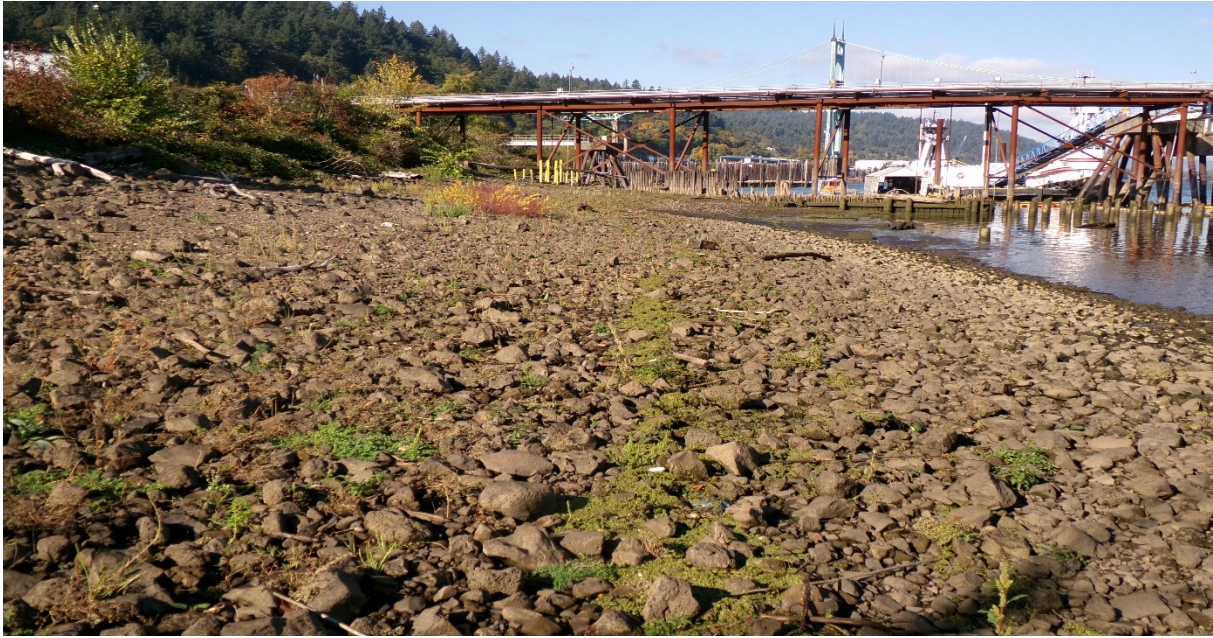
Photo 3 shows the water surface and shoreline immediately downriver of the sediment cap. No sheen was observed within the cap area.

Photo 3
Conditions Immediately Downriver of Cap Area Looking Downriver (10/27/2023)
