Holt Services / PDI-124 CPT / 8010 NW St Helens Rd

OPERATOR: OGE DMM
 CONE ID: DPG1386
 HOLE NUMBER: PDI-124 CPT
 TEST DATE: 10/17/2019 1:47:45 PM
 TOTAL DEPTH: 65.617 ft

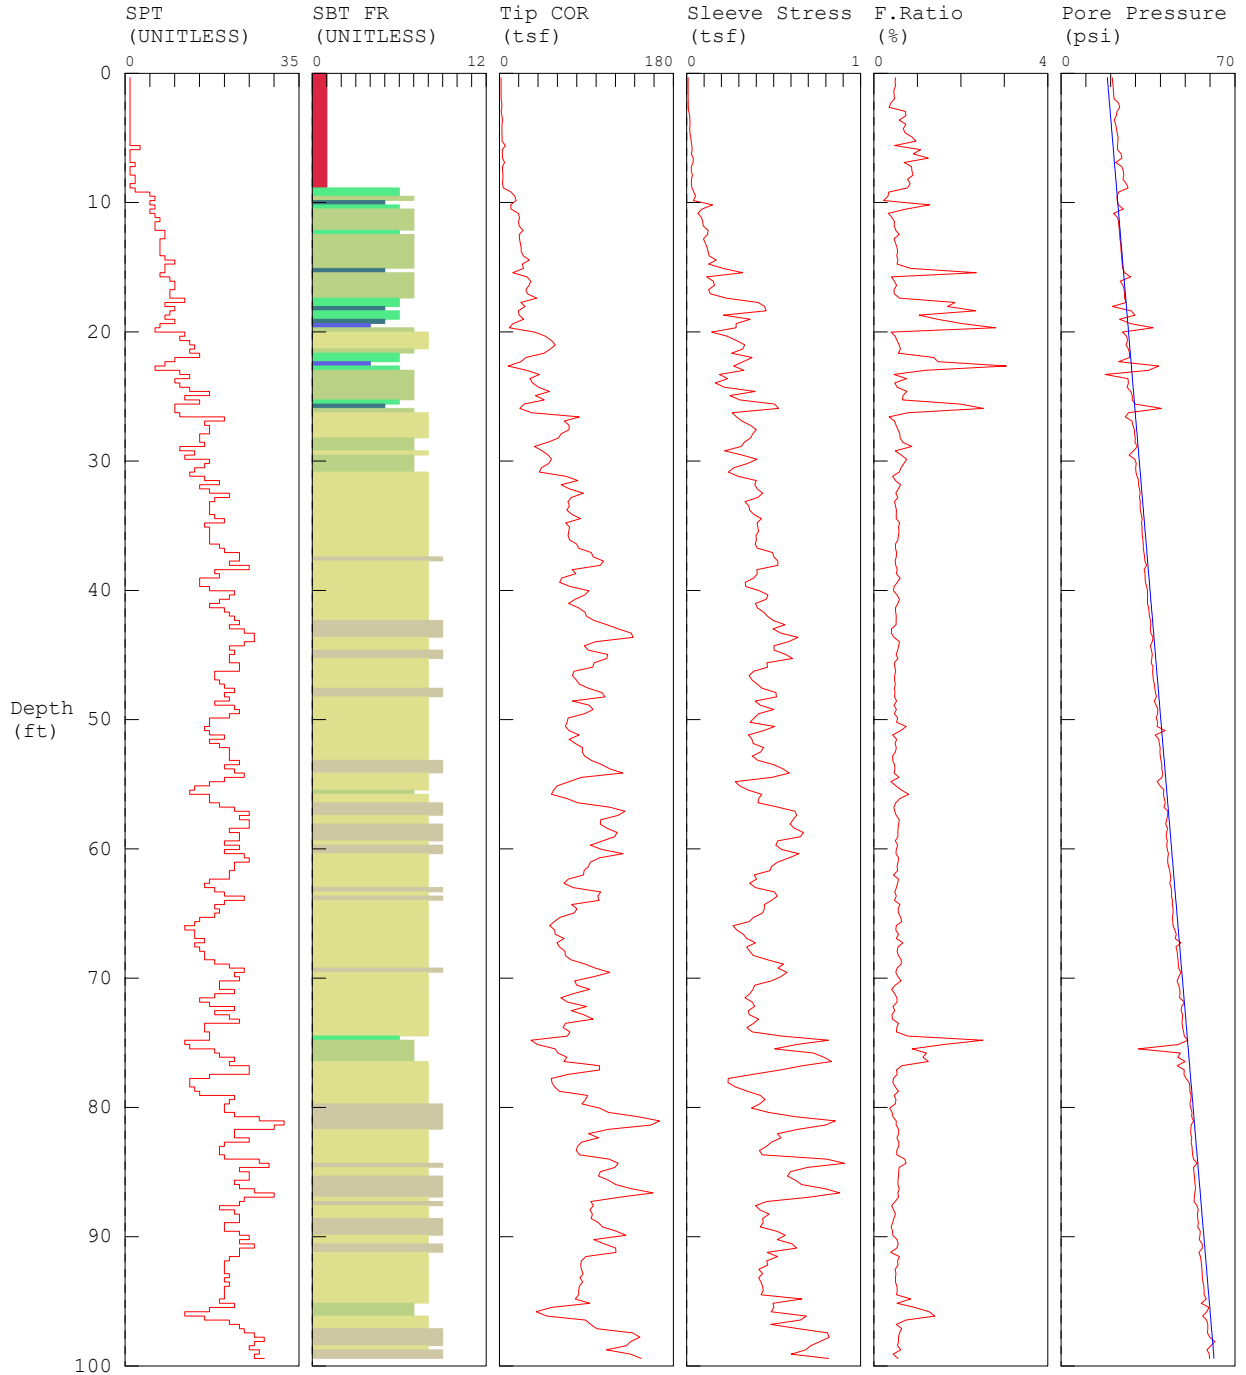
Holt Services / PDI-125 CPT / 8010 NW St Helens Rd

OPERATOR: OGE DMM
 CONE ID: DPG1323
 HOLE NUMBER: PDI-125 CPT
 TEST DATE: 10/22/2019 12:26:44 PM
 TOTAL DEPTH: 99.409 ft

| 1 | sensitive fine gra | 4 | silty clay to cl | 7 | silty sand to sandy | 10 | gravelly sand to sand |
| 2 | organic materia | 5 | clayey silt to silt | 8 | sand to silty sa | 11 | very stiff fine grained (*) |
| 3 | clay | 6 | sandy silt to claye | 9 | sand | 12 | sand to clayey sand (*) |

- *SBT/SPT CORRELATION: UBC-1983

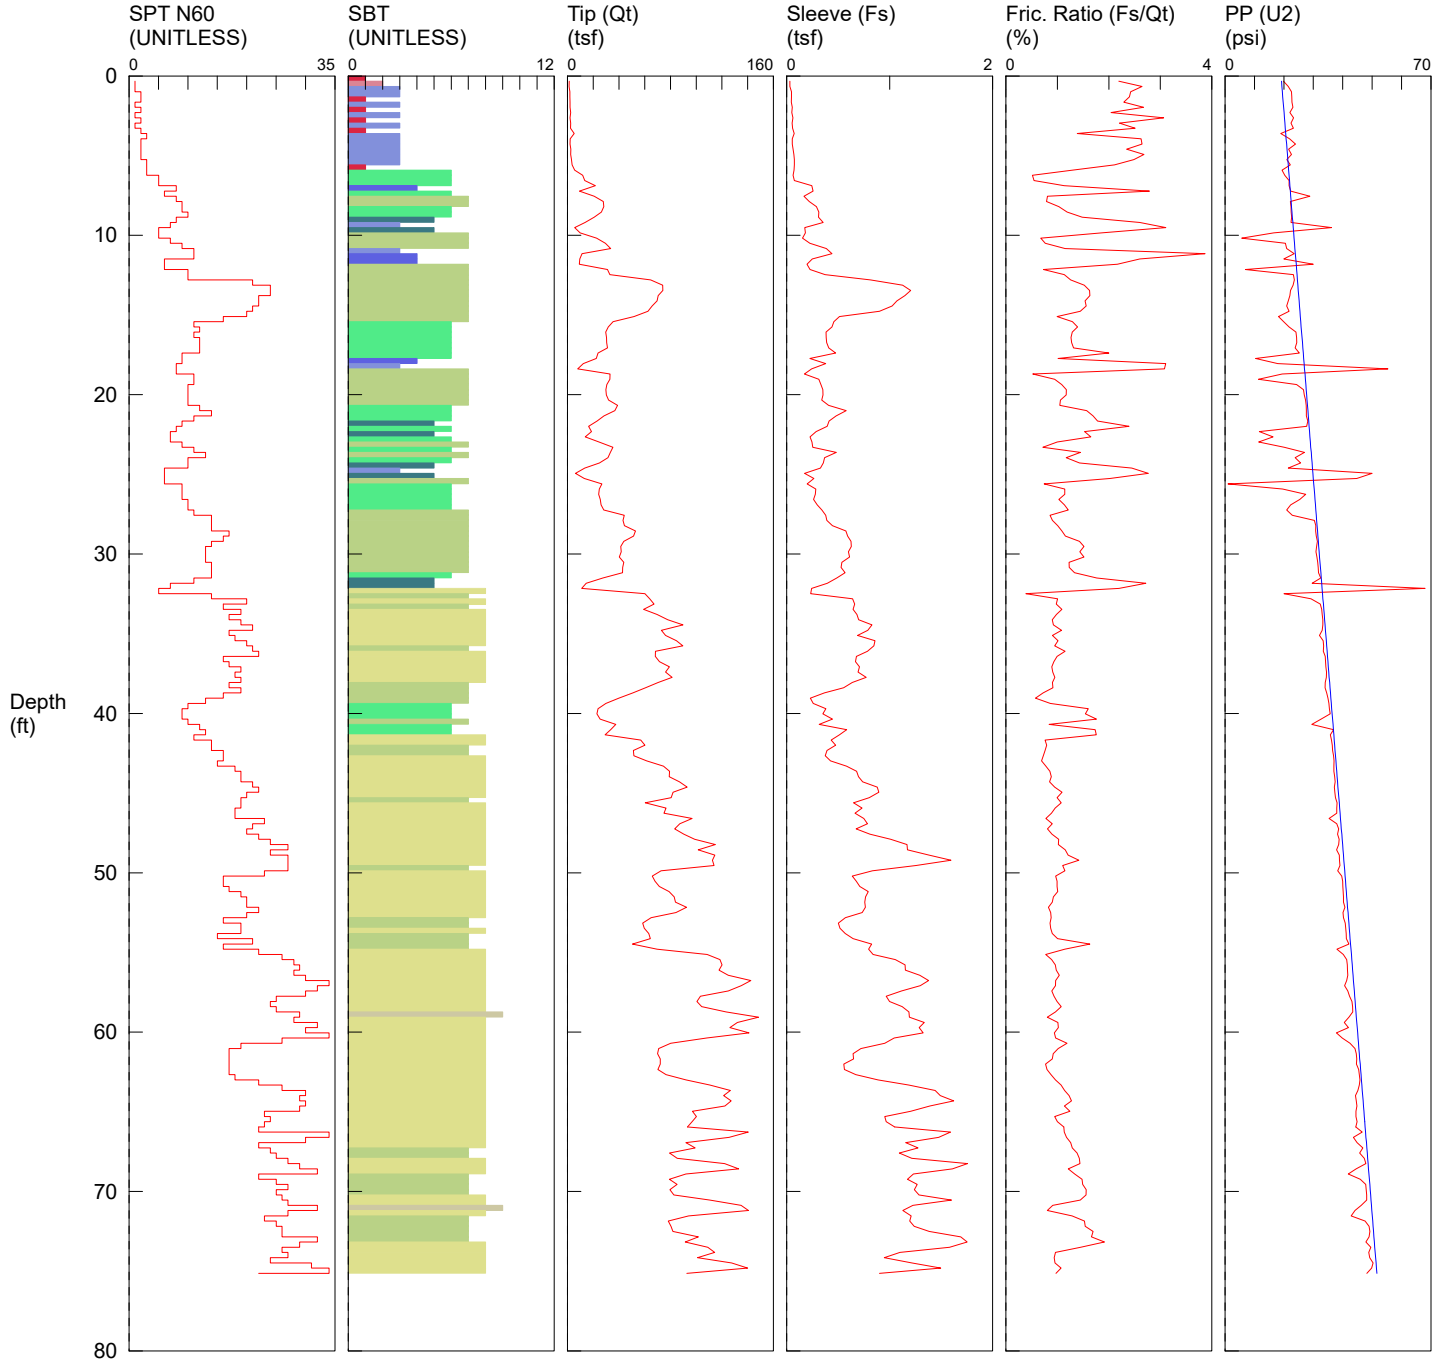
Holt Services / PDI-126 CPT / 8010 NW St Helens Rd

OPERATOR: OGE DMM
 CONE ID: DPG1386
 HOLE NUMBER: PDI-126CPT
 TEST DATE: 10/17/2019 10:21:46 AM
 TOTAL DEPTH: 75.131 ft

| ■ 1 sensitive fine grained | ■ 4 silty clay to clay | ■ 7 silty sand to sandy silt | ■ 10 gravelly sand to sand |
| ■ 2 organic material | ■ 5 clayey silt to silty clay | ■ 8 sand to silty sand | ■ 11 very stiff fine grained (*) |
| ■ 3 clay | ■ 6 sandy silt to clayey silt | ■ 9 sand | ■ 12 sand to clayey sand (*) |

*SBT/SPT CORRELATION: UBC-1983

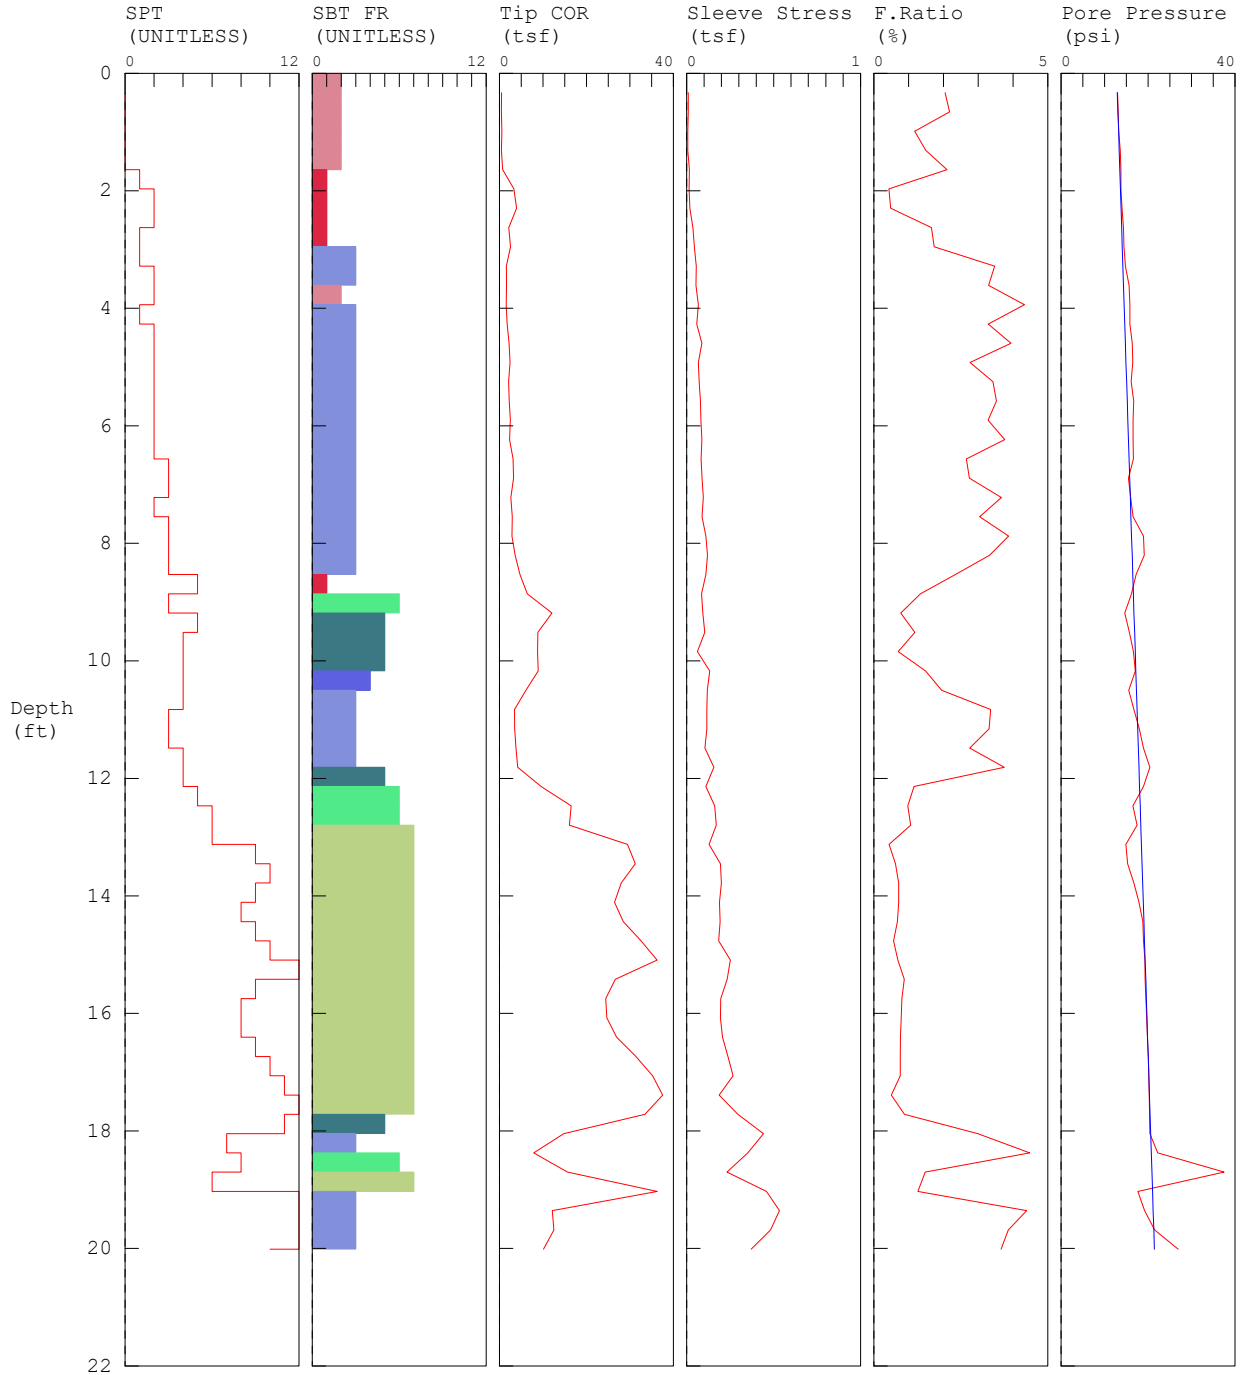
Holt Services / PDI-127 CPT / 8010 NW St Helens Rd

OPERATOR: OGE DMM
 CONE ID: DDG1296
 HOLE NUMBER: PDI-127 CPT
 TEST DATE: 10/25/2019 12:43:26 PM
 TOTAL DEPTH: 20.013 ft

| 1 | sensitive fine gra | 4 | silty clay to cl | 7 | silty sand to sandy | 10 | gravelly sand to sand |
| 2 | organic materia | 5 | clayey silt to silt | 8 | sand to silty sa | 11 | very stiff fine grained (*) |
| 3 | clay | 6 | sandy silt to claye | 9 | sand | 12 | sand to clayey sand (*) |

- *SBT/SPT CORRELATION: UBC-1983

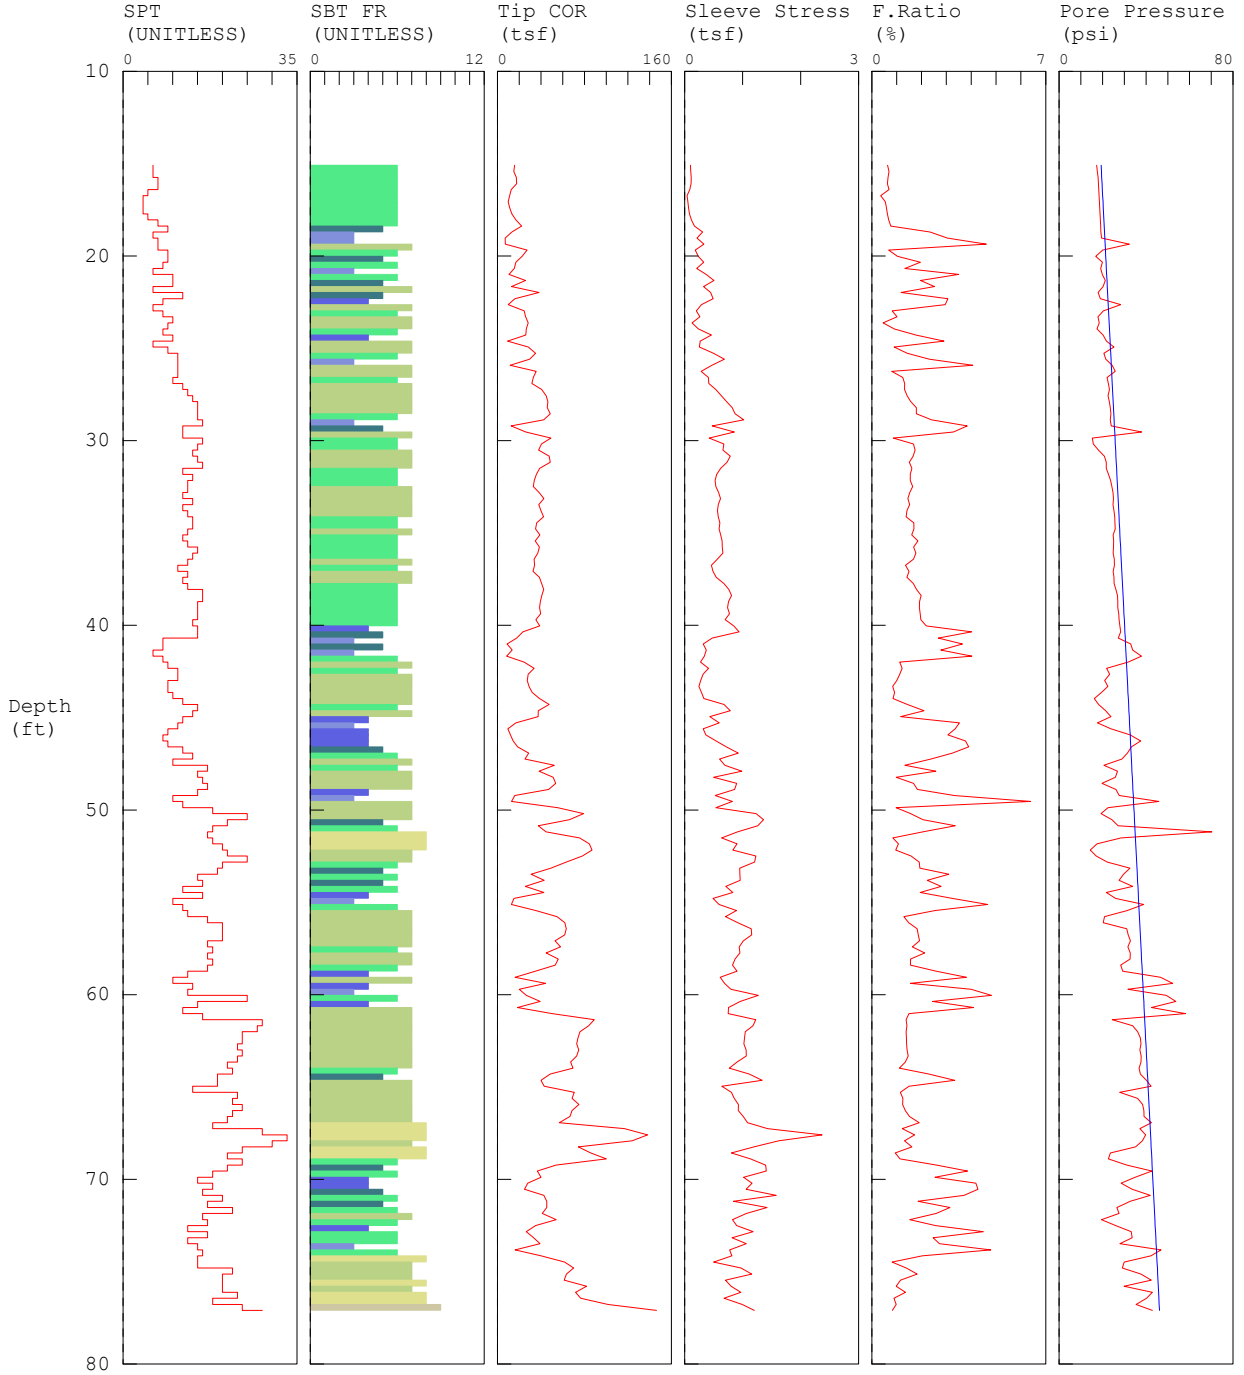
Holt Services / PDI-127b CPT / 8010 NW St Helens Rd

OPERATOR: OGE DMM
 CONE ID: DDG1296
 HOLE NUMBER: PDI-127b CPT
 TEST DATE: 10/25/2019 2:36:13 PM
 TOTAL DEPTH: 77.100 ft

| 1 | sensitive fine gra | 4 | silty clay to cl | 7 | silty sand to sandy | 10 | gravelly sand to sand |
| 2 | organic materia | 5 | clayey silt to silt | 8 | sand to silty sa | 11 | very stiff fine grained (*) |
| 3 | clay | 6 | sandy silt to claye | 9 | sand | 12 | sand to clayey sand (*) |

- *SBT/SPT CORRELATION: UBC-1983

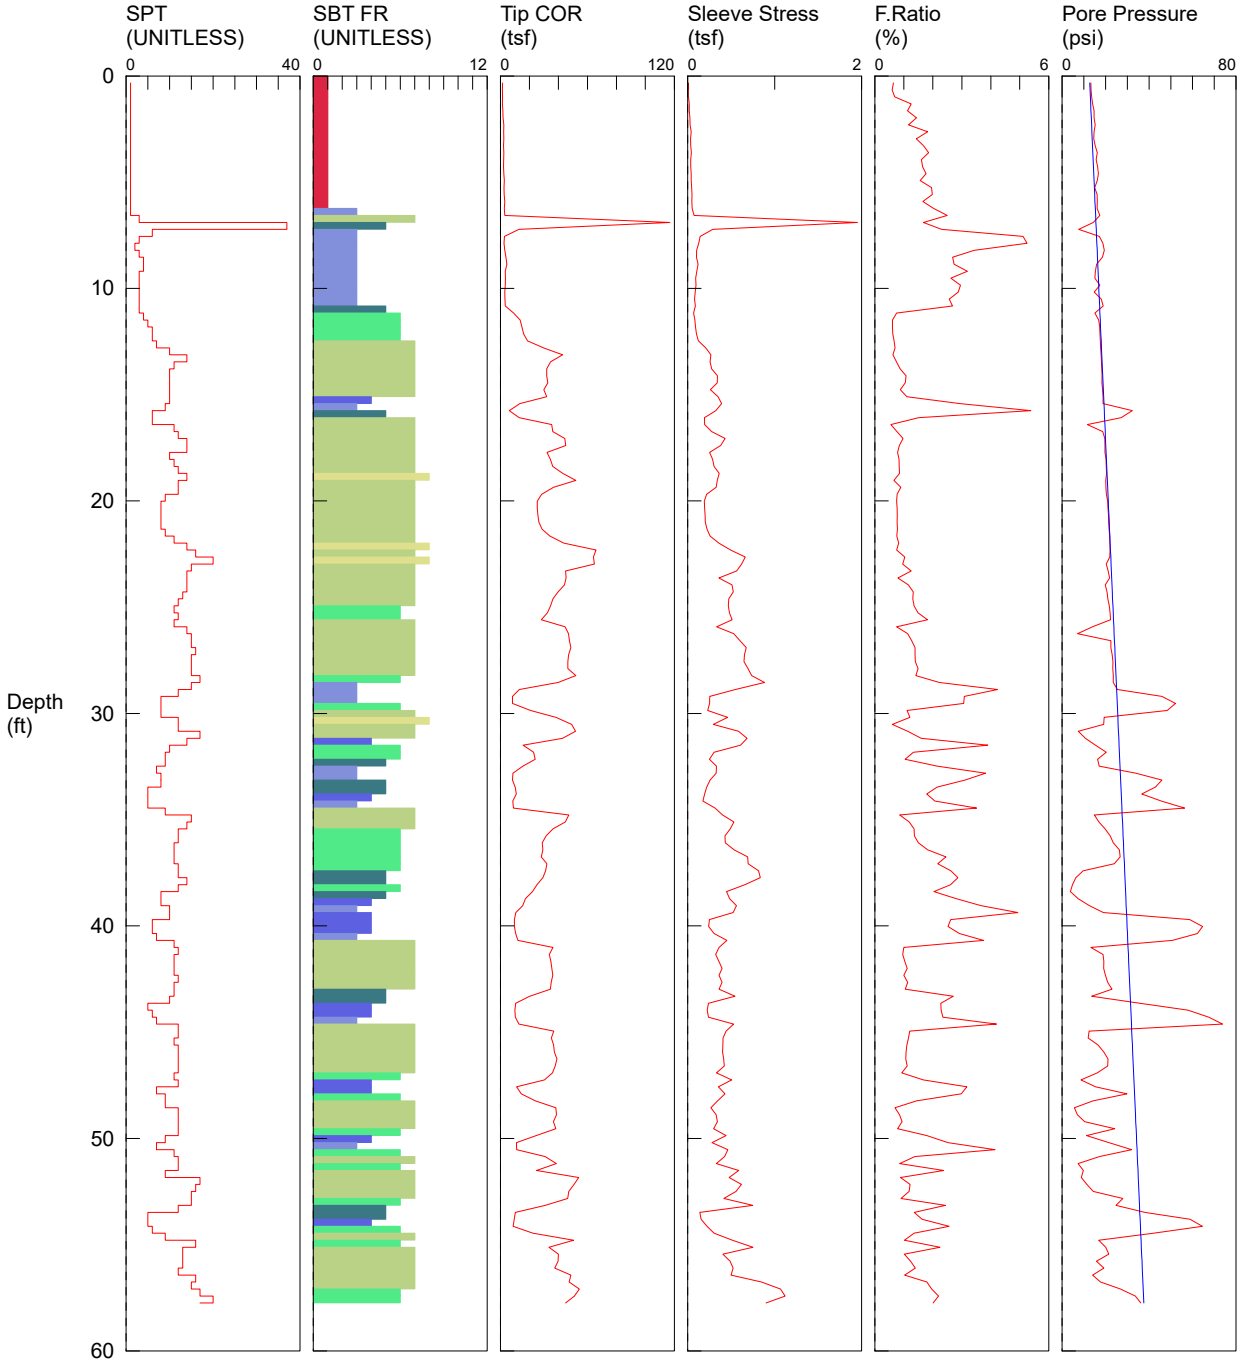
Holt Services / PDI-128 CPT / 8010 NW St Helens Rd

OPERATOR: OGE DMM
 CONE ID: DPG1386
 HOLE NUMBER: PDI-128 CPT
 TEST DATE: 10/18/2019 8:11:38 AM
 TOTAL DEPTH: 57.743 ft

| ■ 1 sensitive fine grained | ■ 4 silty clay to clay | ■ 7 silty sand to sandy silt | ■ 10 gravelly sand to sand |
| ■ 2 organic material | ■ 5 clayey silt to silty clay | ■ 8 sand to silty sand | ■ 11 very stiff fine grained (*) |
| ■ 3 clay | ■ 6 sandy silt to clayey silt | ■ 9 sand | ■ 12 sand to clayey sand (*) |

- *SBT/SPT CORRELATION: UBC-1983

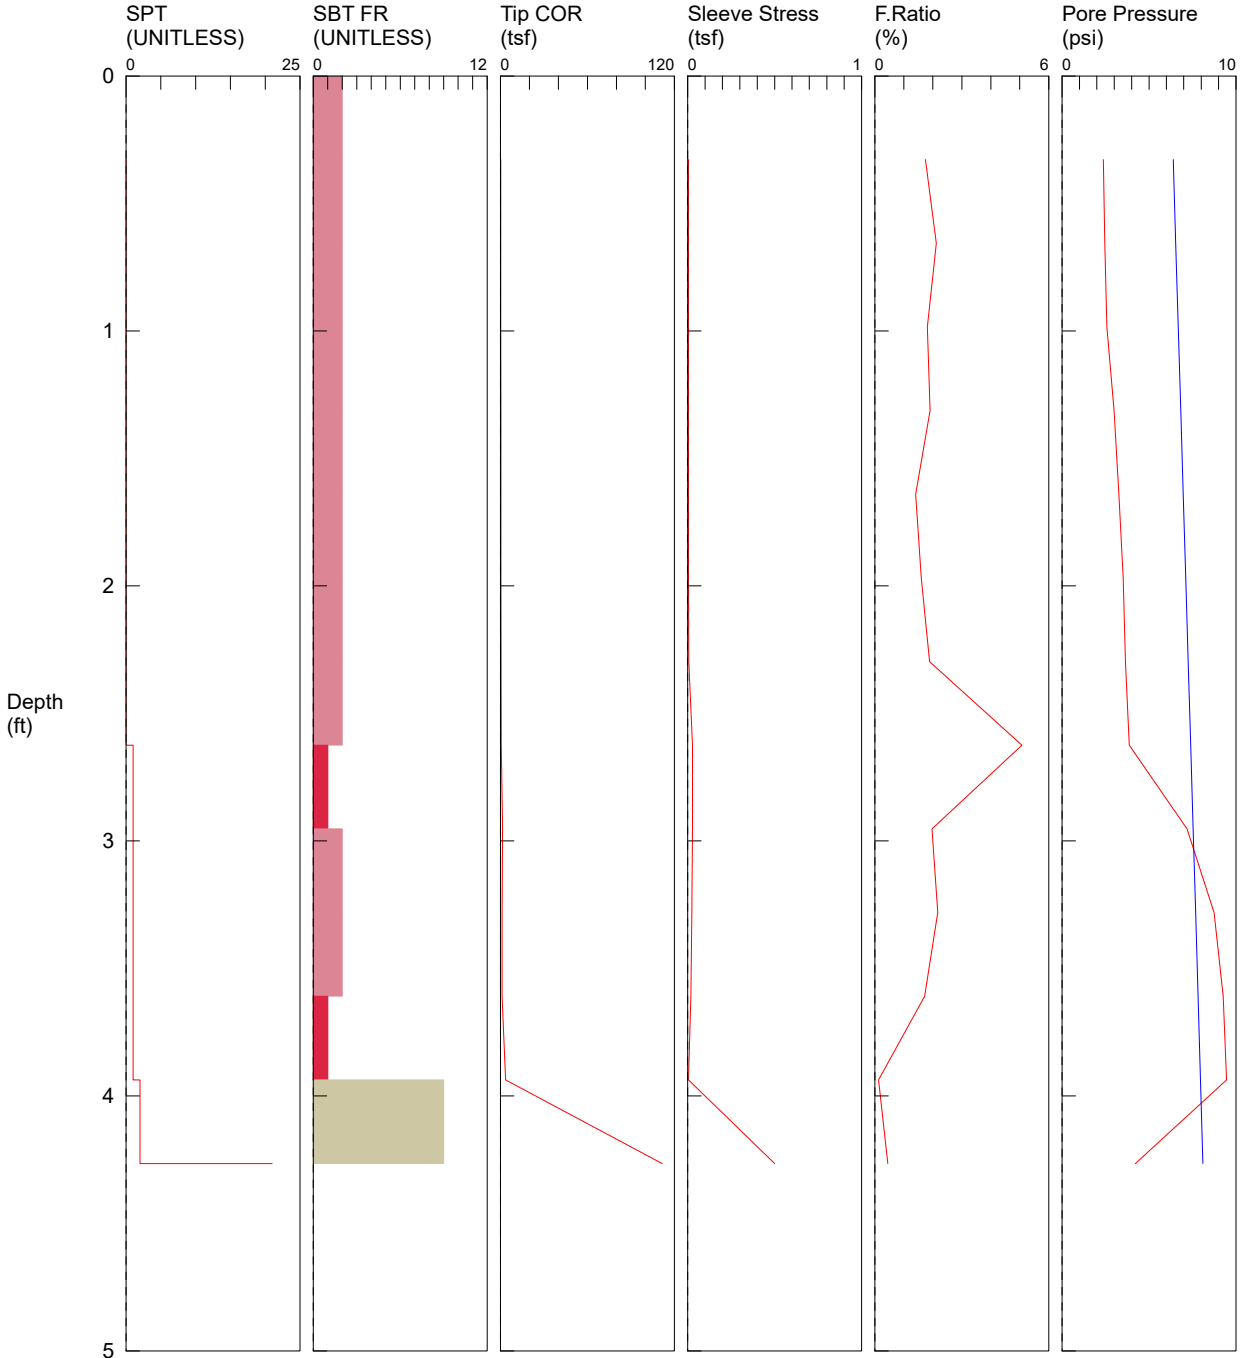
Holt Services / PDI-129 CPT / 8010 NW St Helens Rd

OPERATOR: OGE DMM
 CONE ID: DDG1296
 HOLE NUMBER: PDI-129 CPT
 TEST DATE: 10/24/2019 10:31:06 AM
 TOTAL DEPTH: 4.265 ft

| ■ 1 sensitive fine grained | ■ 4 silty clay to clay | ■ 7 silty sand to sandy silt | ■ 10 gravelly sand to sand |
| ■ 2 organic material | ■ 5 clayey silt to silty clay | ■ 8 sand to silty sand | ■ 11 very stiff fine grained (*) |
| ■ 3 clay | ■ 6 sandy silt to clayey silt | ■ 9 sand | ■ 12 sand to clayey sand (*) |

*SBT/SPT CORRELATION: UBC-1983

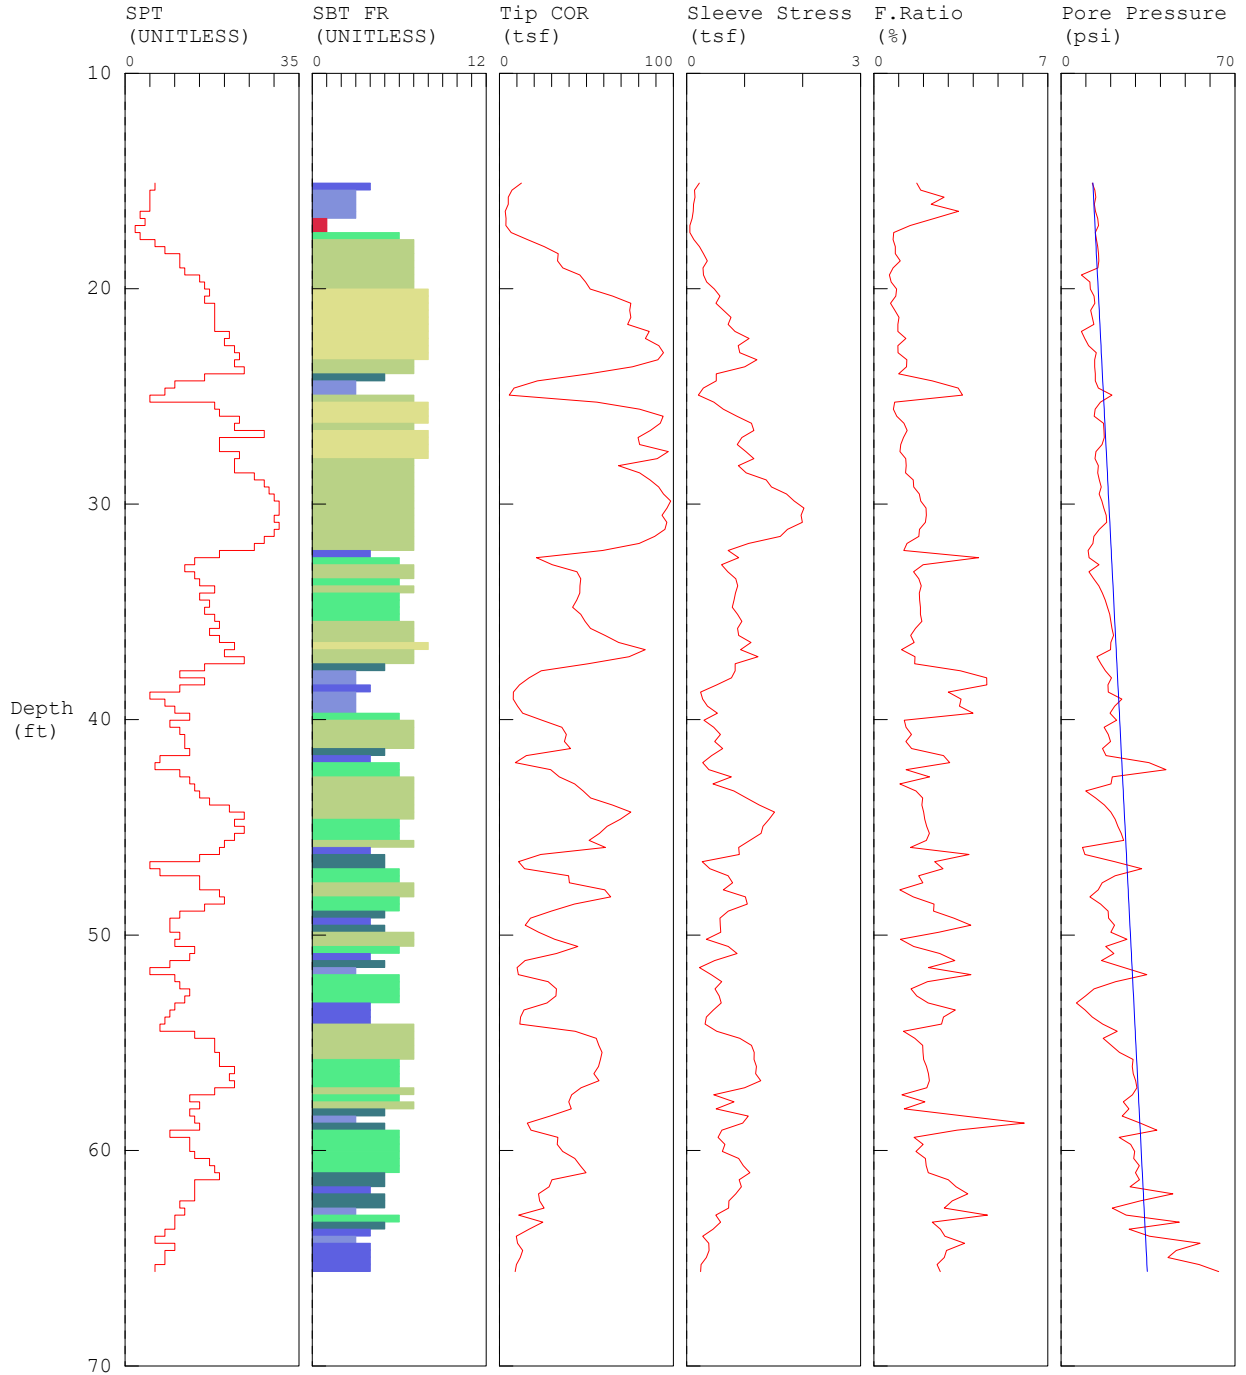
Holt Services / PDI-129b-3 CPT / 8010 NW St Helens Rd

OPERATOR: OGE DMM
 CONE ID: DDG1296
 HOLE NUMBER: PDI-129b-3 CPT
 TEST DATE: 10/24/2019 2:16:26 PM
 TOTAL DEPTH: 65.617 ft

| 1 sensitive fine gra | 4 silty clay to cl | 7 silty sand to sandy | 10 gravelly sand to sand |
| 2 organic materia | 5 clayey silt to silt | 8 sand to silty sa | 11 very stiff fine grained (*) |
| 3 clay | 6 sandy silt to claye | 9 sand | 12 sand to clayey sand (*) |

- *SBT/SPT CORRELATION: UBC-1983

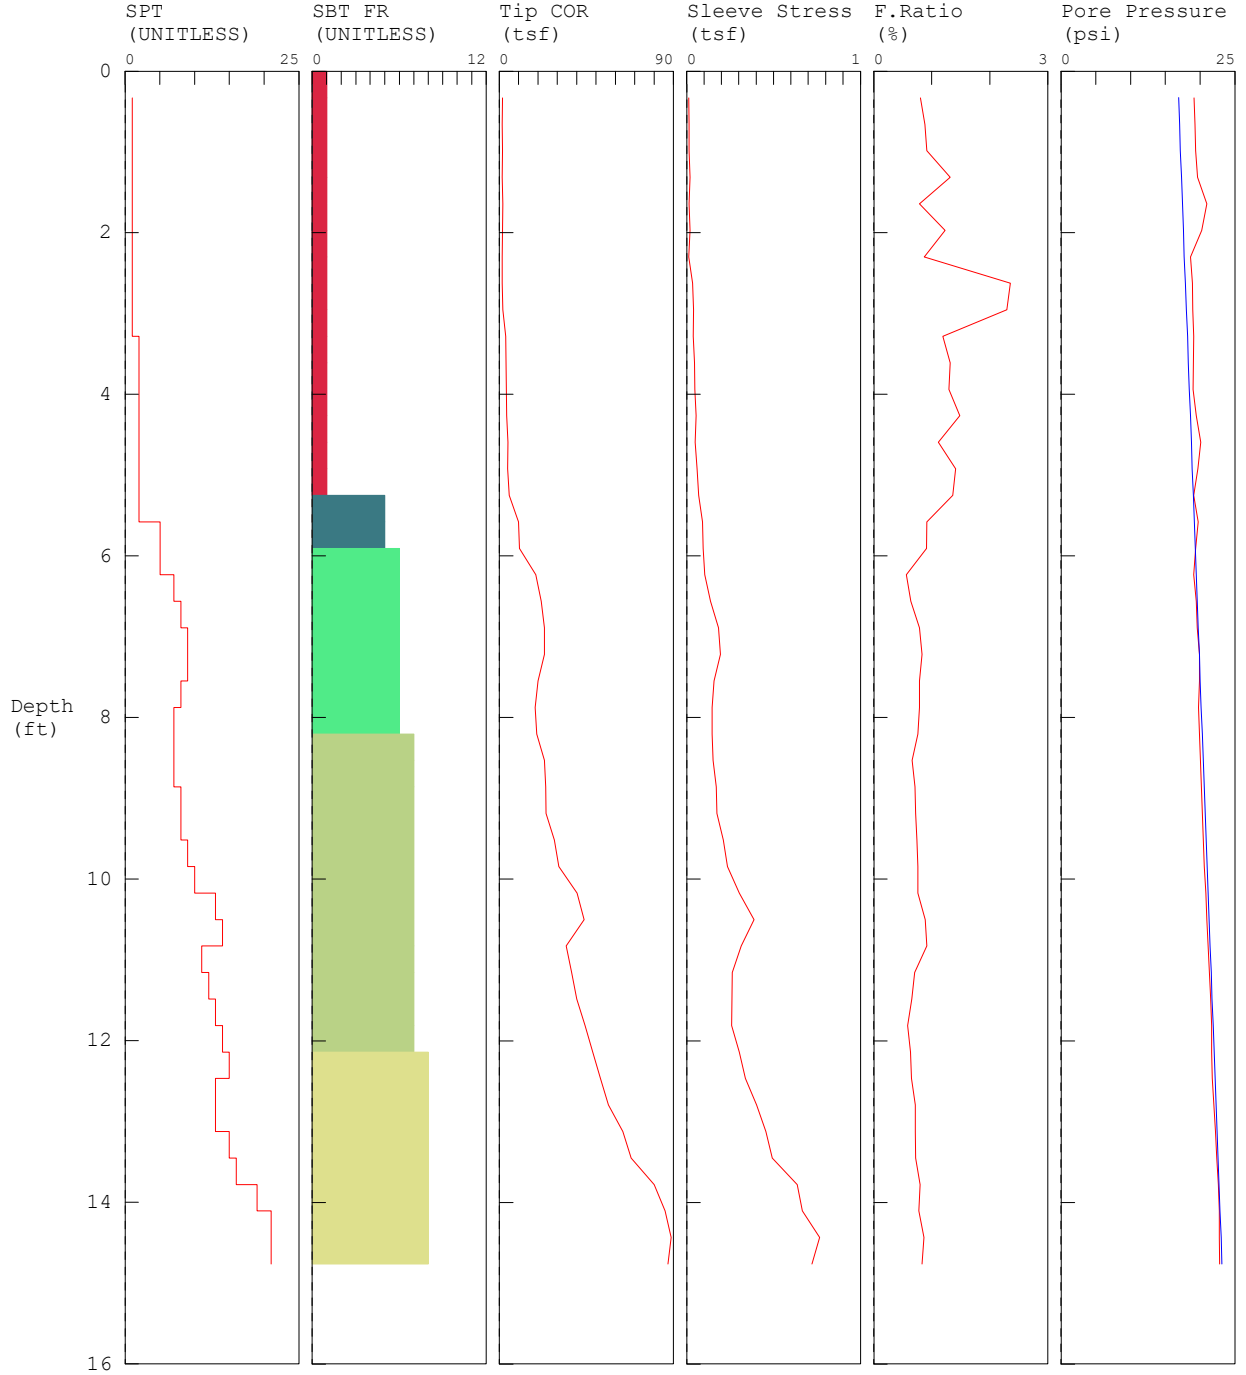
Holt Services / PDI-130 CPT / 8010 NW St Helens Rd

OPERATOR: OGE DMM
 CONE ID: DDG1296
 HOLE NUMBER: PDI-130 CPT
 TEST DATE: 10/25/2019 7:44:44 AM
 TOTAL DEPTH: 14.764 ft

| 1 | sensitive fine gra | 4 | silty clay to cl | 7 | silty sand to sandy | 10 | gravelly sand to sand |
| 2 | organic materia | 5 | clayey silt to silt | 8 | sand to silty sa | 11 | very stiff fine grained (*) |
| 3 | clay | 6 | sandy silt to claye | 9 | sand | 12 | sand to clayey sand (*) |

- *SBT/SPT CORRELATION: UBC-1983

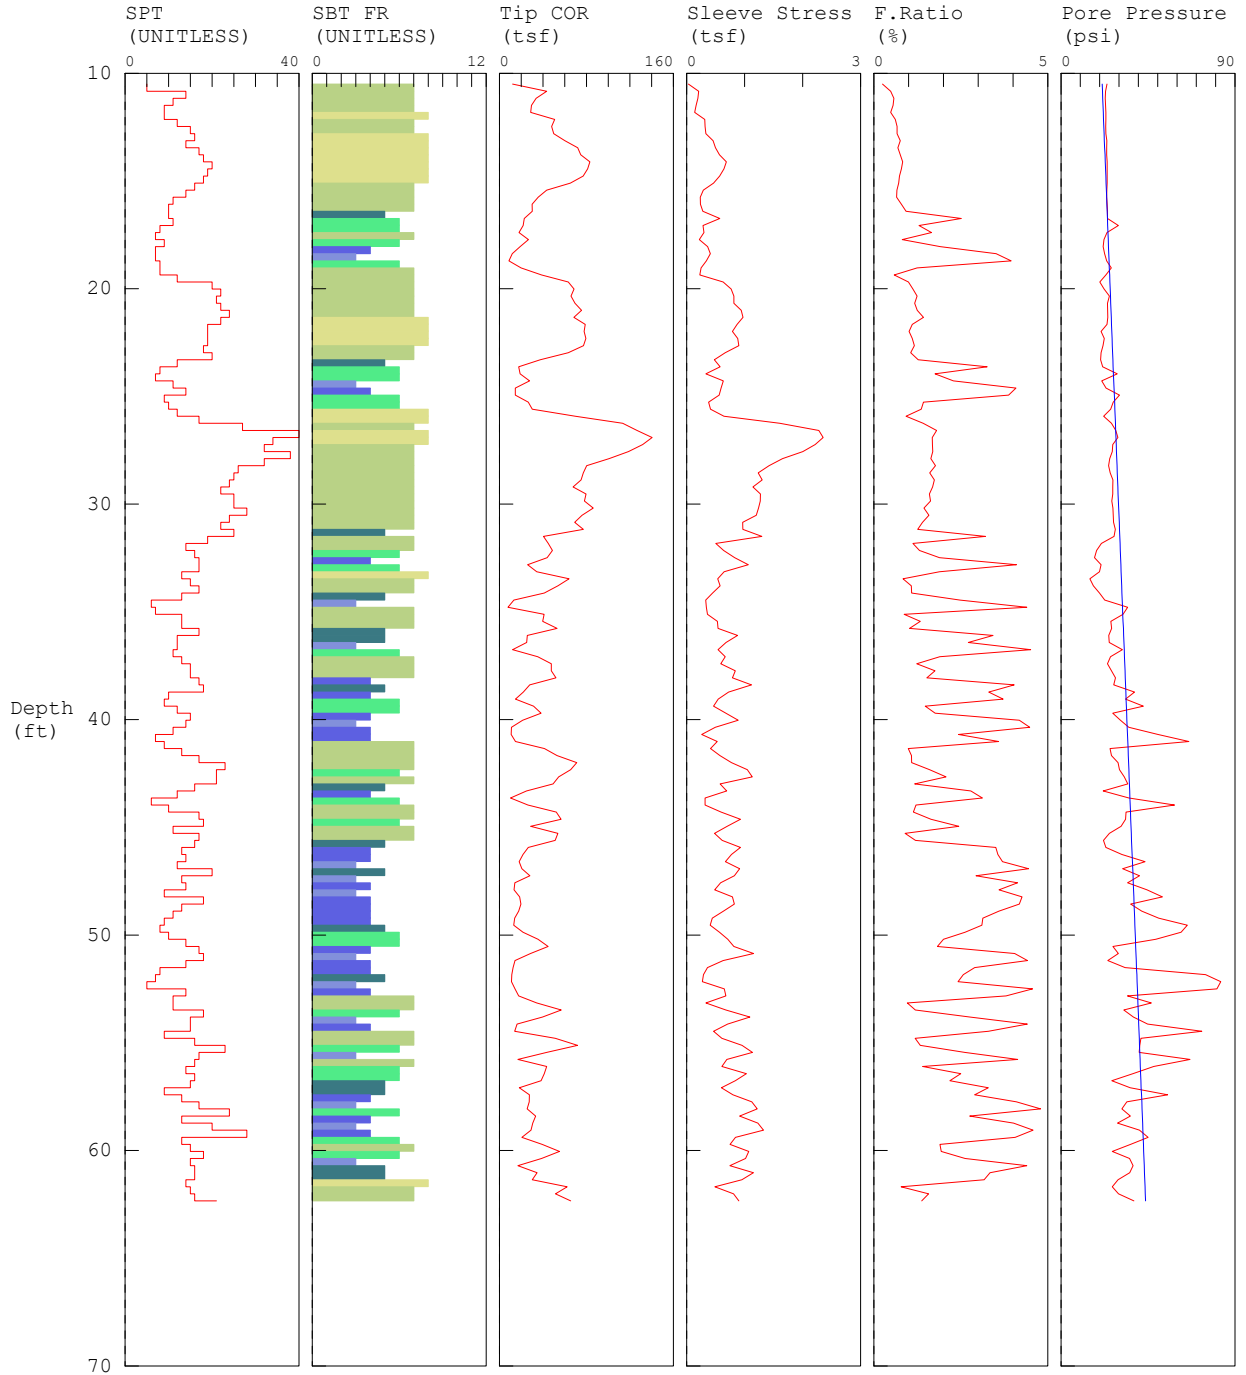
Holt Services / PDI-130b CPT / 8010 NW St Helens Rd

OPERATOR: OGE DMM
 CONE ID: DDG1296
 HOLE NUMBER: PDI-130b CPT
 TEST DATE: 10/25/2019 10:36:33 AM
 TOTAL DEPTH: 62.336 ft

1	sensitive fine gra	4	silty clay to cl	7	silty sand to sandy	10	gravelly sand to sand
2	organic materia	5	clayey silt to silt	8	sand to silty sa	11	very stiff fine grained (*)
3	clay	6	sandy silt to claye	9	sand	12	sand to clayey sand (*)

*SBT/SPT CORRELATION: UBC-1983

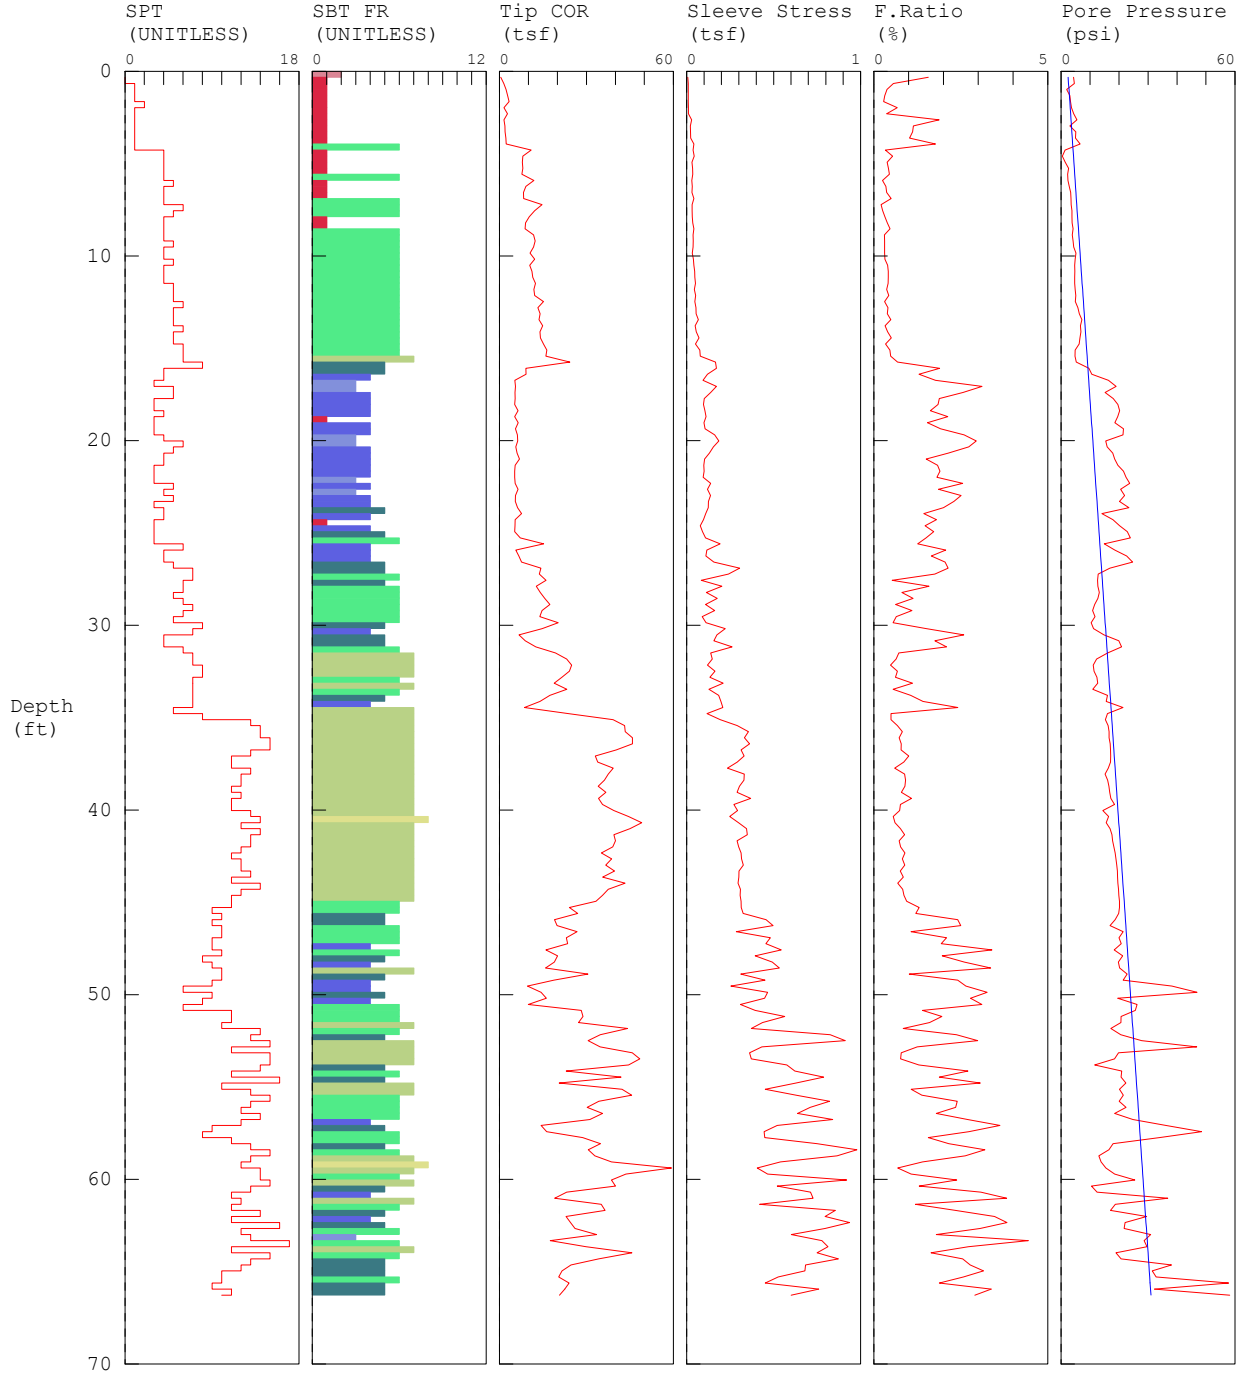
Holt Services / PDI-131 CPT / 8010 NW St Helens Rd

OPERATOR: OGE DMM
 CONE ID: DPGL323
 HOLE NUMBER: PDI-131 CPT
 TEST DATE: 10/23/2019 8:14:01 AM
 TOTAL DEPTH: 66.273 ft

| 1 | sensitive fine gra | 4 | silty clay to cl | 7 | silty sand to sandy | 10 | gravelly sand to sand |
| 2 | organic materia | 5 | clayey silt to silt | 8 | sand to silty sa | 11 | very stiff fine grained (*) |
| 3 | clay | 6 | sandy silt to claye | 9 | sand | 12 | sand to clayey sand (*) |

- *SBT/SPT CORRELATION: UBC-1983

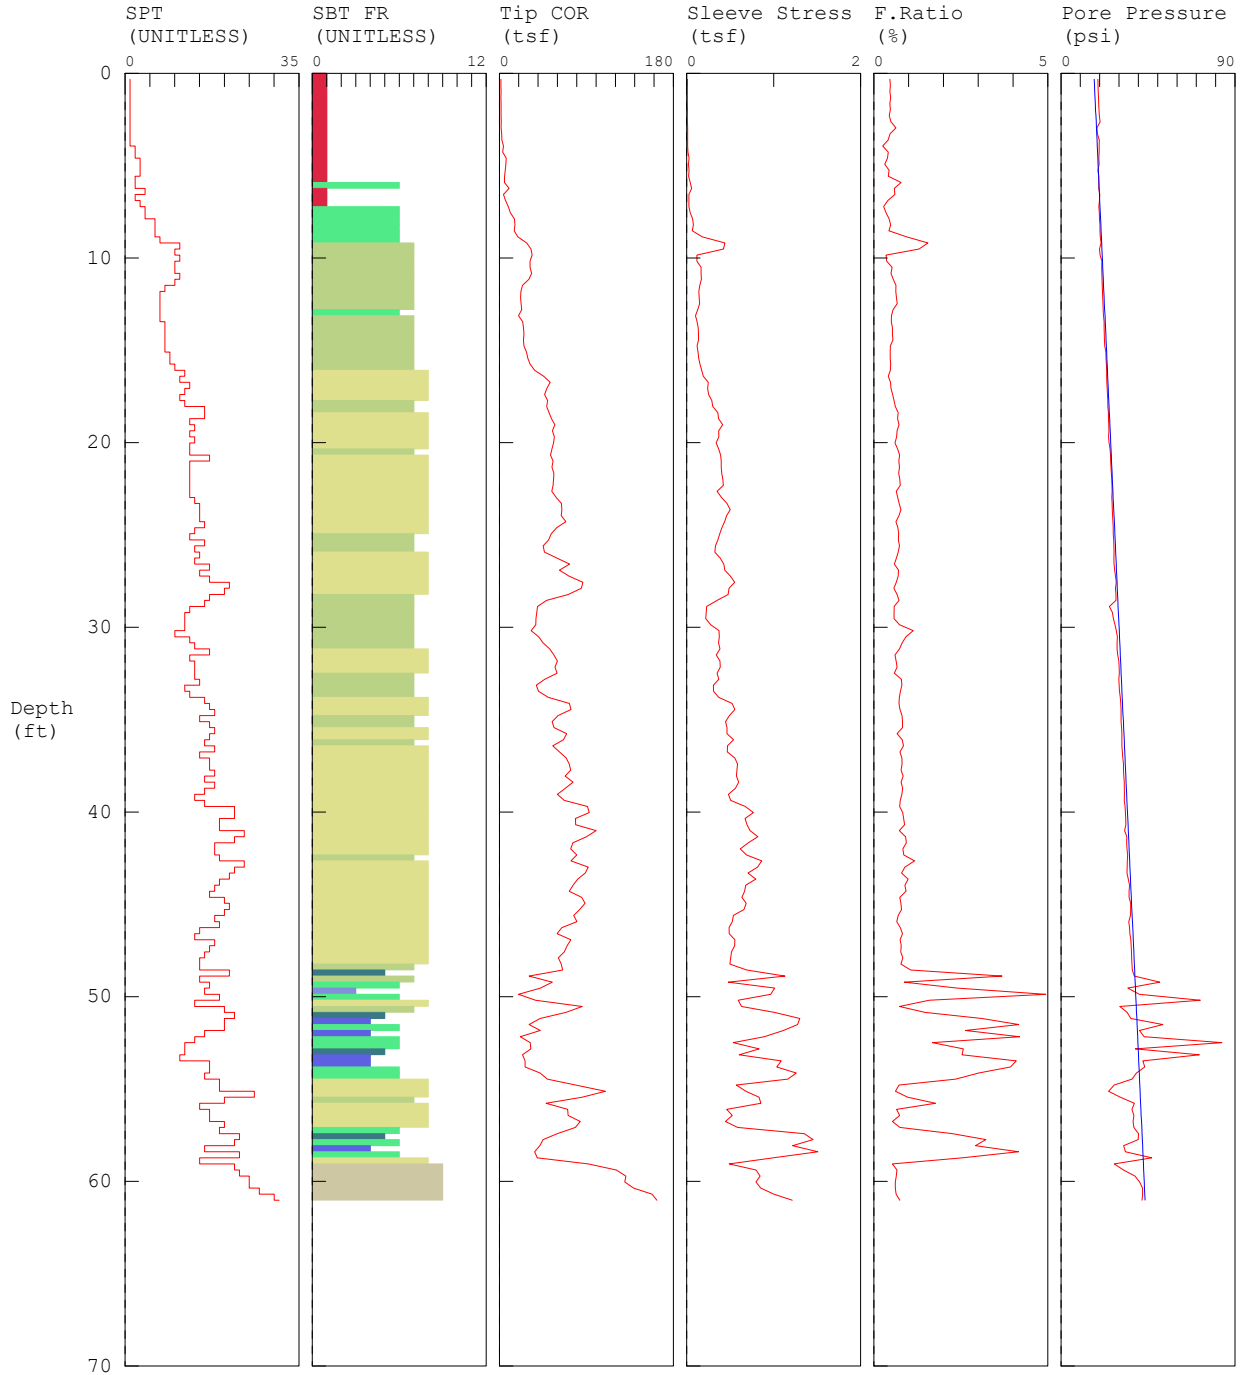
Holt Services / PDI-132 CPT / 8010 NW St Helens Rd

OPERATOR: OGE DMM
 CONE ID: DPGL323
 HOLE NUMBER: PDI-132 CPT
 TEST DATE: 10/23/2019 11:43:43 AM
 TOTAL DEPTH: 61.024 ft

| 1 | sensitive fine gra | 4 | silty clay to cl | 7 | silty sand to sandy | 10 | gravelly sand to sand |
| 2 | organic materia | 5 | clayey silt to silt | 8 | sand to silty sa | 11 | very stiff fine grained (*) |
| 3 | clay | 6 | sandy silt to claye | 9 | sand | 12 | sand to clayey sand (*) |

- *SBT/SPT CORRELATION: UBC-1983

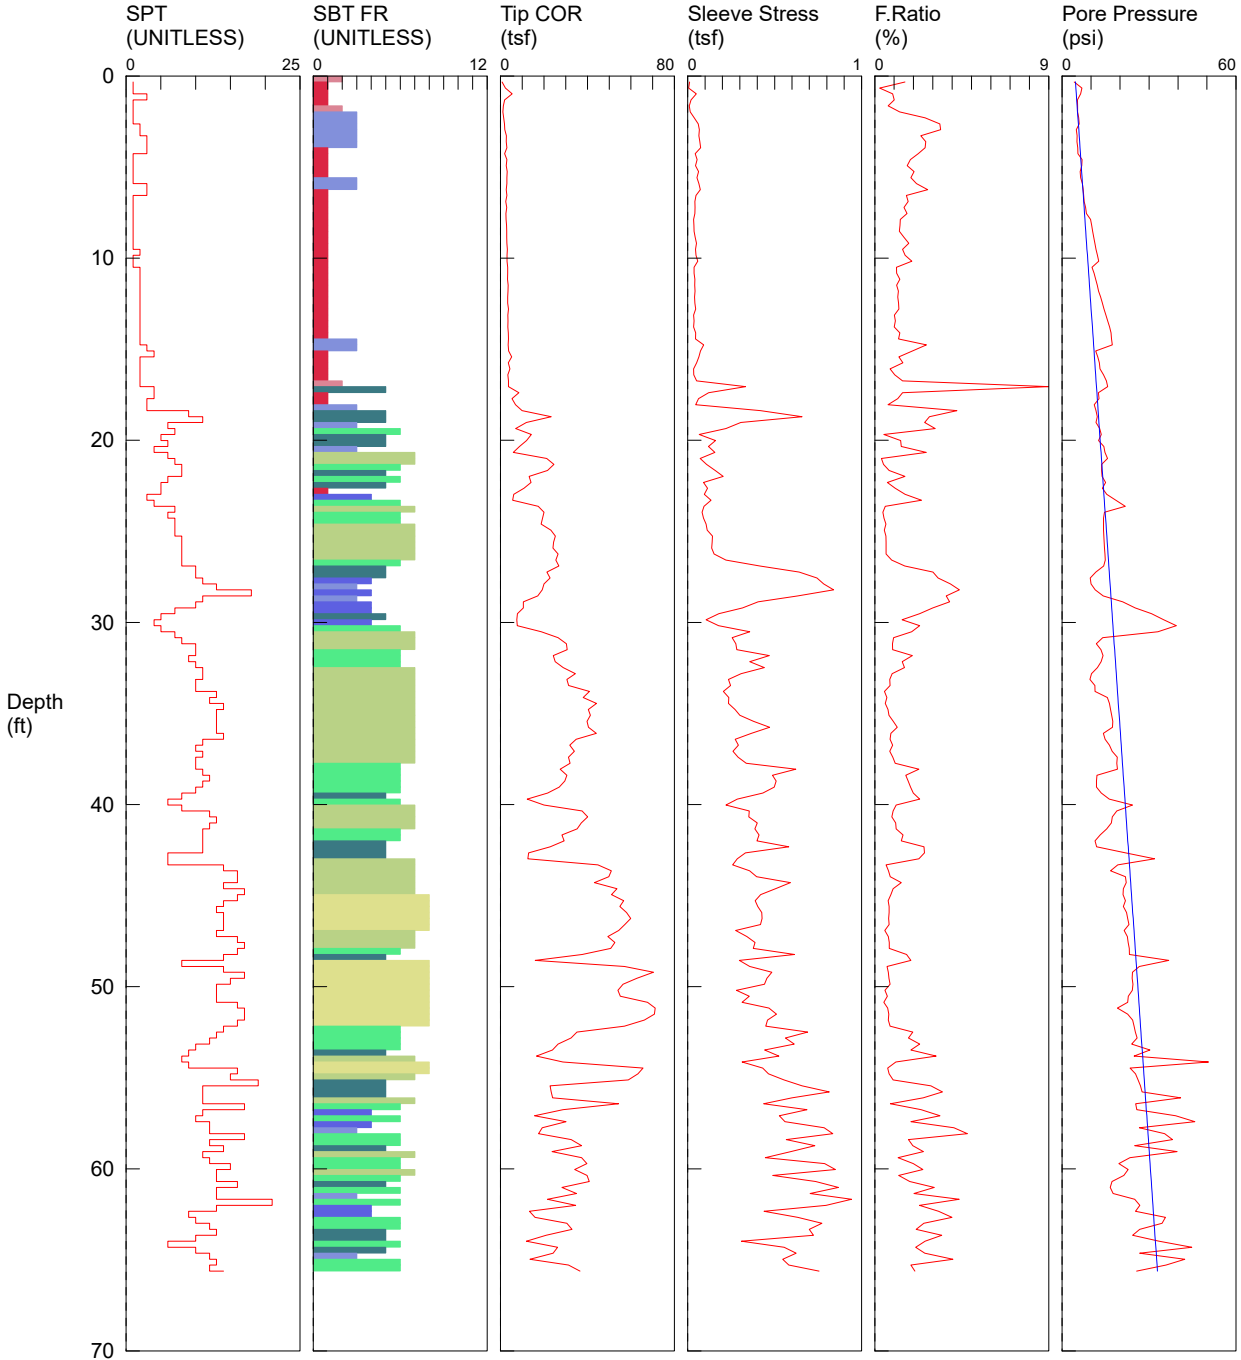
Holt Services / PDI-133d CPT / 8010 NW St Helens Rd

OPERATOR: OGE DMM
 CONE ID: DPG1323
 HOLE NUMBER: PDI-133d CPT
 TEST DATE: 10/21/2019 1:25:23 PM
 TOTAL DEPTH: 65.617 ft

| 1 sensitive fine grained | 4 silty clay to clay | 7 silty sand to sandy silt | 10 gravelly sand to sand |
| 2 organic material | 5 clayey silt to silty clay | 8 sand to silty sand | 11 very stiff fine grained (*) |
| 3 clay | 6 sandy silt to clayey silt | 9 sand | 12 sand to clayey sand (*) |

*SBT/SPT CORRELATION: UBC-1983
