Holt Services / PDI-124 CPT / 8010 NW St Helens Rd

OPERATOR: OGE DMM
 CONE ID: DPG1386
 HOLE NUMBER: PDI-124 CPT
 TEST DATE: 10/17/2019 1:47:45 PM
 TOTAL DEPTH: 65.617 ft

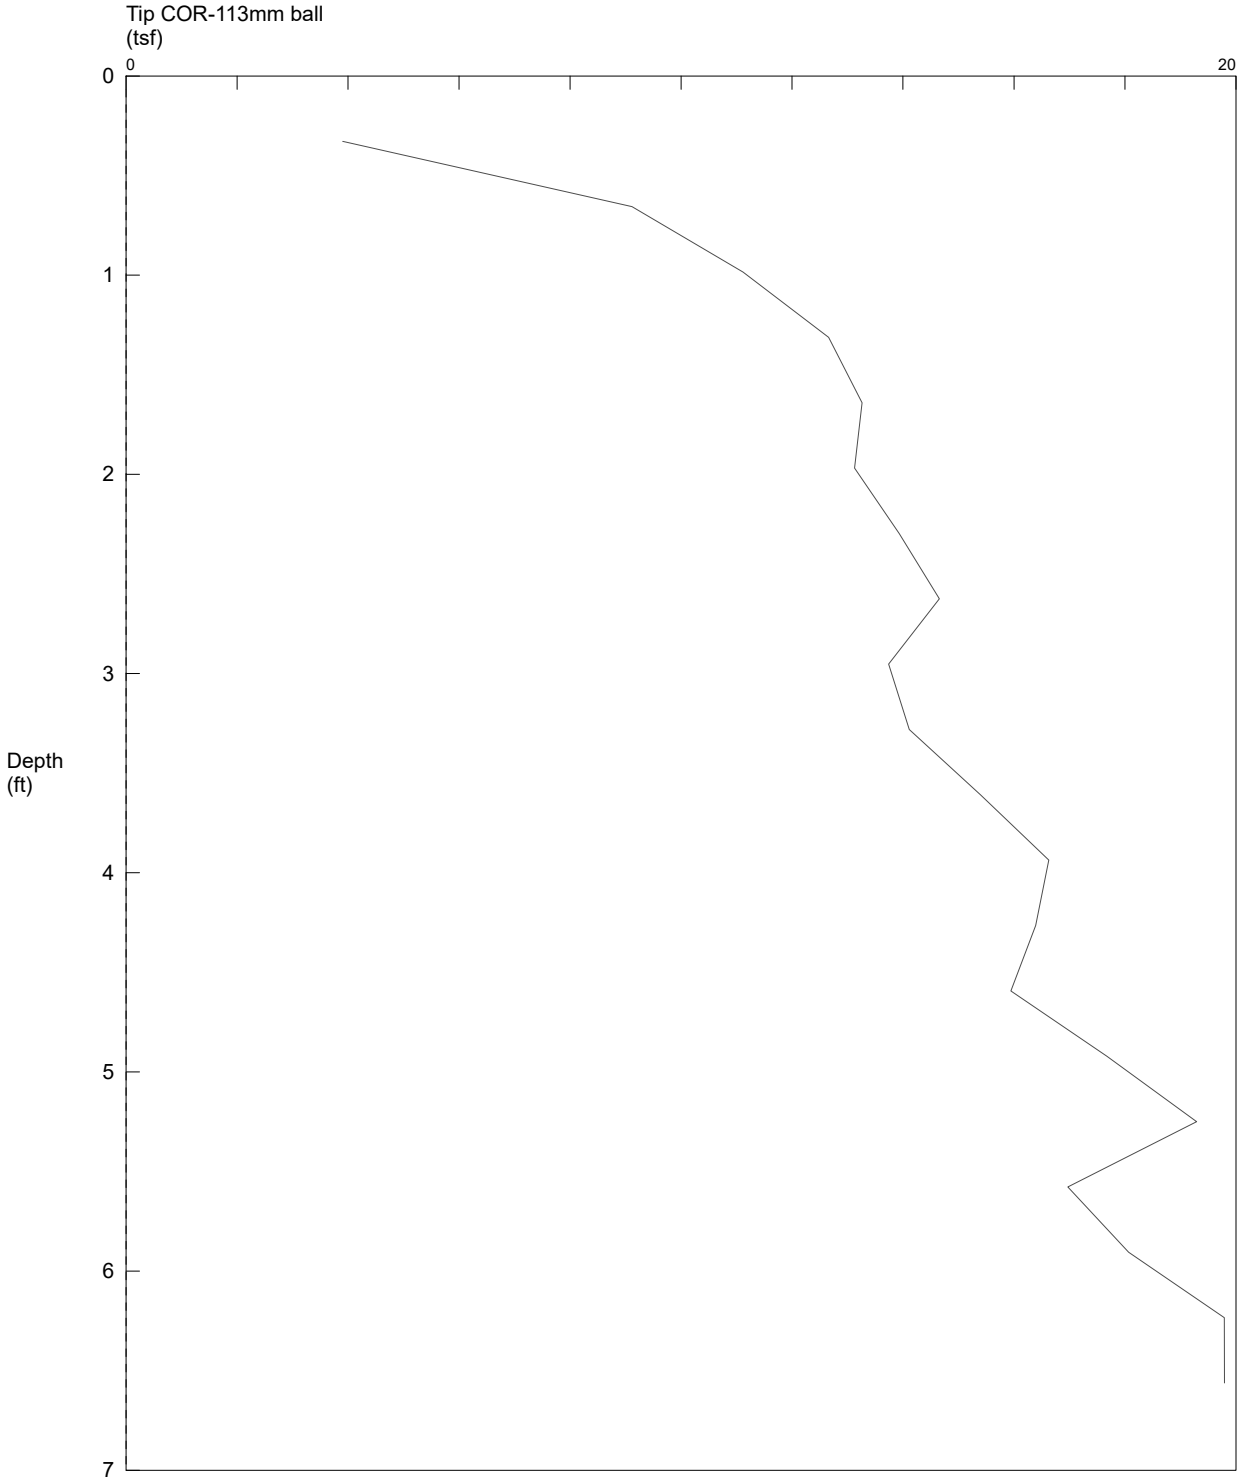
Holt Services / PDI-124 FFP / 8010 NW St Helens Rd

OPERATOR: OGE DMM
CONE ID: DPG1386
HOLE NUMBER: PDI-124 FFP
TEST DATE: 10/17/2019 4:31:21 PM
TOTAL DEPTH: 6.562 ft

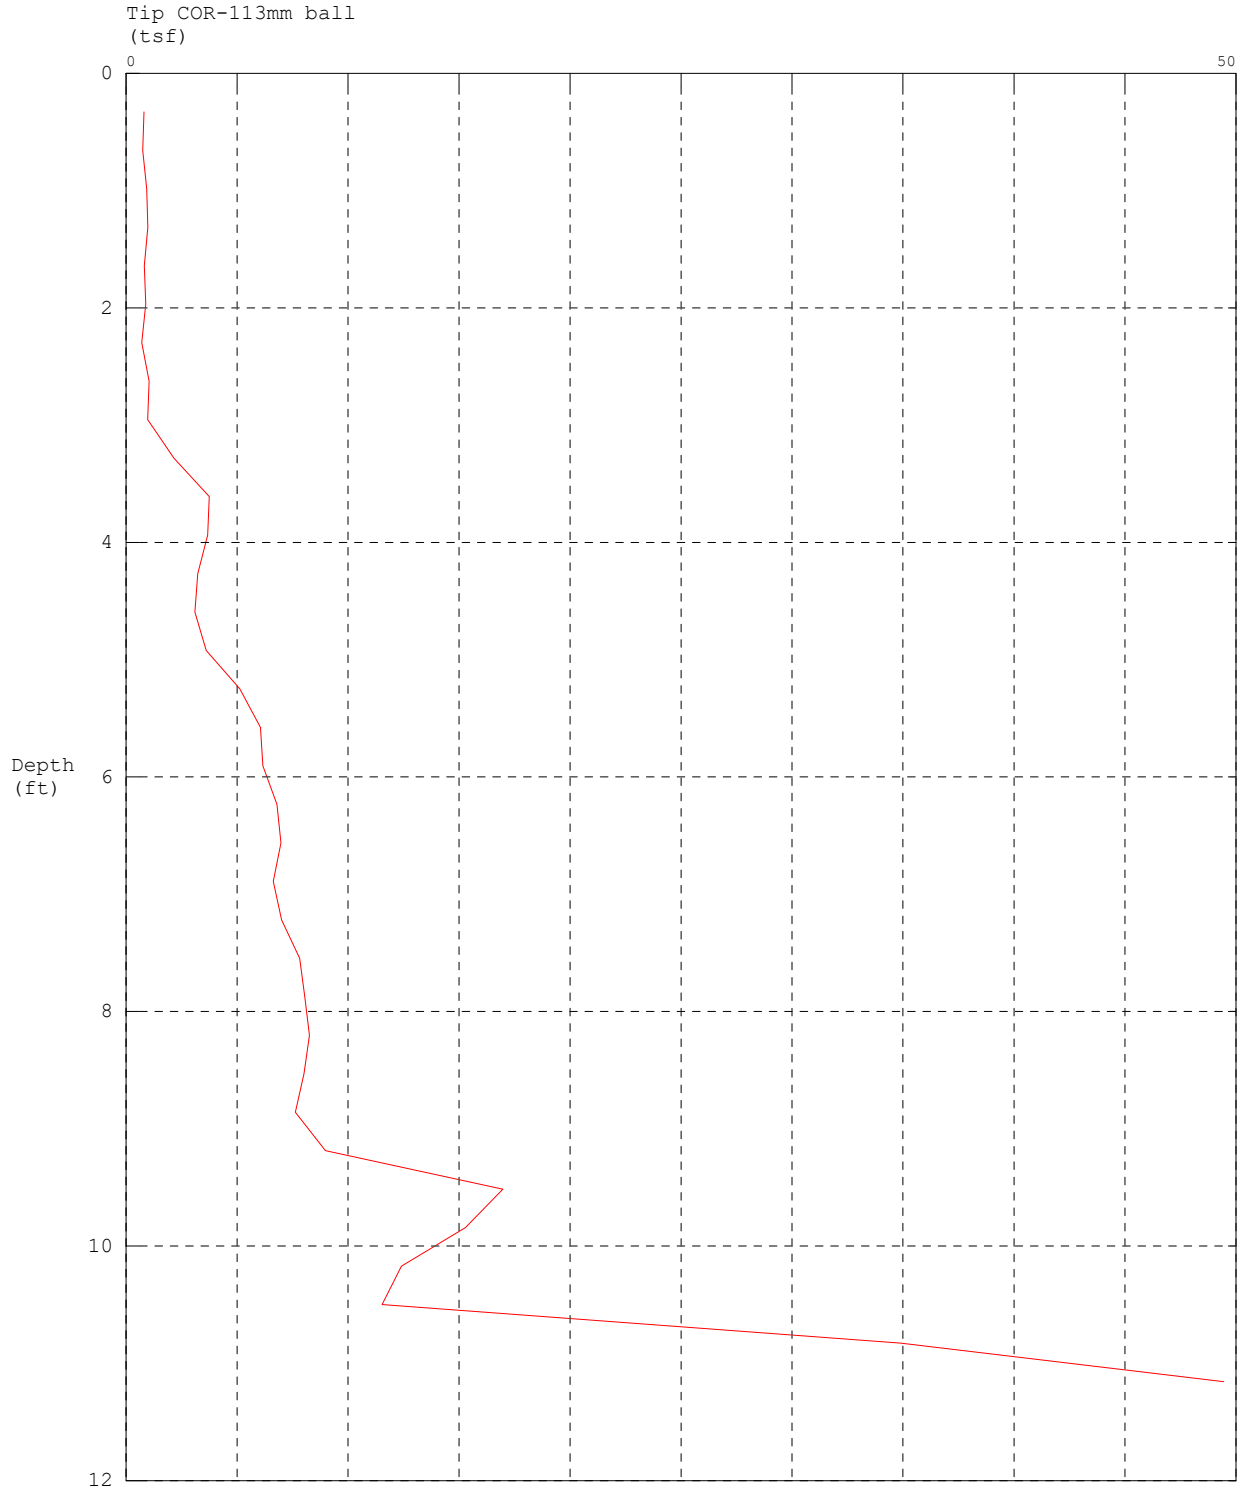
Holt Services / PDI-125 FFP / 8010 NW St Helens Rd

OPERATOR: OGE DMM
CONE ID: DPGL323
HOLE NUMBER: PDI-125 FFP
TEST DATE: 10/22/2019 4:10:01 PM
TOTAL DEPTH: 11.155 ft

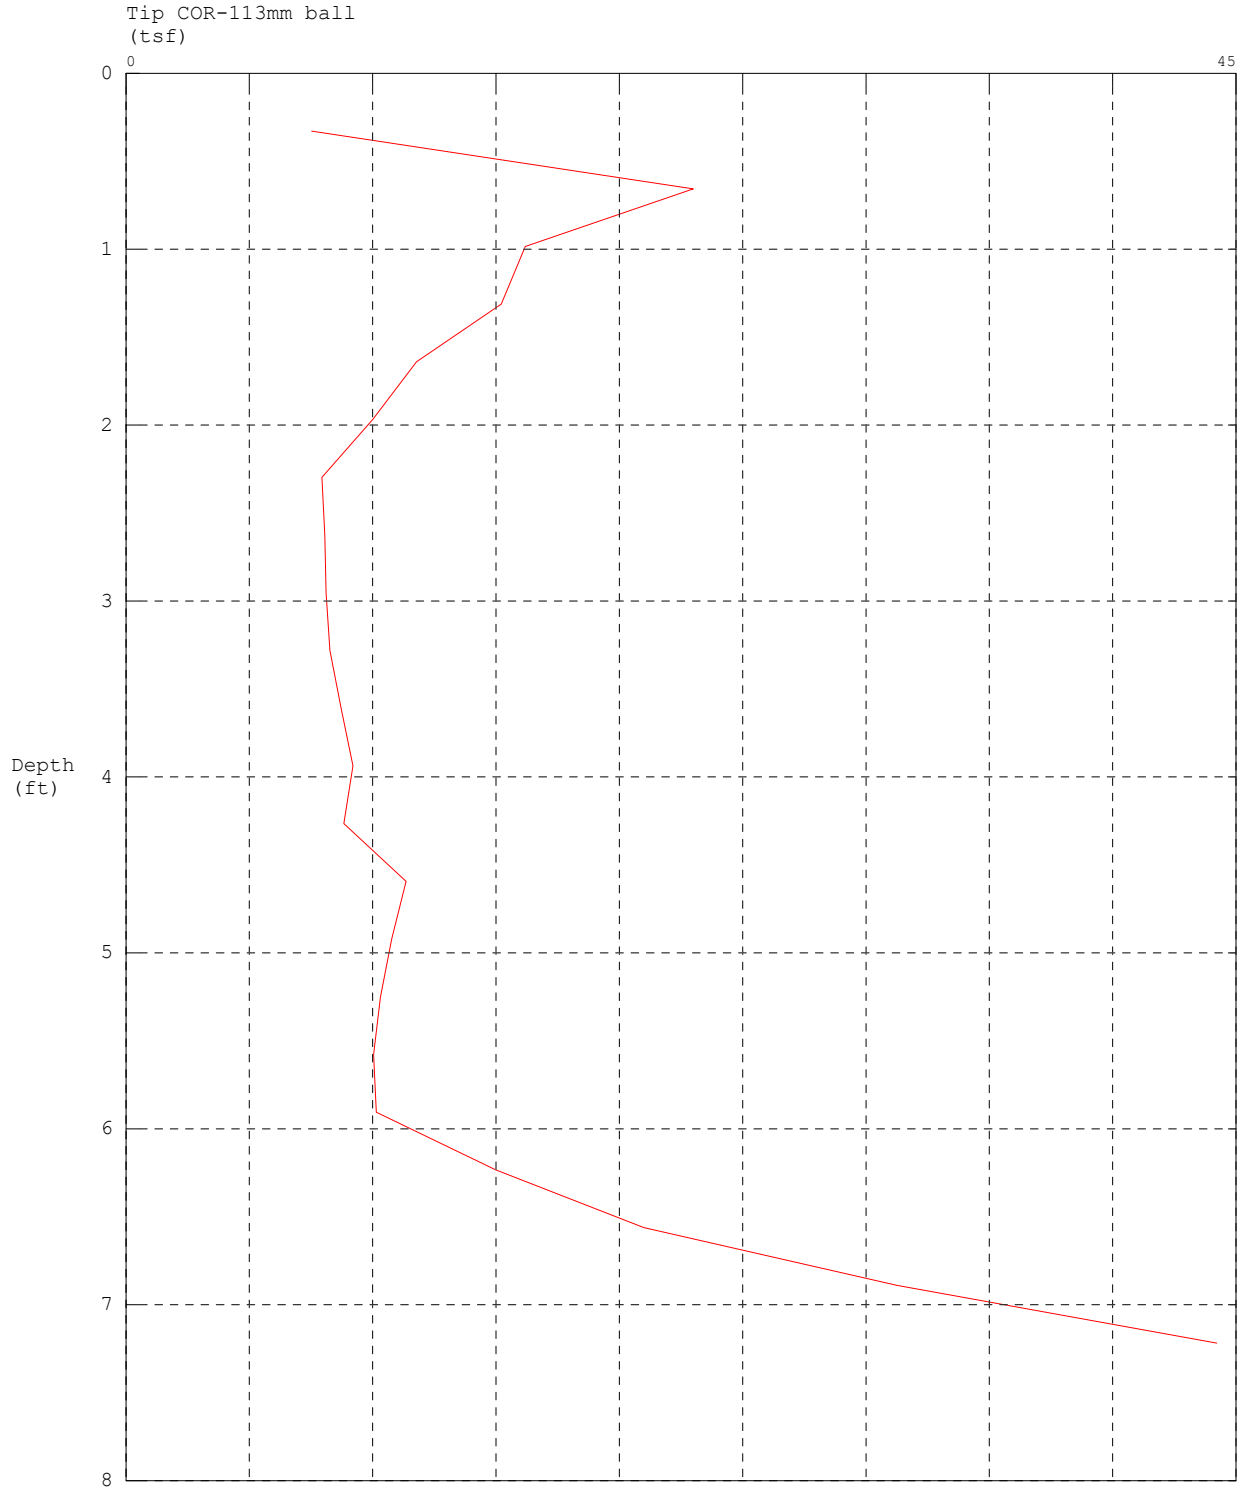
Holt Services / PDI-126 FFP / 8010 NW St Helens Rd

OPERATOR: OGE DMM
CONE ID: DPGL323
HOLE NUMBER: PDI-126 FFP
TEST DATE: 10/22/2019 4:58:41 PM
TOTAL DEPTH: 7.218 ft

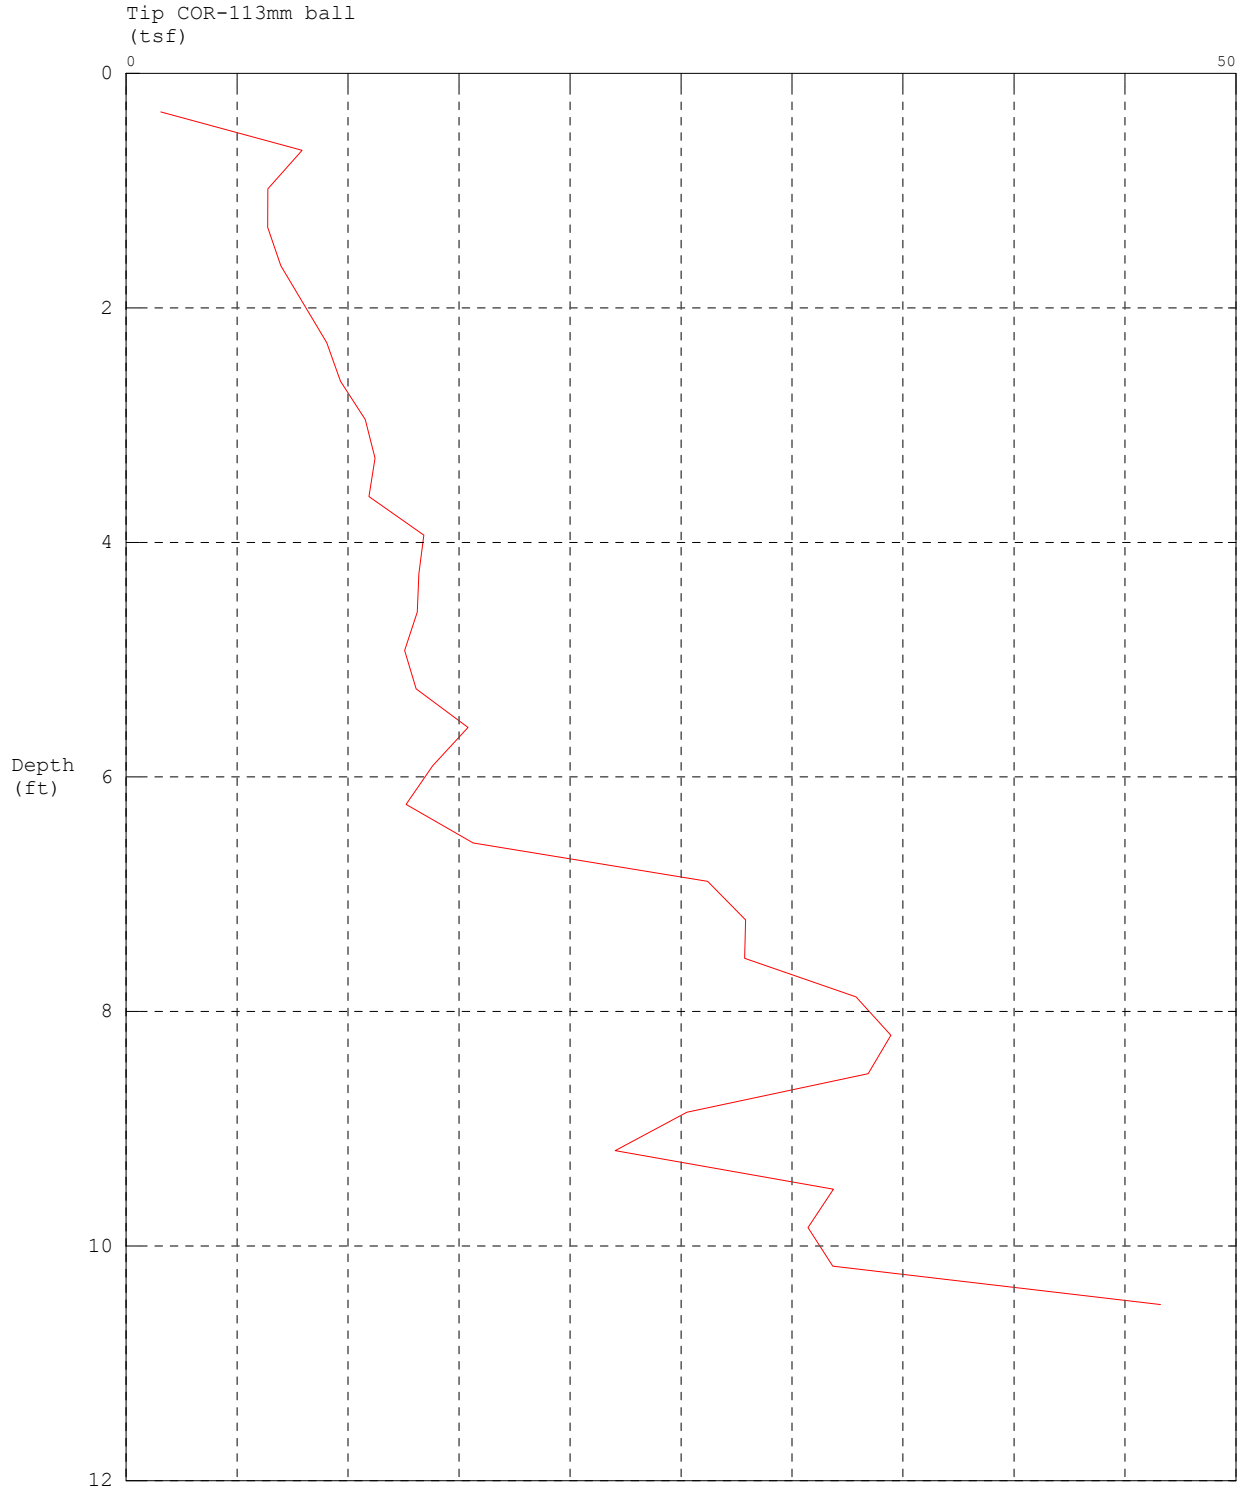
Holt Services / PDI-127 FFP / 8010 NW St Helens Rd

OPERATOR: OGE DMM
CONE ID: DDG1296
HOLE NUMBER: PDI-127 FFP
TEST DATE: 10/25/2019 4:13:20 PM
TOTAL DEPTH: 10.499 ft

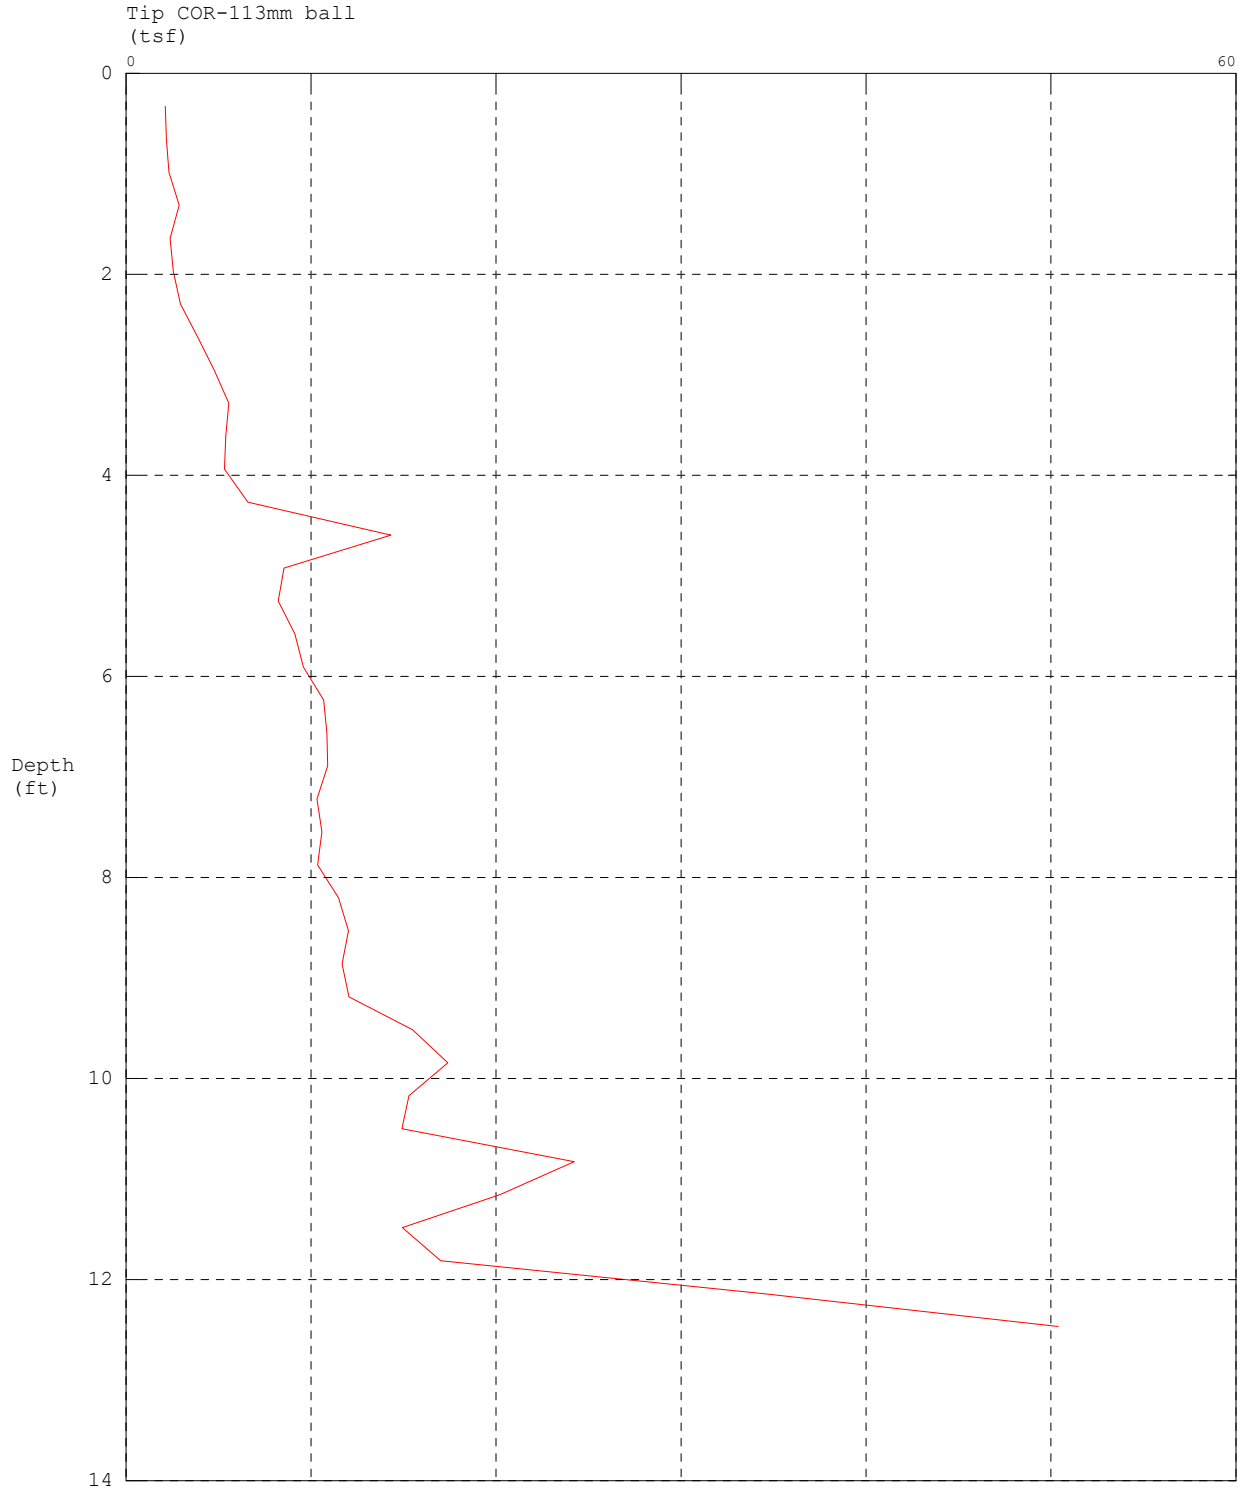
Holt Services / PDI-128a FFP / 8010 NW St Helens Rd

OPERATOR: OGE DMM
CONE ID: DPG1323
HOLE NUMBER: PDI-128a FFP
TEST DATE: 10/18/2019 4:50:52 PM
TOTAL DEPTH: 12.467 ft

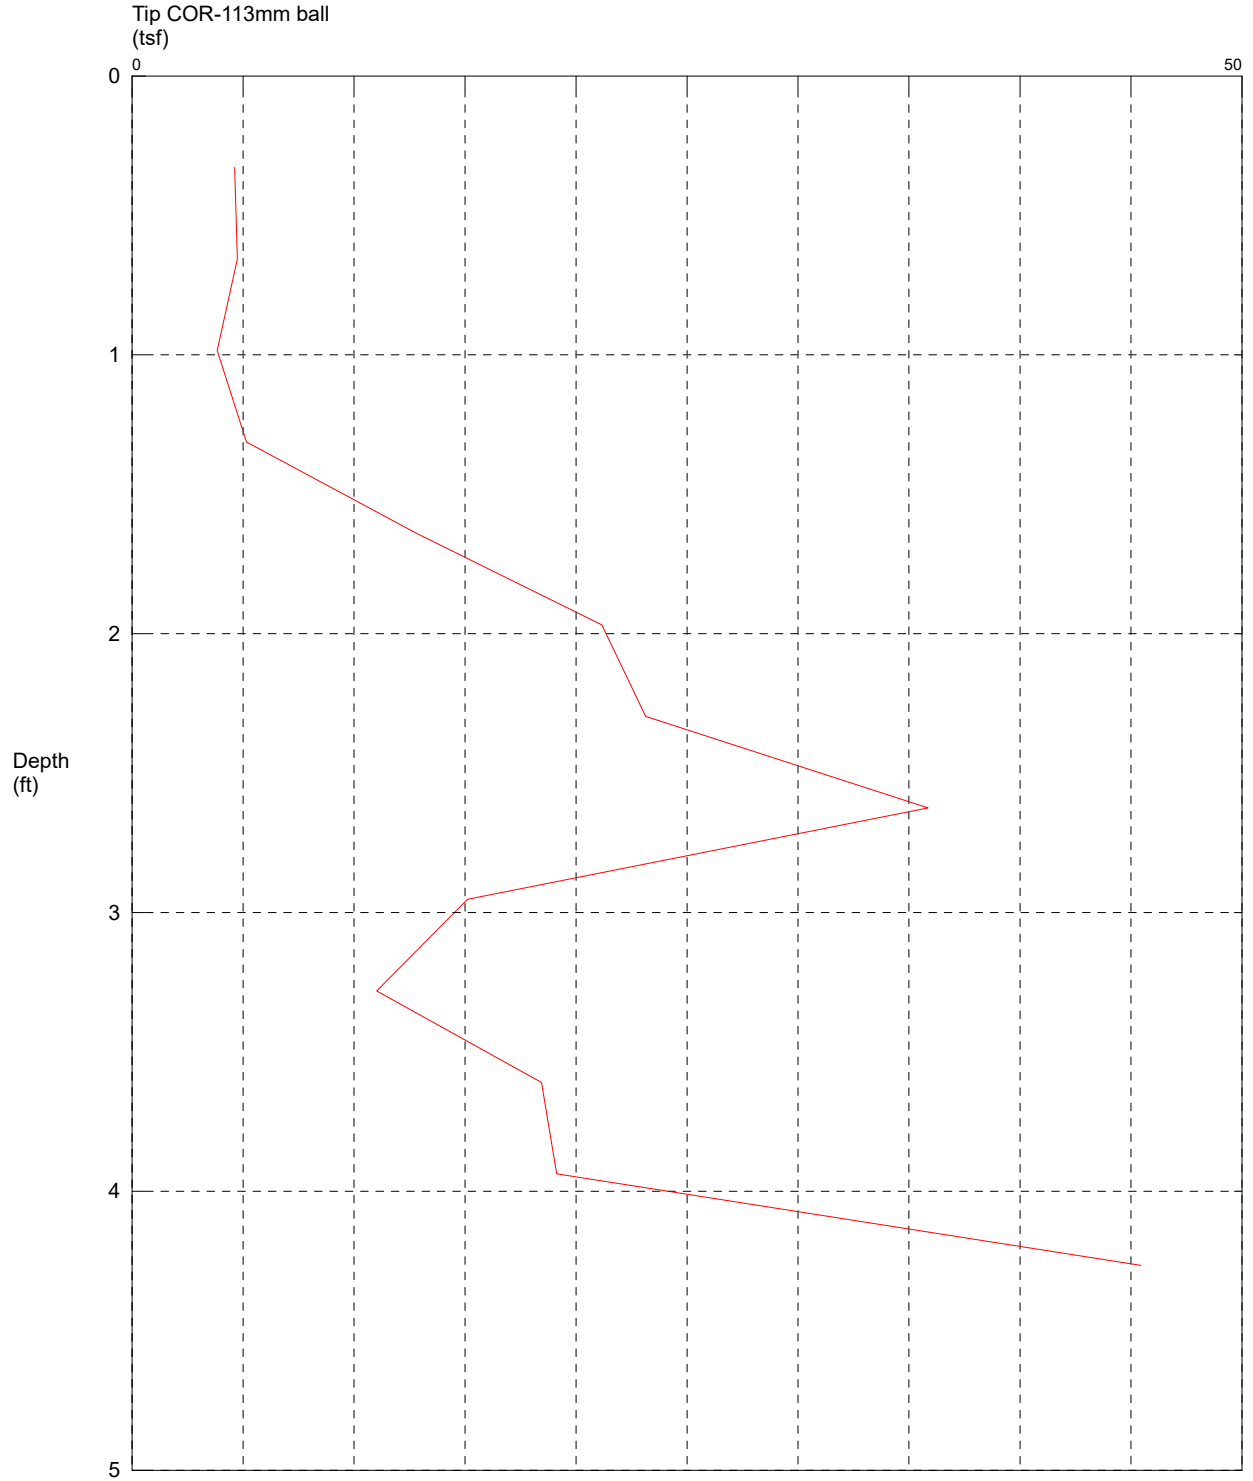
Holt Services / PDI-129 FFP / 8010 NW St Helens Rd

OPERATOR: OGE DMM
CONE ID: DDG1296
HOLE NUMBER: PDI-129 FFP
TEST DATE: 10/24/2019 3:54:48 PM
TOTAL DEPTH: 4.265 ft

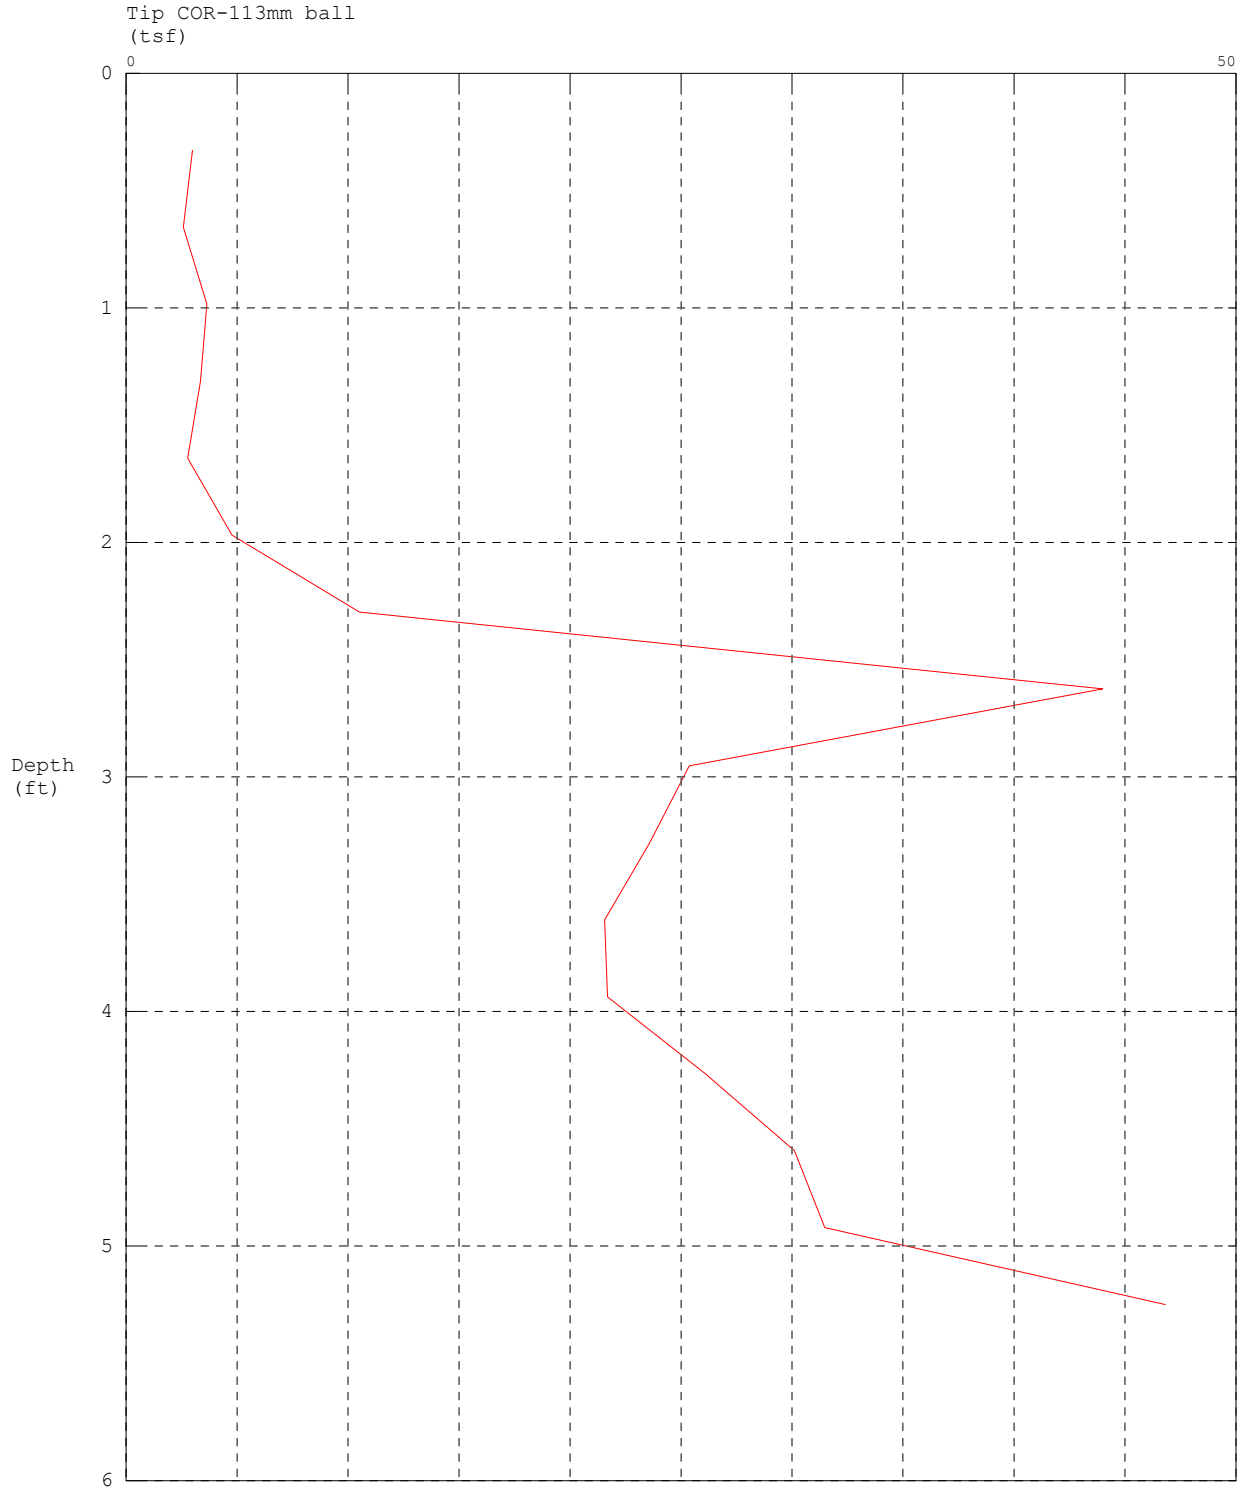
Holt Services / PDI-130 FFP / 8010 NW St Helens Rd

OPERATOR: OGE DMM
CONE ID: DDG1296
HOLE NUMBER: PDI-130 FFP
TEST DATE: 10/24/2019 4:41:16 PM
TOTAL DEPTH: 5.249 ft

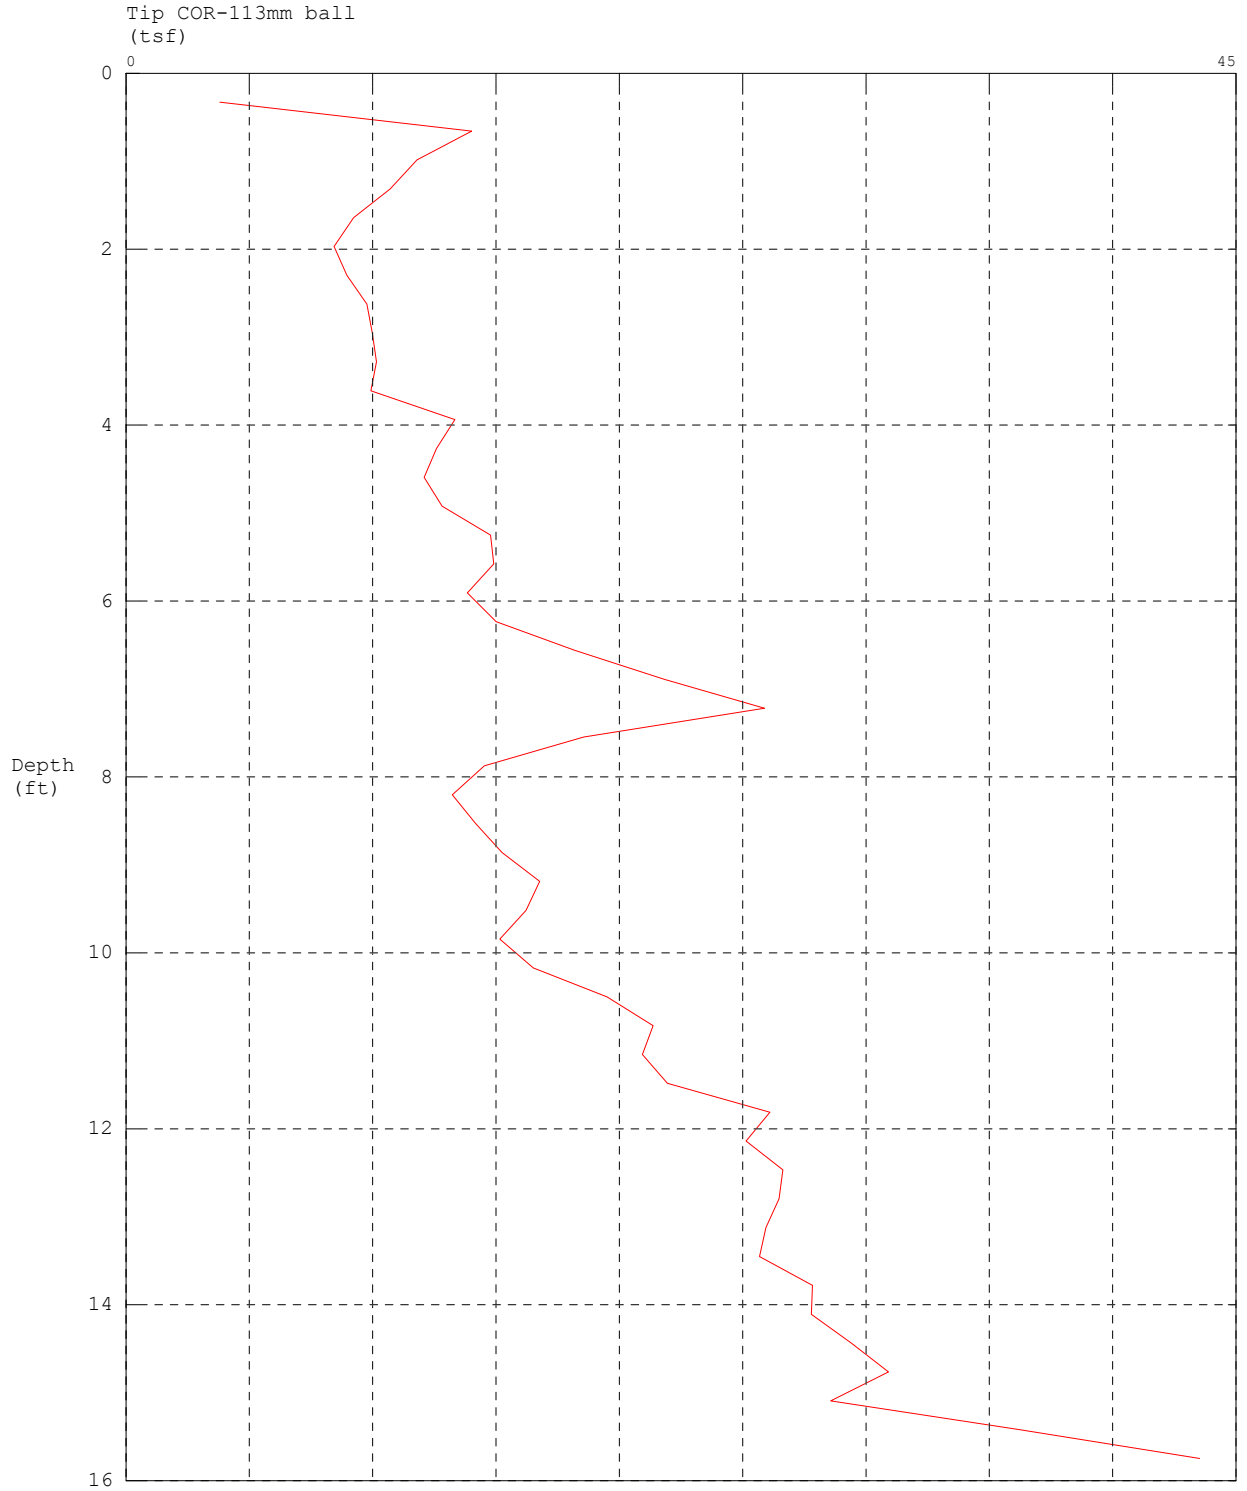
Holt Services / PDI-131 FFP / 8010 NW St Helens Rd

OPERATOR: OGE DMM
CONE ID: DPGL323
HOLE NUMBER: PDI-131 FFP
TEST DATE: 10/23/2019 10:59:11 AM
TOTAL DEPTH: 15.748 ft

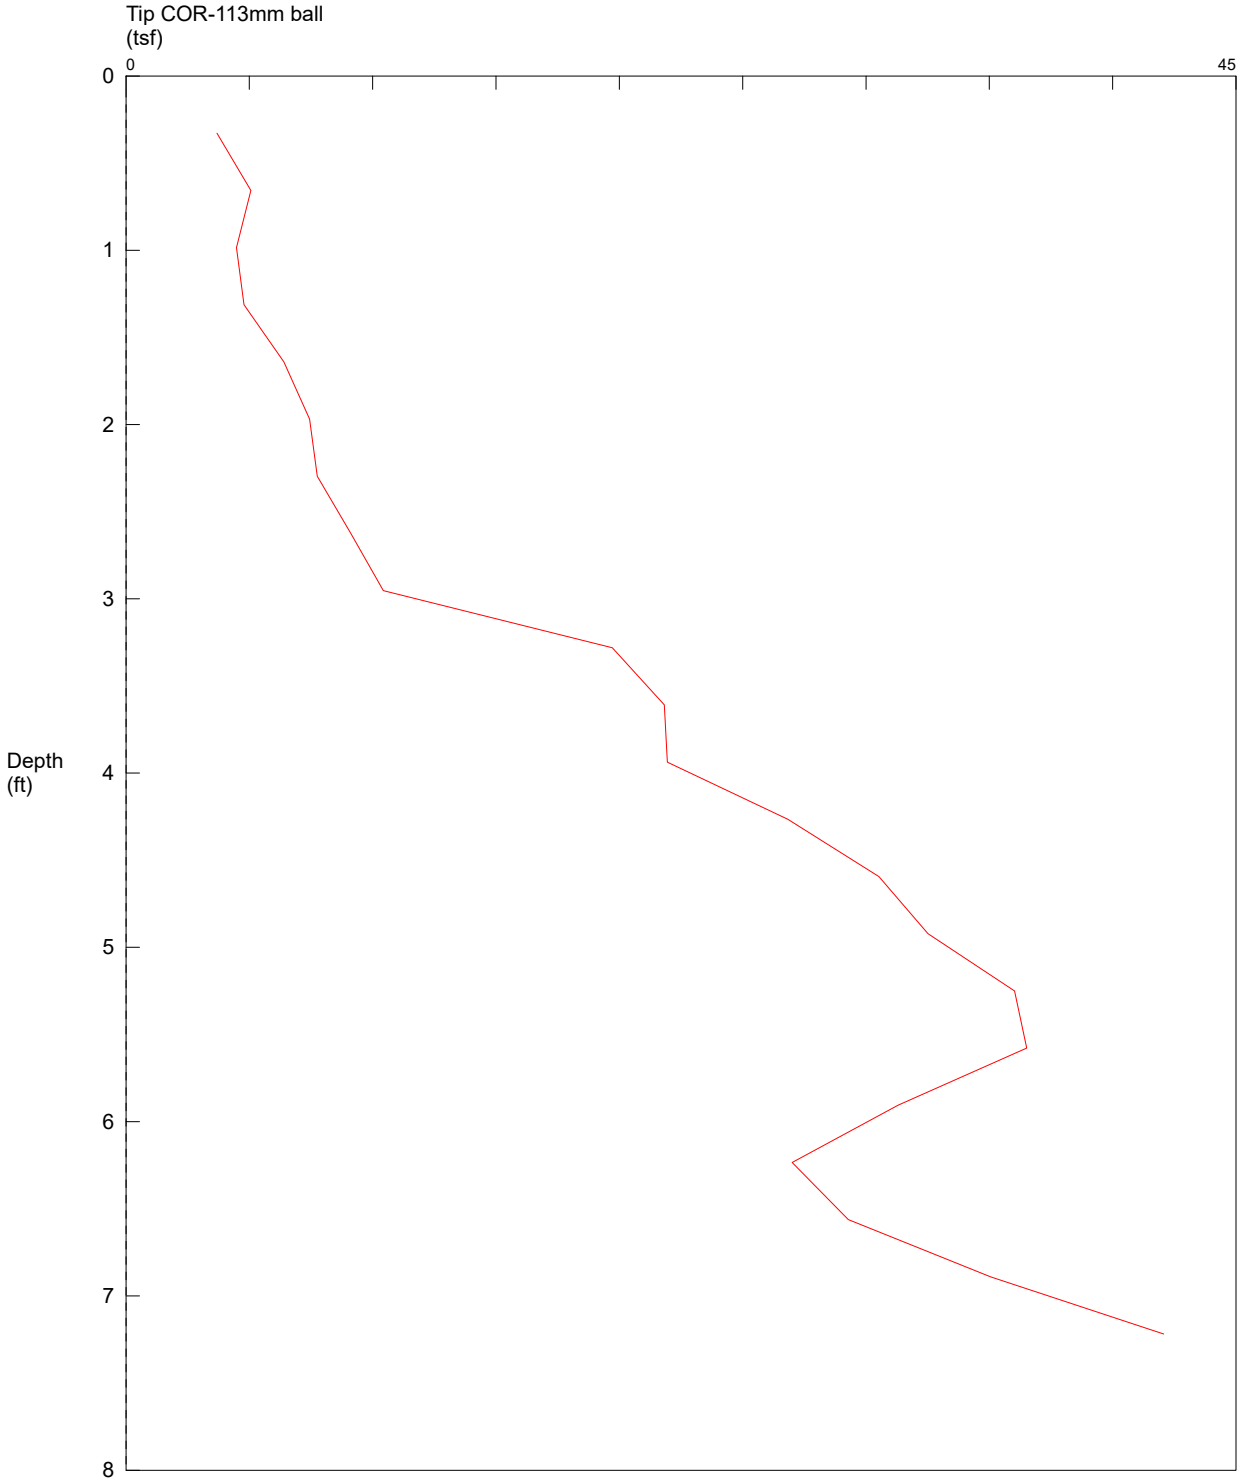
Holt Services / PDI-132 FFP / 8010 NW St Helens Rd

OPERATOR: OGE DMM
CONE ID: DDG1296
HOLE NUMBER: PDI-132 FFP
TEST DATE: 10/24/2019 9:12:06 AM
TOTAL DEPTH: 7.218 ft

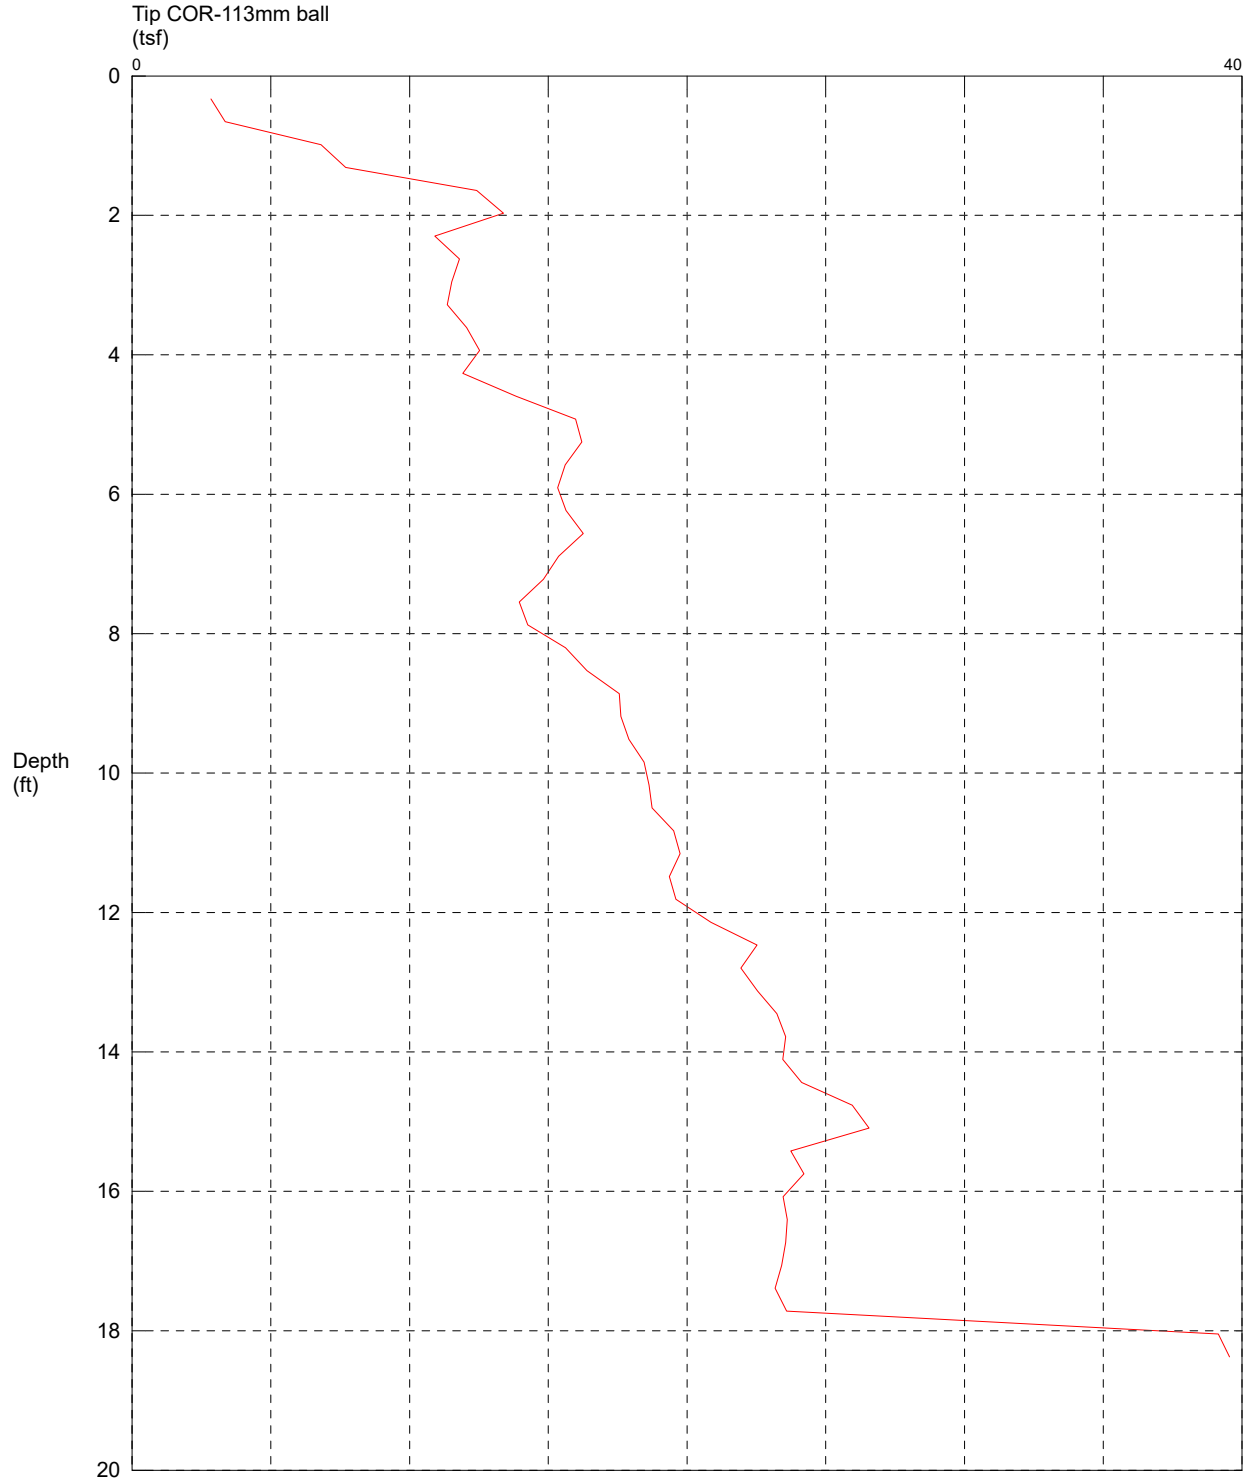
Holt Services / PDI-133 FFP / 8010 NW St Helens Rd

OPERATOR: OGE DMM
CONE ID: DPG1323
HOLE NUMBER: PDI-133 FFP
TEST DATE: 10/22/2019 11:25:28 AM
TOTAL DEPTH: 18.373 ft
