**Final Report No. 605601**  
**Report Date: July 2016**

## **Development of Delineator Material/Impact Testing Specific to Managed Lane Use for Optimization of Service Life**

Sponsored by  
**State of Florida Department of Transportation**

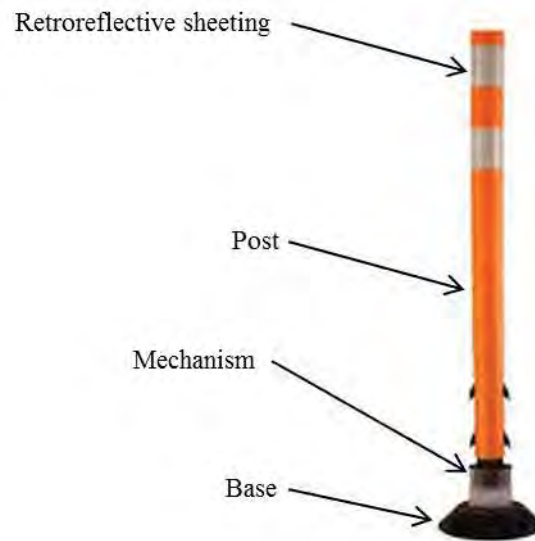
Delineators have four main parts: the retroreflective sheeting (required for nighttime use), the post (can be various colors), the mechanism that connects the post and the base (typically a proprietary component), and the base. Figure 1 shows these parts that compose one delineator.

**Figure 1. Delineator Parts**

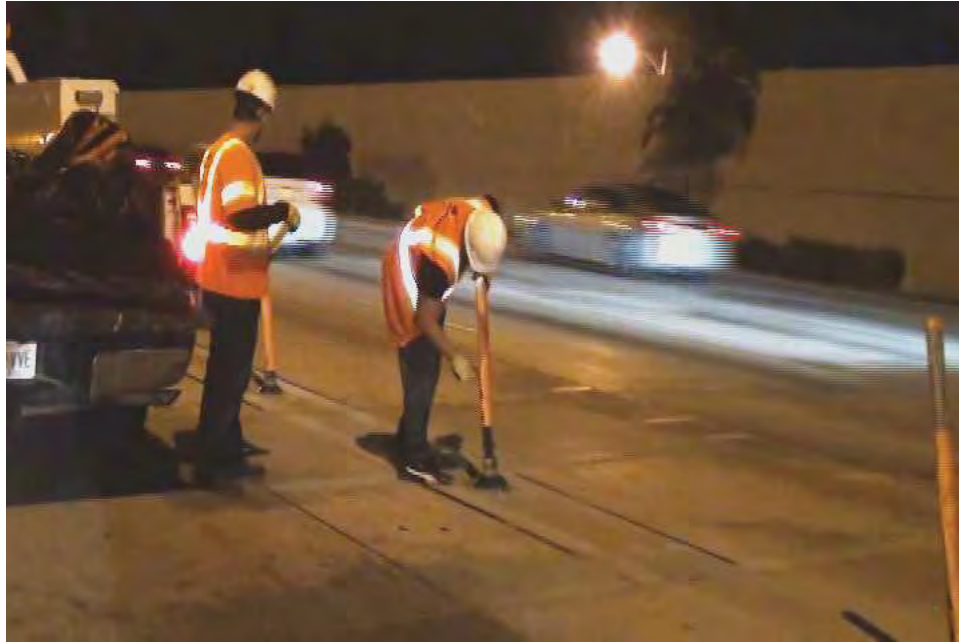
The first three failure modes (sheeting failure, post failure to restore, and post failure at connection) comprised 84 percent of the repair/replace activities witnessed in Phase 1. All of these failures required replacement of the post to correct. The workers used a cutting tool to remove any portions of the failed posts (as shown in Figure 3) and attached the new post by shoving it down onto the connector. Each of these repairs took about 15 seconds for one worker to perform.

**Figure 3. Sheeting Failure and Post Failure Replacement.**

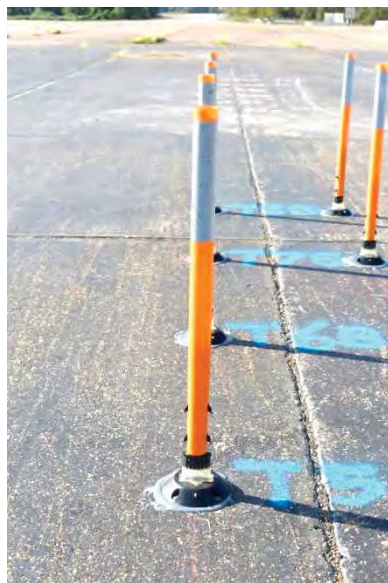
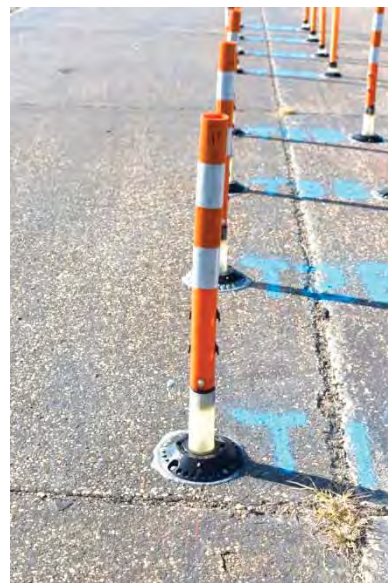
The products currently installed in the I-95 corridor were tested according to the procedure established in Texas A&M Transportation Institute (TTI)/Texas Department of Transportation (TxDOT) Research report 0-6772-1, which is based on the existing National Transportation Product Evaluation Program (NTPEP) Temporary Traffic Control Devices (TTCDD) evaluation standard (1). Figure 6 shows the products installed at the TTI testing facility.

(a) Phase 1 delineator  
(42-in Flexstake TM754)

(b) Phase 2 delineator  
(36-in Flexstake TM754)

**Figure 6. Products Tested during Task 1.**

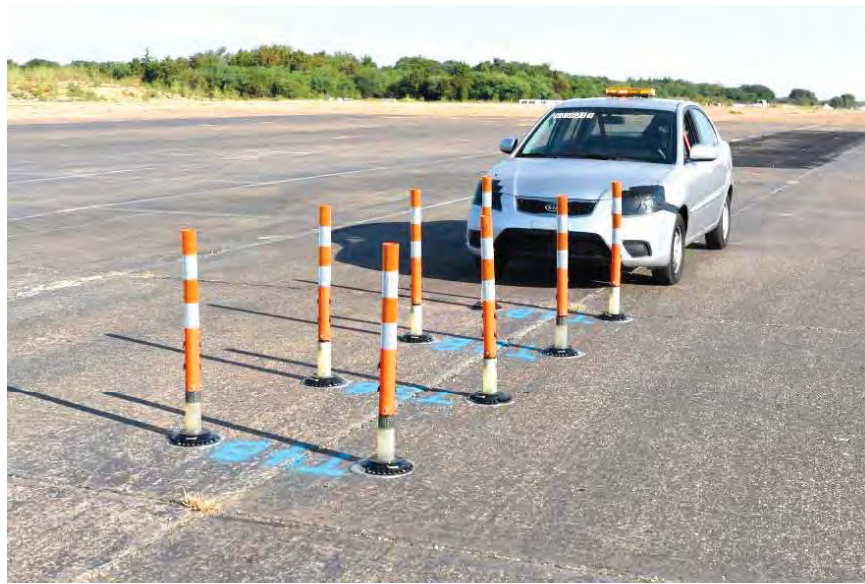
**Figure 8. Test Vehicle in Impact Position prior to Testing.**

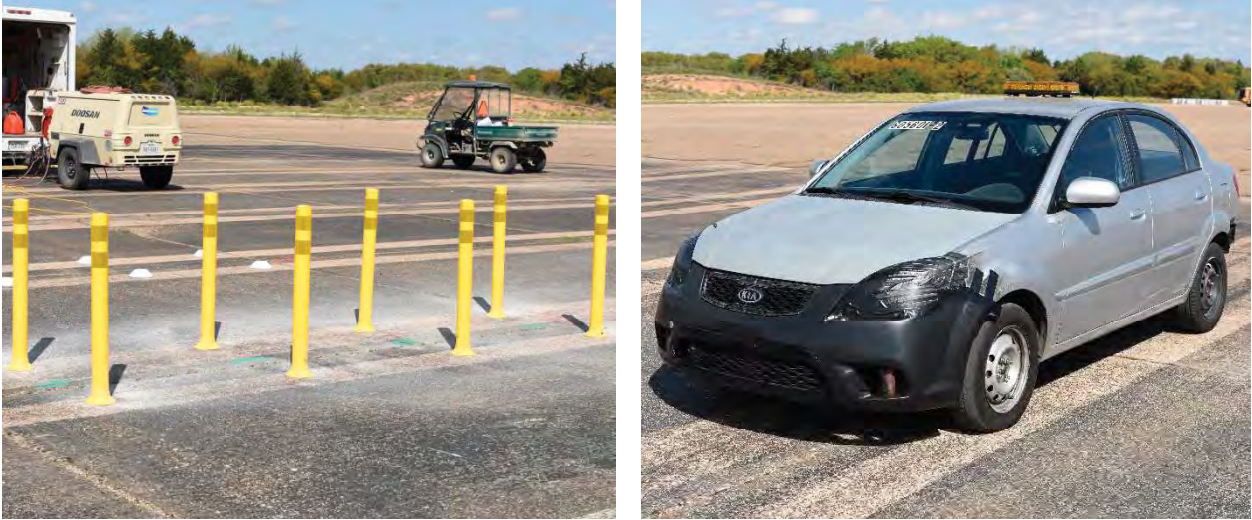
**Figure 13. 605601-2 before Testing.**

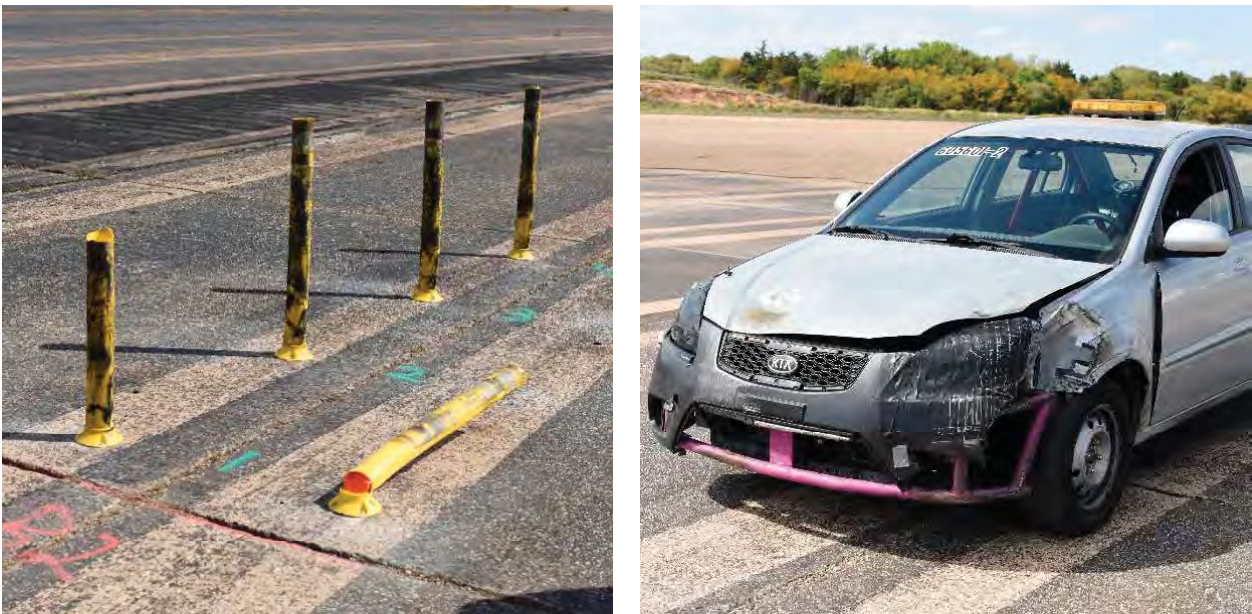
**Figure 14. 605601-2 after Testing.**

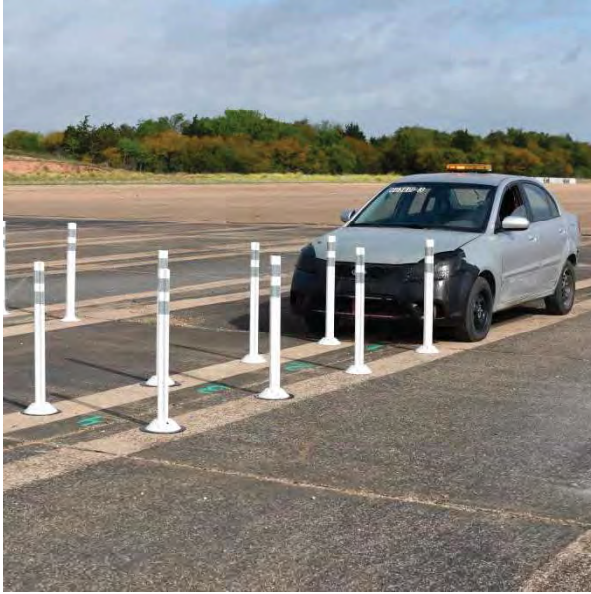
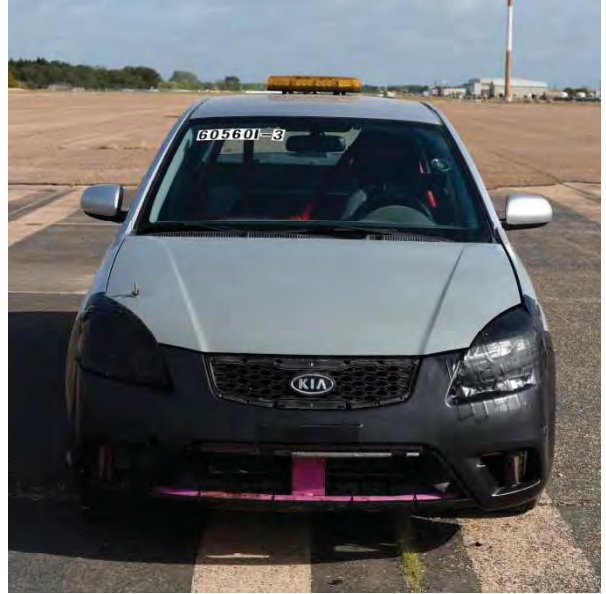
**Figure 16. 605601-3 before Testing.**

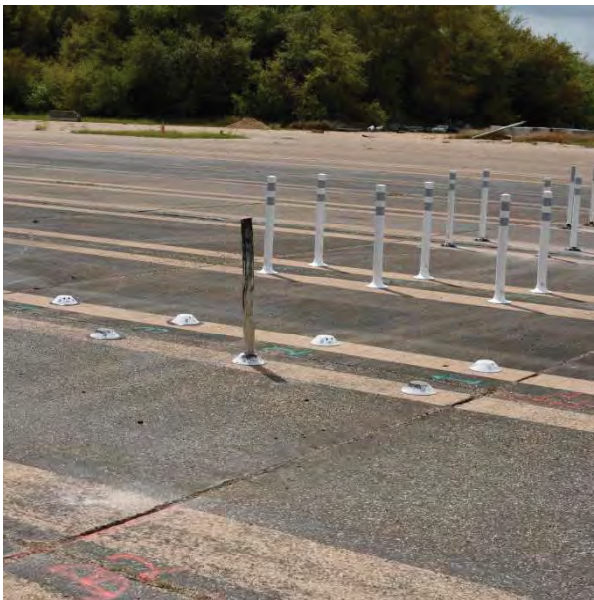
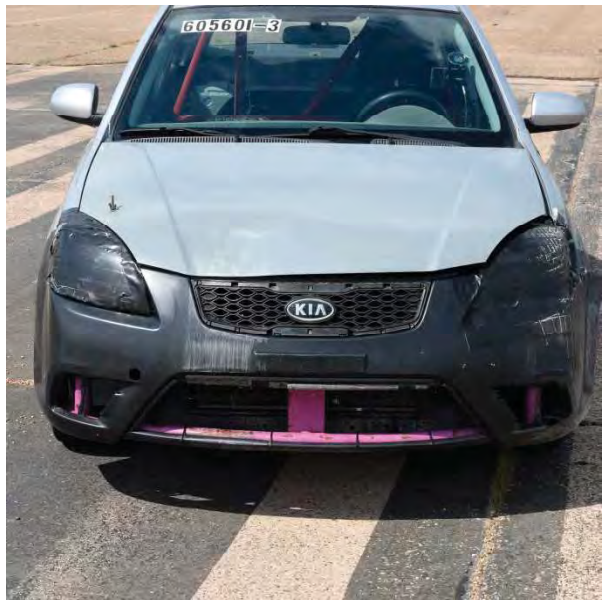
**Figure 17. 605601-3 after Testing.**

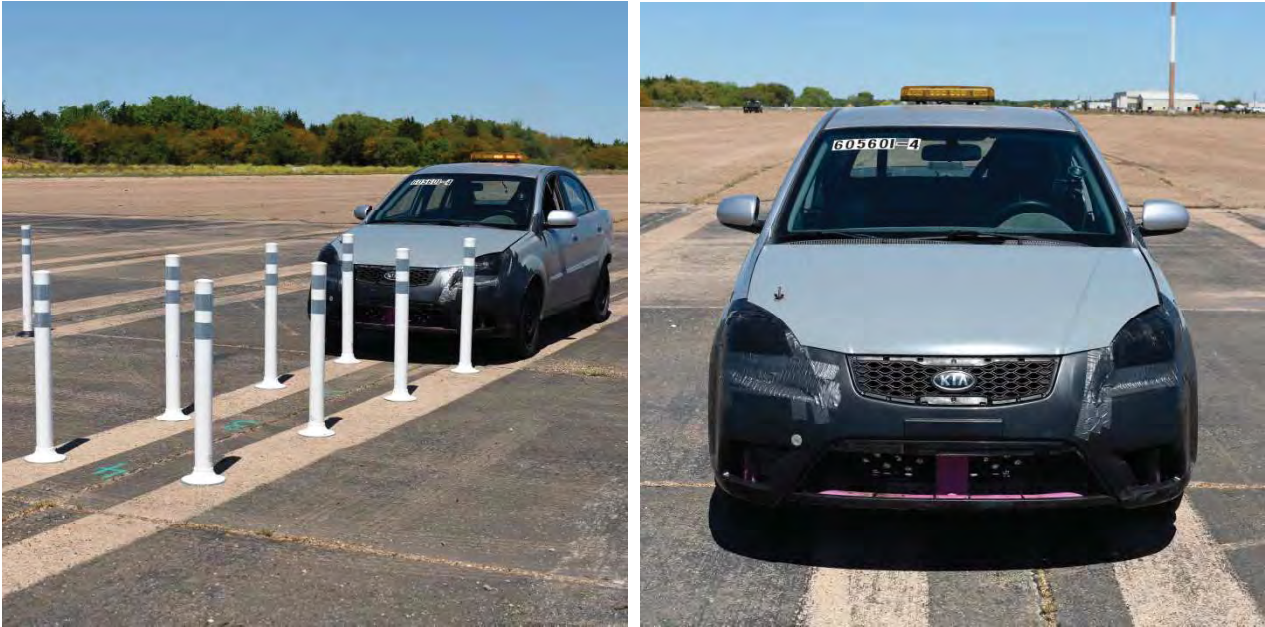
**Figure 19. 605601-4 before Testing.**

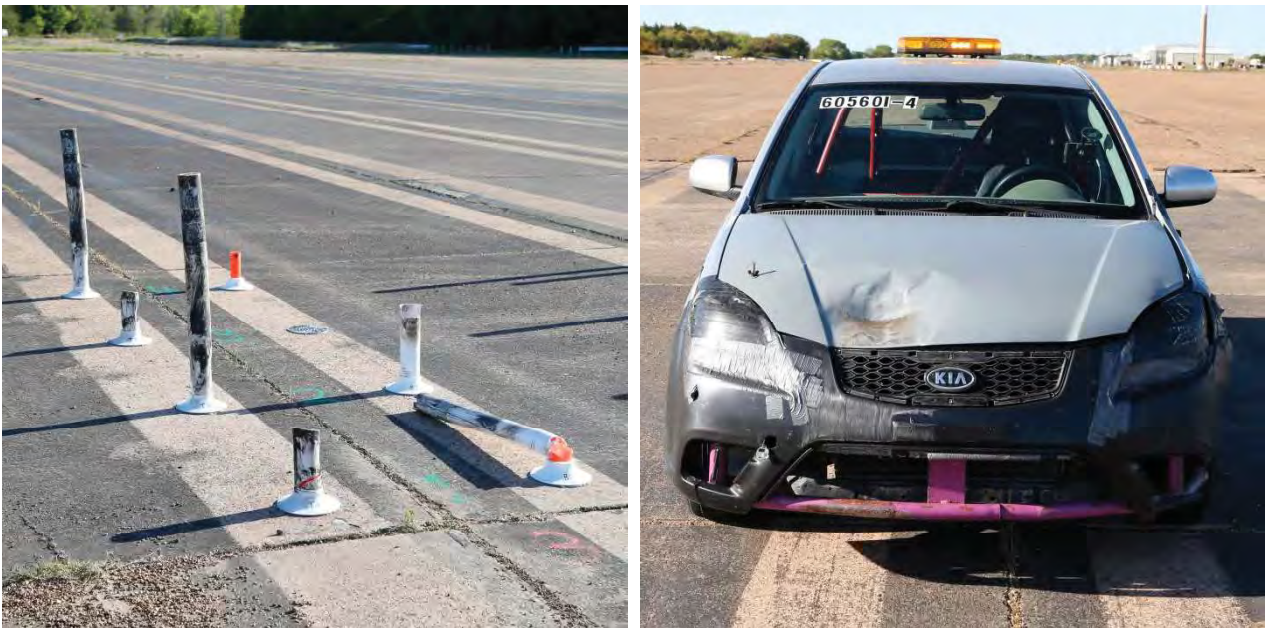
**Figure 20. 605601-4 after Testing.**

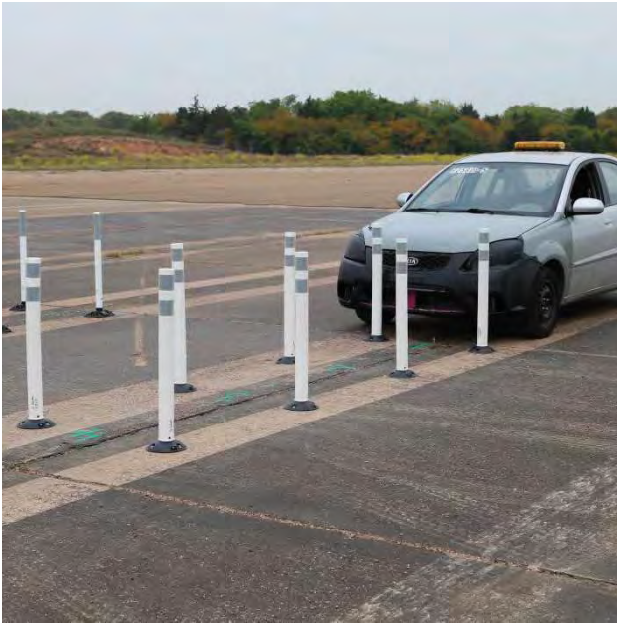
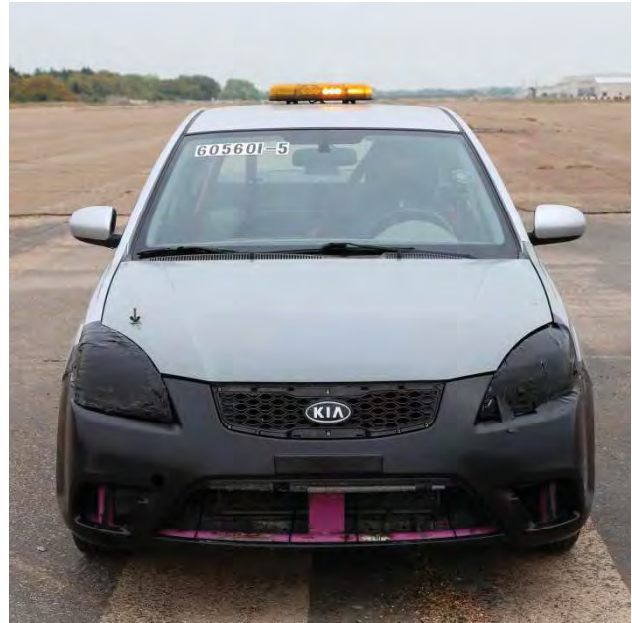
**Figure 22. 605601-5 before Testing.**

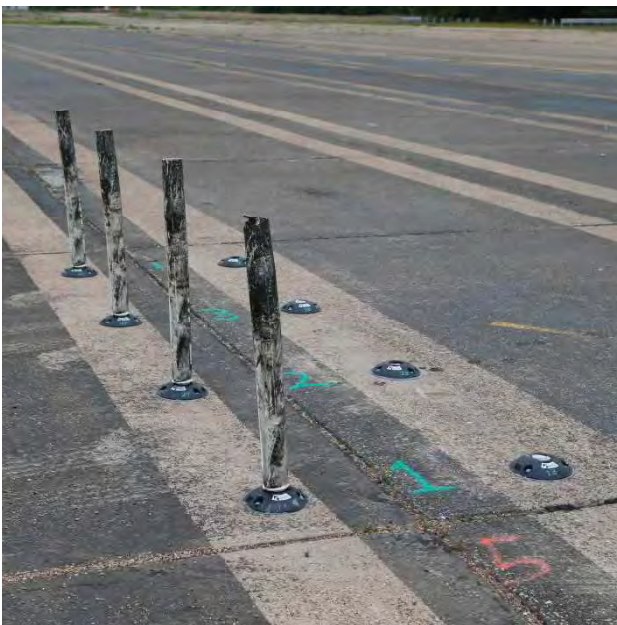
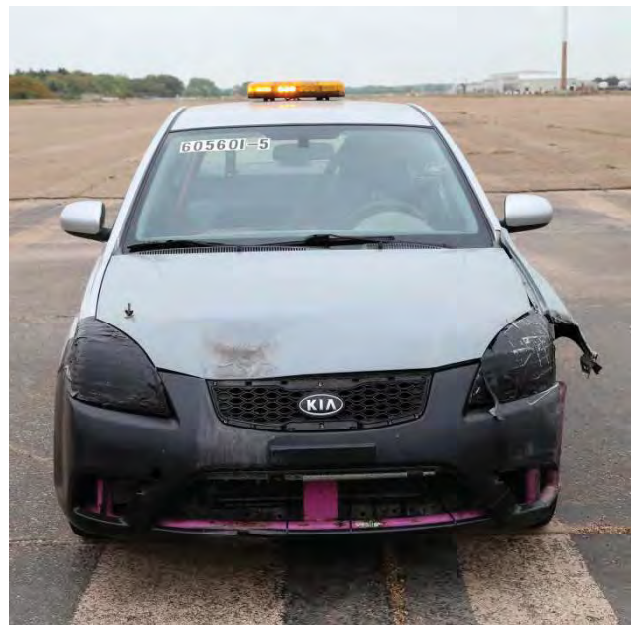
**Figure 23. 605601-5 after Testing.**

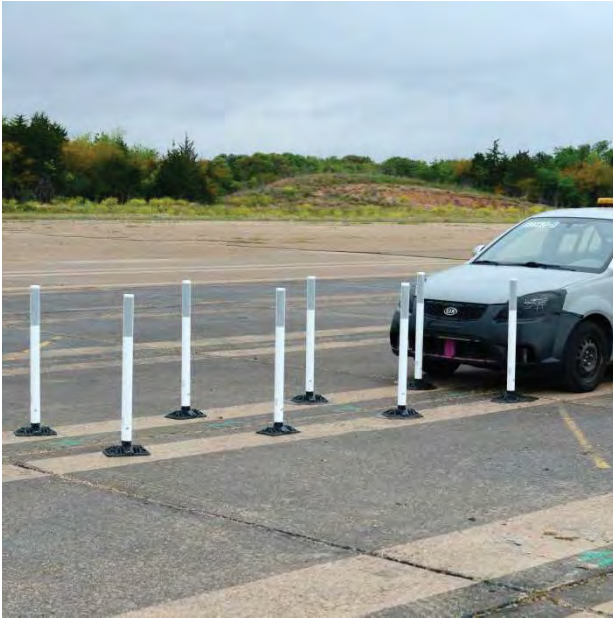
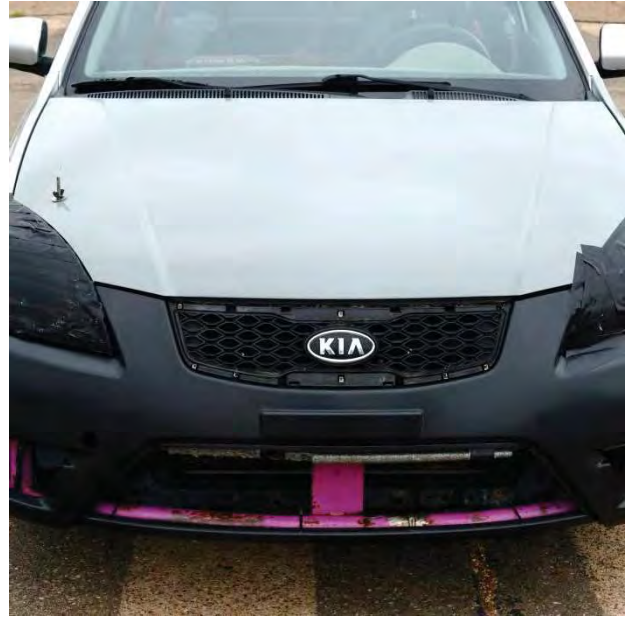
**Figure 25. 605601-6 before Testing.**

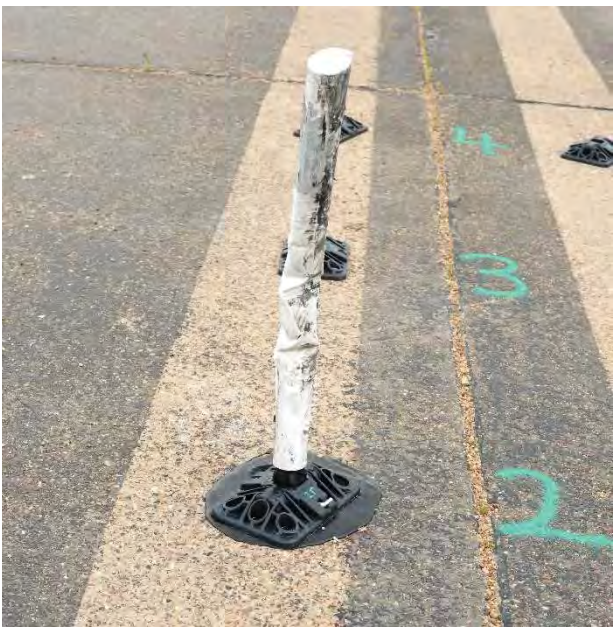
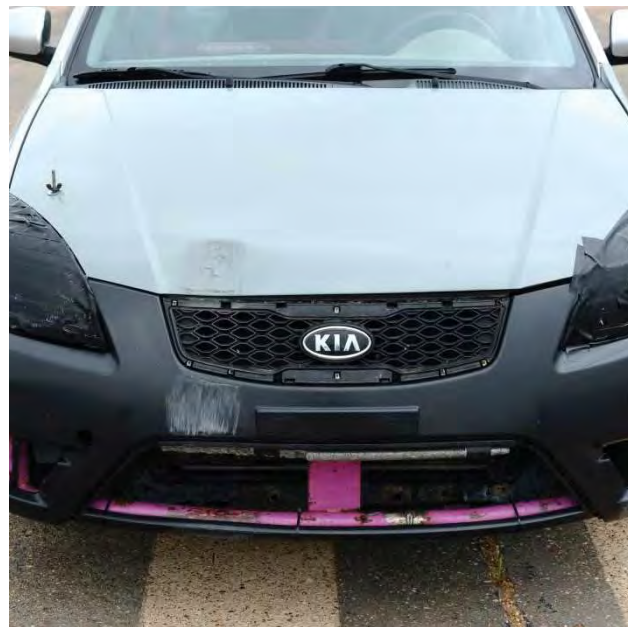
**Figure 26. 605601-6 after Testing.**

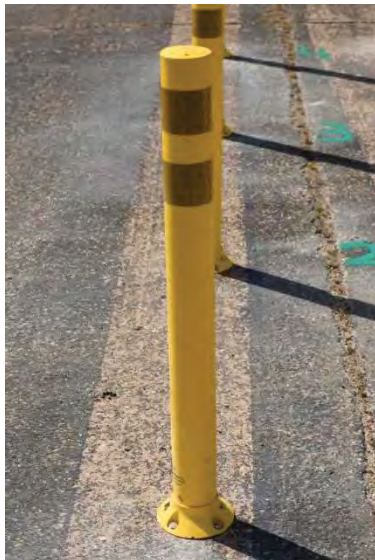
Test #605601-2, performed on March 22, was an impact durability test performed on 36<sup>3</sup>/<sub>4</sub>-inch tall Pexco Surface Mount City Post samples secured with Hilti 3/8 inch HCA Coil Anchor Bolts as shown in Figure 27. The product resisted an average of 180 tire impacts. The product resisted an average of 128 bumper impacts. The product resisted a combined average of 154 tire and bumper impacts. Table 8 shows a summary of the results. The primary failure mode of the sample was anchorage failure.

Figure 27. 605601-2 Product Sample.

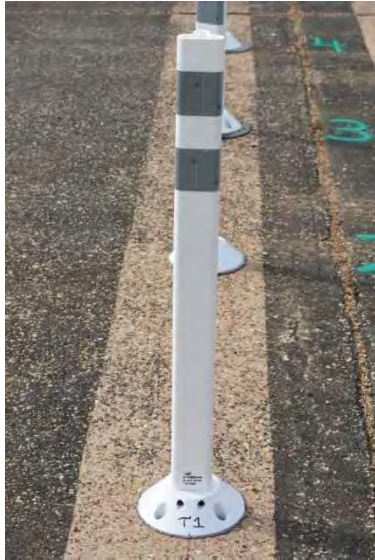
Test #605601-3, performed on March 23, was an impact durability test performed on FG300 samples secured with two different epoxy adhesives as shown in Figure 28. The first four samples were secured with FIRMmarker™ #18M900C20 2-part epoxy adhesive, and the second four samples were secured with Crafcro Hot-Applied Bituminous Marker Adhesive #34269. The product resisted an average of 95 tire impacts. The product resisted an average of 14 bumper impacts. The product resisted a combined average of 54 tire and bumper impacts. Table 9 shows a summary of the results. The primary failure mode of the sample was failure at retention pin holes.

Figure 28. 605601-3 Sample.

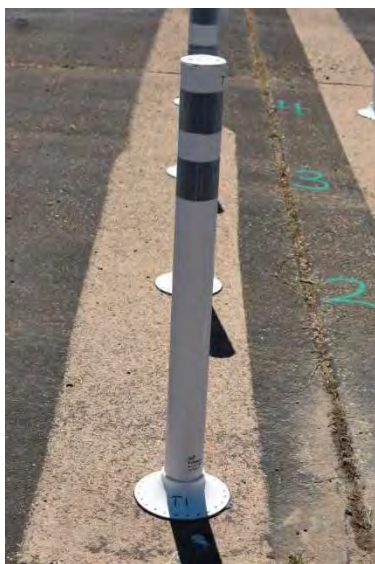
Test #605601-4, performed on March 28, was an impact durability test performed on 36<sup>3</sup>/<sub>4</sub>-inch Pexco Surface Mount City Post samples secured with FIRMmarker™ #18M900C20 2-part epoxy adhesive as shown in Figure 29. The product resisted an average of 178 tire impacts. The product resisted an average of 145 bumper impacts. The product resisted a combined average of 161 tire and bumper impacts. Table 10 shows a summary of the results. The primary failure mode of the sample was rupturing of the samples near the base.

Figure 29. 605601-4 Sample.

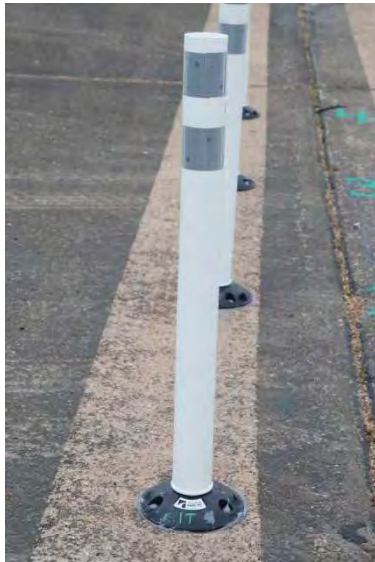
Test #605601-5, performed on March 29, was an impact durability test performed on Dura-Post samples secured by both epoxy and mechanical methods. The first four samples were secured with SHEPX-13-K1 epoxy, and the second four samples were secured with 20 mm × 90 mm plastic anchor sleeves and 3/8-inch × 4-inch lag screws as shown in Figure 30. The product resisted an average of 200 tire impacts. The product resisted an average of 81 bumper impacts. The product resisted a combined average of 141 tire and bumper impacts. Table 11 shows a summary of the results. The primary failure mode of the sample was exceeding the maximum allowable degree of lean.

Figure 30. 605601-5 Sample.

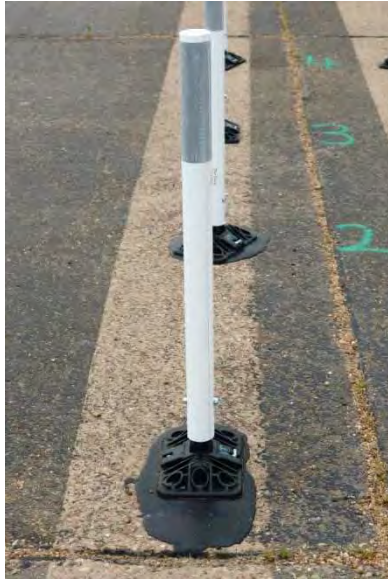
Test #605601-6, performed on March 30, was an impact durability test performed on Shur-Flex Surface Mount samples secured by both adhesive and mechanical methods. The first four samples were secured with Henry HE913 Dot Stick Adhesive, and the second four samples were secured with 1/2-inch × 3-inch Shur-Tite Nylon Plugs and 1/2-inch × 3 1/2-inch lag screws (with USS flat washers) in four corner holes as shown in Figure 31. The product resisted an average of 53 tire impacts. The product resisted an average of 26 bumper impacts. The product resisted a combined average of 39 tire and bumper impacts. Table 12 shows a summary of the results. The primary failure mode of the sample was exceeding the maximum allowable degree of lean.

Figure 31. 605601-6 Sample.

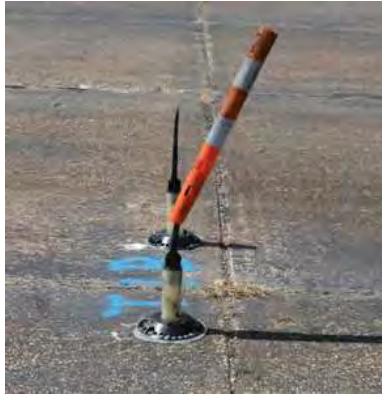
**Figure A-1. Sample 1T Failure at 53 Impacts.**

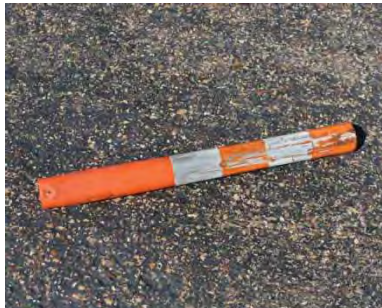
**Figure A-2. Sample 1B Failure at 27 Impacts.**

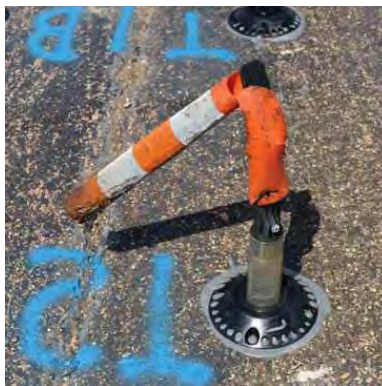
**Figure A-3. Sample 2T Failure at 66 Impacts.**

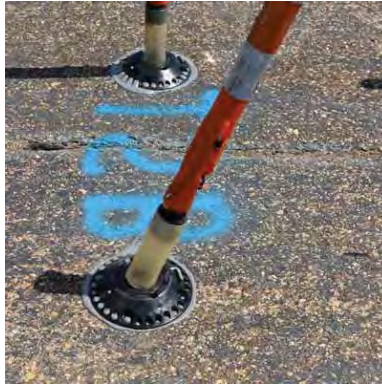
**Figure A-4. Sample 2B Failure at 44 Impacts.**

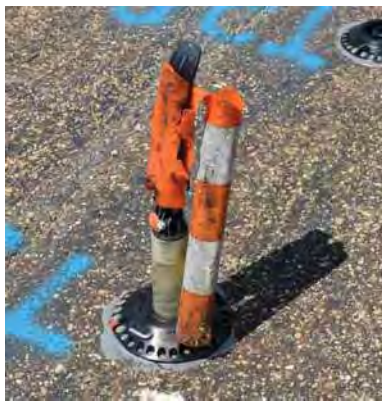
**Figure A-5. Sample 3T Failure at 71 Impacts.**

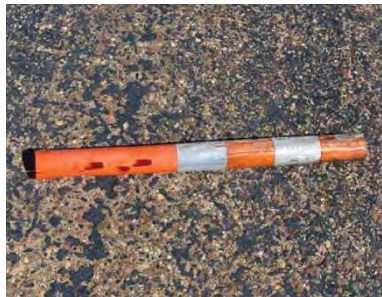
**Figure A-6. Sample 3B Failure at 28 Impacts.**

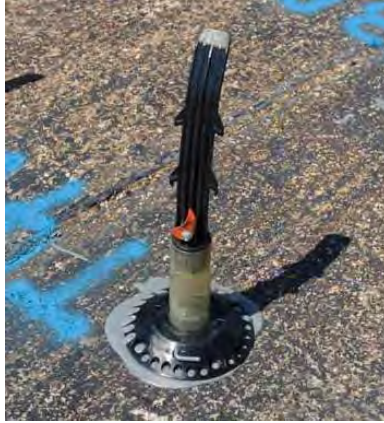
**Figure A-7. Sample 4T Failure at 56 Impacts.**

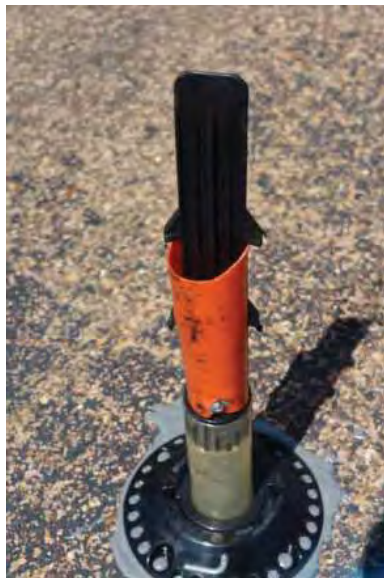
**Figure A-8. Sample 4B Failure at 42 Impacts.**

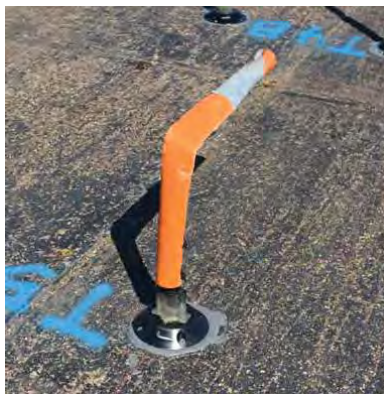
**Figure A-9. Sample 5T Failure at 32 Impacts.**

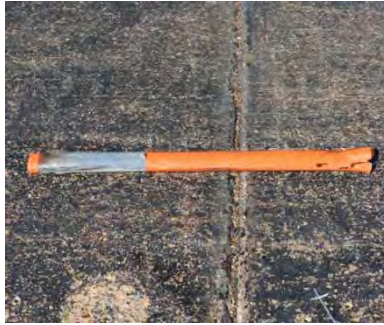
**Figure A-10. Sample 5B Failure at 21 Impacts.**

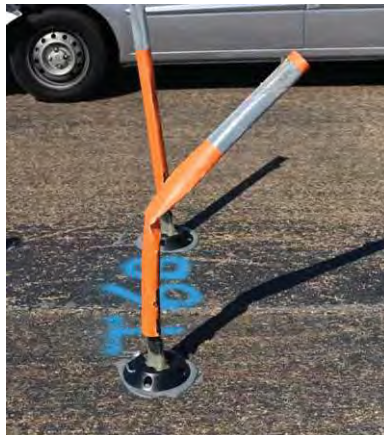
**Figure A-11. Sample 6T Failure at 25 Impacts.**

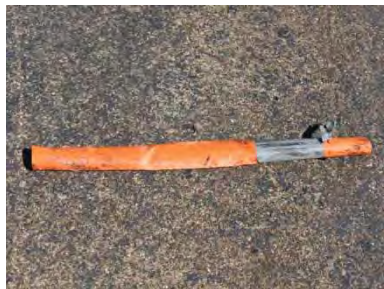
**Figure A-12. Sample 6B Failure at 29 Impacts.**

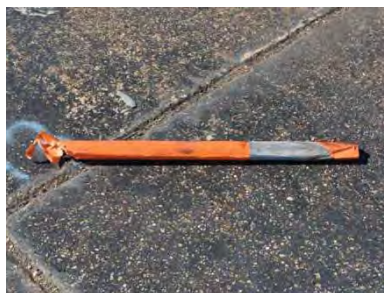
**Figure A-13. Sample 7T Failure at 29 Impacts.**

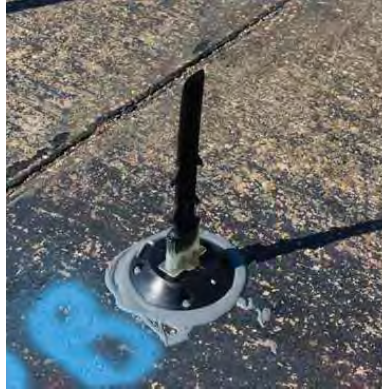
**Figure A-14. Sample 7B Failure at 18 Impacts.**

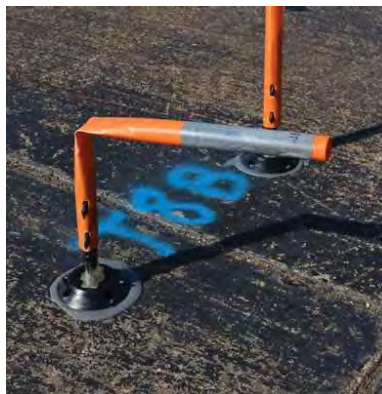
**Figure A-15. Sample 8T Failure at 6 Impacts.**

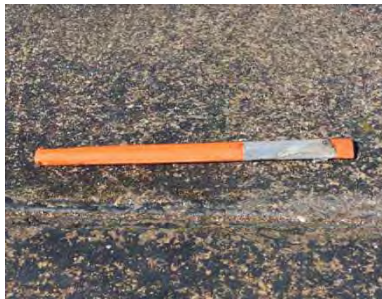
**Figure A-16. Sample 8B Failure at 28 Impacts.**
