Investigation Report

Greenwood Natural Gas Pipeline Explosion - March 9, 2016

Docket PG-160924

September 20, 2016

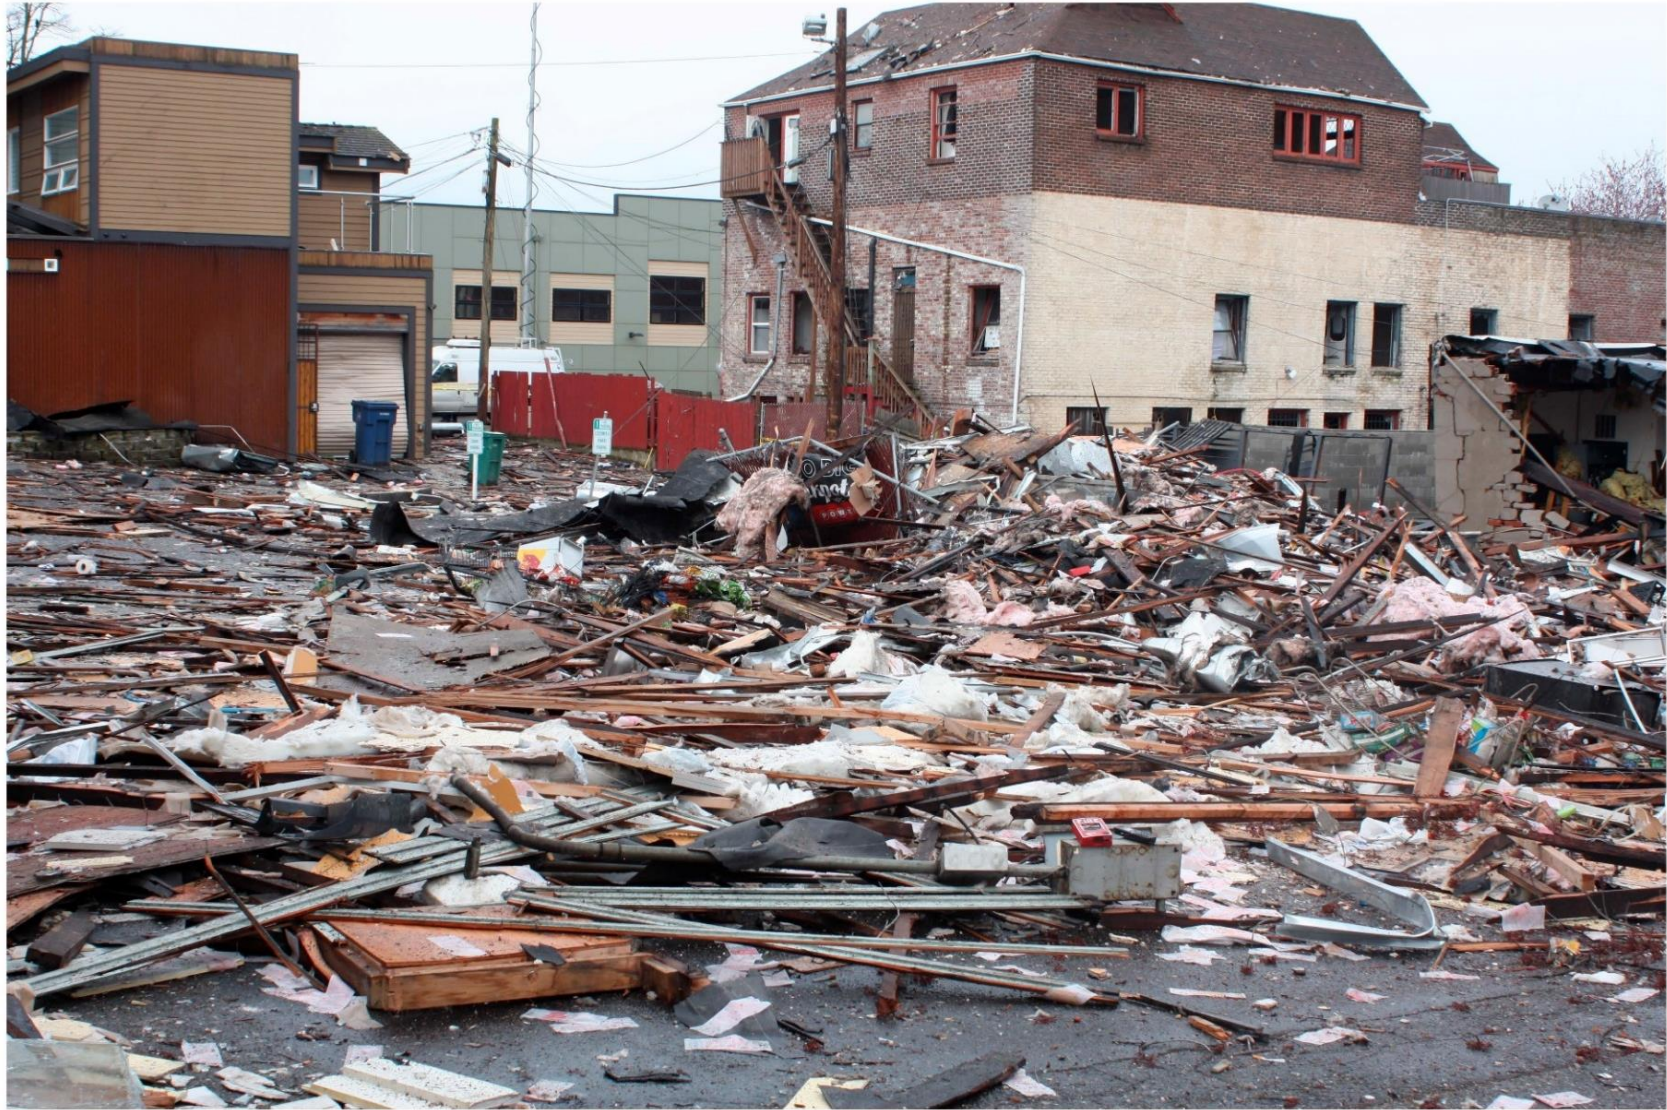
Image 3. Debris spread facing west from Greenwood Avenue North.

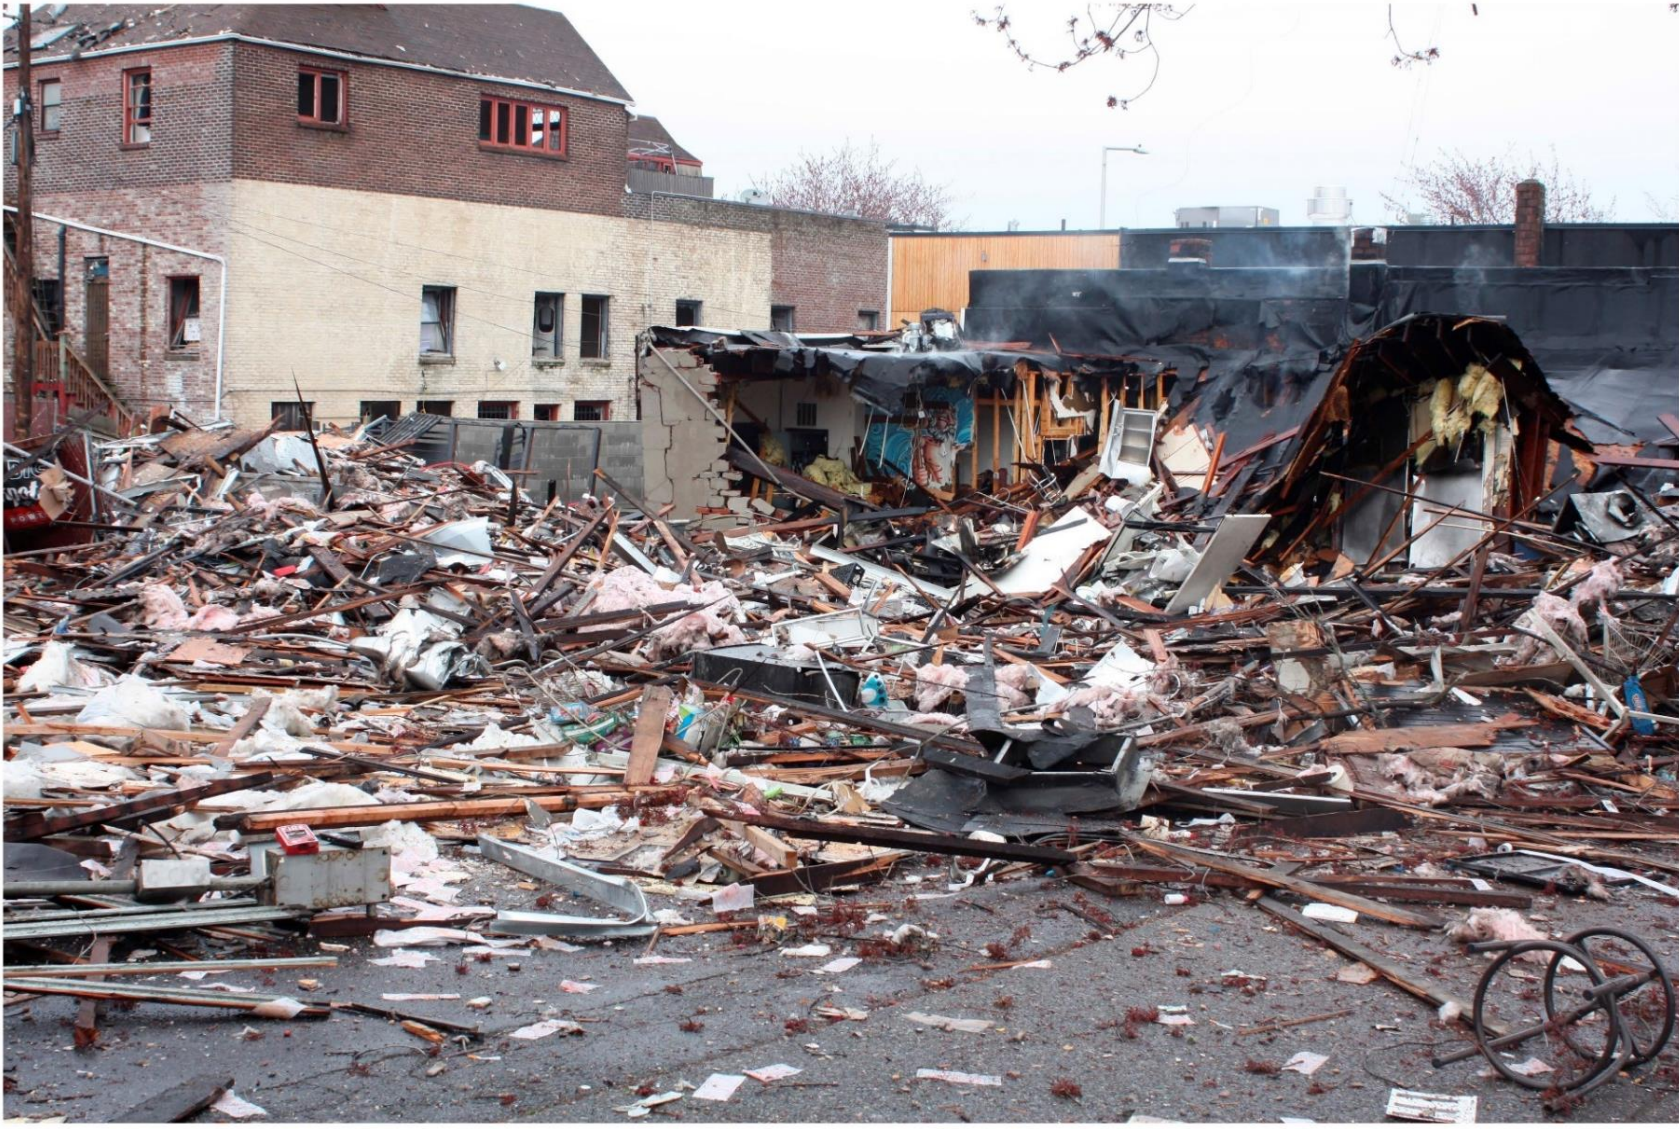
Image 4. Debris spread facing northwest from Greenwood Avenue North.

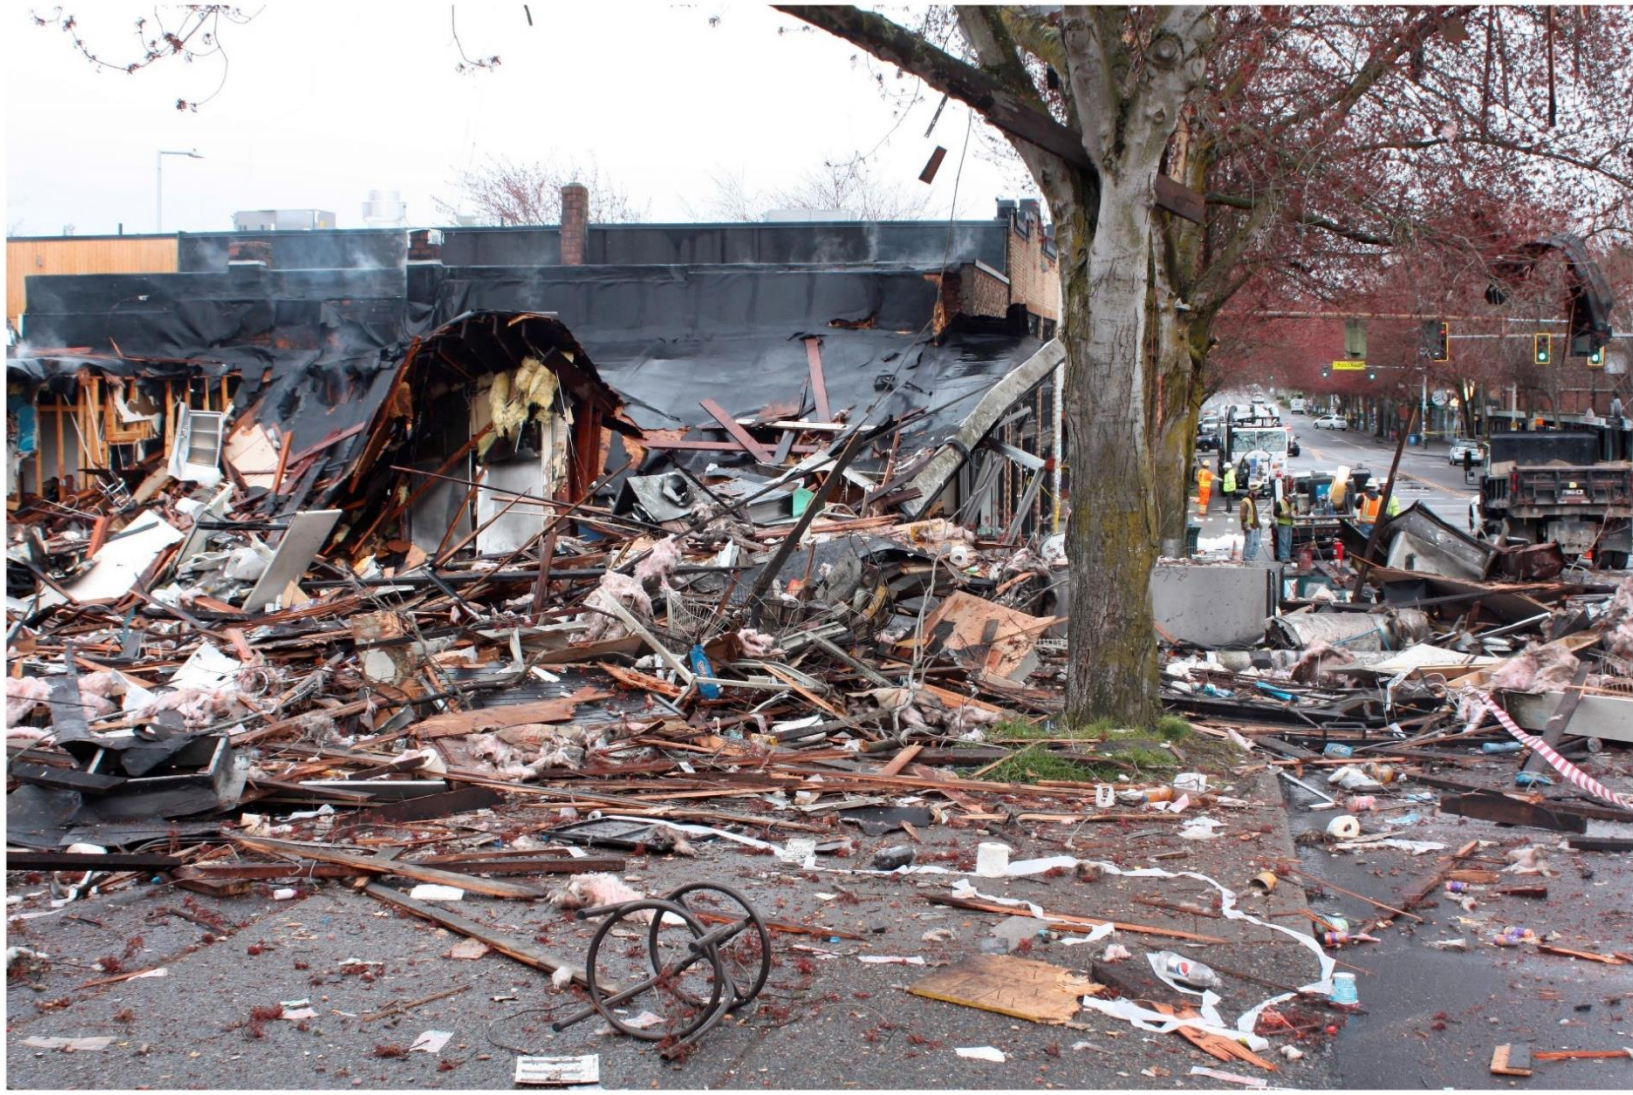
Image 5. Debris spread facing north from Greenwood Avenue North.

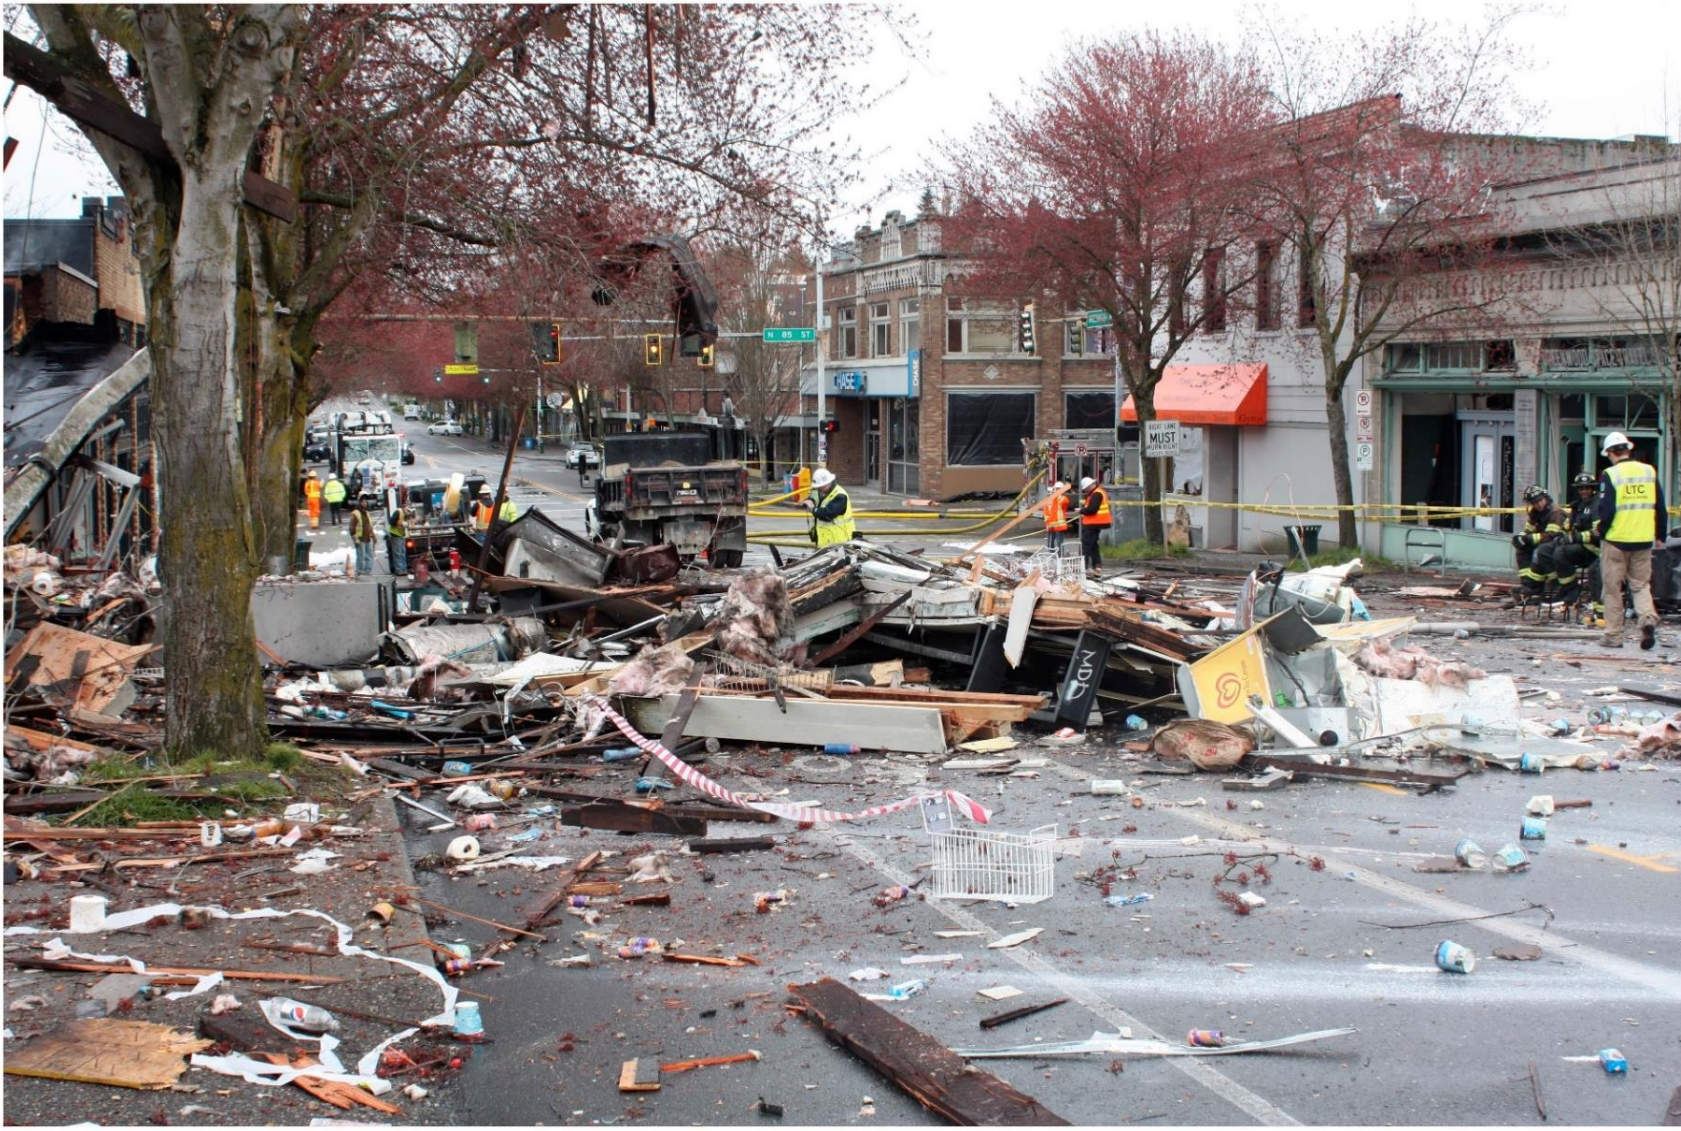
Image 6. Debris spread facing north from Greenwood Avenue North.

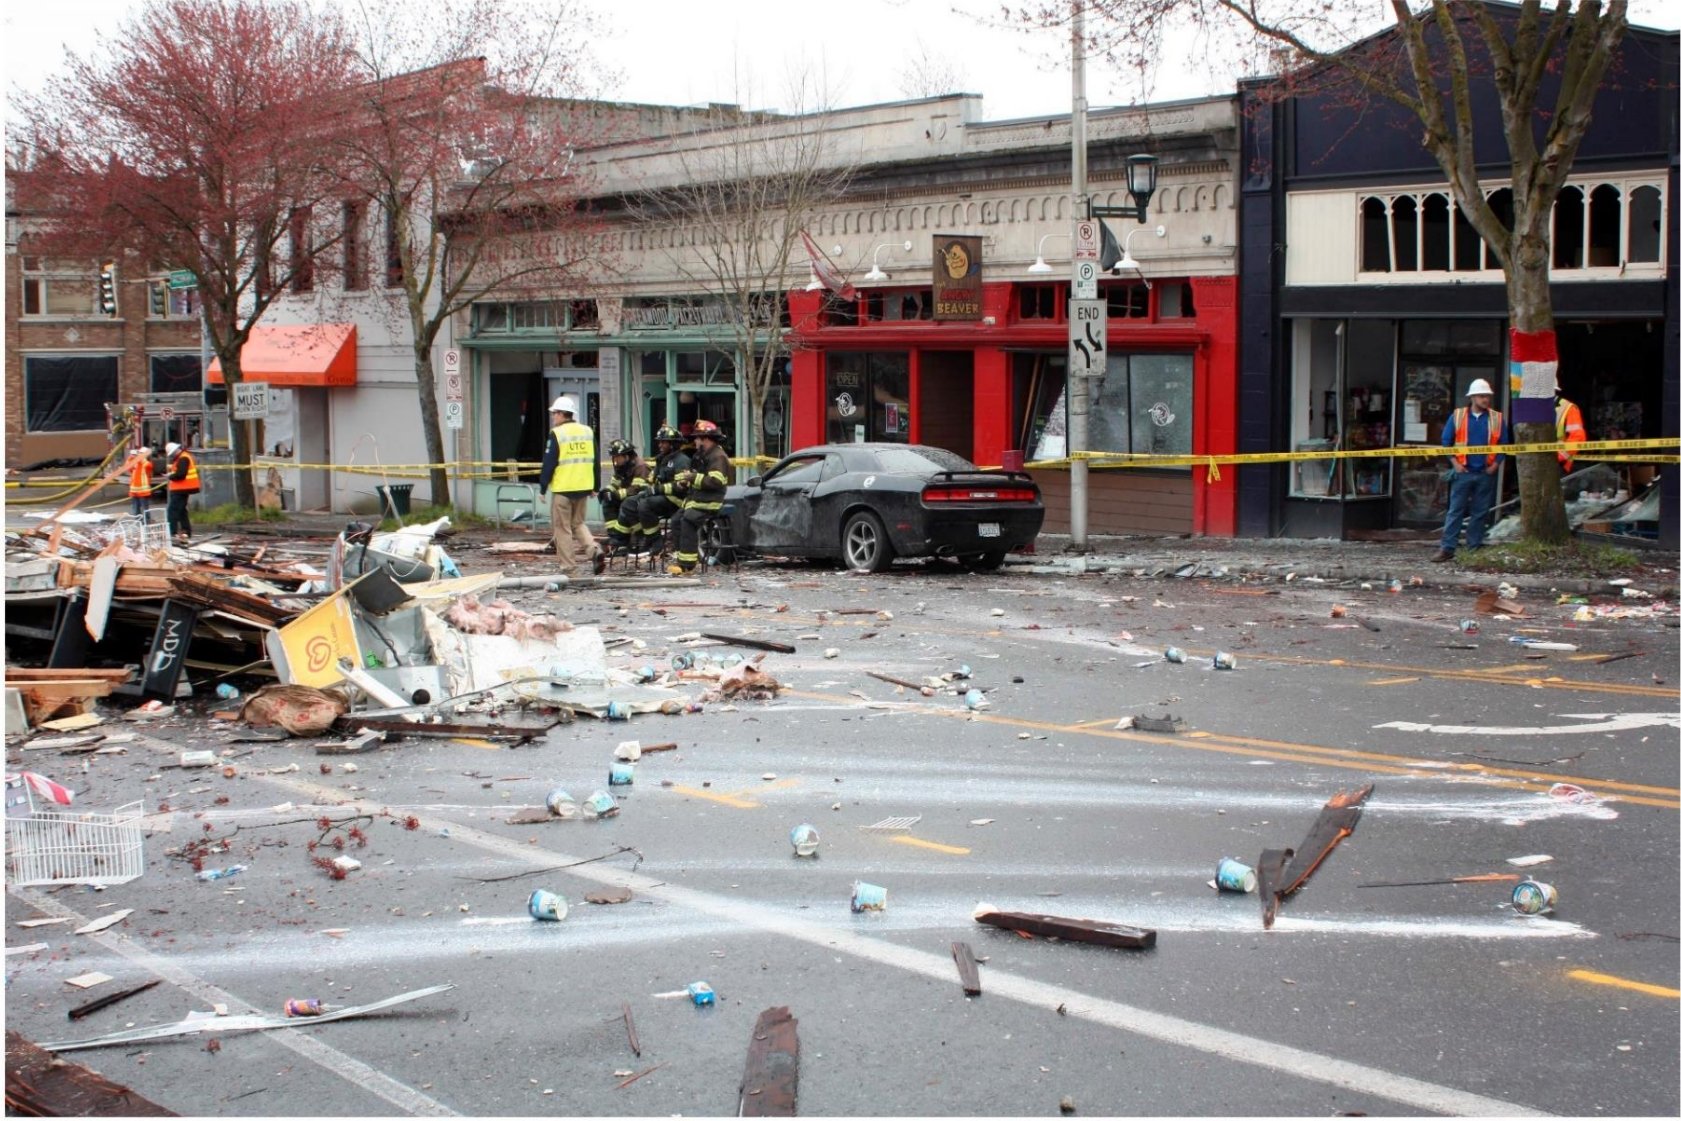
Image 7. Debris spread facing northeast from Greenwood Avenue North.

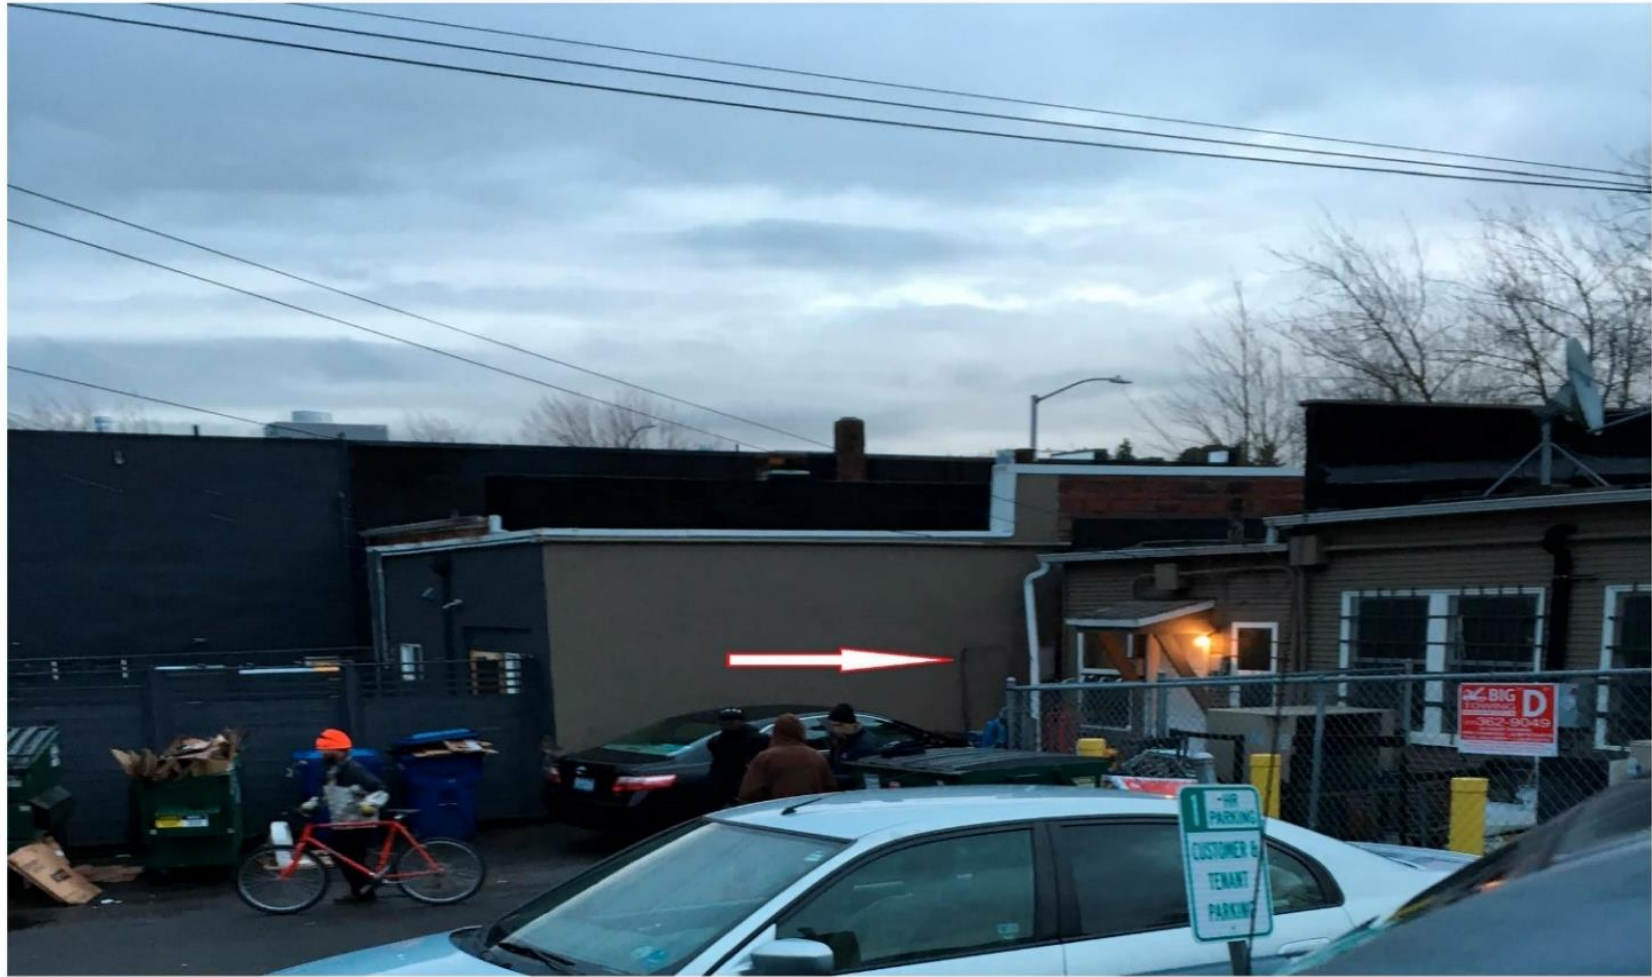
According to SFD firefighter Nathan Buck, the leak occurred in the narrow space between the Mr. Gyros (8411) and Neptune Coffee (8415) buildings, at a union connecting two threaded pipe sections attached to the north-facing wall of the Mr. Gyros structure. The exposed, threaded connection was situated one to two feet above the ground. Mr. Buck recalled seeing a plastic bag rippling on the ground, indicating to him that the gas was shooting downward toward the Mr. Gyros foundation.

Image 9. Location of narrow space between Mr. Gyros and Neptune Coffee buildings where leak occurred.

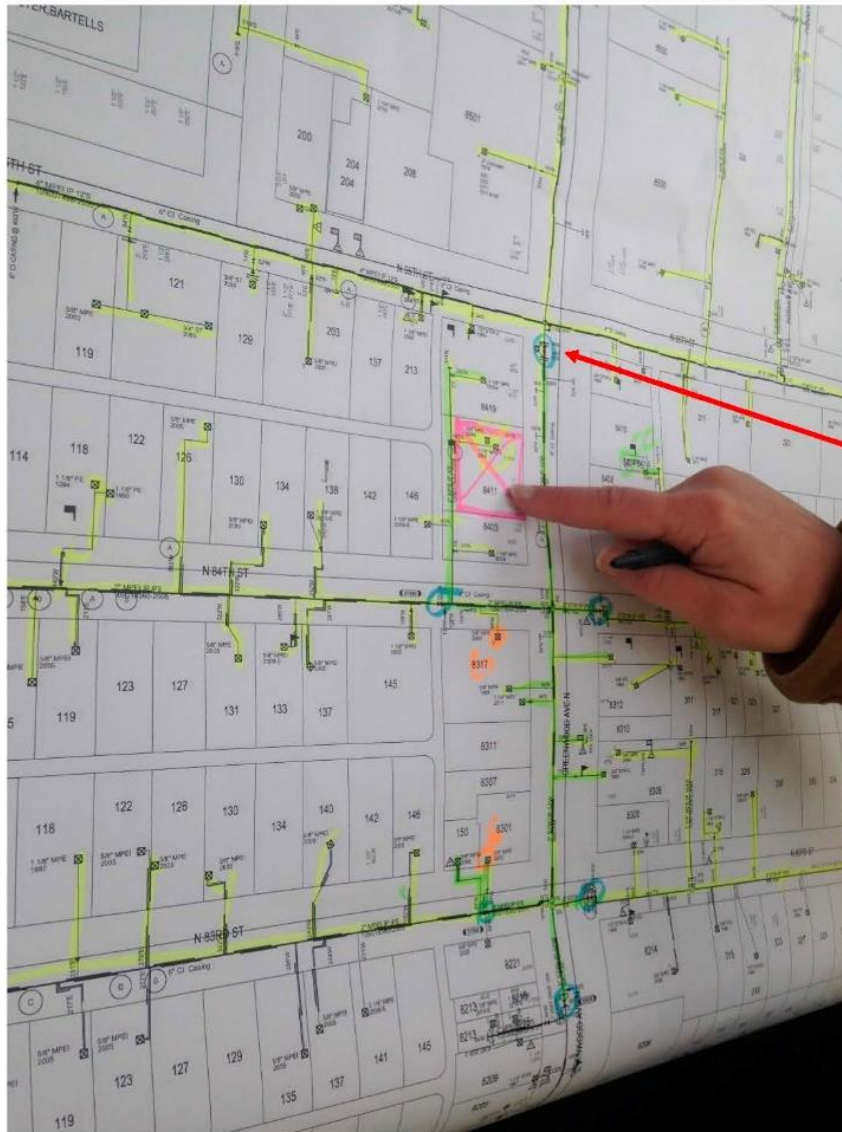
Image 10. PSE plat map.

PSE plat map depicting incident location in pink, the post incident leak survey in yellow, and the isolation valves in blue.

Final valve excavated to stop the flow of gas. This was not an emergency valve and was not intended to be accessible due to no intended active services on this portion of Greenwood Ave. North.

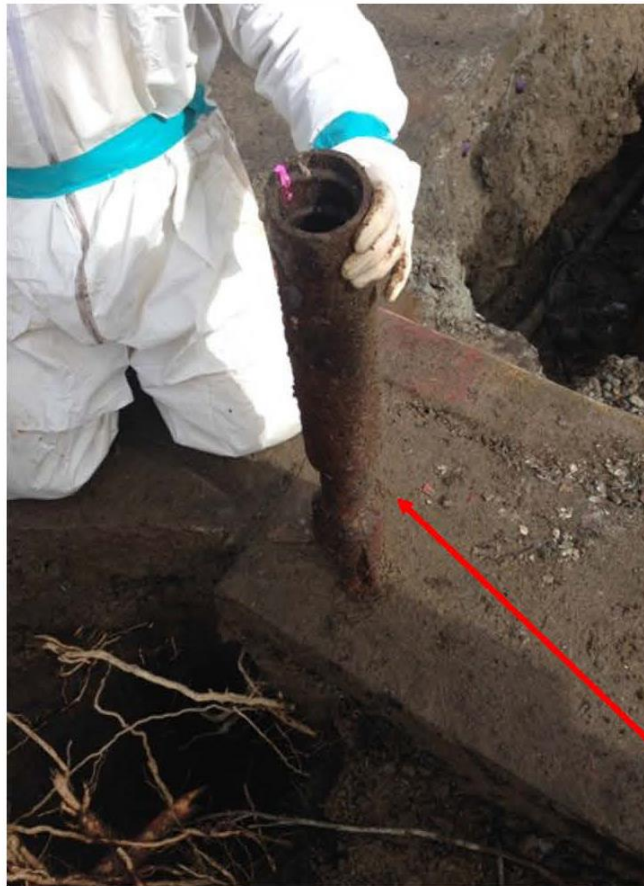
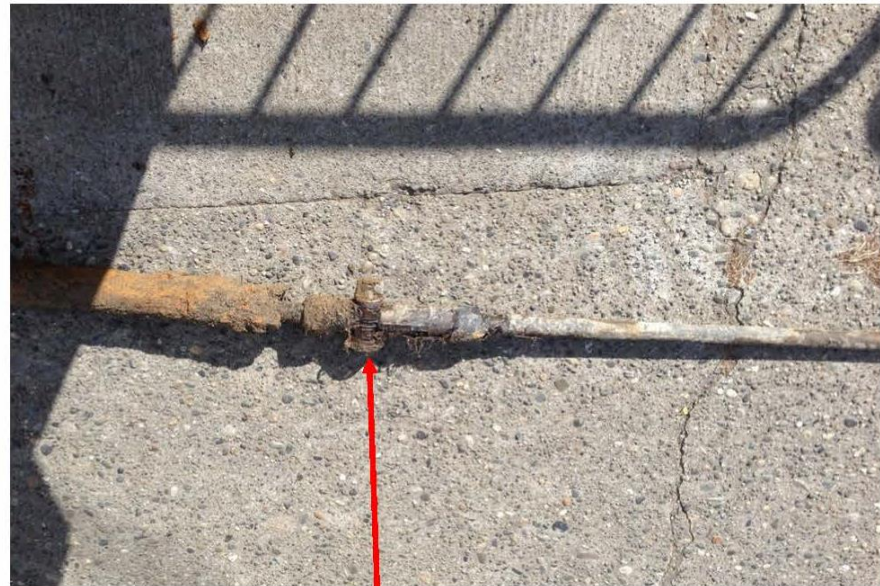
Image 11. Curb valve recovered post-incident.

Curb valve and 3/4" service line inserted into 2
iron pipe

Curb valve box recovered under paved sidewalk
in position over curb valve.

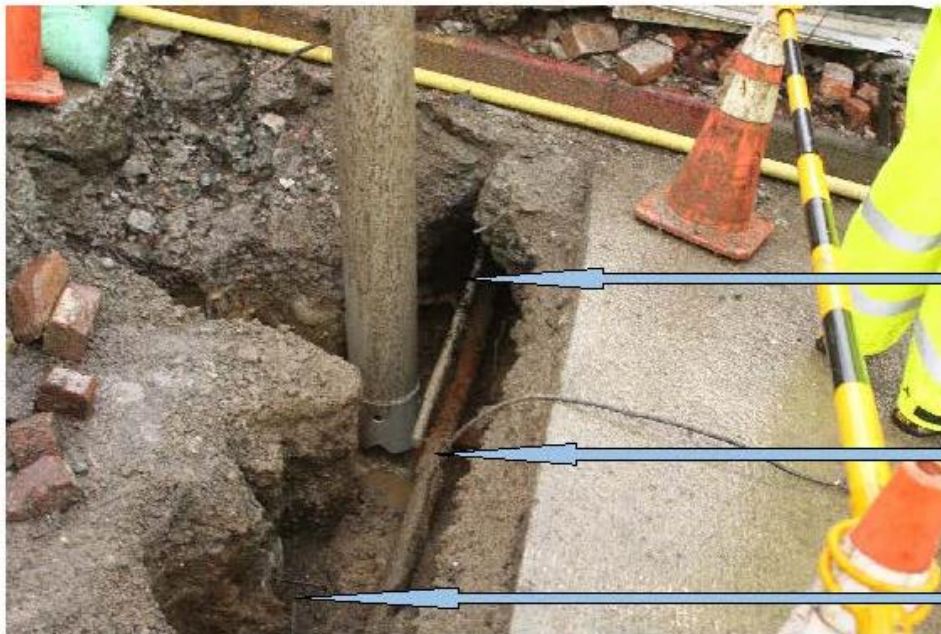
During its investigation, staff located the below-ground portion of the service line by excavating sections of the sidewalk and southbound lane of Greenwood Avenue North. Contrary to PSE's D-4 card, the line had not been cut and capped. Staff did, however, locate a steel pipe of unknown origin approximately 15 inches above the service line. This pipe appeared to have been cut with a wheel tool used for cutting pipe.

The foreign section of abandoned line, identified as specimen 14 is located slightly above the in-service line.

Active, at time of incident, cathodically protected 3/4" gas service line inserted into 2" iron pipe and connected to the 3" STW 6" cast iron inserted main running north/south on Greenwood Ave

32# Anode installed per "D-1" documents provided in response to DR 2-27 on 9/1/2004 162 N CL (N 84 St) and 22-W CL.

Image 12. Illustration and image depicting excavation of service line and foreign line post-incident.

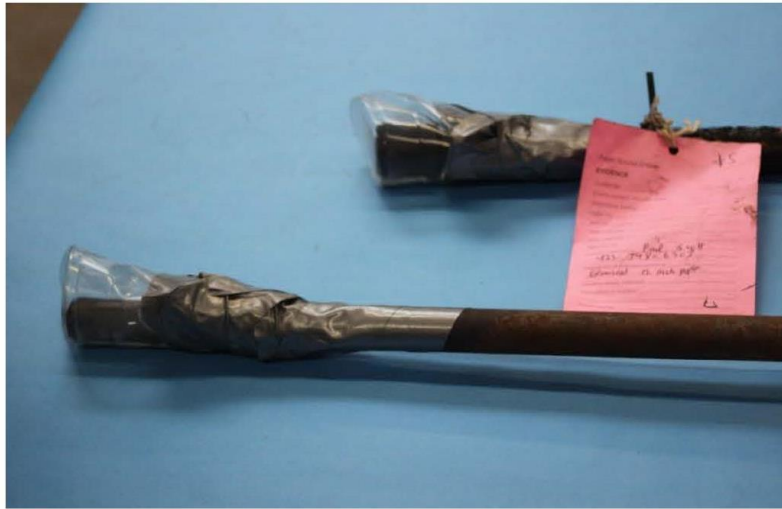
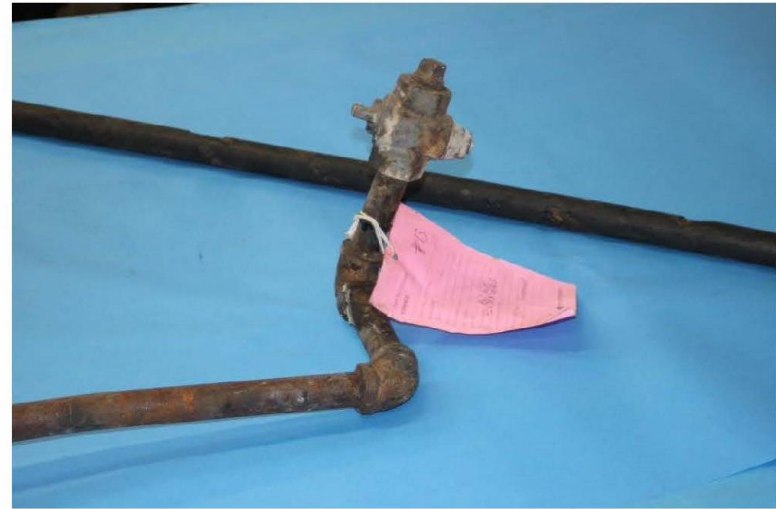
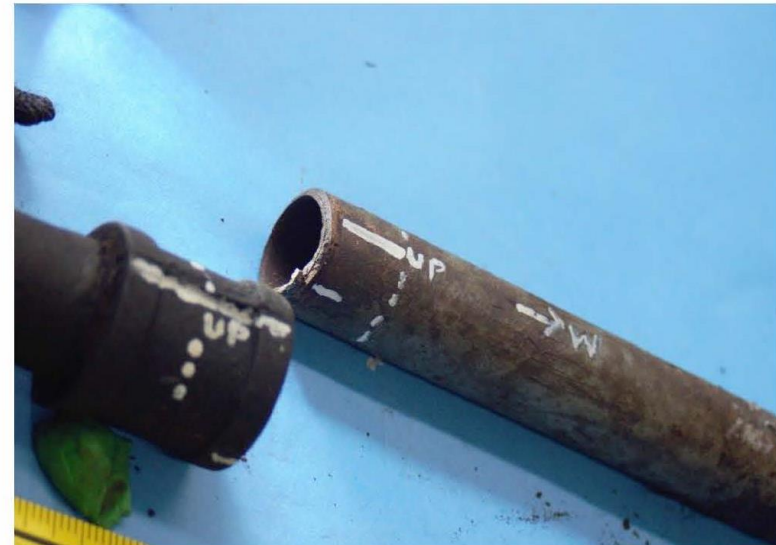
Image 17. Lab photo.

PSE also hired Ron Liem, P.E., Investigative Sciences, to conduct laboratory analyses of specimens recovered from the scene. Mr. Liem concluded that the service line recovered from the narrow space between the Mr. Gyros and Neptune Coffee buildings failed at a threaded connection due to applied external force.

Specimen 13 fracture end at the laboratory in forefront

Specimen 13 opposite end at the laboratory

Specimen 5 fracture end at the laboratory

This image shows specimen 13 and 5 with orientation lines added

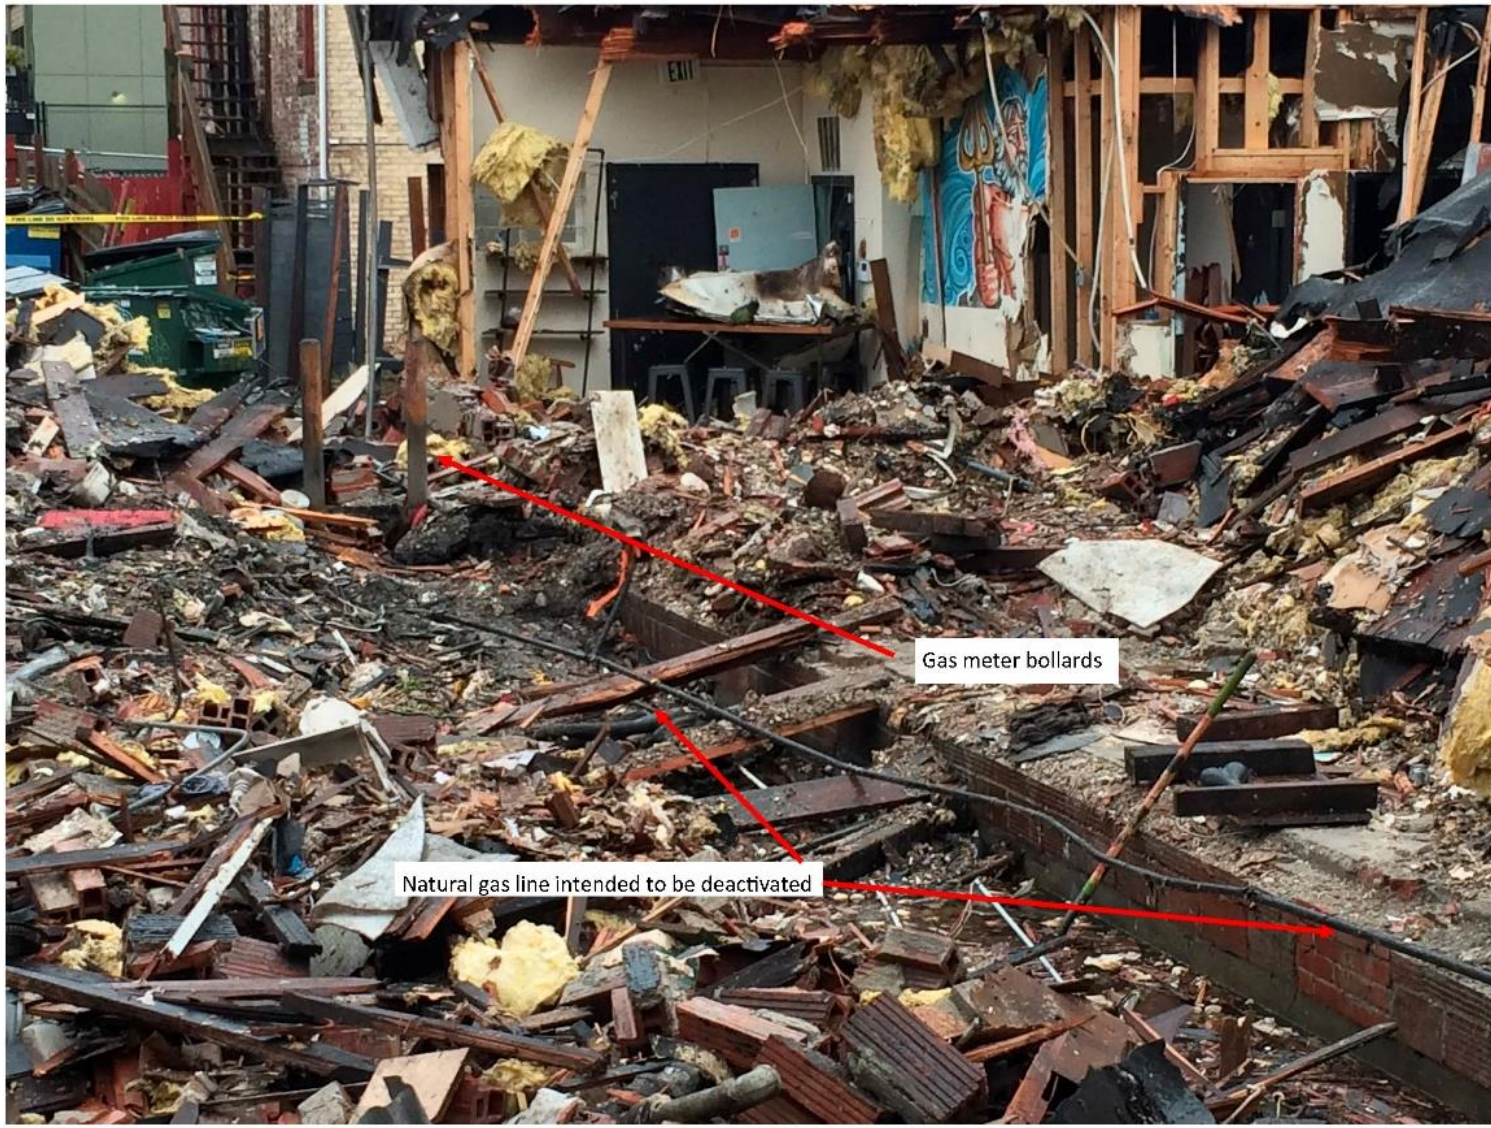
Image 23. Photo depicting location of service line involved in explosion.

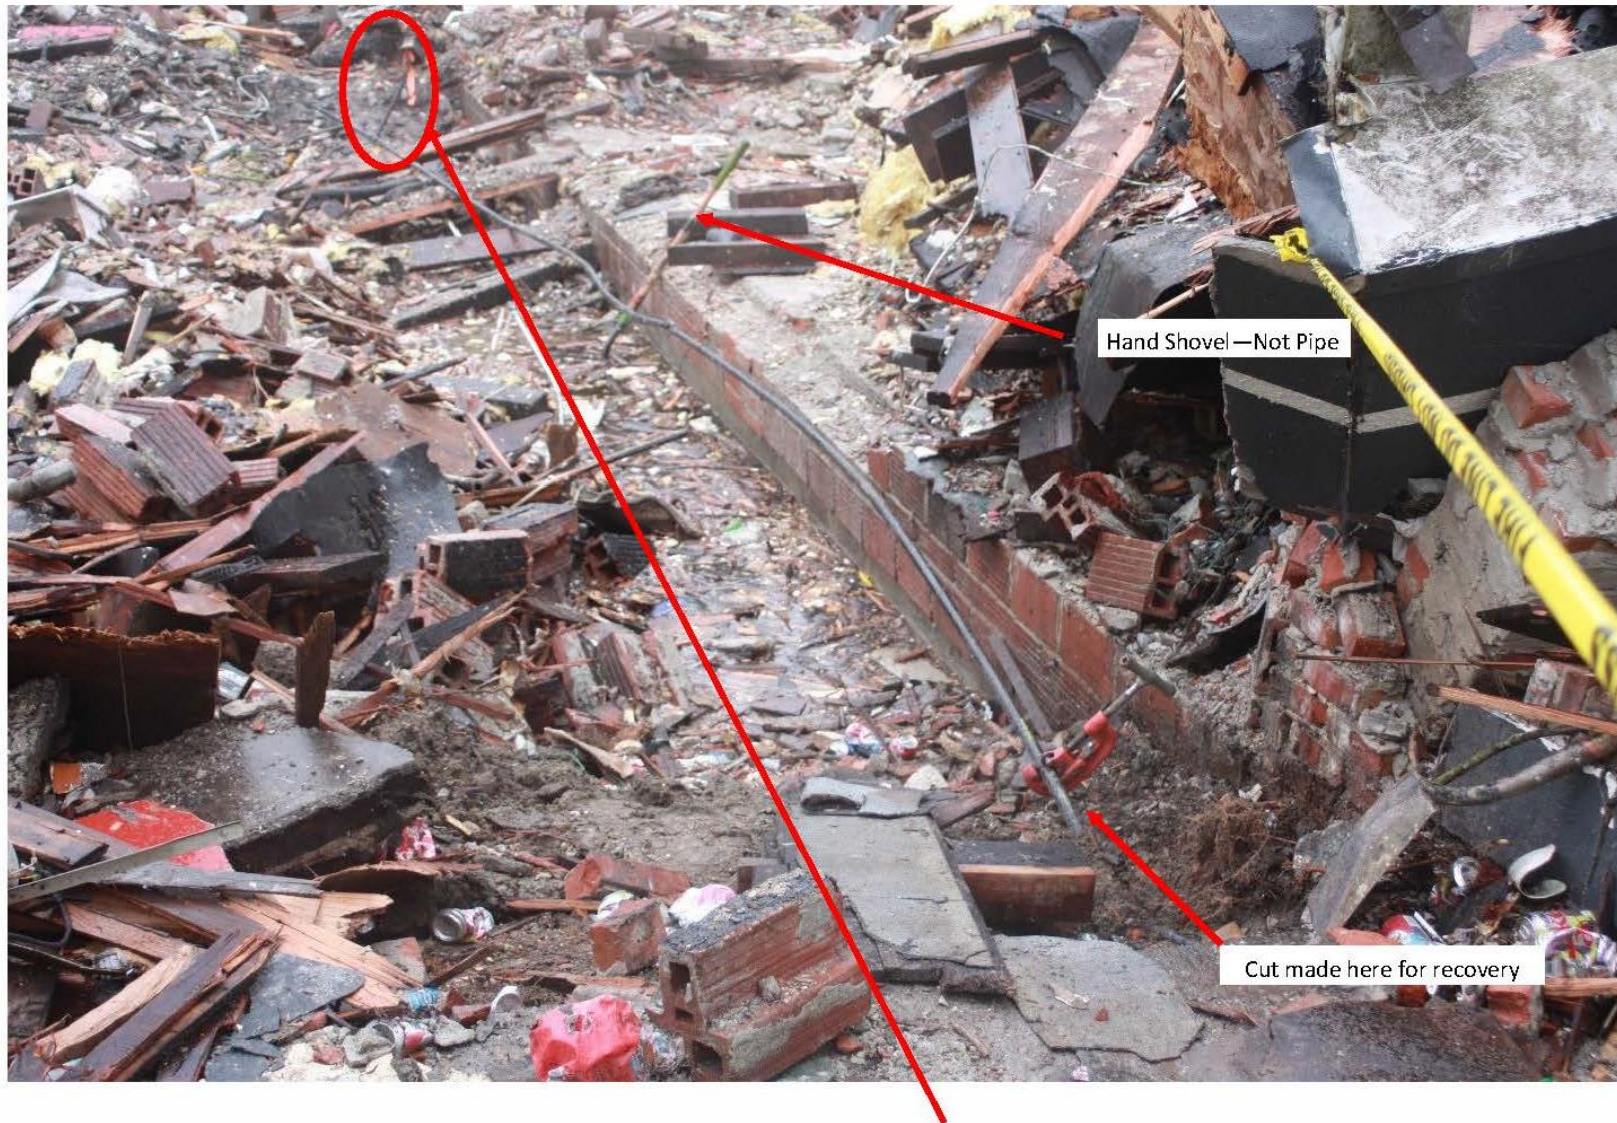
Image 24. Circled region of photo shows riser that fed 8409 and 8411 Greenwood Avenue North, with the dual “twin” service branching off to what is now 8415 Greenwood Avenue North.
