M&L Construction vs Avista

Case 240962

515 W Regina Ave. Spokane WA

Avista Utilities Supporting Documentation

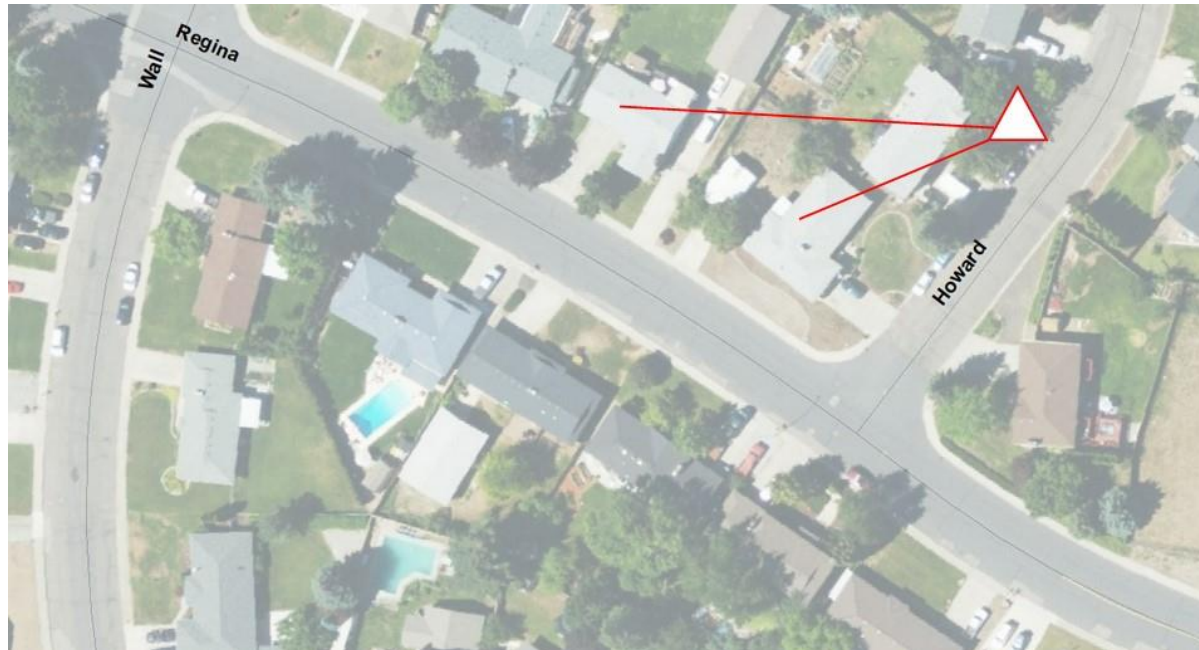
How they were mapped

3. Electric Secondaries Sketches
