## DEVELOPMENT OF DELINEATOR TESTING STANDARD

**Test Report No. 0-6772-1**

**TEXAS A&M TRANSPORTATION INSTITUTE  
COLLEGE STATION, TEXAS**

Project Title: Development of New Delineator Material and Impact Testing Standard to Prevent  
Premature Failures Specific to Installation Application

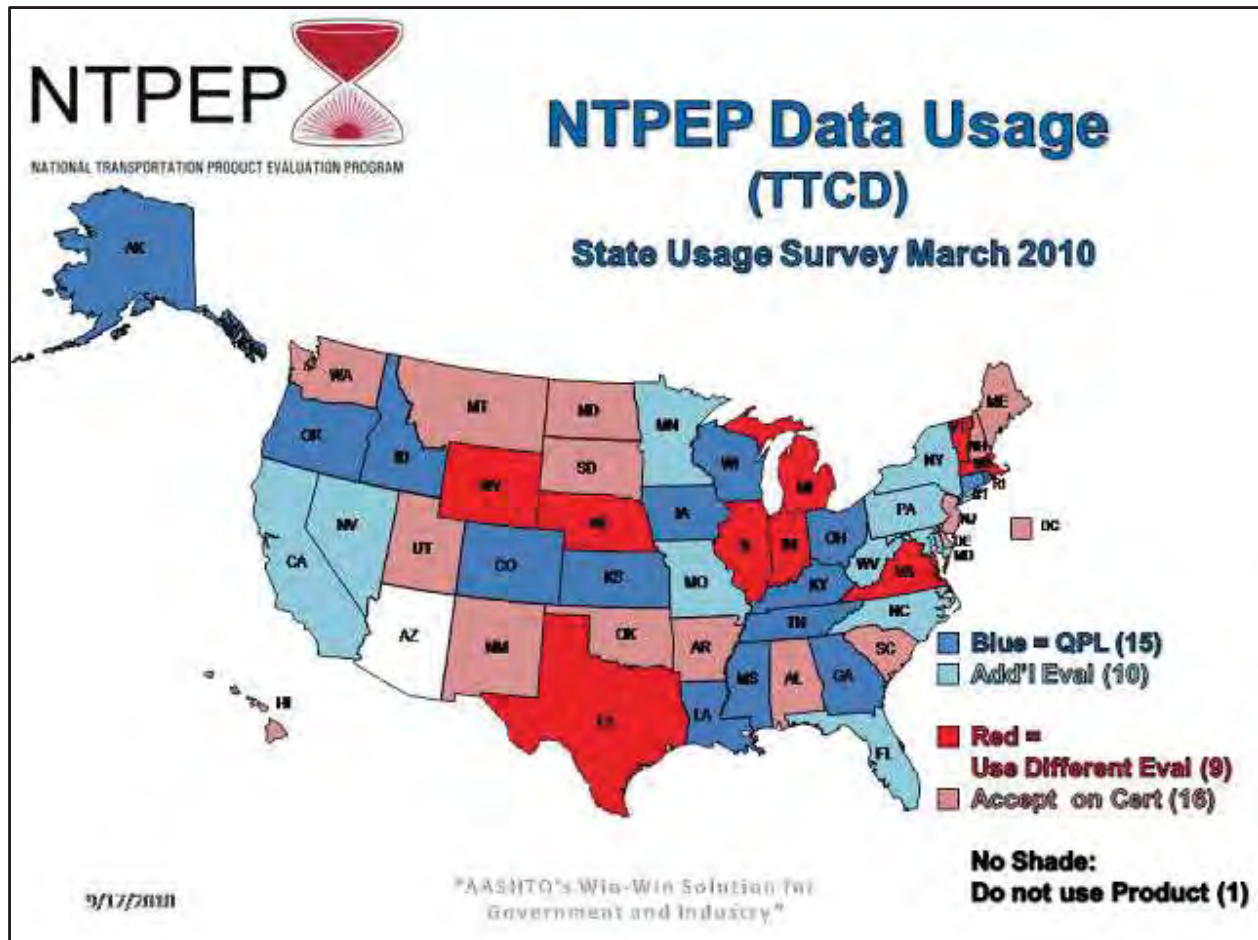
**Figure 1.1. NTPEP’s Summary Map of State Delineator Testing Requirements.**

Many states who have additional requirements simply increase the number of impacts and keep the same testing protocol. As manufacturers strengthen their designs to resist an increased number of impacts, it is expected that the likelihood of failures in the field would decrease. This method is not necessarily the most efficient solution to the problem. The standard may in fact be driving up the cost of delineators without actually addressing failures in the field. These testing standards may result in a delineator design that will perform well in a test, but may perform poorly in the field. An example of this may be a result of using the wrong test vehicle (different test vehicles result in different impact delineator performance). Some states, shown in red, have developed their own independent specifications, which can be less stringent than the NTPEP impact standard.

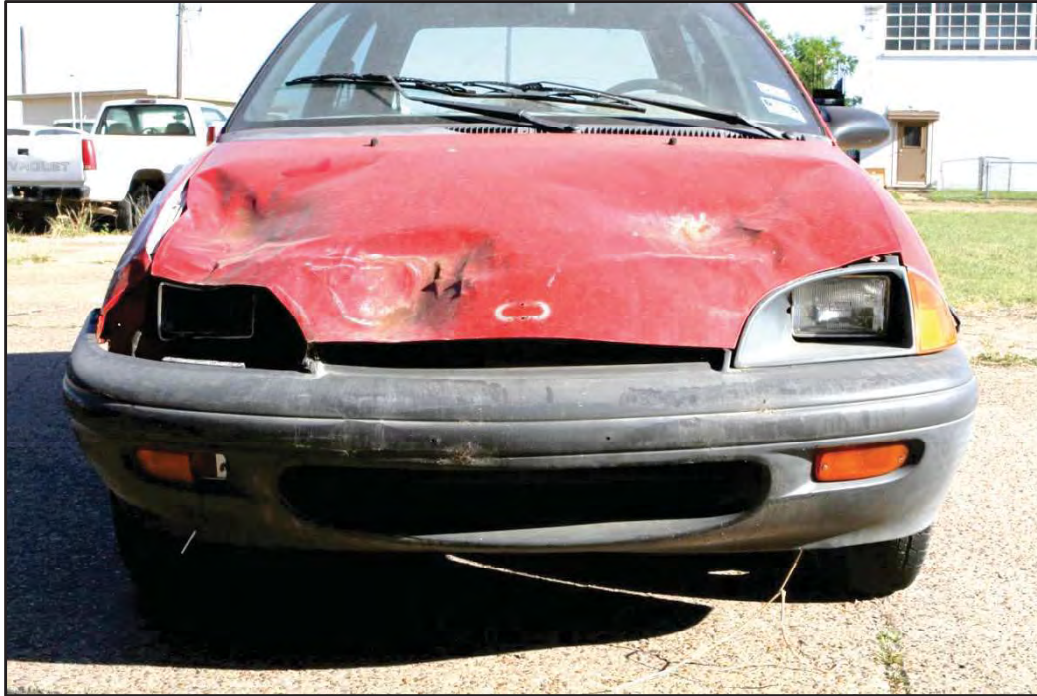
**Figure 1.2. Geo Metro (NCHRP Report 350 Test Vehicle) after Approximately 50 Impacts.**

Over the years, TTI researchers have learned how the vehicle becomes damaged and have been able to compensate to an extent. As an example, [Figures 1.2](#) and [1.3](#) show the resulting damage to two different test vehicles after being impacted 50+ times. The vehicle in [Figure 1.2](#) was from one of the first attempts at running the Florida high durability testing standard. That vehicle was damaged beyond repair and would not have been able to finish the testing; however, it did outlast the product being tested. The test vehicle shown in [Figure 1.3](#) was from the latest set of tests, where the vehicle impacted a set of delineators 100 times.

Notice the significant difference in the damage between [Figure 1.2](#) and [Figure 1.3](#). Some of the reduced damage is due to a difference in delineator design, some is due to a difference in the vehicle design, and finally some is due to the proposed modifications to the testing procedure. This vehicle could be used in future testing with some minor modifications; however, there is some damage to the vehicle that changed the profile of the vehicle and therefore the impact characteristics of the vehicle. TTI researchers believe that the use of technology used in the racing industry, such

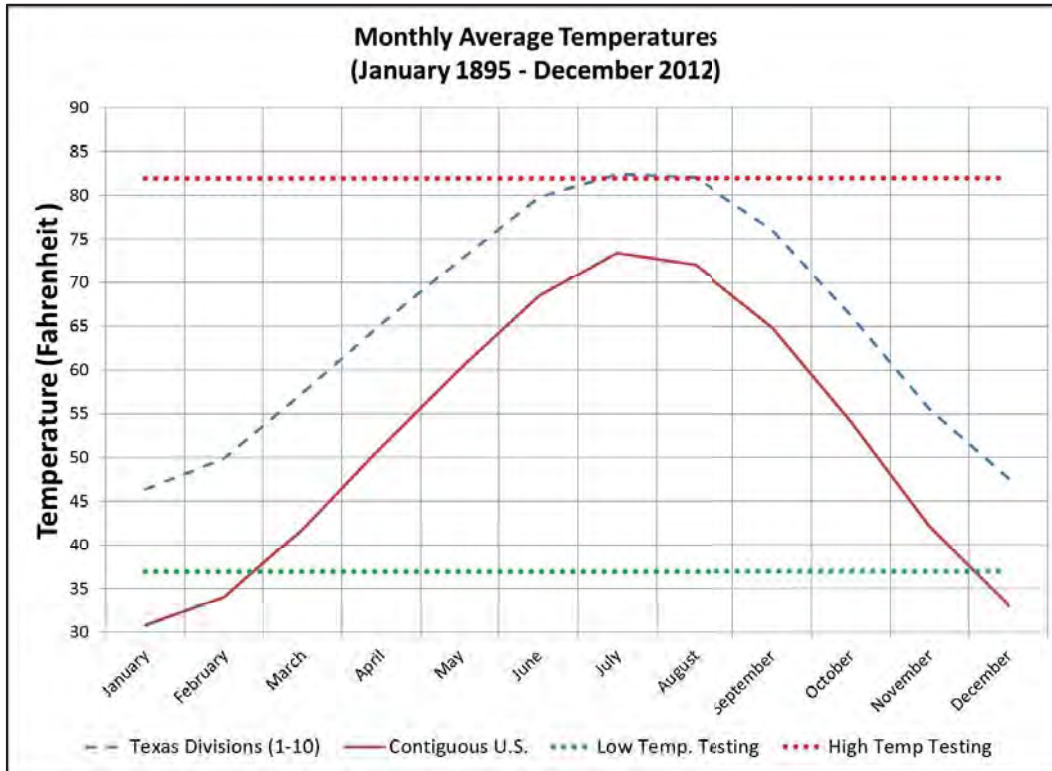
Figure 3.1. Average Temperature Comparison.

The NTPEP standard addresses this mechanism by defining two testing temperatures, one high (85°F) and one low (32°F). On the other hand, with its moderate climate, Florida has decided to perform all of its testing at 65°F. To evaluate the normal temperature fluctuations in the state of Texas, the researchers gathered temperature data from National Oceanic and Atmospheric Administration (NOAA) databases (7). [Figure 3.1](#) shows a plot of the average monthly ambient temperature between 1895 and 2012. The blue line represents the average monthly temperature for the entire state of Texas. The maroon line represents the average monthly temperature for the contiguous United States. Notice that the average temperatures are approximately 10°F warmer than the overall United States average. This would lead one to believe that real-world results would more closely relate to the higher temperature tests.

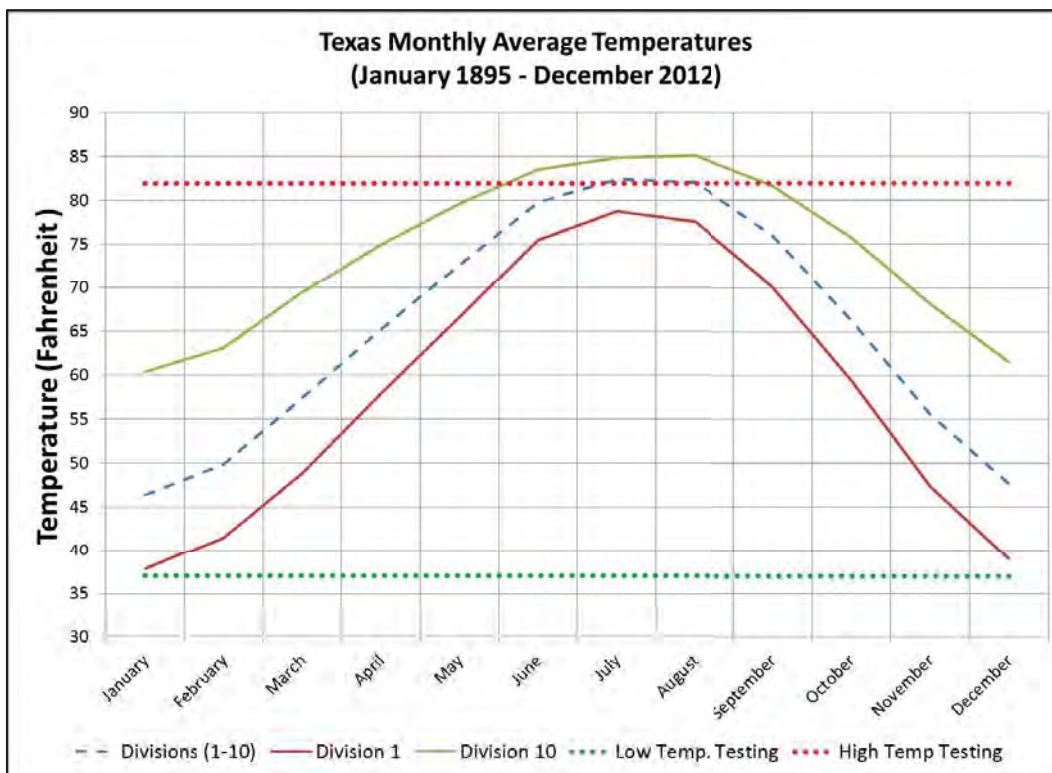
Figure 3.2. Texas Average Temperature Comparison.

Since Texas is such a large state, it contains many different sub-climates. For this reason, [Figure 3.2](#) was generated to see the effect portions of Texas have on the temperature data. Two Texas divisions were chosen to bound the extremes of the temperature effects. The first division chosen was Division 1. [Figure 3.3](#) shows that Division 1 has the highest latitude leading to the coldest expected temperatures. This division includes Amarillo, along with other smaller communities in the panhandle of Texas. The second division selected was Division 10, which is the most southern division in the state. It is expected that this division should represent one of the warmer portions of Texas. When plotted on the same axis, it shows that there are portions of Texas that regularly fall both above and below the recommended NTPEP testing temperatures. For this reason, the researchers determined that temperature effects cannot be simply ignored. The researchers recommend that testing be performed to determine if these temperature variations provide a significant difference in performance. If no substantial difference is noticed, then TTI researchers suggest following the example of Florida. If a substantial difference is noticed, then TTI researchers suggest that Texas follow the example set by NTPEP.

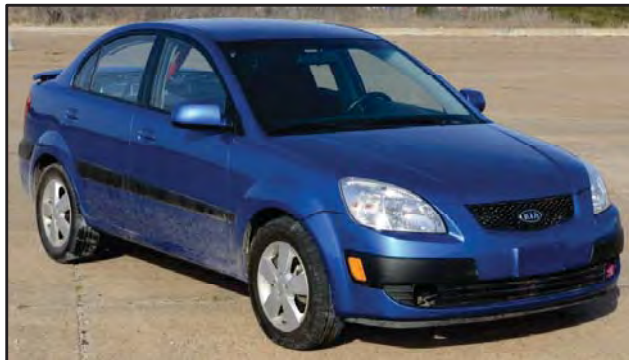
Figure 4.1. Modified 1100C.

Figure 4.1 shows the 2009 Kia Rio that was selected for modification and testing. This vehicle meets all of the AASHTO *MASH* 1100C standard vehicle requirements and is the primary vehicle used in current accredited *MASH* testing facilities. This vehicle model has been used at the TTI Proving Ground for testing delineators under contracts for private manufacturers. Figure 4.2 shows damage to the vehicle due to repeated impacts and also shows how the damage significantly altered the profile of the impacting vehicle's bumper. This damage significantly changes the way the delineators react when the vehicle impacted them. This shows that modifications to the vehicle bumper structure are required to support the bumper shell to prevent damage and to prevent alteration of the bumper profile during testing due to damage.

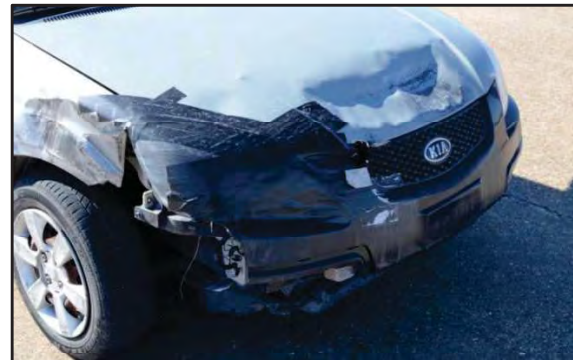
Figure 4.2. Damage to Previous Test Vehicle.

After evaluating the damage patterns shown in [Figure 4.2](#), the researchers recommended that the primary focus of the modifications should be on supporting the bumper shell of the vehicle. Previous testing show that the bumper shell of the impacting vehicle becomes severely damaged after only a few impacts. This behavior should be prevented through modifications to the vehicle. These modifications should be designed to minimize the variance in impact behavior between a modified and unmodified vehicle.

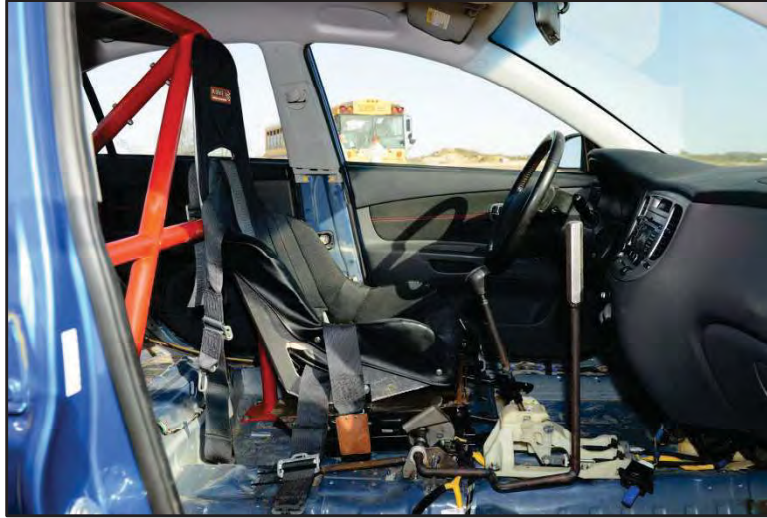
**Figure 4.3. Modified 1100C.**

Modifications to the 1100C vehicle were not limited to impact performance. Many of the modifications were performed to increase safety for the test vehicle operator. First, the entire interior of the vehicle (including seats, carpet, molding, and storage compartments) were removed to decrease the weight of the vehicle and to make room for safety equipment to be installed. Second, a roll cage meeting racing standards was installed near the “B” pillar of the vehicle (8). This roll cage minimizes occupant compartment deformation in the event of a rollover. Next, a racing seat with 5-point racing harness was installed to safely and securely restrain the vehicle operator in the event of a rollover or unplanned impact during testing. Finally, the vehicle controls were modified to allow for easier access for the operator while properly restrained by the racing seat and harness. Figure 4.3 shows the modifications made to the interior of the 1100C vehicle.

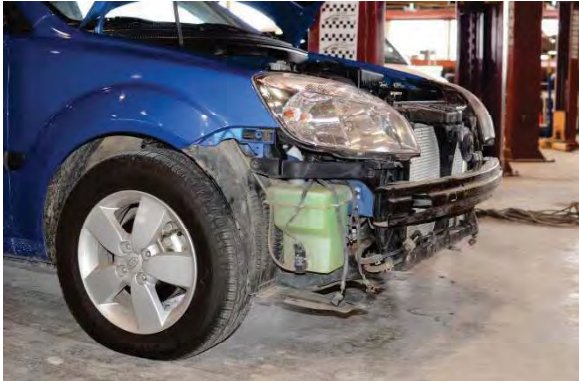
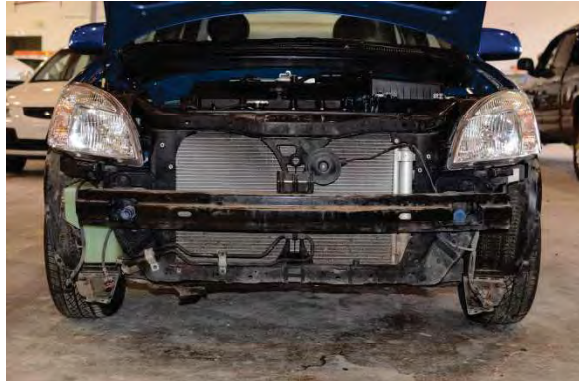
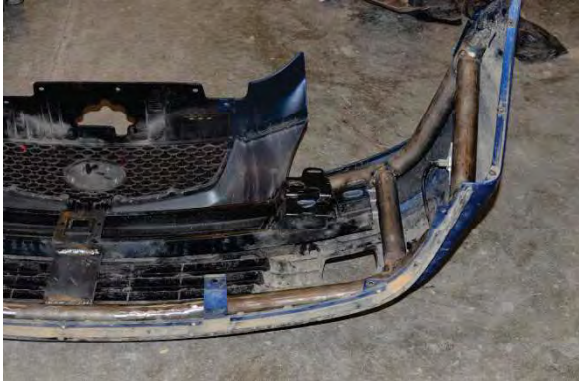
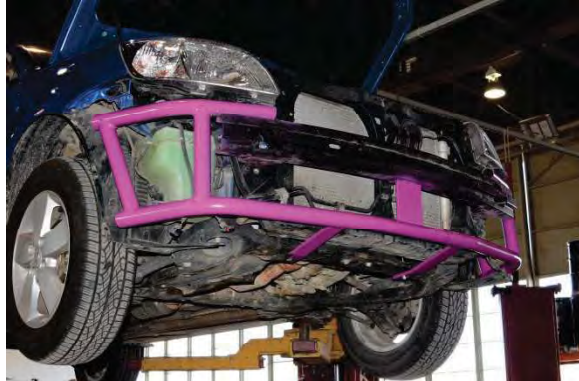
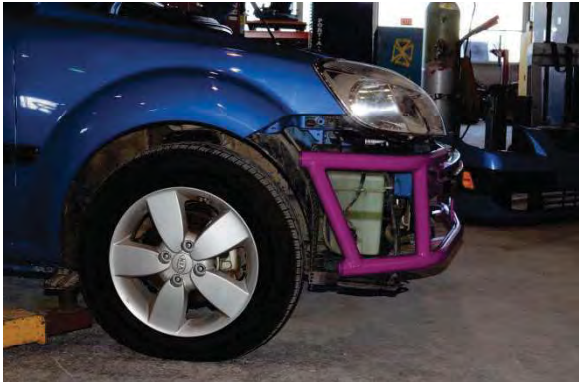
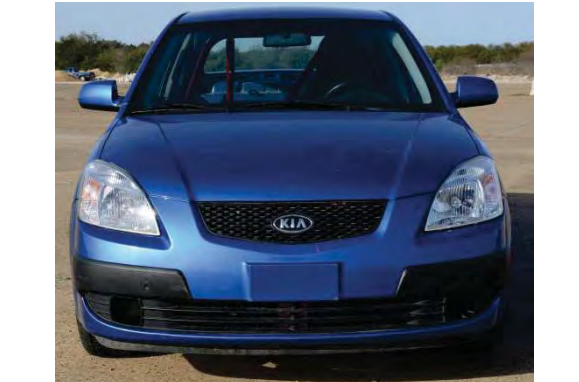
**Table 4.1. Vehicle Bumper Modifications.**

<p>A: Unmodified Bumper (Side View)</p>	<p>B: Unmodified Bumper (Front View)</p>

<p>C: Modified Bumper Inside Bumper Shell</p>	<p>D: Modified Bumper (Front View)</p>

<p>E: Modified Bumper (Side View)</p>	<p>F: Reassembled Modified Bumper</p>

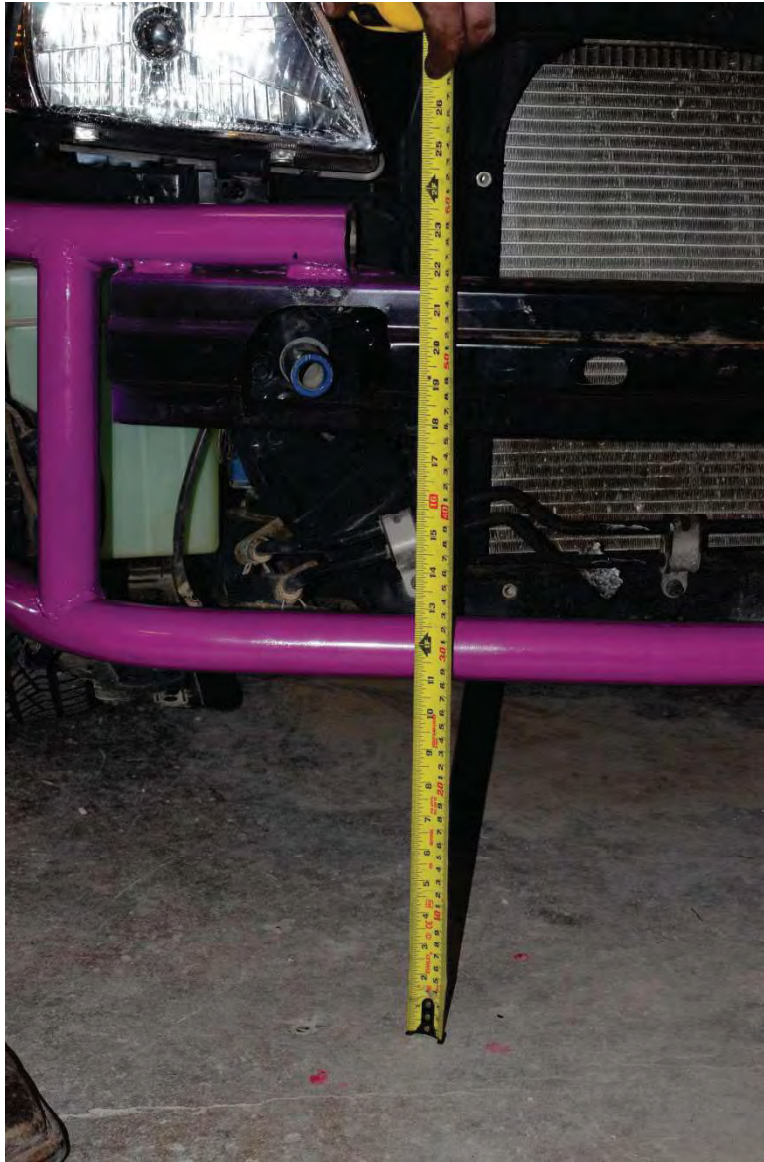
**Figure 4.4. Modified Bumper Ground Clearance.**

[Figure 4.4](#) shows the stiffened support structure's ground clearance. The bottom of the support has an approximate clearance of 11 inches.

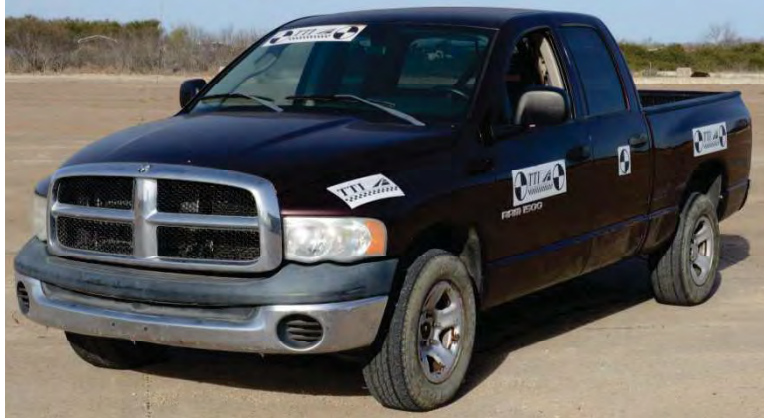
**Figure 4.5. Modified 2270P.**

A 2003 Dodge Quad Cab, shown in [Figure 4.5](#), was selected to represent the *MASH* 2270P impact vehicle. This vehicle had been used previously in *MASH* compliance testing of a curb mounted delineator system. The truck was selected to reduce the cost of the project while still meeting the requirements of *MASH* 2270P specifications. Notice that only cosmetic damage was induced during testing. This minimizes the list of modifications required to perform the proposed low-speed impact tests. However, similar to the modified 1100C impact vehicle, the interior of the pickup truck was removed and safety equipment was installed to protect the operator of the test vehicle. [Figure 4.6](#) shows the interior of the modified vehicle.

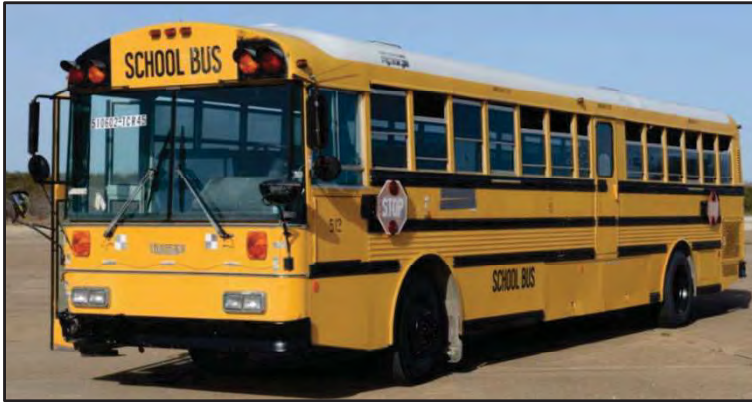
**Figure 4.7. Heavy Transit Vehicle.**

To replicate a transit class vehicle, a 1996 Thomas School Bus, shown in [Figure 4.7](#), was selected. This vehicle was selected for its rear axle capacity and its low ground clearance (~14 inches). This low ground clearance and high axle weight produces a severe impact condition for delineators. To increase the rear axle weight to 20,000 lb (axle capacity) certain modifications were made to the impacting vehicle. First, all of the seats were removed from the interior of the passenger area of the bus (see [Figure 4.8](#)). This made it easier for our mechanic technicians to ballast the impacting vehicle. Another reason this vehicle was selected was due to the rigidity and safety requirements this class of vehicle must meet to transport passengers. Due to these added safety requirements and the low-impact speed, further safety equipment was not deemed necessary to protect the operator of the vehicle. Finally, to bring the rear axle weight up to 20,000 lb, eight barrels (shown in [Figure 4.9](#)) were installed in the bus near the rear axle. Each barrel was loaded with sand and weighted approximately 650 lb. The eight barrels were fastened together using two ratchet straps to prevent the ballast from shifting during testing. The final rear axle weight was measured to be 20,050 lb.

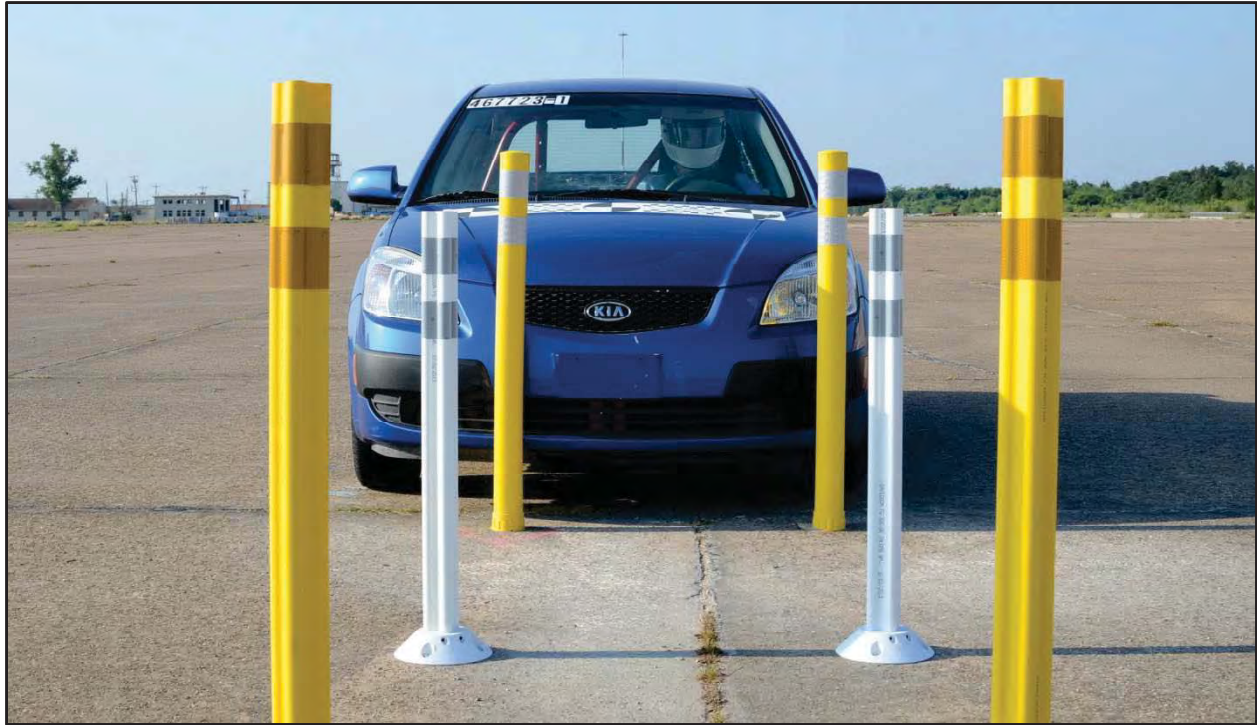
Figure 5.1. 1100C Impact Position before Testing.

Figure 5.1 shows the modified 2009 Kia Rio selected for testing aligned such that the driver's side tire impacts one row of delineators, and the bumper impacts the other row of delineators just right of the centerline of the vehicle. The test procedure requires the delineators be impacted up to 200 times at 70 mph. Figure 5.2 is a diagram of the test layout. Two rows of delineators were installed with seven samples in each row. The centerlines of the two rows were separated by 36 inches. Samples 2, 4, 6, and 7 in each row were rotated 25° from the path of the impacting vehicle. Samples with a "W" suffix were impacted by the driver's side tire. Samples with a "B" suffix were impacted by the bumper just right of the centerline of the vehicle.

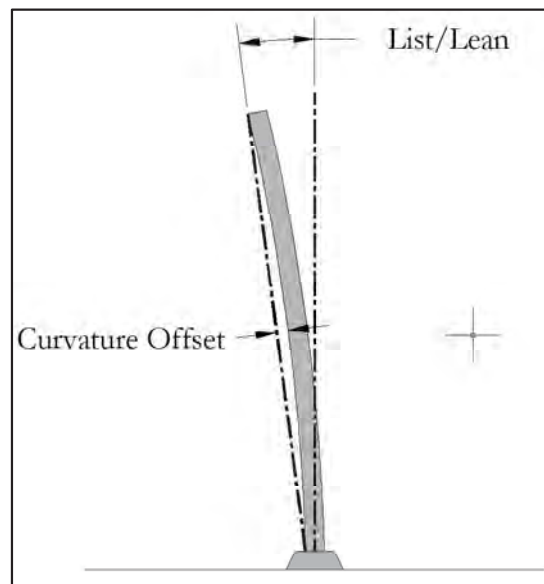
**Figure 5.3. Diagram of Measurement Methods.**

The primary method for evaluating whether a delineator can restore to a vertical orientation is to measure list and lean. List is how far the delineator slopes left or right when compared to the path of the vehicle. Lean is how far the delineator slopes toward or away from the impacting vehicle. In existing standards, it is unclear exactly how to measure the angle of the delineator as the delineator naturally curves. Should it be measured at the top, bottom, or from the top to the bottom? This can make a significant difference in the measured value and could mean the difference in a pass versus failure of the delineator. In addition, there is currently no recommended method to address how to measure the amount of curvature the delineator has sustained.

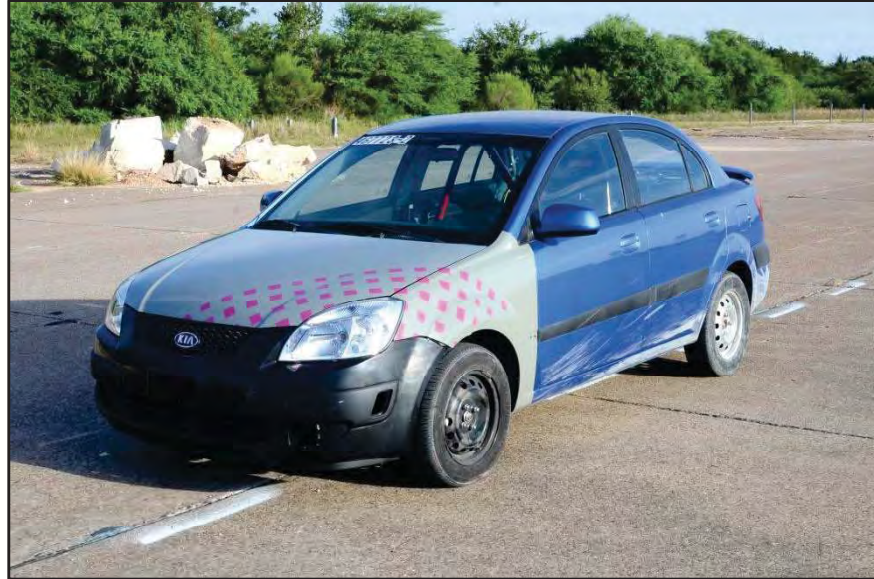
**Figure 5.4. 1100C after Being Repaired and before Low Durability Testing.**

[Figure 5.4](#) shows the modified 2009 Kia Rio selected for testing after it was repaired. The entire hood, driver's side quarter panel, bumper shell assembly, and driver's side headlight were replaced. None of the vehicle's structural or powertrain components were damaged during previous testing. Again, the vehicle was aligned such that the driver's side tire impacts one row of delineators, and the bumper impacts the other row of delineators just right of the centerline of the vehicle. The test procedure requires the delineators be impacted up to 10 times at 50 mph. [Figure 5.5](#) is a diagram of the test layout. Two rows of delineators were installed with six samples installed in each row. The centerlines of the two rows were separated by 36 inches. Samples 2, 4, and 6 in each row were rotated 25° from the path of the impacting vehicle. Samples with a "W" suffix were impacted by the driver side tire. Samples with a "B" suffix were impacted by the bumper just right of the centerline of the vehicle. The first four samples in each row were installed in Georgetown road base, graded, and compacted to meet AASHTO *MASH* standards. See [Appendix B](#) for further details of the road base used in testing.

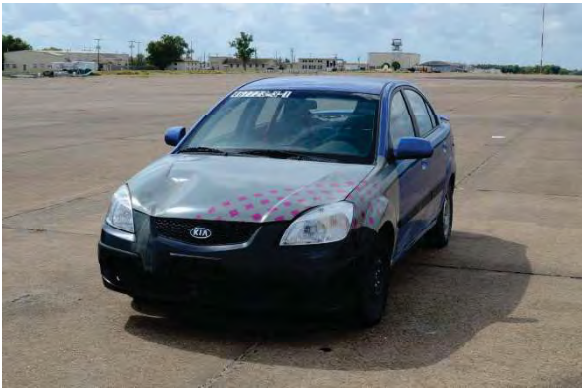
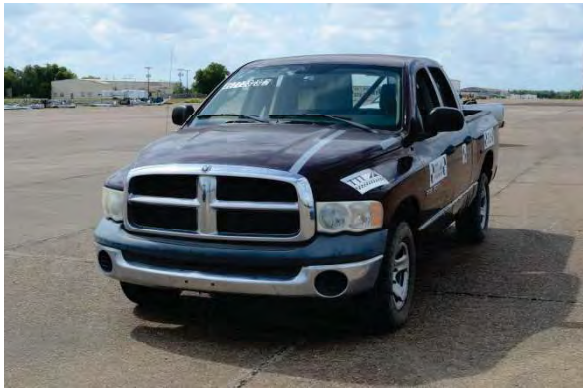
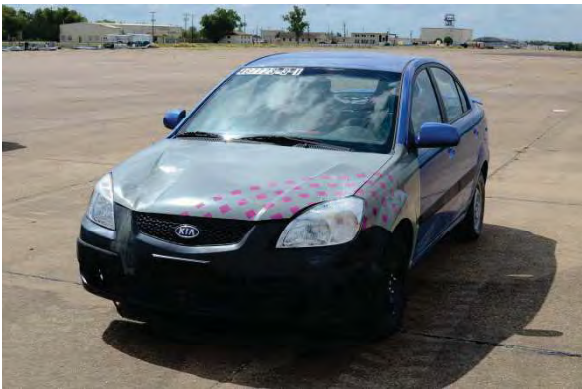
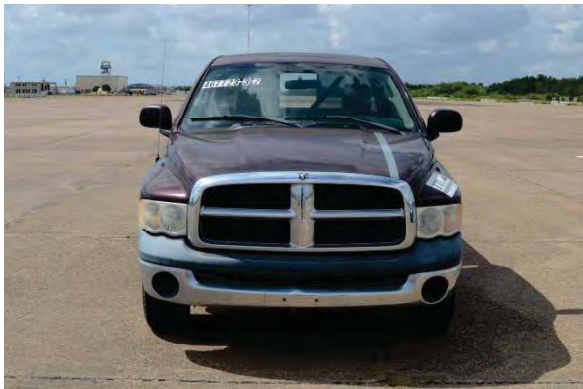
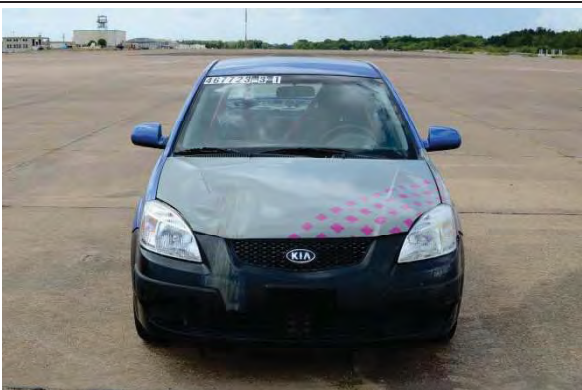
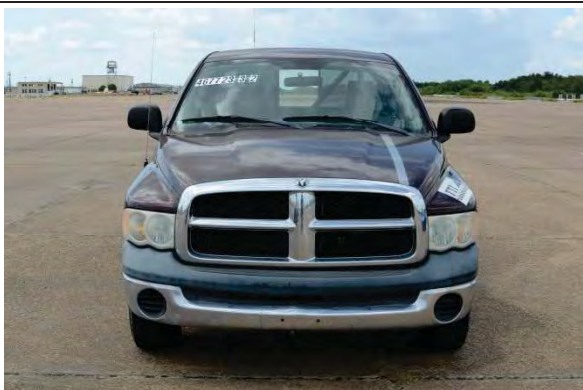
**Table 5.7. Vehicle Impact Damage.**

Images of the test vehicles were taken during testing to document damage and variances in the vehicle profile throughout testing. [Table 5.7](#) documents damage to the bumper, hood, headlight, and quarter panel of the impacting vehicles.

<p>A photograph of a silver Kia sedan with pink polka dots on the hood, parked in an open lot. The car shows minimal damage after one impact.</p>

<p>A photograph of a dark blue Ram pickup truck with white stripes on the hood, parked in an open lot. The truck shows minimal damage after one impact.</p>
<p>C: 1100C After 1 Impact</p>	<p>D: 2270P After 1 Impact</p>

<p>A photograph of the same silver Kia sedan, showing more visible damage to the hood and front end after five impacts.</p>

<p>A photograph of the same dark blue Ram pickup truck, showing more visible damage to the hood and front end after five impacts.</p>
<p>E: 1100C After 5 Impacts</p>	<p>F: 2270P After 5 Impacts</p>

<p>A photograph of the silver Kia sedan, showing significant damage to the hood and front end after ten impacts.</p>

<p>A photograph of the dark blue Ram pickup truck, showing significant damage to the hood and front end after ten impacts.</p>

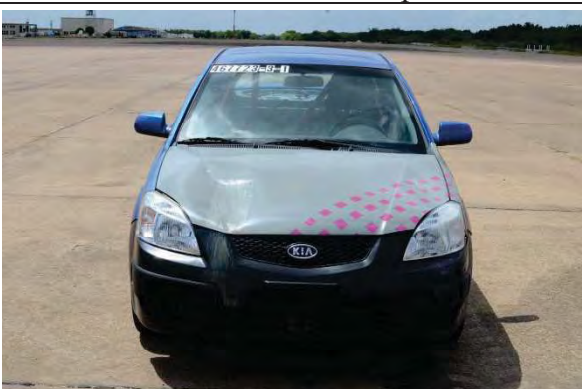
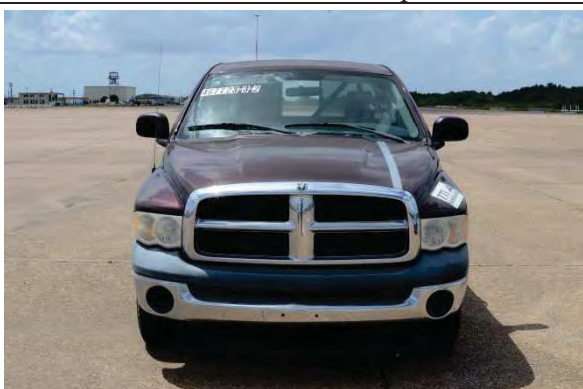
<p>A photograph of the silver Kia sedan, showing extensive damage to the hood and front end after fifty impacts.</p>

<p>A photograph of the dark blue Ram pickup truck, showing extensive damage to the hood and front end after fifty impacts.</p>
<p>I: 1100C After 50 Impacts</p>	<p>J: 2270P After 50 Impacts</p>

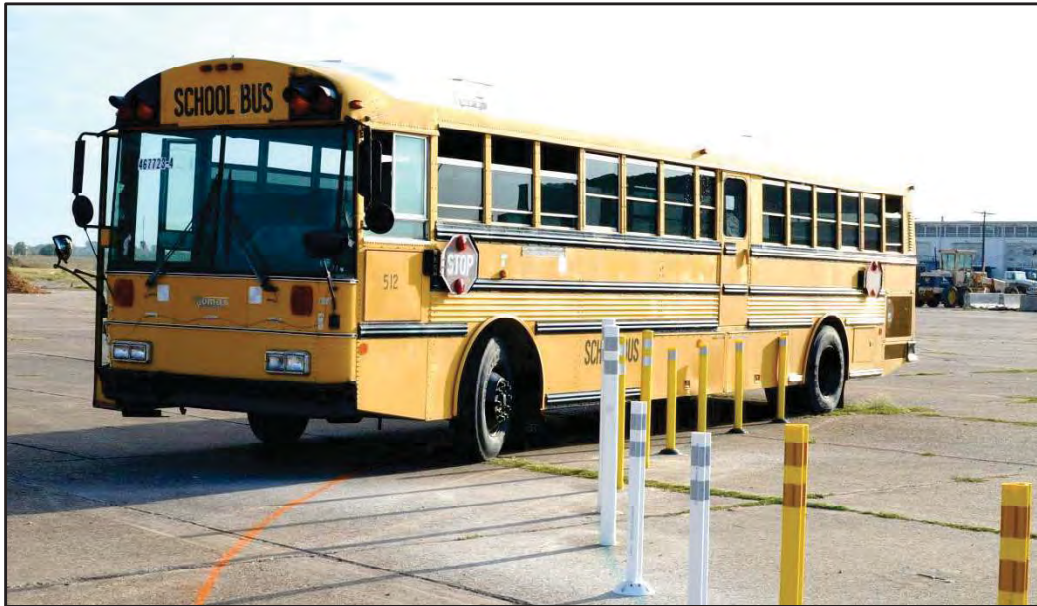
**Figure 5.7. Modified Transit Vehicle prior to Impact.**

Figure 5.7 shows the modified transit vehicle selected for testing. This vehicle was previously used in a crash test on an unrelated project. None of the vehicle's structural, powertrain, or body components were damaged during the previous testing. The vehicle was aligned such that the driver's side rear tandem tires impacted one row of delineators installed on a 125-foot diameter arc. The test procedure required the delineators be impacted up to 200 times at a speed between 10 mph and 20 mph. Figure 5.8 is a diagram of the test layout. A total of 14 samples were installed in single row. All samples were rotated to align the delineators with the tangent of the circle.

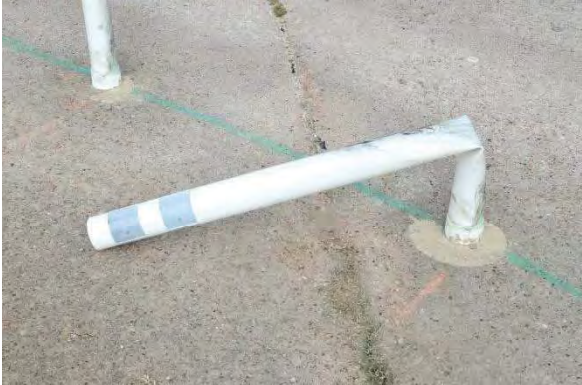
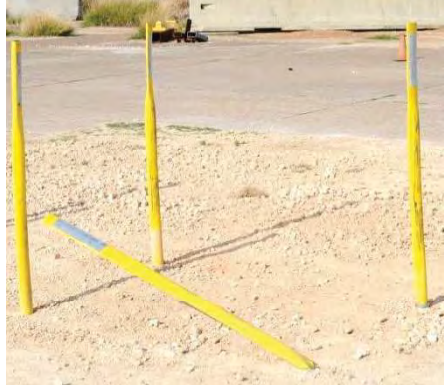
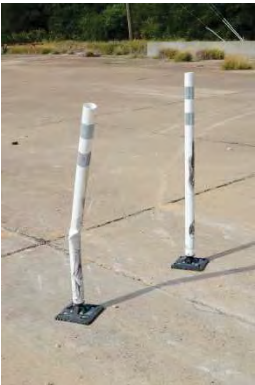
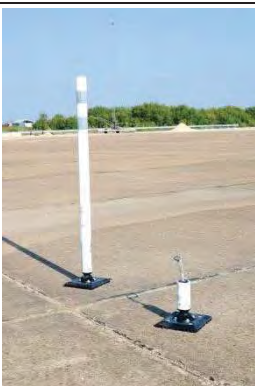
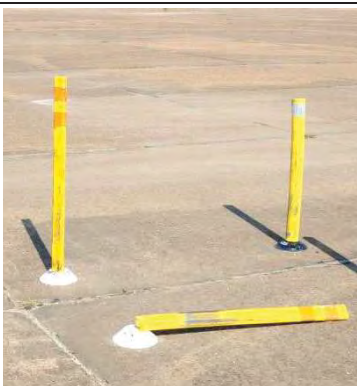
**Table 5.10. Witnessed Delineator Failure Modes.**

<p>A: Failure to Restore to Upright Position</p>

<p>B: Failure to Restore to Upright Position</p>

<p>C: Excessive List/Lean/Curvature</p>

<p>E: Post Rupture</p>

<p>F: Post Rupture (at base)</p>

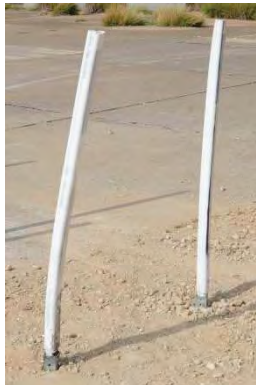
Multiple failure modes were witnessed during testing of the delineator samples using the various testing procedures. [Table 5.10](#) is a collection of photos showing common failure modes of delineators. In addition to these failure modes, the researchers have also witnessed, on multiple occasions while testing products on unrelated projects, the disengagement of the base and the roadway surface. This failure mode has also been witnessed in the field. This failure mode has been witnessed extensively with the use of epoxy, mechanical anchors, and heat sensitive polymer pads; however, this failure mode was not witnessed during this series of testing.

<p>D: Excessive List/Lean/Curvature</p>

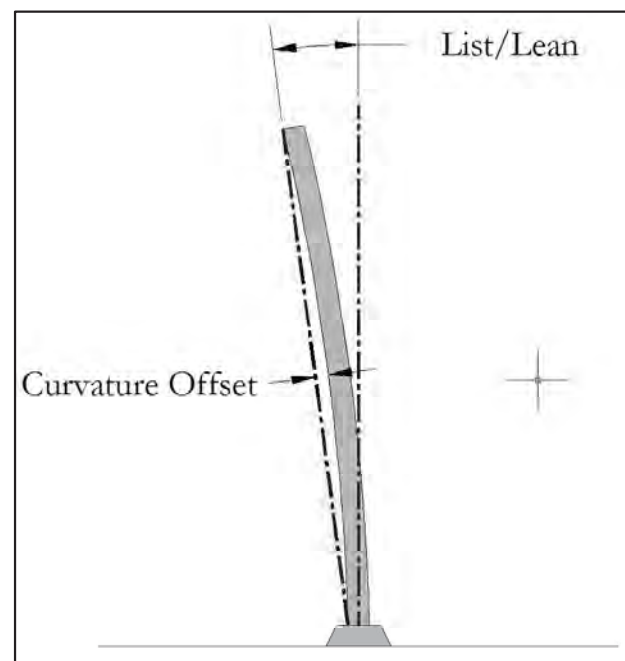
**Figure 6.1. Diagram of Measurement Methods.**

For this reason, the researchers developed a standard method for measuring List/Lean and curvature offset, shown in Figure 6.1. Table 6.1 shows the list and lean measured from the base of the delineator to the top edge of the delineator using a digital level that reads degrees as an example. The Curvature Offset is measured at the maximum offset from the level in inches.

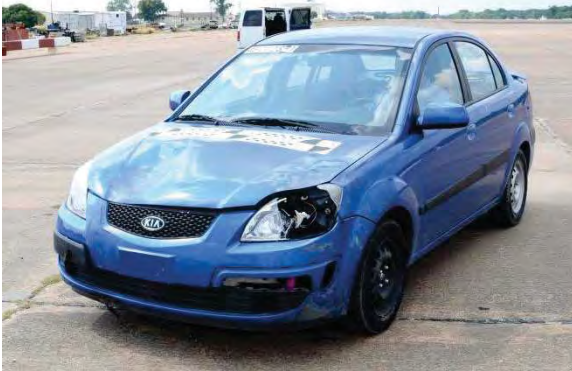
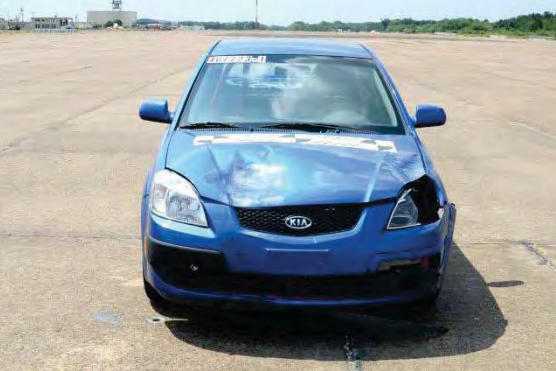
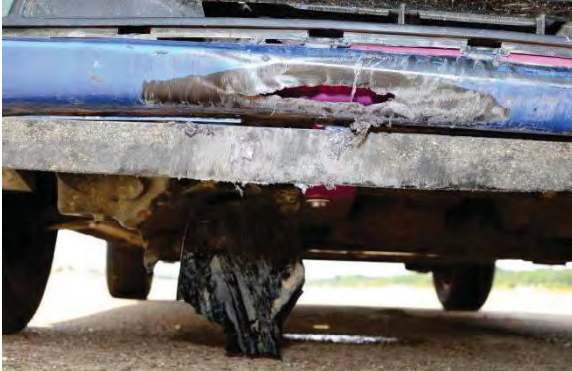
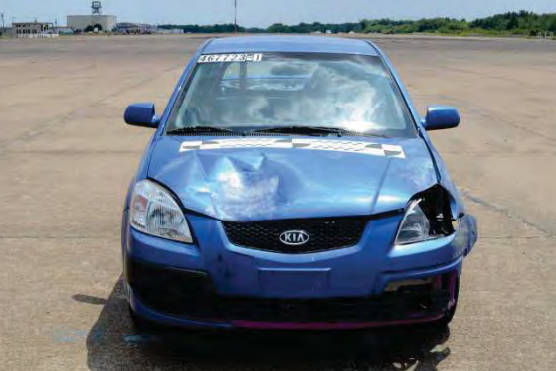
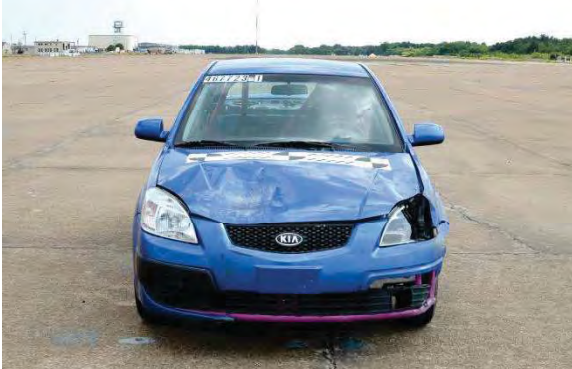
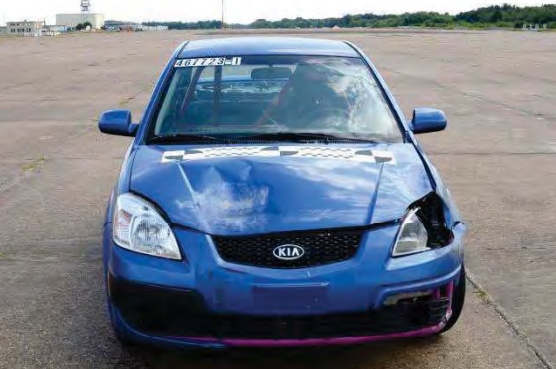
**Table 6.2. Modified Vehicle Impact Damage (Continued).**

Images of the test vehicle were taken during testing to document damage and variances in the vehicle profile throughout testing. Table 6.2 documents damage to the bumper, hood, headlight, and front quarter panel of the impacting vehicle during the High Speed High Durability test performed in summer 2013. The headlight fractured during the 24<sup>th</sup> impact. The air dam on the bottom of the bumper wore through due to repeated impact at the bumper impact location. The air dam was completely worn through and torn free on the left side of the impacting vehicle by the 100<sup>th</sup> impact.

E: After 24 Impacts	F: After 50 Impacts

G: Bumper After 50 Impacts	H: After 100 Impacts

I: After 150 Impacts	J: After 175 Impacts

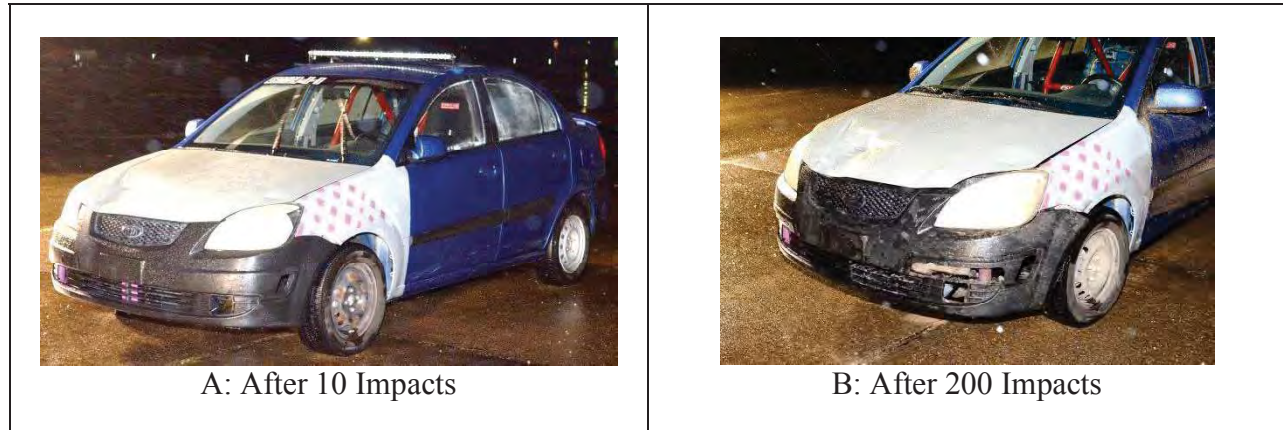
**Table 6.3. Modified Vehicle Impact Damage (Low Temp Testing).**

Table 6.3 documents damage to the bumper, hood, headlight, and quarter panel of the impacting vehicle during the Low Temperature High Durability Metropolitan Delineator test performed in January 2014. Notice that the headlamps were purposefully filled with foam to prevent failure as witnessed in summer 2013. The air dam, hood, and quarter panel were almost completely intact. The only significant damage was to the hood where it was dented due to repeated impacts. There was also a short tear in the hood from low cycle fatigue of the sheet metal skin at the location where top of the delineator impacts the hood. The researchers consider the damage to the hood significant; however, they do not believe that it significantly affected the results of the tests. The researchers believe that any attempts to prevent this behavior would in

and of themselves affect the testing and would likely lead to significant increases in the cost of testing. It is thought that the incurred cost would not be outweighed by the better performance of the hood. The researchers believe that the performance witnessed in these two tests are adequate and suggest maintaining the current configuration.

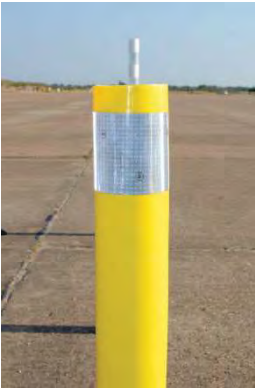
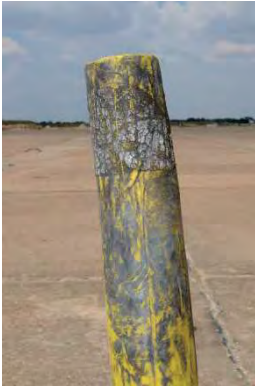
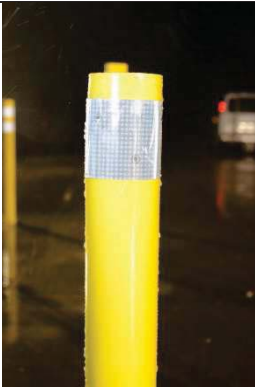
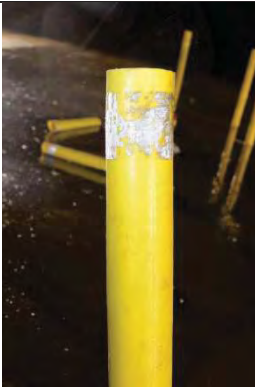
**Table 6.4. Post Discoloration and Reflective Sheeting Damage.**

<p>A: Before Testing (Warm Temp)</p>

<p>B: After 180 Impacts (Warm Temp)</p>

<p>C: Before Testing (Cold Temp)</p>

<p>D: After 150 Impacts (Cold Temp)</p>

[Table 6.4](#) also shows the difference between cold weather testing at 55 mph and warm weather testing at 70 mph. All four images are of the same product. Notice the reflective sheeting damage is very similar, but the post discoloration is significantly different. It should be noted that it was sleeting during the cold weather testing and could have served to reduce the friction between the post and the vehicle. No ice buildup was noticed in the impact regions of the vehicle. The impact with the vehicle served to remove the ice before it had time to build up.

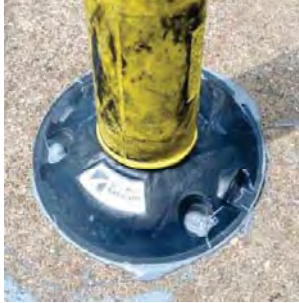
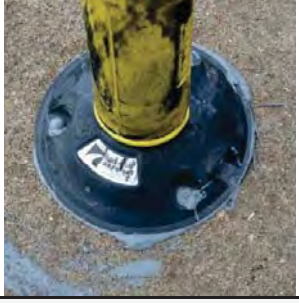
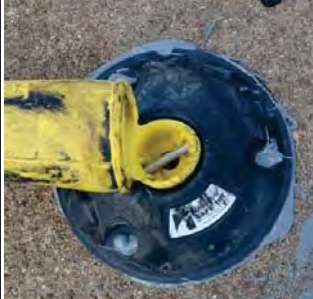
**Table 6.5. Post Damage Documentation – Sample Post # 5W (Continued).**

Photos - Post # 5W			
Run #	Reflective Sheeting	Full Post	Base or Damage
100

150

200	X	X	X
Failure/Final 180

There are up to 24 pictures for each sample (generally 8 sample posts). This project was focused on evaluating the impact vehicle and test procedure and not evaluation of the test samples. For this reason, only one table of images for one post sample are included in this memo as an example of how the damage to the post and reflective sheeting was documented. [Table 6.5](#) is an example table for sample post # 5W from warm weather testing in summer 2013. The researchers suggest continuing this method of analysis of sheeting and post damage.

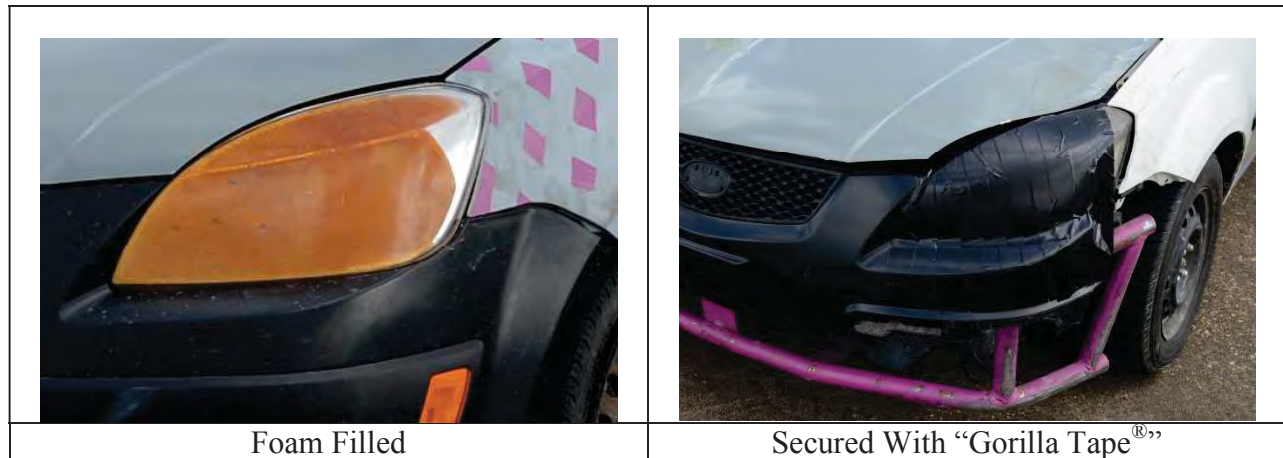
**Figure 7.3. Headlamp Modifications.**

lens from fracturing. This solved the fracture problem; however, in later testing the intact headlamp was knocked free of its supports by the impacting delineator. The headlamp was first replaced using its original mounting screws, but the failure mode repeated itself. To address this issue, the headlamp was secured to the body and bumper shell using a layer of black “Gorilla Tape<sup>®</sup>.” An image of the modification can be found in [Figure 7.3](#). The use of the layer of “Gorilla Tape” did not seem to affect the performance of the delineator impacted by the tire. It is the recommendation that these two methods of modifications be utilized in all future testing to provide a consistent and repeatable impact test.

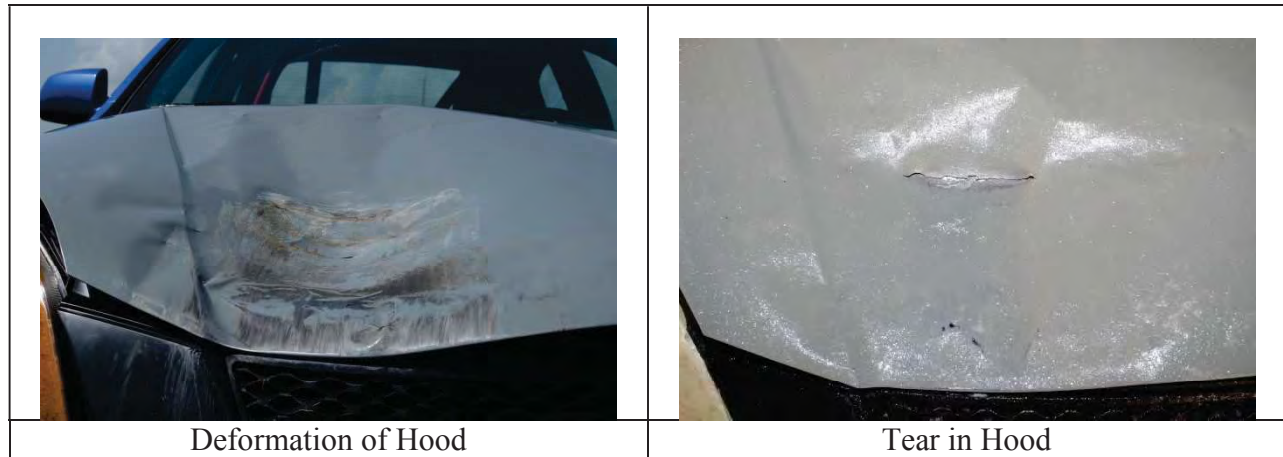
**Figure 7.4. Hood Damage.**

While the damage to the hood was significant, it did not seem to change the performance of the delineator. The researchers did investigate possible methods of strengthening the hood. The researchers took the strict stance that they did not want to change the surface of the hood or change its deflection characteristics significantly. The researchers did not want to stiffen the hood too much for fear of making the simulated impact too severe when compared to a “real world” impact. Upon investigation, the researchers found that most of the supporting structure under the hood in the front of the vehicle was made from plastic. This, coupled with the tight spaces under the hood, makes creating a support structure (similar to the bumper modification) very problematic. One idea that was tested includes filling voids within the hood with expanding foam (fire resistant), as shown in [Figure 7.5](#). While this did seem to help the performance of the hood, the researchers are not sure the minor added capacity is worth the cost of using the foam.
