## DEVELOPMENT OF DELINEATOR TESTING STANDARD

**Test Report No. 0-6772-1**

**TEXAS A&M TRANSPORTATION INSTITUTE  
COLLEGE STATION, TEXAS**

Project Title: Development of New Delineator Material and Impact Testing Standard to Prevent  
Premature Failures Specific to Installation Application

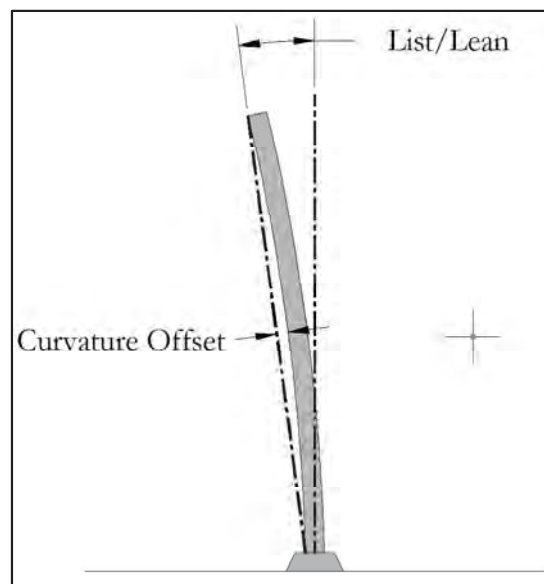
Figure 8.1. Diagram of Measurement Methods.

Testing and evaluation under this project showed that list and lean generally remained unchanged throughout testing until just before failure. The researchers noted that a delineator would fail soon after reaching a list or lean greater than  $15^\circ$ . For this reason, the researchers recommend a maximum angle (in any direction) of  $15^\circ$ .

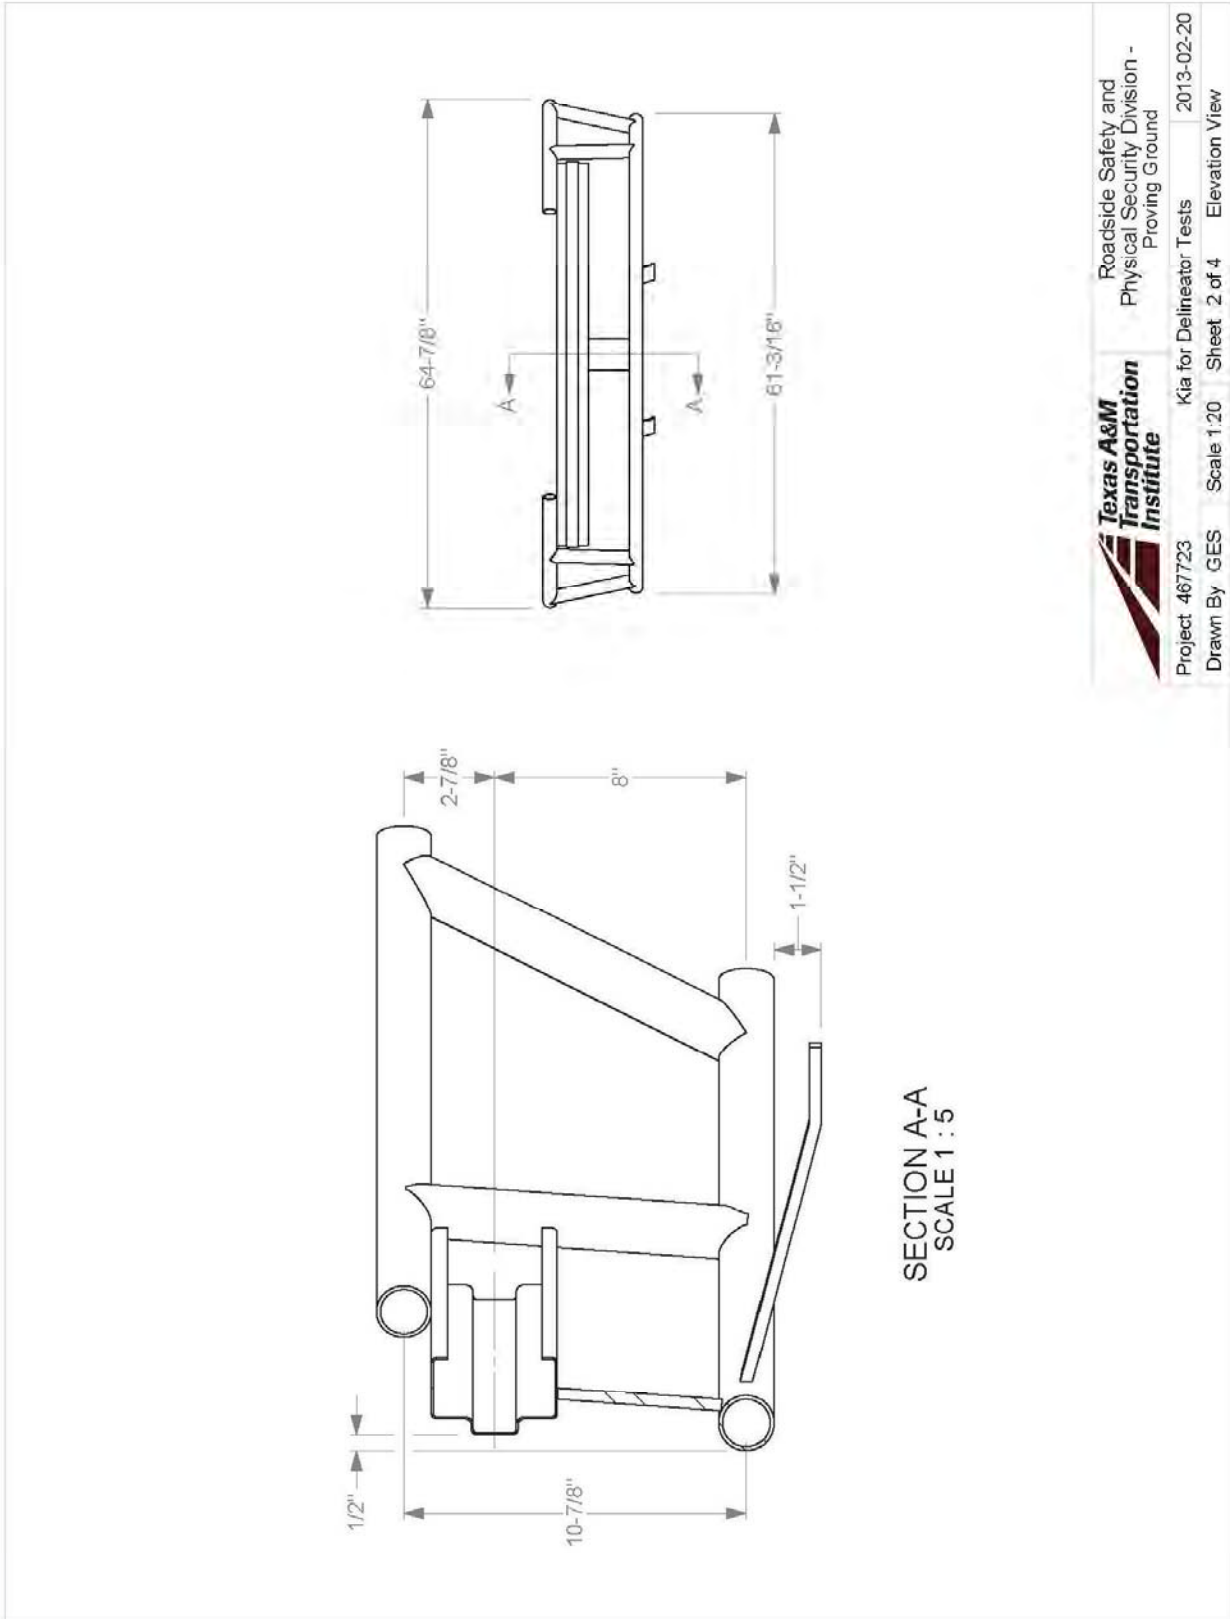
Roadside Safety and Physical Security Division - Proving Ground	
	Project 467723	Kia for Delineator Tests
Drawn By GES	Scale 1:20	Sheet 2 of 4
		Elevation View

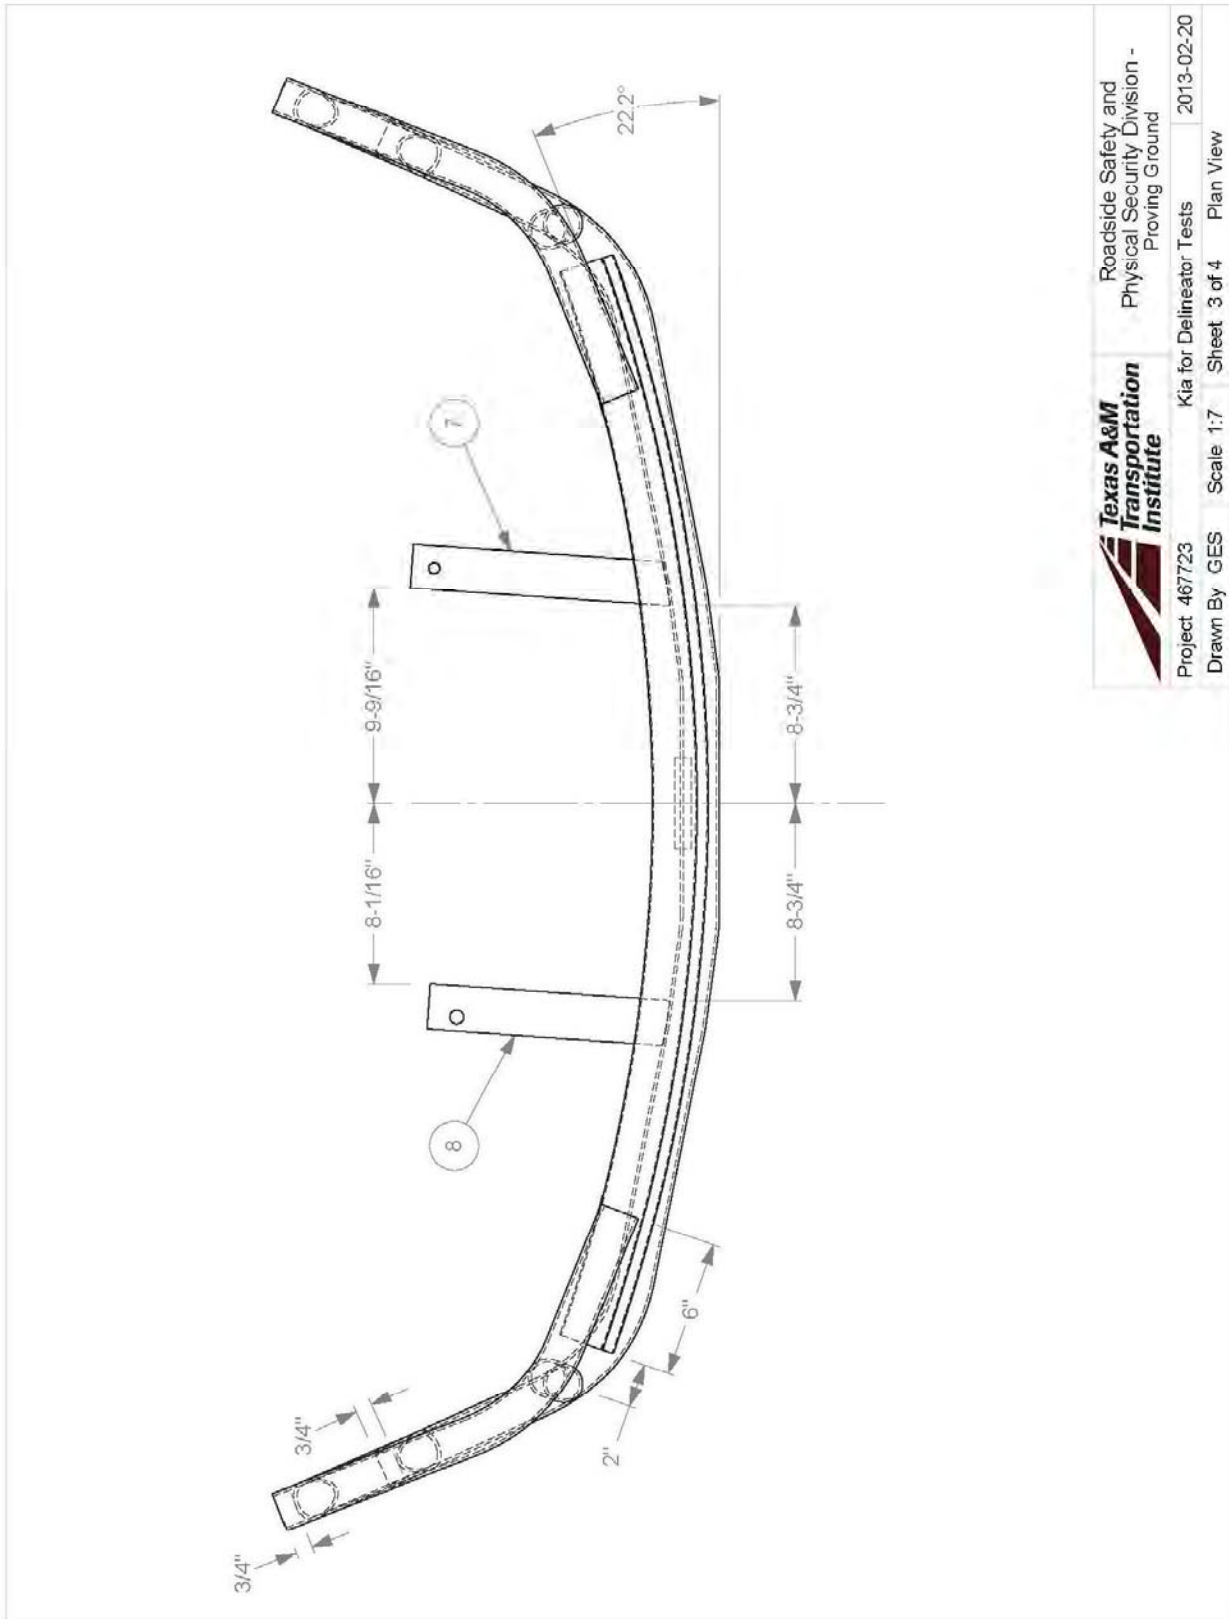
Roadside Safety and Physical Security Division - Proving Ground	
	Project 467723	Kia for Delineator Tests
Drawn By GES	Scale 1:7	Sheet 3 of 4
		Plan View
		2013-02-20

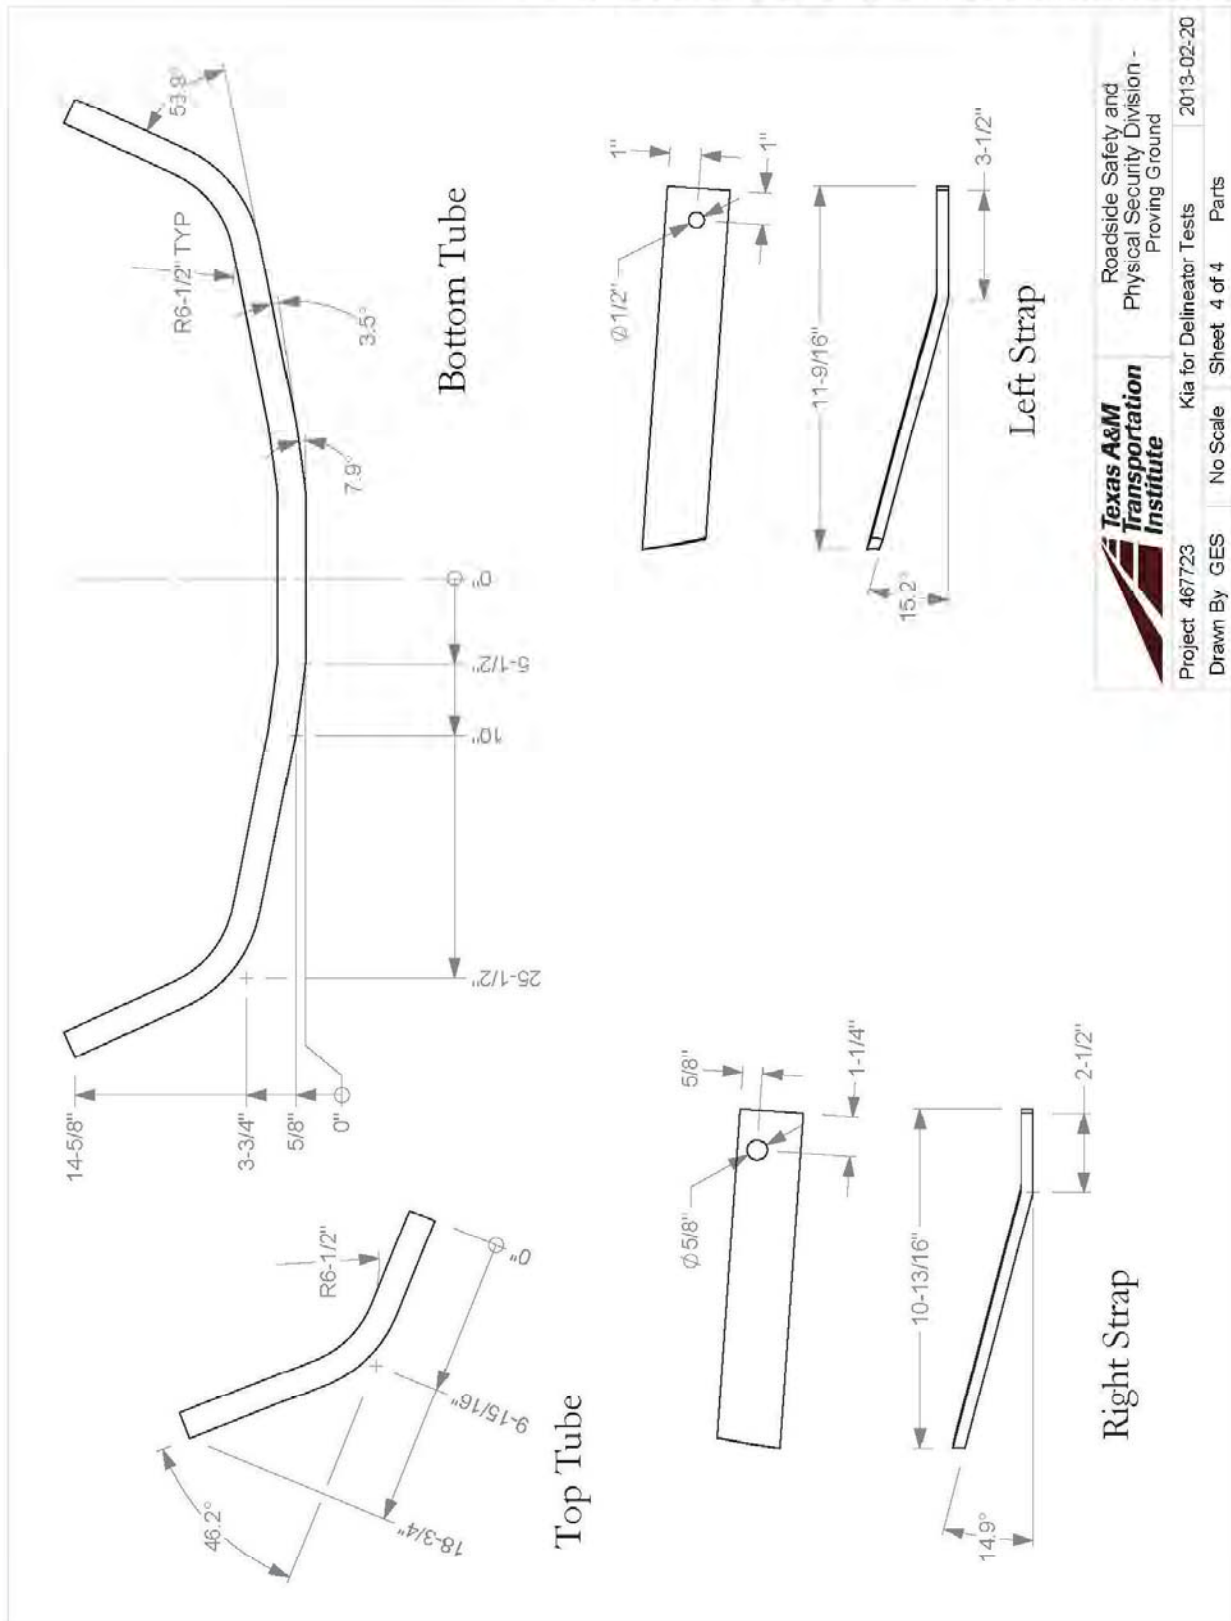
**Texas A&M Transportation Institute**  
 Roadside Safety and Physical Security Division - Proving Ground  
 Project 467723 Kia for Delineator Tests 2013-02-20  
 Drawn By GES No Scale Sheet 4 of 4 Parts

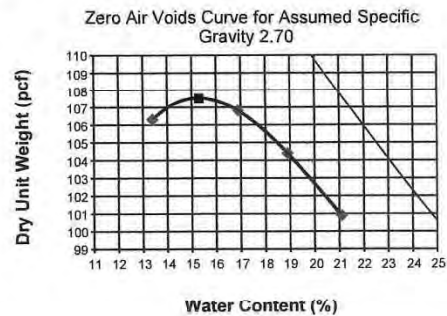
**Services:** Moisture-Density Relations

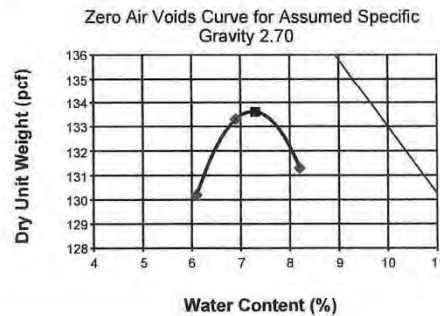
**Maximum Dry Unit Weight (pcf):** 127.4  
**Optimum Water Content (%):** 10.2

**Services:** Moisture-Density Relations
