Complaint 23-099

7811 N Panorama Dr

Avista and ELM had 1 total mislocated and 1 total no locate of the power service at 7811 Panorama twice.

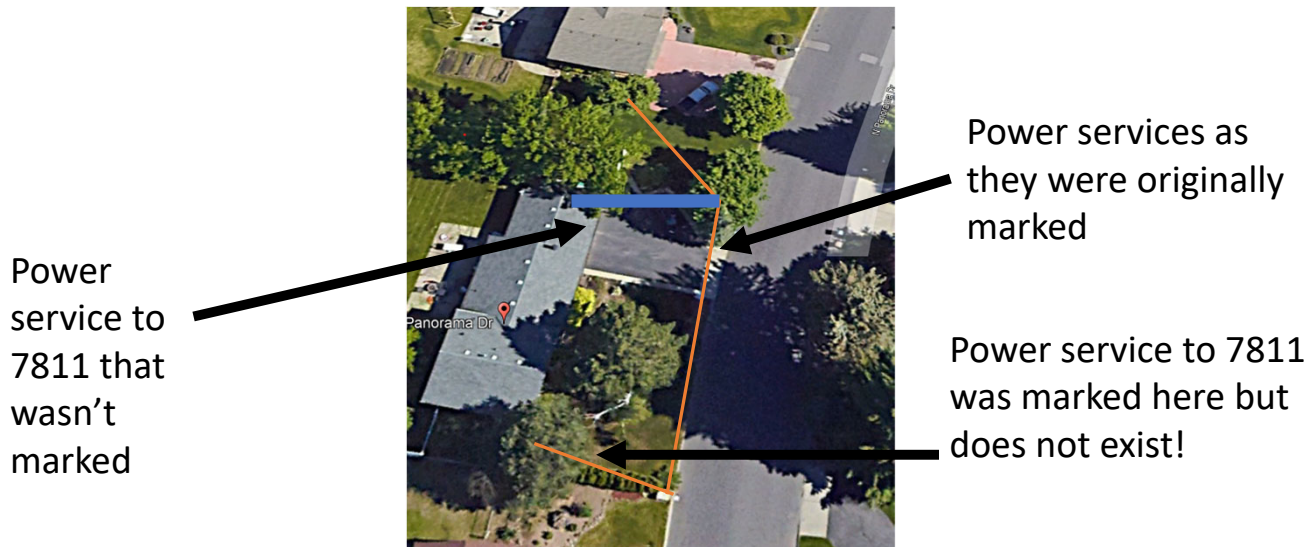
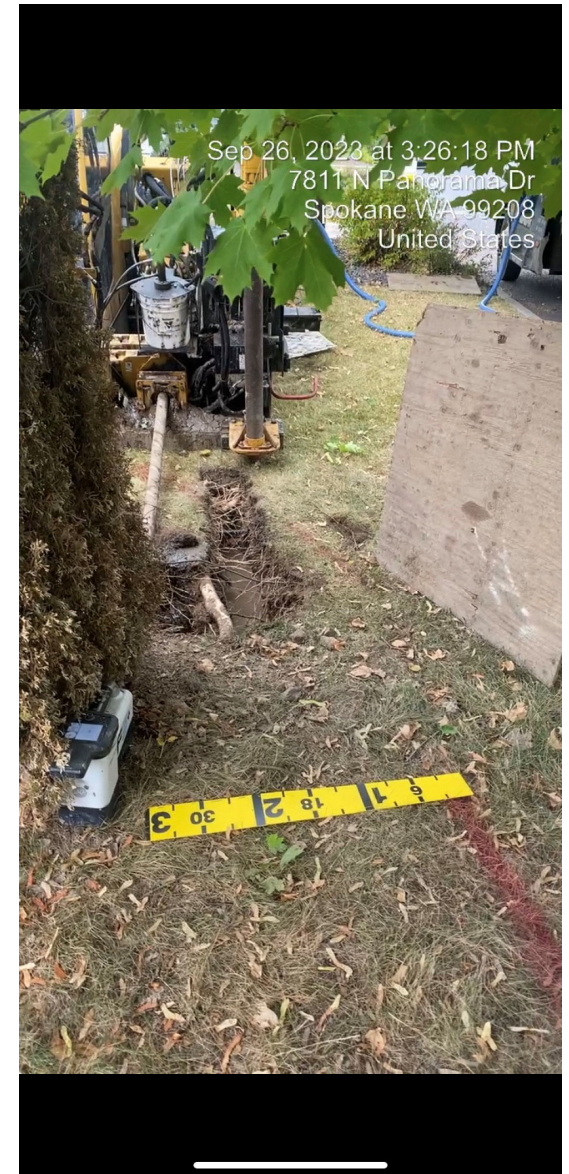
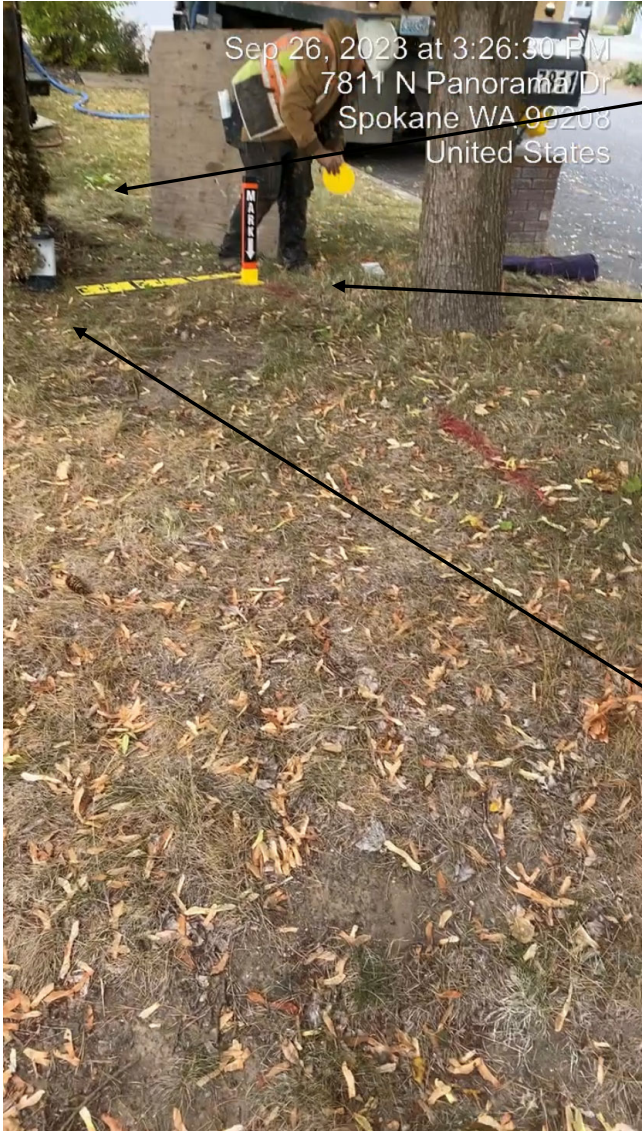
Before ELM arrived on site 9/26

- No power box located
- Only one power service located, which we potholed, found and safely crossed
- About 3' into the shot (where the ruler is) the strike alert went off, the operator shut down the drill and this picture was taken.
- As you can see the power service is marked in a line to the house 7821 and there is no service going to the house at 7811 Panorama

Power service to 7821
that is marked

Location of
power box
that is buried

Location of power service that is not marked and
location of utility strike

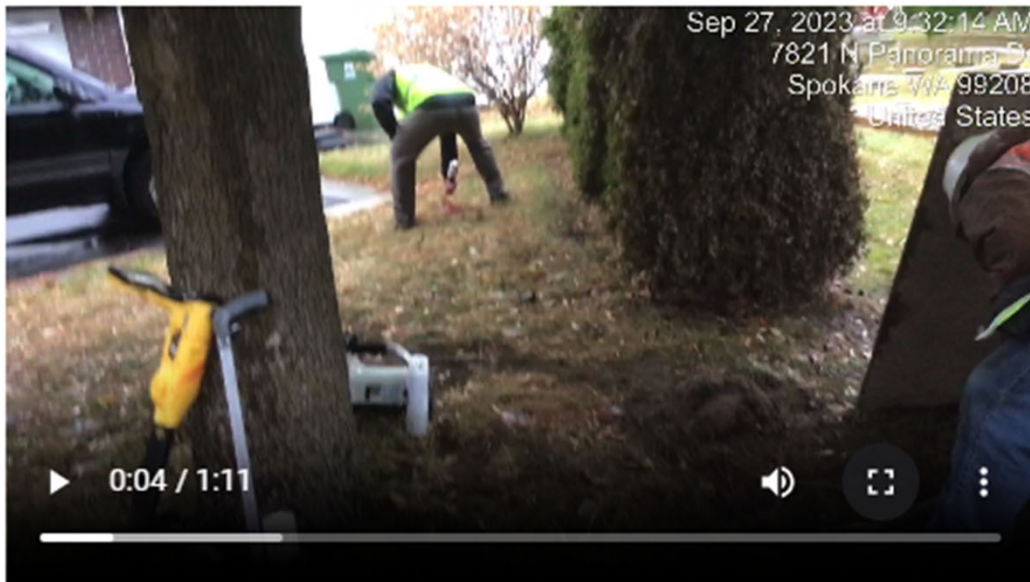
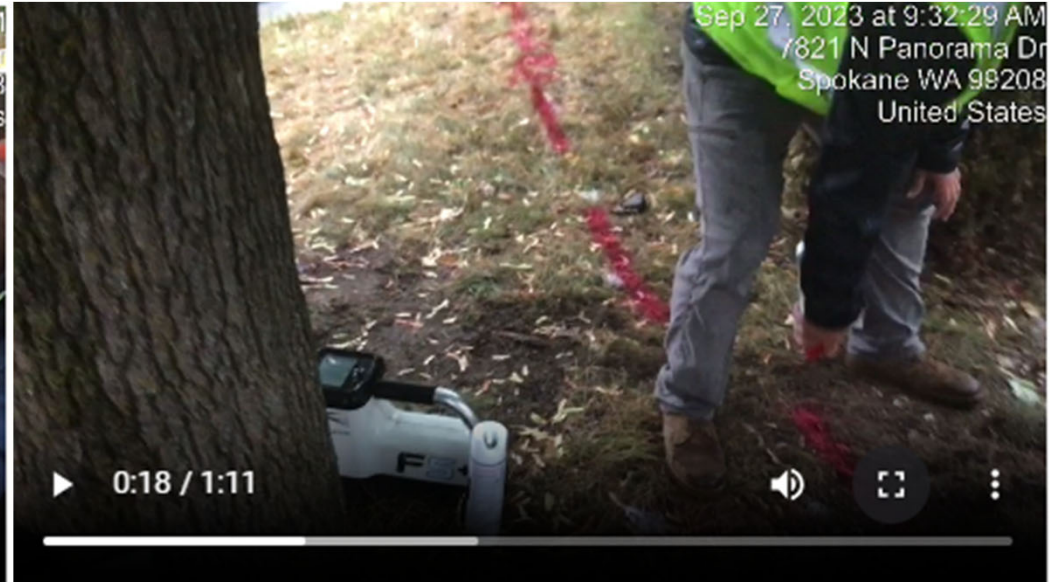
When ELM arrived on site 9/27

ELM Locator adding paint on 9/27

- The ELM locator arrived on site at 9:00 A.M. and hooked up to the meter at 7811 N Panorama, he traced the line back to this pull box that was buried.
- The locator grabbed a shovel and dug this box up.
- He added the red paint there to show where the service goes.
- Copy link for video showing ELM locating line after locate was due and strike alert
- <https://youtu.be/C59mKHJos0Y> (ctrl+click)
- ELM was the first responder from Avista after Avista was made aware of a possible utility damage.
- At this point there is exposed electrical wires in the ground and an electrical hazard to anyone within 10' of the damage, including the ELM locator.

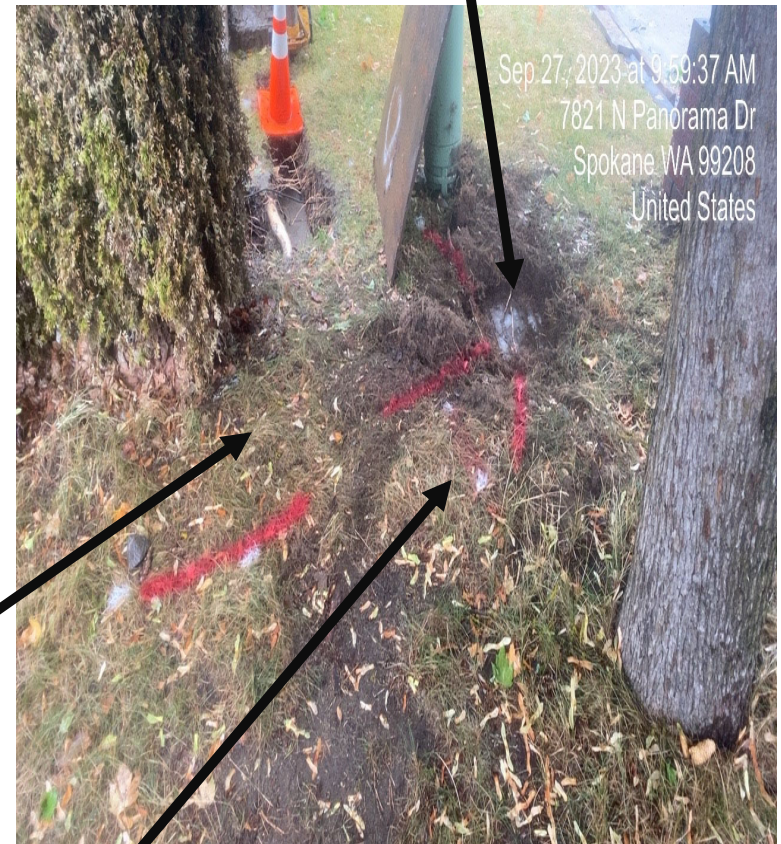
Power box that the ELM locator dug up

Location of utility strike and new power locate after ELM arrived on site 9/27

Old paint showing no tee for power service

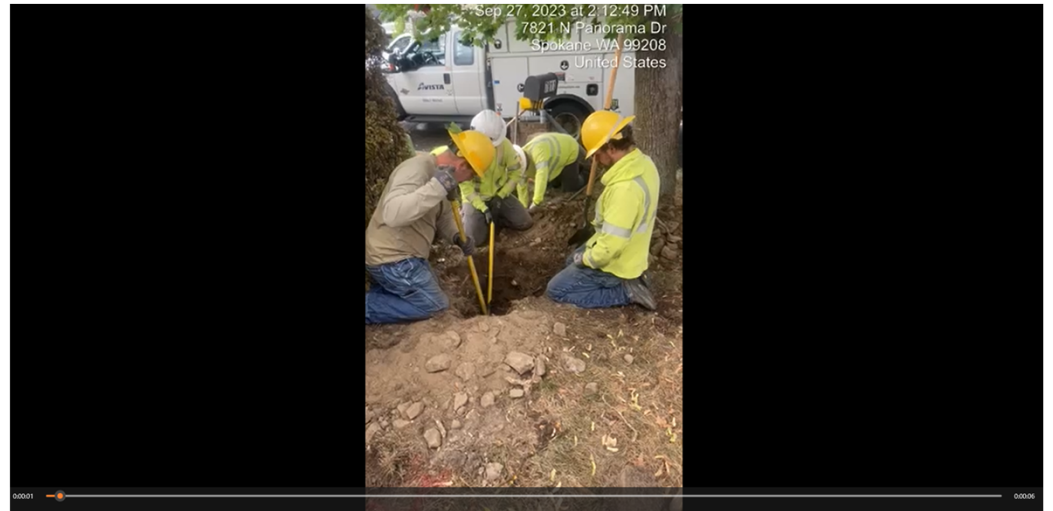
Repair

- Avista lineman arrived on site at 1:00 P.M. 9/27 and shut the power off at the pull box. At this point the site finally became safe for the construction crew, locators and the homeowner. For about 22 hours there was live electrical current in the ground creating a potential electrocution hazard.
- They then dug up the power service where our bore path intersected the new locates.
- They discovered our drill had severed at least one leg of the power and it needed to be repaired.
- By about 4:00 P.M. they had finished splicing the power and repairing the conduit.
- Video showing added power locates and Avista Lineman exposing damaged conduit
- <https://youtube.com/shorts/rnHqoRClJqc> (ctrl+click)

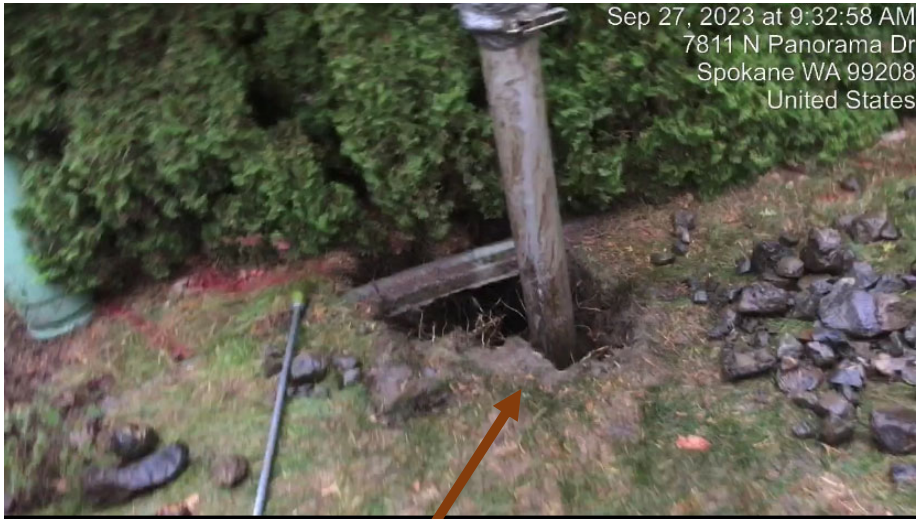
Vactruck Pothole

Locating line at South PL of 7811 Panorama

- Our vac truck spent 3 hours looking for the power service to 7811 Panorama on 9/26. They never found the service on the south property line because it was on the north property line.
- Avista is required by law to accurately locate their lines. How is it possible that they used the best possible information to find their line when they located a line that doesn't exist and missed the power service that does exist?

Service marked to 7811
Panorama on South Side of
Property line. It is actually on
north side of address

Pothole where we did
not find power service

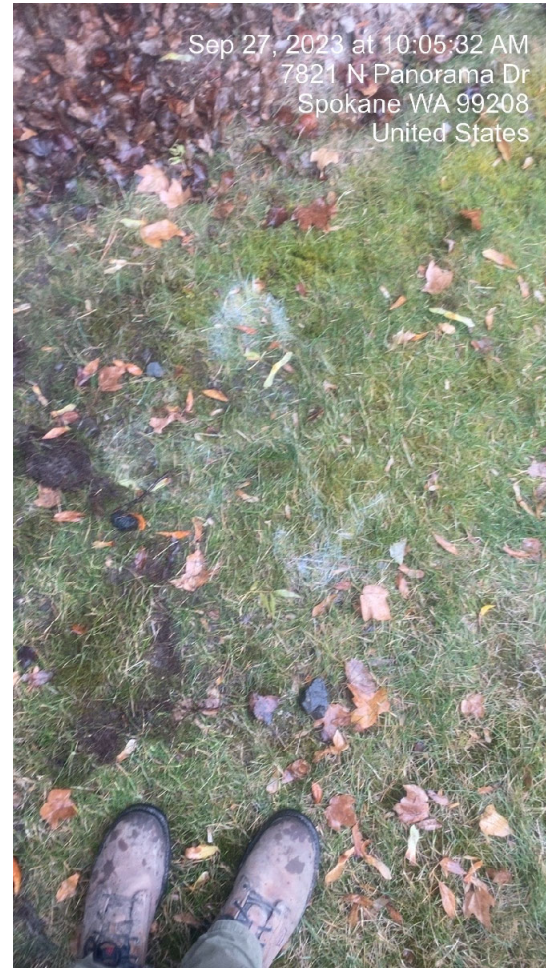
Location of
 Damage

Demarcation
at back of
ROW
