Re: July 2020 Monthly Progress Report  
Administrative Settlement Agreement and Order on Consent for Removal Action  
EPA Region 10 Docket No. CERCLA 10-2009-0255  
Gasco Sediments Site within the Portland Harbor Superfund Site

Attachment A Monthly Visual Monitoring Report for Pilot Cap Vicinity

# Visual Observations Log Form

**Project:** NW Natural – Gasco

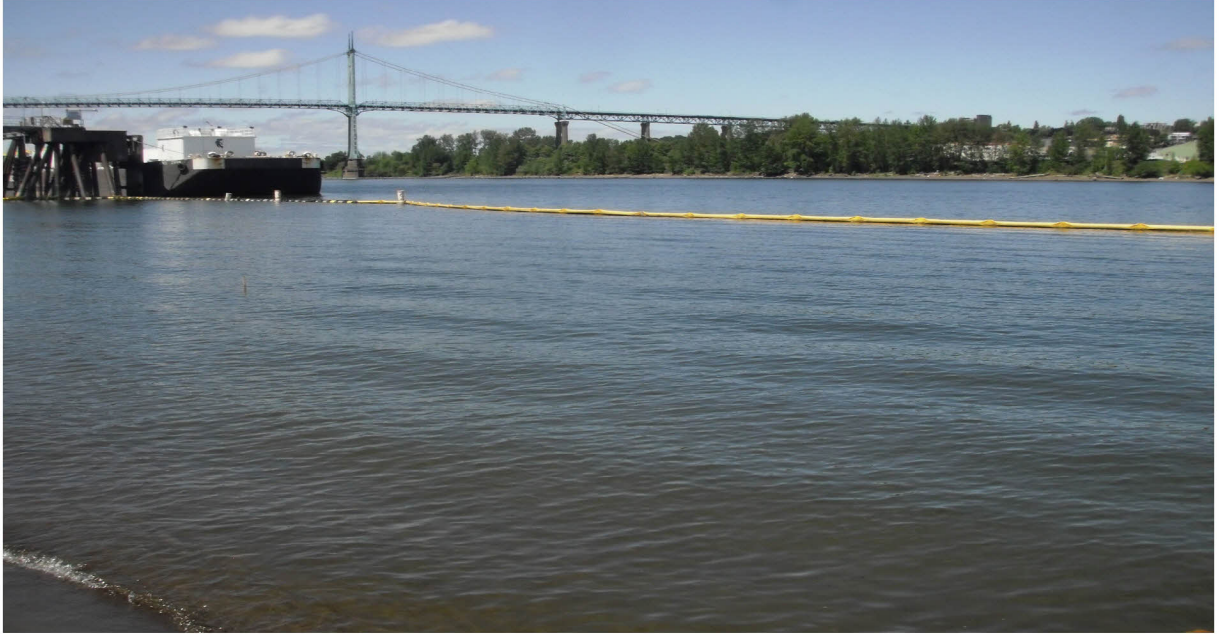
During the observation, a barge was moored at the dock, and the PacTerm containment boom was in place from the dock to the upriver dolphin. The three buoys identifying the cap area to mariners were in place as installed. The positions of the PacTerm oil boom and warning buoys are shown in Photo 1.

**Photo 1**  
**PacTerm Oil Boom Placement from Dock to Dolphin with Three Mariner Warning Buoys at Pilot Cap Area (7/23/2020)**

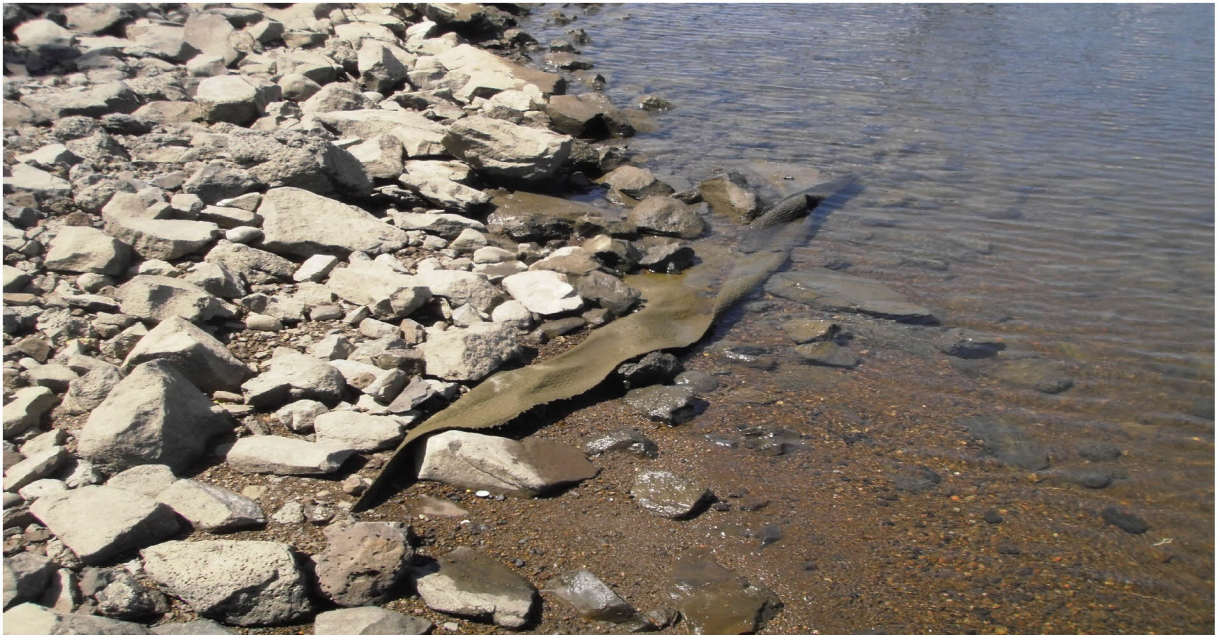
The footprint of exposed organoclay mat near the shoreward lateral midpoint of the cap has expanded approximately 1 to 2 feet. Some minor trash and woody debris are noted along the shoreline.

All exposed organoclay mat material segments are visible but submerged in the water. A segment 6 feet in length is exposed at the water’s edge near the lateral midpoint of the cap area. A 15-foot section is submerged and exposed perpendicular to the shoreline at the upriver boundary of the cap area. A section of organoclay mat material measuring 40 feet in length is exposed along the shoreline extending 1 to 5 feet riverward (Photo 2).

**Photo 2**  
**Exposed Organoclay Mat Material at the Shoreward Lateral Midpoint of Cap (7/23/2020)**

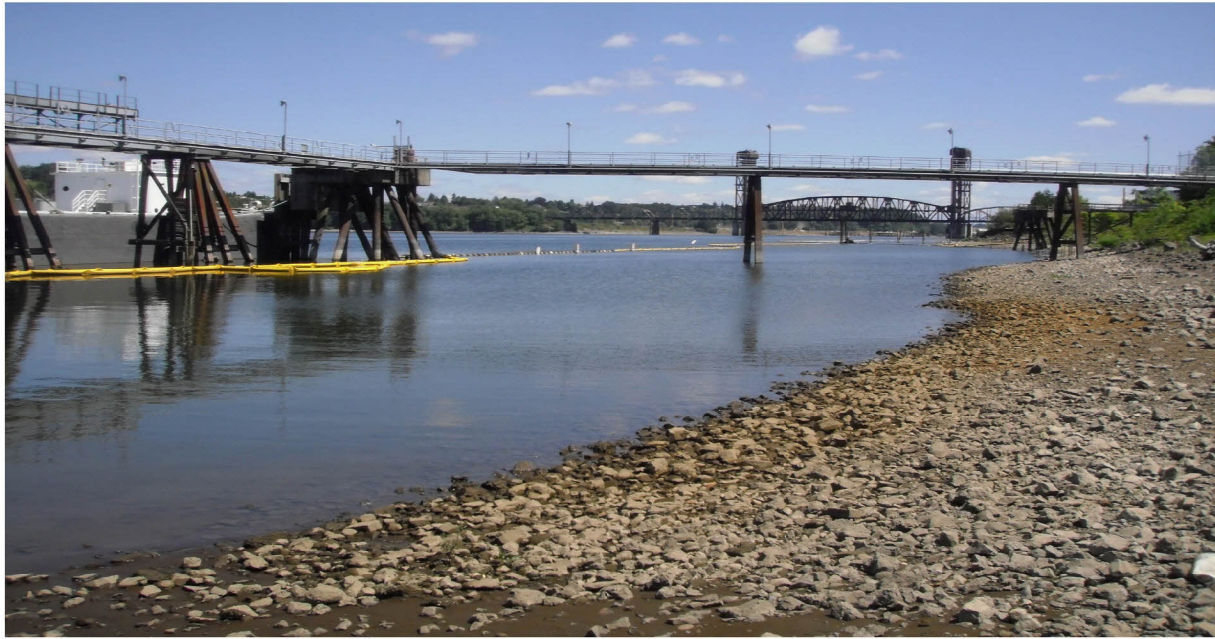
No sheen was observed. Photo 3 shows the water surface and shoreline immediately downriver of the sediment cap.

**Photo 3**  
**Conditions Immediately Downriver of Cap Area (7/23/2020)**
