**PUGET SOUND ENERGY  
PIPE SEGMENT INTEGRITY STUDY  
IN THE VICINTIY OF THE VASA PARK RECTIFIER**

**June 21, 2005**

**Purpose**

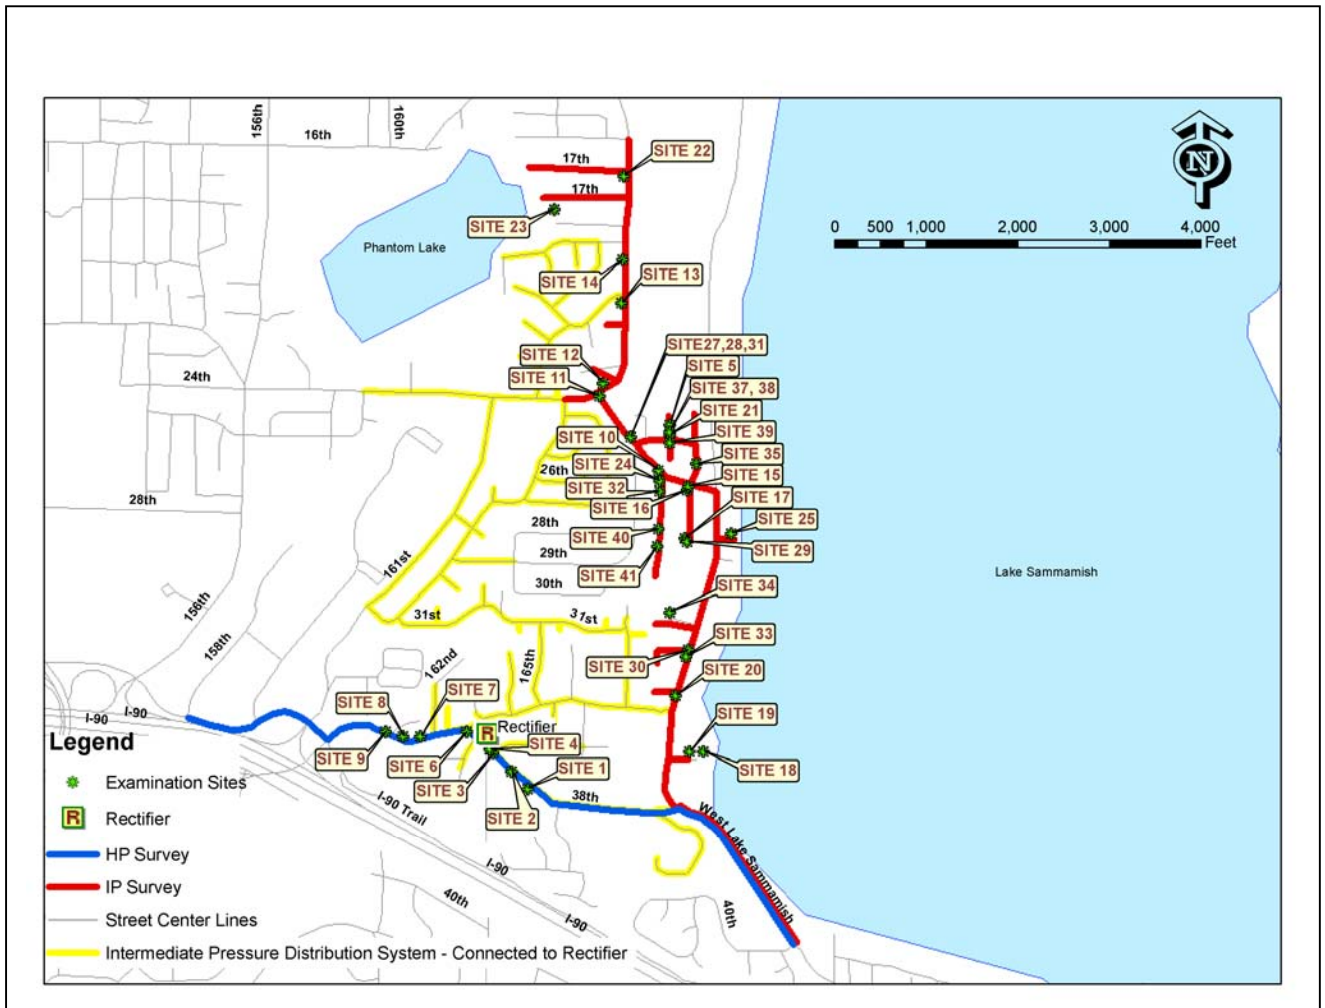
Figure 2 Examination Sites

Forty sites were selected for excavation based on coating or pipe potential indications warranting further examination, including the twelve confirmatory examinations. A confirmation excavation at one of the sites was relocated due to landscape conflicts, resulting in forty-one entries listed in *Appendix B, Table 1, List of Examination Sites*. Seven of the entries were not examined, five after reevaluating the data, one was a duplicate entry and another was a service which was replaced. The site locations are shown in *Appendix A, Figure 2, Examination Sites*.
