Sinking of US Cargo Vessel *SS El Faro*  
Atlantic Ocean, Northeast of Acklins and Crooked Island,  
Bahamas  
October 1, 2015

NTSB/MAR-17/01  
PB2018-100342

# Marine Accident Report

**Abstract:** On Thursday, October 1, 2015, the SS *El Faro*, a 40-year-old cargo ship owned by TOTE Maritime Puerto Rico and operated by TOTE Services, Inc., was on a regular route from Jacksonville, Florida, to San Juan, Puerto Rico, when it foundered and sank in the Atlantic Ocean about 40 nautical miles northeast of Acklins and Crooked Island, Bahamas. The ship had sailed directly into the path of Hurricane Joaquin, carrying a crew of 33, including 5 Polish contract repair workers. All those aboard perished in the sinking. As part of its accident investigation, the National Transportation Safety Board (NTSB) led a joint effort with the US Navy, Woods Hole Oceanographic Institution, and the National Science Foundation to locate the ship's wreckage and retrieve its voyage data recorder (VDR). The VDR was pulled from 15,250 feet below the ocean surface in August 2016 during the third undersea mission and yielded more than 26 hours of parametric data and audio files. The NTSB's accident investigatio

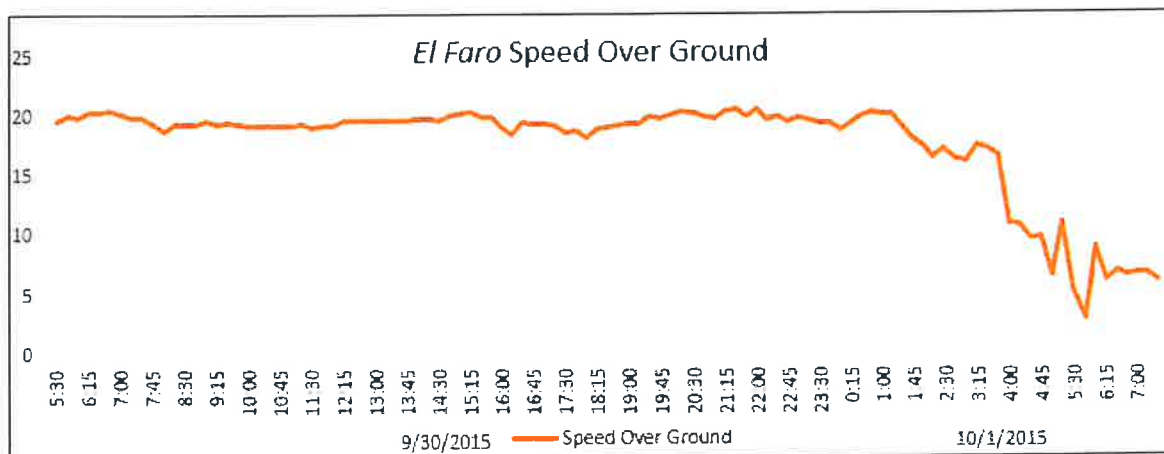
Figure 7 plots the ship’s speed over ground, which is the ship’s motion relative to the earth’s surface, as measured by GPS. The VDR recorded this information from the morning of September 30 to the time of the sinking. On October 1, as shown in the figure, the ship’s speed over ground slowly decreased after 0100, then dropped precipitously about 0400.

Figure 7. Vessel’s speed over ground from 0530 on September 30 until sinking. (Based on VDR parametric data)

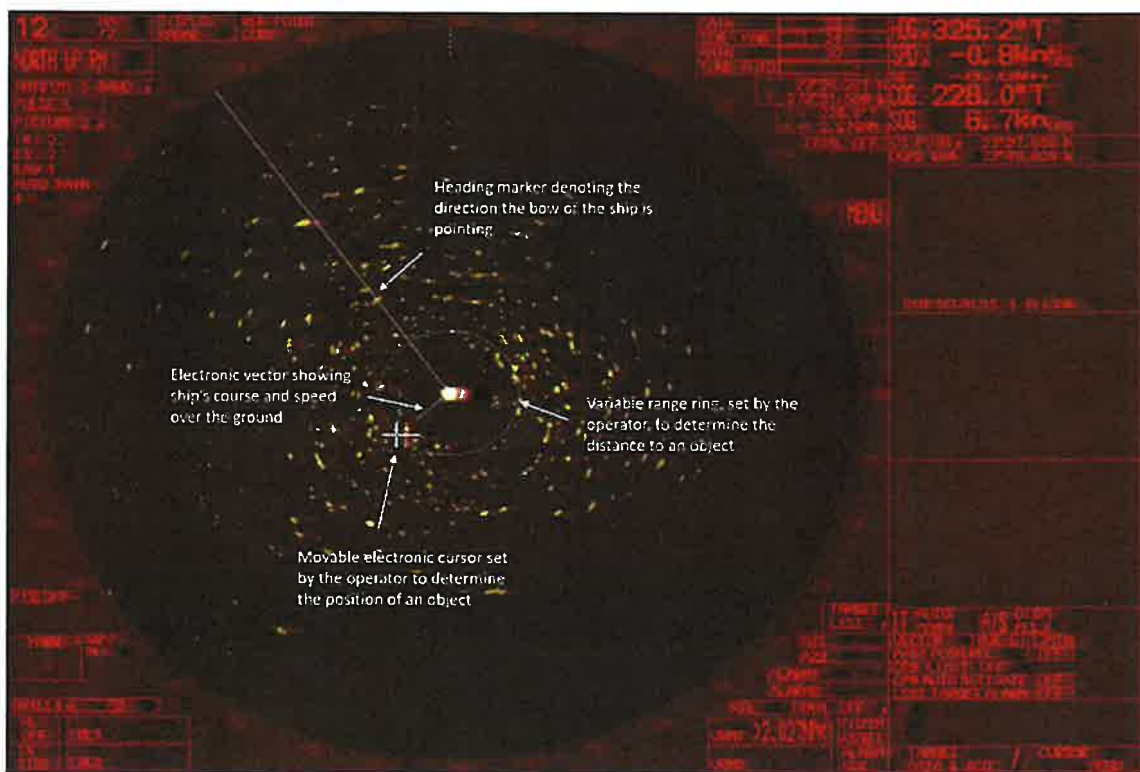
At 0644, the captain told the AB on watch, “You got some turns right now,” meaning that propulsion seemed to have returned. The radar image in figure 8, obtained from the VDR, shows that *El Faro*’s bow was headed northwest but that the ship was actually traveling southwest, at a speed (in relation to the ground) of 6.7 knots—that is, it was being pushed sideways by the wind and waves, nearly perpendicular to its original course before losing propulsion.

**Figure 8.** Radar image from 0644 on October 1 showing *El Faro* heading (bow direction) northwest (325.2°) but moving southwest (228°).

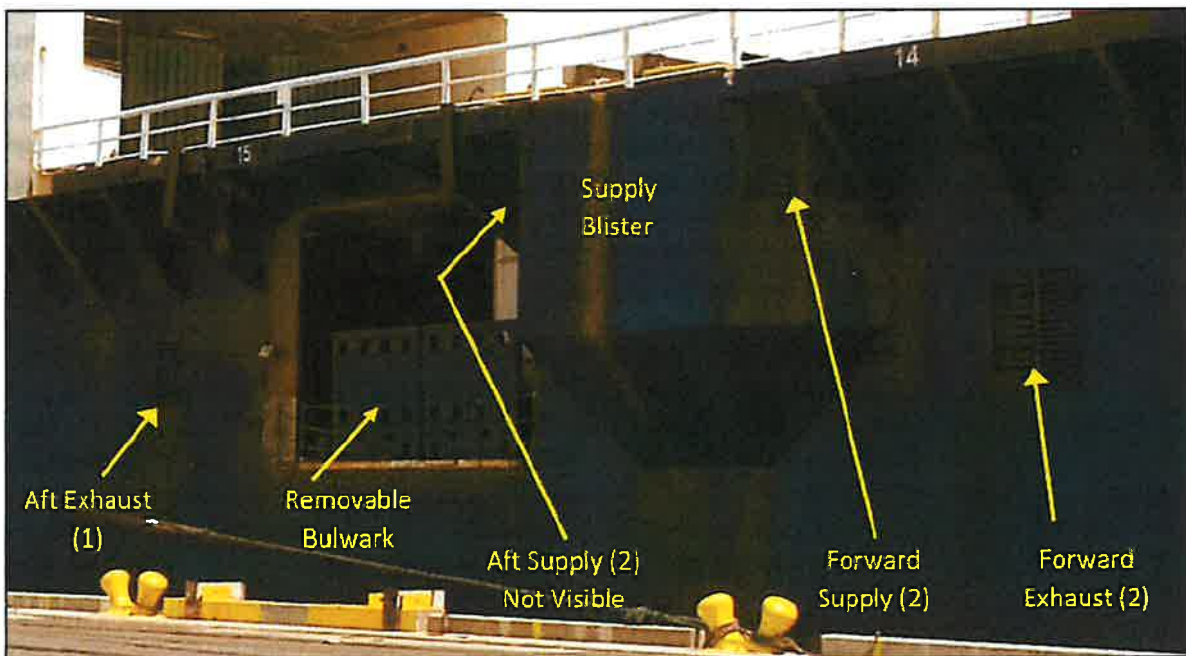
All cargo holds had two supply trunks (port and starboard) and at least two exhaust trunks. The supply trunks were fitted with electrically driven fans mounted port and starboard (directly opposed) on the enclosed part of the second deck. The supply fans were in “blisters” that bulged out from the hull below the overhanging main deck (figure 10). The fans pulled air through four sets of rectangular louvers mounted on the forward and aft sides of the three-sided blister shell plate, then drew it into the fan bellmouth. The fans pushed supply air through the fire dampers into a single trunk that passed through the tween holds and into the lower holds at the tanktop. There the trunk split into horizontal runs mounted longitudinally against the sides of the hold. The lower horizontal supply ventilation trunks in the cargo holds were fitted with downward-facing registers, measured as 12 inches above the tanktop.

**Figure 10.** Starboard side of *El Faro* showing supply and exhaust ventilation openings to cargo hold 3. (Photo by Herbert Engineering)

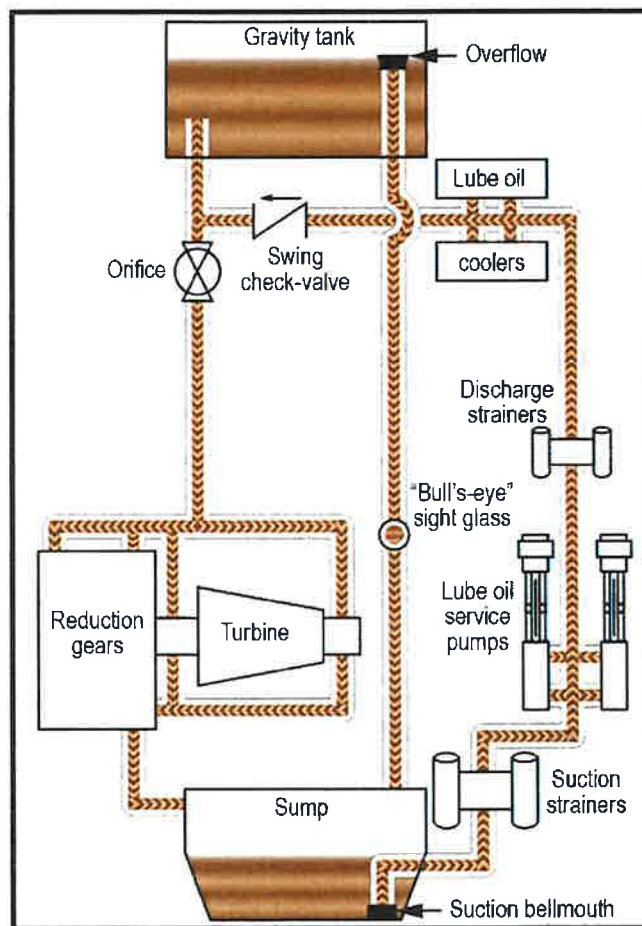
**Lubricating Oil.** According to the 1973 ABS rules for building and classing steel vessels, the lubricating oil system of the main engine was “to be so arranged that it will function satisfactorily when the vessel is permanently inclined to an angle of 15 degrees athwartship and 5 degrees fore and aft.” The Coast Guard had no rules for main engine or lube oil operation angles when the vessel was built (or when it was lengthened in 1993). *El Faro*’s lubricating oil system is diagrammed in figure 11. Because the suction for the lubricating oil service pump was located in the starboard, aft section of the sump, a port list with a forward trim would be the worst-case scenario for exposing the suction bellmouth, which could result in a loss of lubricating oil to the main engine.

**Figure 11.** Schematic of *El Faro*’s lubricating oil system, showing component parts and direction of oil flow.

The VDR recorded no conversations from the engine room, so it is unknown what actions the crew took to counter the problem with the lubrication oil levels (which were not captured electronically) or what the problem actually was. The mostly likely scenario, however, is that the vessel's sustained list to port caused the lubrication oil in the main engine sump to fall below the bellmouth of the suction pipe leading to the pumps (refer to figure 11, section 1.3.6).

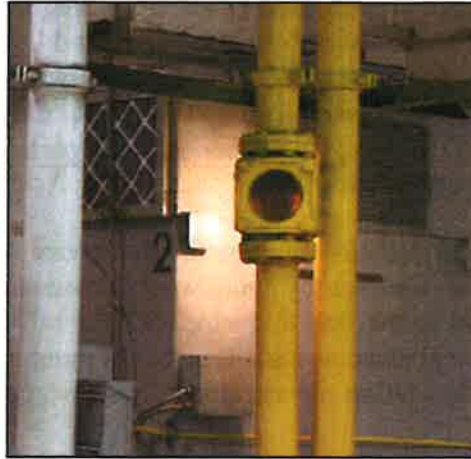
From the engine room, overflowing oil, indicating proper operation of the lube oil service pumps, could be monitored through an illuminated port (“bull’s-eye”) in the supply line that returned oil to the sump (figure 12). An engineer who had served aboard TOTE’s *Ponce*-class vessels (last in 2012) told the third marine board that in rough weather, flow in the bull’s-eye might be interrupted by sloshing oil in the gravity tank. In the event of a pressure loss, about 8 minutes

**Figure 12.** Bull's-eye for monitoring lube oil flow from gravity tank. (Photo from *El Yunque*)

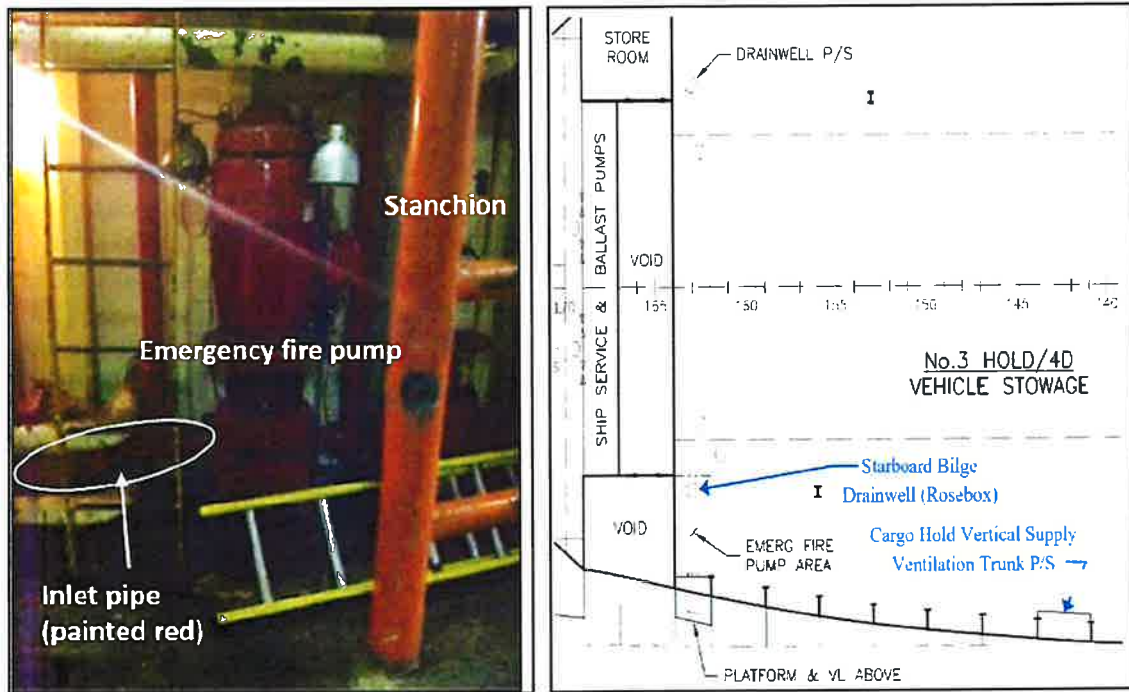
**Fire Main.** The fire main system consisted of a combination pump, called a bilge, fire, and general service pump, located on the starboard side of the lower engine room. The pump was a Worthington vertical, centrifugal model rated for 575 gpm at 125 psig. An emergency fire pump, rated for 635 gpm at 125 psig, was located on the starboard side of cargo hold 3, on the tanktop. The pump had its own sea suction (seawater inlet pipe) directly outboard of the pump. As seen in figure 13, the fire pump (shown in the photo) was protected by at least one vertical steel stanchion, and a platform (shown in the drawing) was located above the pump, with a vertical ladder installed nearby.

Figure 13. Emergency fire pump. Photo shows emergency fire pump (center rear) in *El Faro's* hold 3 (photo by Maine Maritime Academy cadet). Diagram, from general arrangement drawing, shows emergency fire pump location in hold 3, fourth deck (VL = vertical ladder).

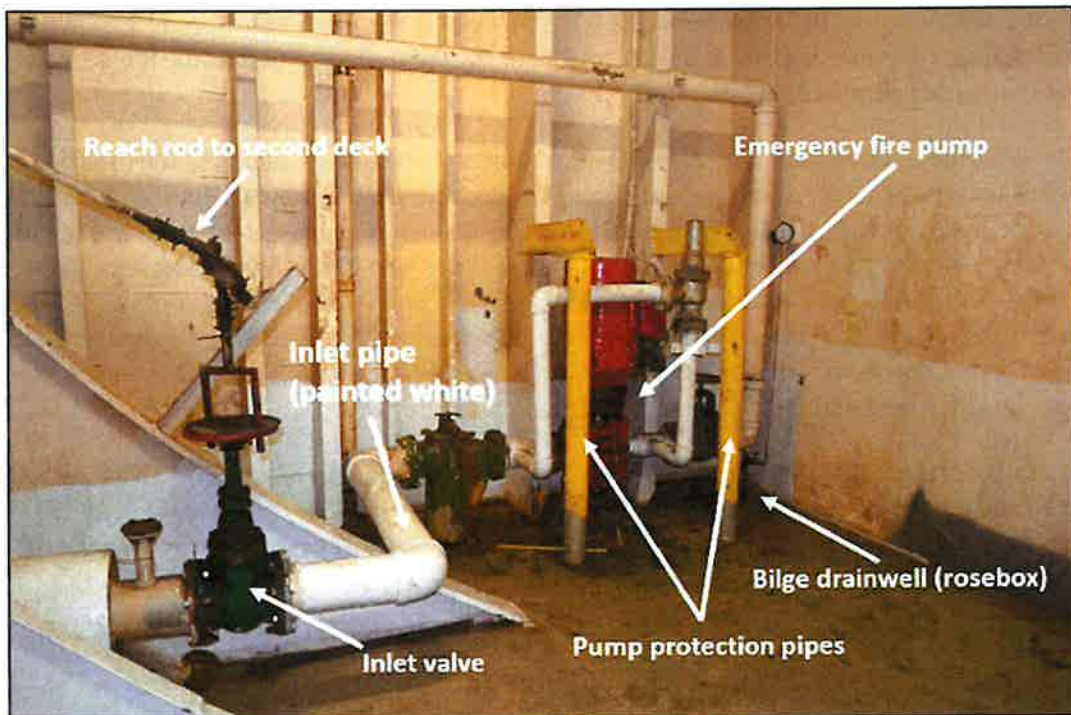
Figure 14. Emergency fire pump and inlet piping in hold 3 of *El Yunque*.

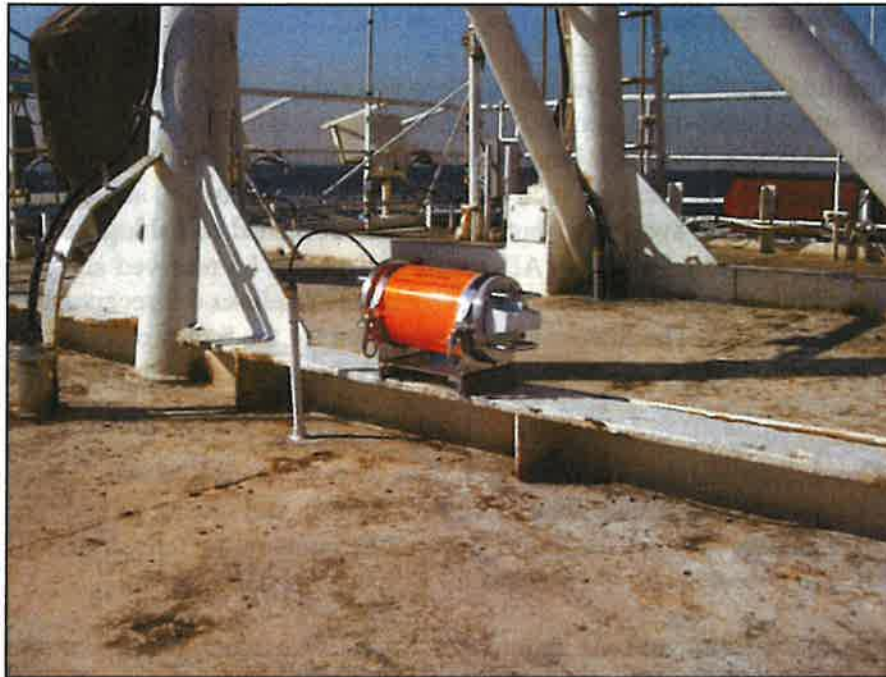
**Voyage Data Recorder.** As required, *El Faro* was equipped with a simplified VDR (S-VDR) that was installed in January and February 2009.<sup>78</sup> The device was a Northrop Grumman Sperry Marine Voyage Master II, manufactured by Danelec Marine (Birkerød, Denmark). The VDR capsule was attached to a steel channel at the base of the antenna mast on the deck above the bridge (figure 15).

**Figure 15.** VDR capsule on deck above *El Faro*'s navigation bridge. (Radio Holland photo<sup>80</sup>)

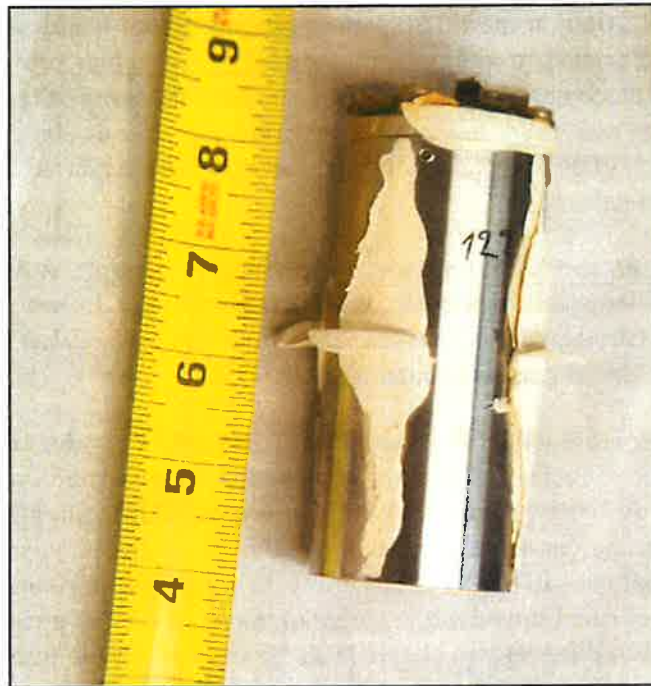
The VDR data were stored on a flash memory chip inside a protective capsule. On August 8, 2016, after the capsule was recovered from *El Faro*'s wreckage, it was submerged in a bath of distilled water aboard the Navy vessel *Apache*, then disassembled and inspected for possible damage to the internal recording medium. Inside the capsule, layers of protective materials housed an inner capsule containing the circuit board assembly that stored the nonvolatile memory (figure 16).<sup>82</sup> The circuit board assembly was inspected for visible signs of damage or corrosion (figure 17) before being transported to the NTSB laboratory in Washington, DC, on August 12.

Figure 16. Inner VDR capsule assembly after removal from outer capsule.

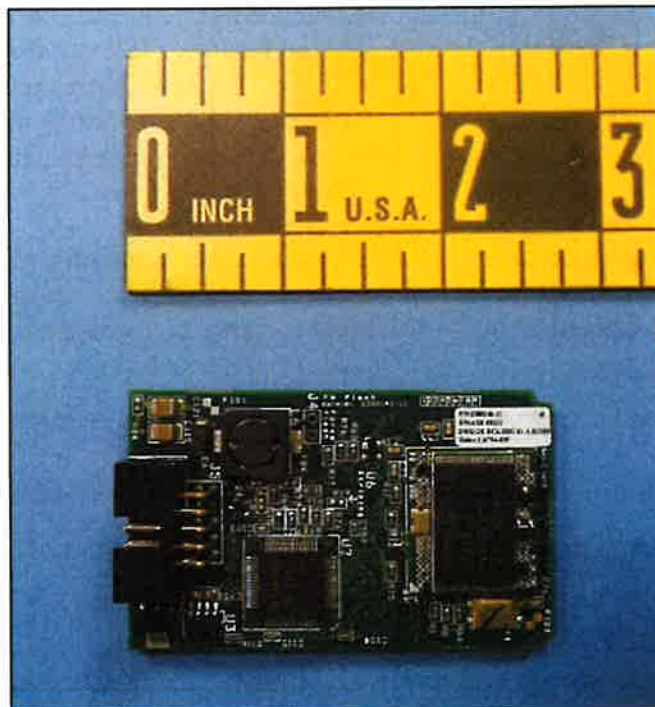
Figure 17. Circuit board assembly from inner VDR capsule.

On August 15, 2016, at the NTSB laboratory, the circuit board assembly from the inner VDR capsule was connected to a functioning surrogate assembly, provided by Danelec. The manufacturer provided technical support and witnessed downloading of the VDR data. A forensic write-blocking bridge was used to copy data from the circuit board assembly.<sup>83</sup> Using manufacturer-provided VDR playback software, the data were exported to a common data file structure for further analysis.<sup>84</sup>

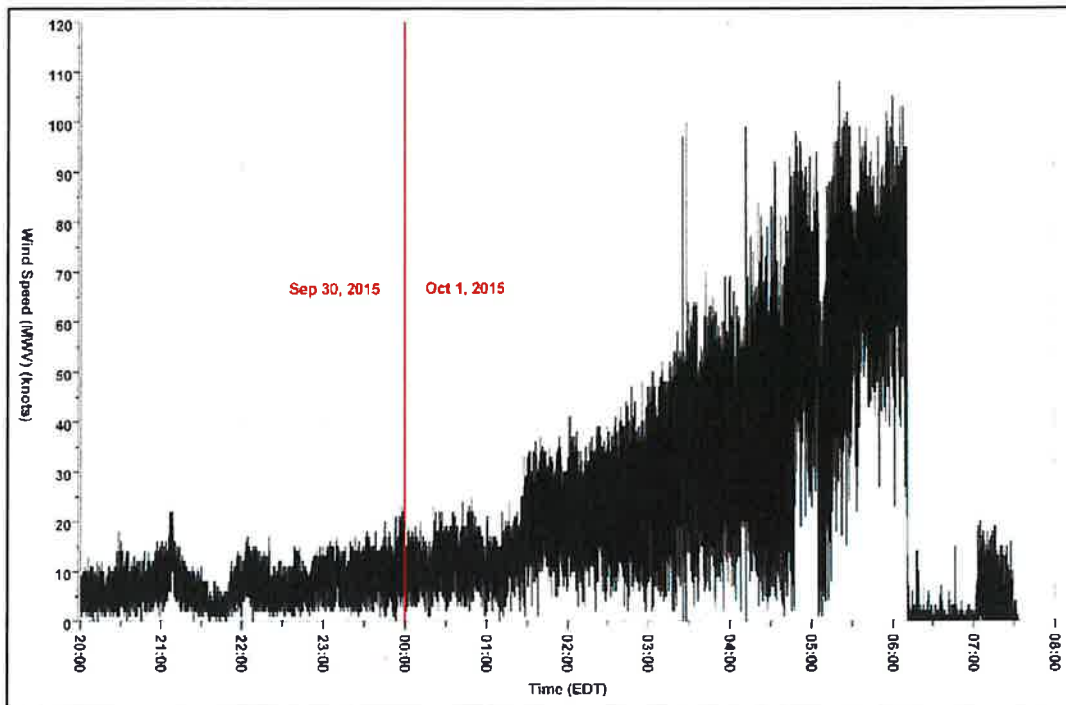
The vessel's anemometer displayed wind data on the bridge. Wind speed and direction were recorded by the VDR.<sup>91</sup> Figure 18 shows raw wind speed data captured by the VDR from 2000 on September 30 until the sinking. Throughout the VDR recording, however, over 99 percent of the anemometer data samples indicated a relative wind direction of between 180° and 193°. On the VDR recording, *El Faro*'s captain, chief mate, and second mate questioned the reliability of the wind speed and stated that the wind direction was "not good" and that "we don't have (any) anemometer."

Figure 18. Raw VDR wind speed data, from 2000 September 30 to data loss.

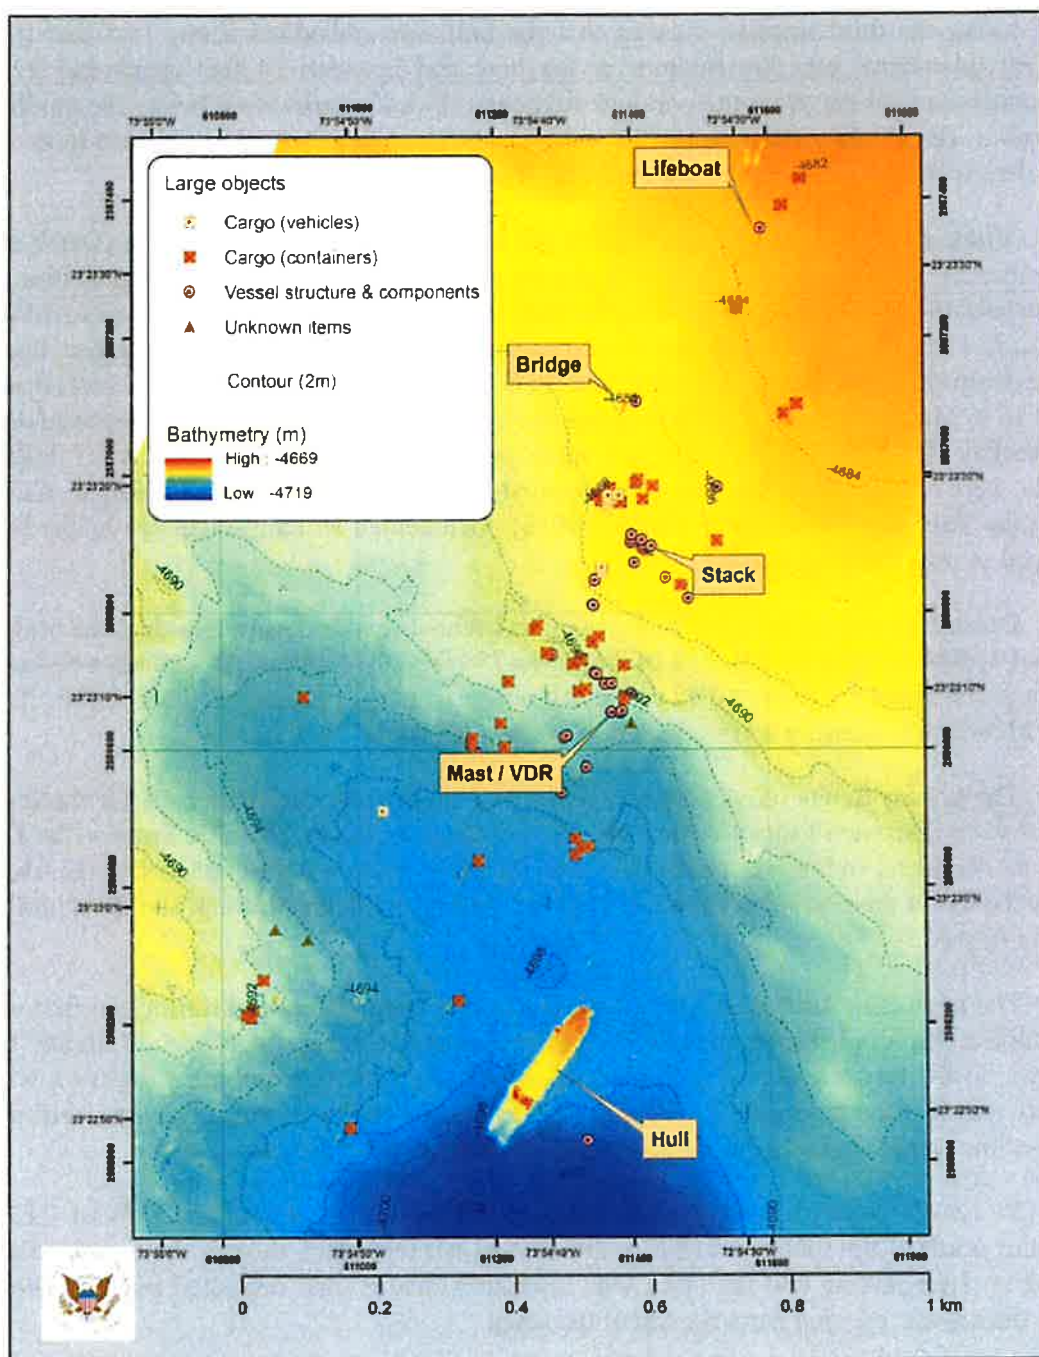
The wreckage of *El Faro* lies at a depth of between 15,318 and 15,482 feet (4,719 to 4,669 meters) in the Atlantic Ocean, about 20 nm northeast of Samana Cay. The primary underwater debris field, which includes the main hull and ship structure, covers an area of about 0.7 square mile (1.8 square kilometers) between latitudes 23.3786N and 23.3936N and longitudes 73.9061W and 73.9172W. Cargo containers, other cargo items, and some ship's equipment and rails were found outside the primary debris field. Inside the primary field were the remains of *El Faro*'s port lifeboat; some of its cargo (about 40 containers and 7 vehicles); the main hull and the structures that separated from it, including the mast (with attached VDR), the exhaust stack, the bridge and the deck below it; and a few unidentified items. Figure 23 is a bathymetric (topographic) map of the seafloor showing the location of the main objects discovered.

**Figure 23.** Map of *El Faro* debris field showing large objects. Bathymetry from multibeam-sonar site survey, April 2016.

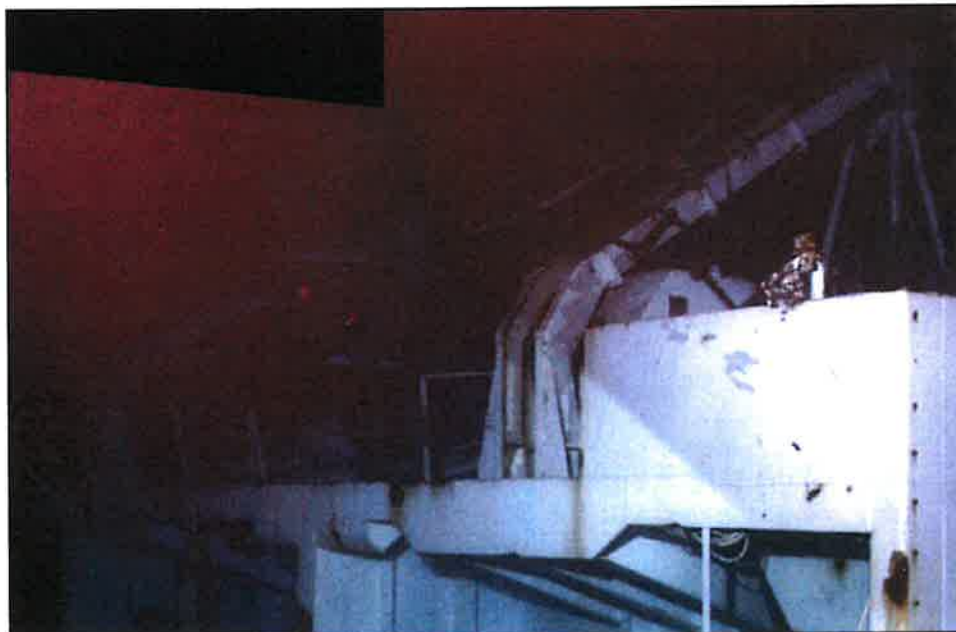
The gravity davits (cranelike devices for lowering boats into the water) for the starboard lifeboat were discovered intact during the second mission (figure 25). The arm for the forward davit was displaced and resting on the deck, but the arm's cable was still attached to the track. The gravity davits for the port lifeboat showed greater damage, with the aft track and davit broken and hanging (figure 26).

**Figure 25.** Intact gravity davits for starboard lifeboat, with forward davit in foreground. (Photomosaic image from mission 2)

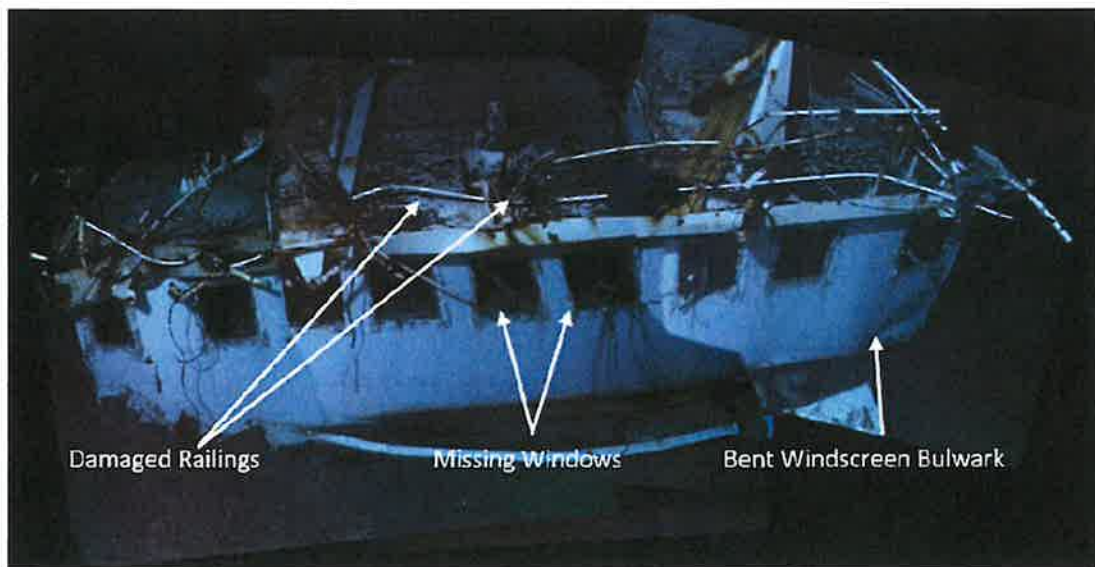
The navigation bridge and bridge deck that had been discovered during the first mission were further explored during mission 2. The photomosaic image in figure 27 shows that all windows on the forward side of the bridge were missing; that the windscreen bulwark was bent forward; and that the top railings were missing, severely bent, or broken. The starboard forward corner of the wreckage had settled deeper into the seabed than the other corners.

**Figure 27.** Bridge and bridge deck, looking aft. (Photomosaic image from mission 2)

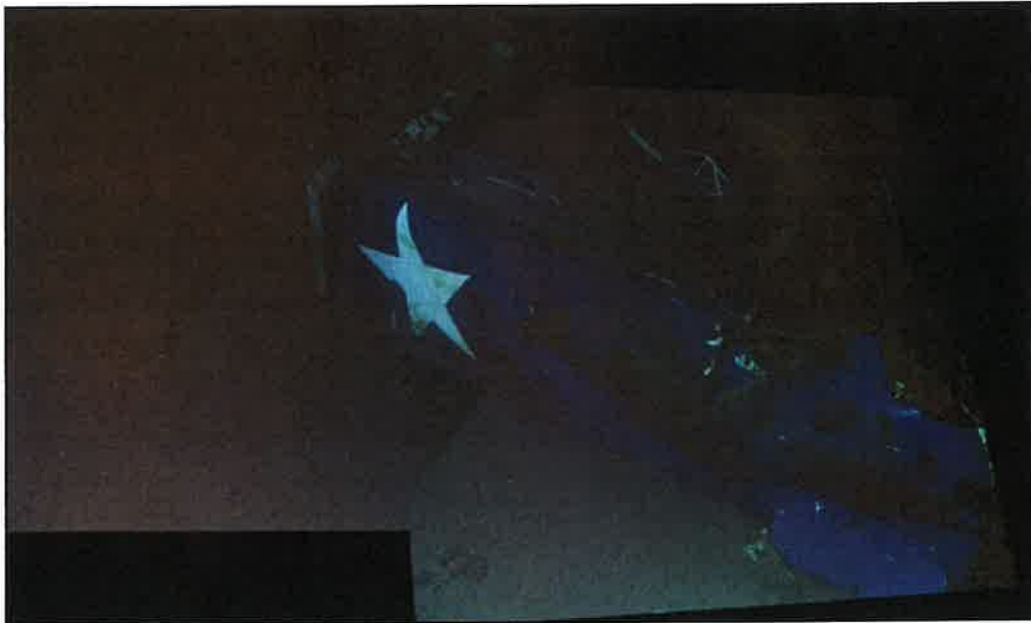
*El Faro's* exhaust stack was discovered during the second mission about 2,625 feet (0.43 nm) north of the main hull (figure 28). It was largely intact, though the forward face was missing its steel plating and the stack was scratched, dented, and deflected inward. The boiler uptake funnel was missing from the top of the stack.

**Figure 28.** Exhaust stack lying on seafloor, Sea Star (company) symbol clearly visible. (Photomosaic image from mission 2)

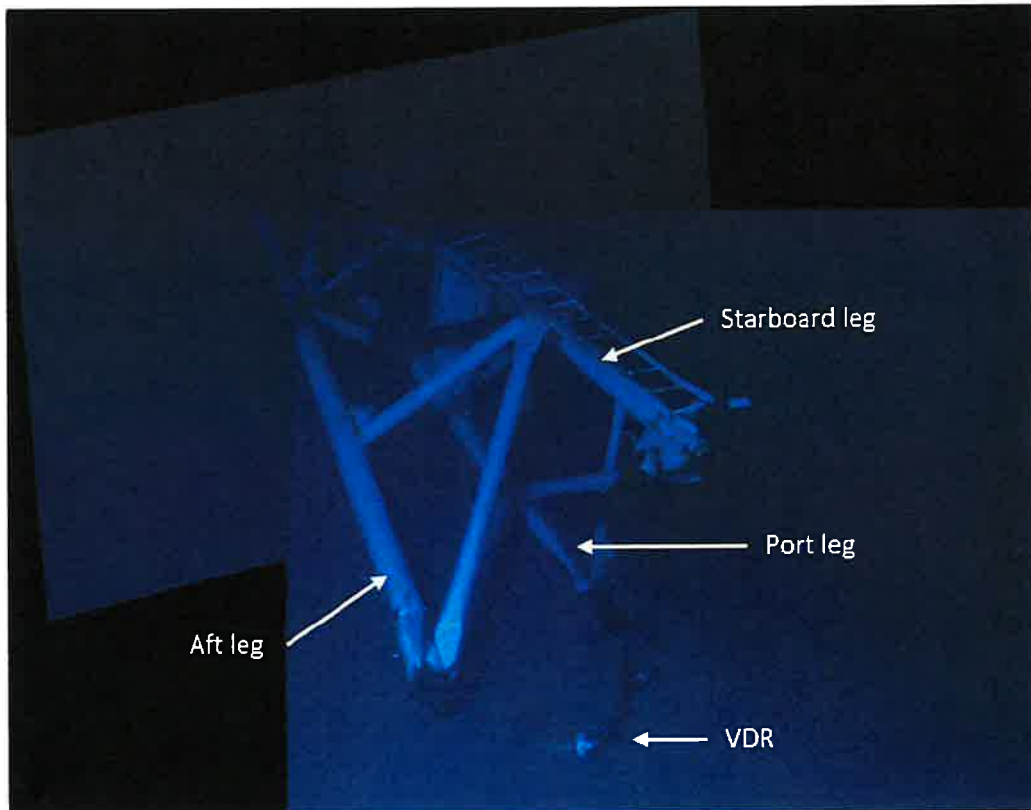
The tripod mast and VDR capsule were discovered on the seafloor about 1,640 feet (0.28 nm) north of the main hull (figure 29). The large structural members were intact, but the overall structure was bent aft. The VDR was attached to the port leg and buried in mud.

**Figure 29.** Mast and VDR capsule on seafloor. (Photomosaic image from mission 2)

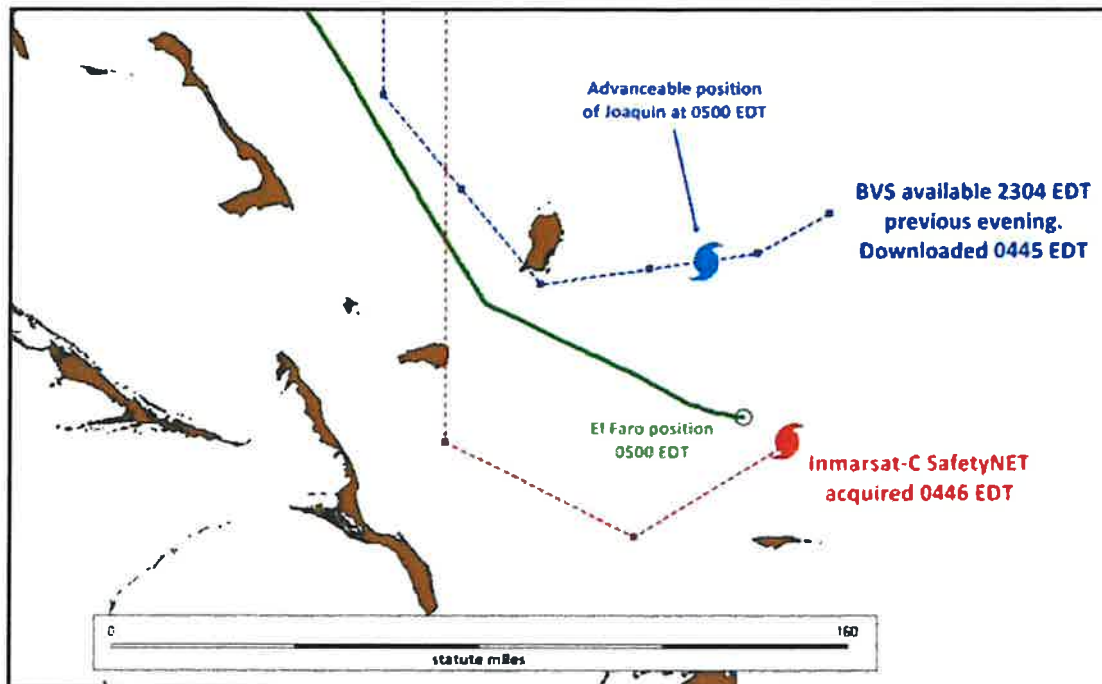
Figure 42 plots the information available to the bridge team around 0500 the morning of the accident, after the captain downloaded the previous evening's BVS file that had been available to him at 2304 and just after the new weather information delivered by Sat-C was available on the bridge (at 0446). At that point, the BVS information (blue) was almost 12 hours old (6-hour latency, as described above, plus additional time between receiving the email and downloading the data). The Inmarsat-C information was current as of 0446.

The captain stated on the VDR at 0503, "We're getting conflicting reports as to where the center of the storm is."

Figure 42. Positions of Joaquin obtained by *El Faro* and available on the bridge around 0500 on October 1. (Plotted by NTSB)

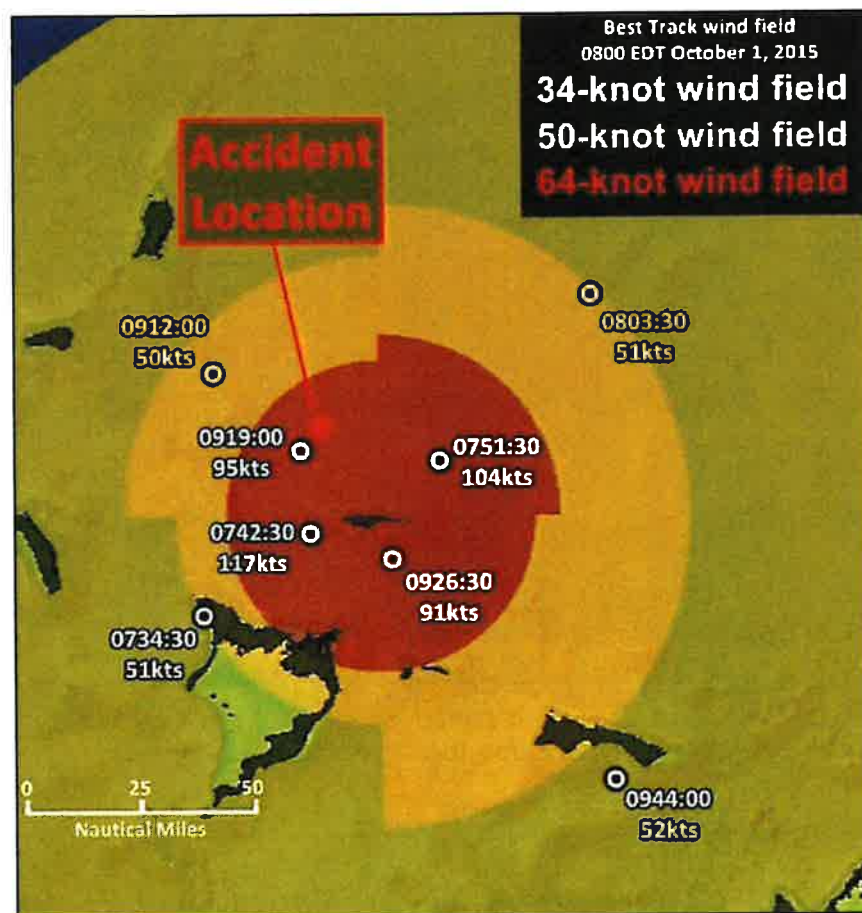
Figure 43 illustrates distances from the storm where 34-, 50-, 64-knot, and peak winds might have occurred near the accident time. Distances are based on SFMR surface wind data retrieved during a reconnaissance flight close to the time of the sinking, as well as the National Hurricane Center's poststorm best-track analysis. The best track is a poststorm, smoothed representation of a tropical cyclone's location and intensity over its lifetime (see section 1.10.5). The SFMR data are peak 10-second average observations of surface wind within a 30-second reporting interval. The red and tan areas depict the best-track estimates of the farthest extent that 50- and 64-knot winds occurred in each storm quadrant about 0800 on October 1. In the storm's northwest quadrant, the best-track analysis was that 50-knot winds extended outward as far as 50 nm from the center.

**Figure 43.** Surface winds from SFMR observations overlaid on best-track wind fields for 0800 on October 1. SFMR observations are labeled with midpoint of each 30-second reporting interval and average wind magnitude.

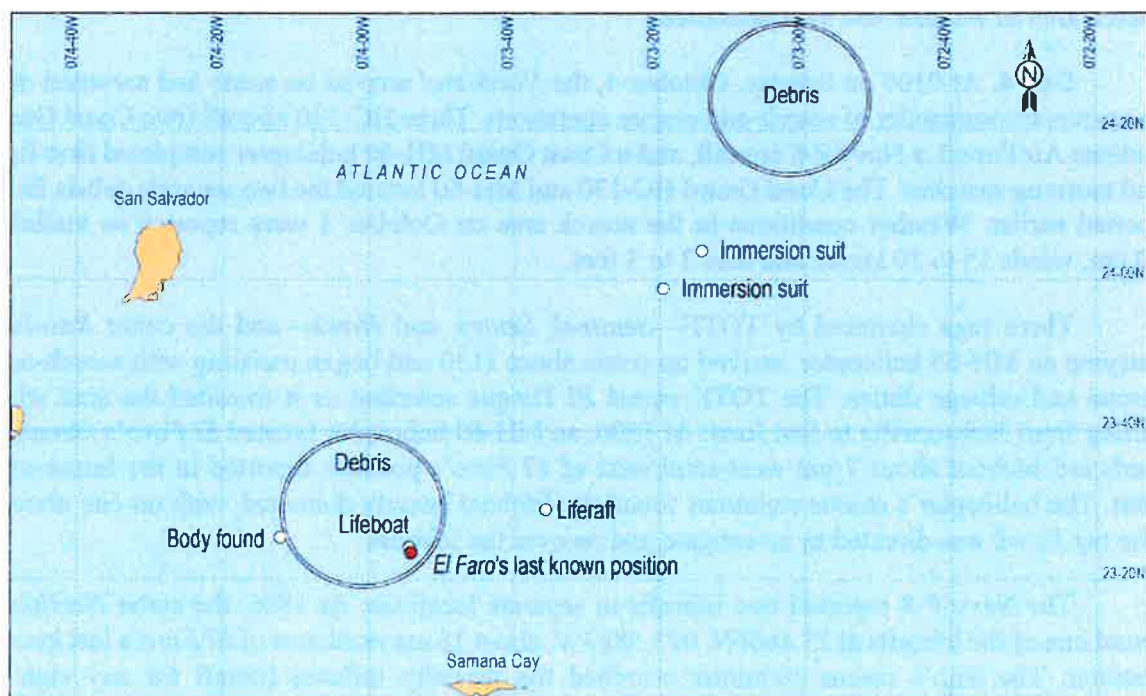
**Figure 47.** Two debris fields located during search-and-rescue operations and *El Faro*'s last known position from VDR data. Distance between debris fields was about 77 nm. Degrees of latitude are 60 nm apart. Distance between degrees of longitude varies with distance from equator, where it is about 60 nm. (Adapted from Coast Guard graphic)

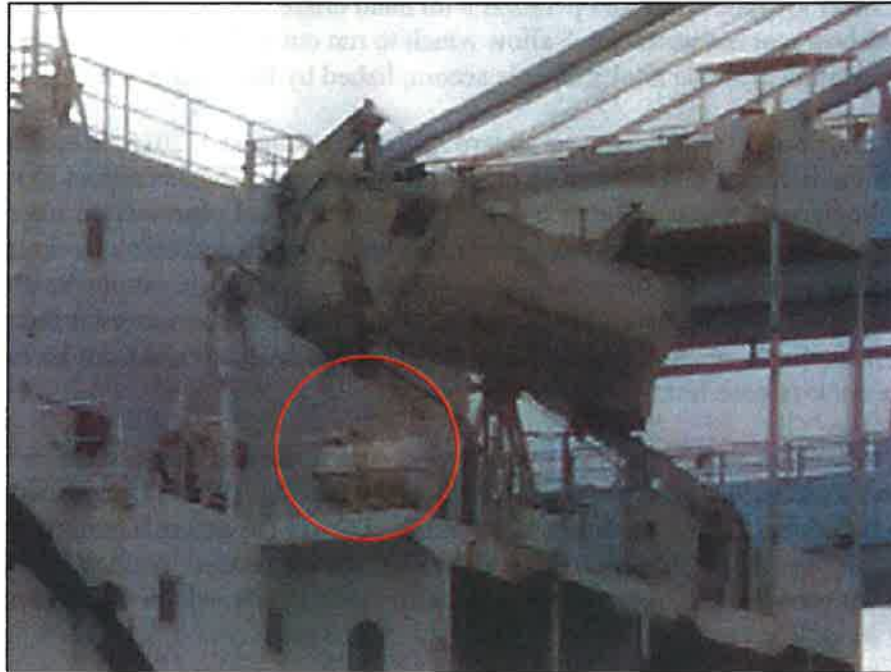
**Figure 49.** Location of liferaft stowed below *El Faro's* starboard lifeboat. (Photo by Maine Maritime Academy cadet, summer 2015)

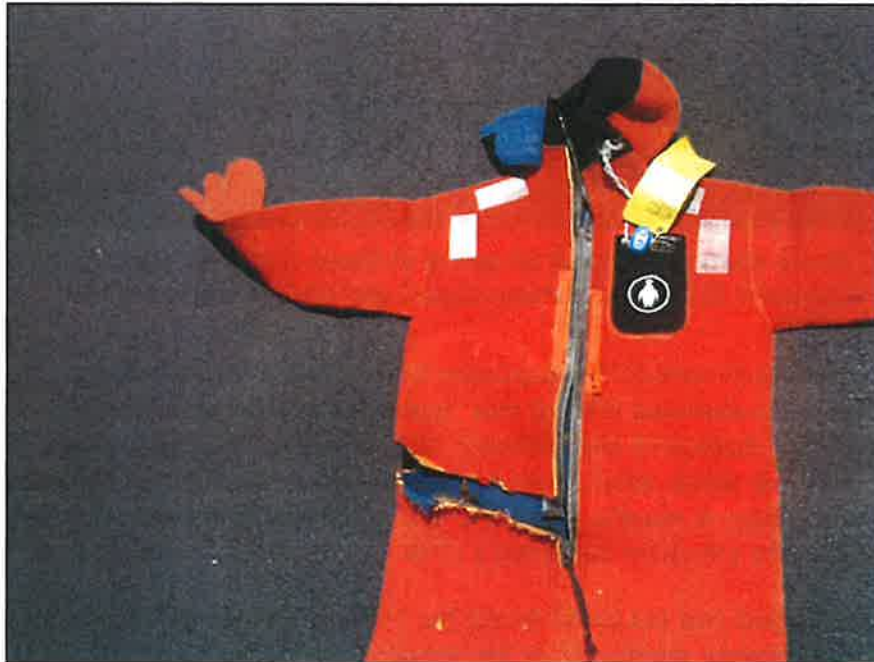
The cutter *Charles Sexton* recovered two of *El Faro*'s immersion suits after the accident. The first suit was recovered on October 6. The back was marked "S.S. El Faro San Juan, P.R." in white but appeared to have been previously marked "El Morro" in black. The second immersion suit (figure 54) was recovered on October 7. It was found with whistle and strobe light (turned off but operational); unzipped, left arm inside out, torn almost in half at right hip seam; and back marked "S.S. El Faro San Juan, P.R." in white but appeared to have been previously marked "El Morro" in black. As noted earlier, an immersion suit containing human remains was located but could not be recovered.

Figure 54. Immersion suit recovered on October 7, 2015.

According to maintenance records for June 2015, the recovered immersion suits were spare immersion suits Nos. 48 and 50. Both were last inspected and pressure-tested in July 2013 by Liferrafts Inc., of Puerto Rico, and each had a light with an expiration date of April 2016.

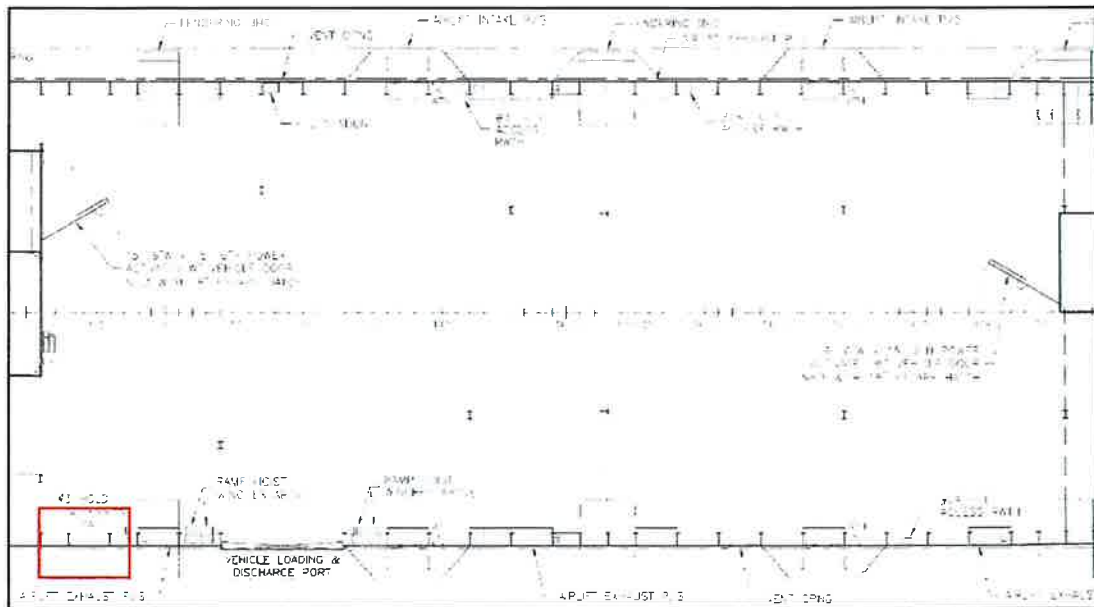
The VDR recording indicates that the vertical-access scuttle on the starboard side of the second deck that led to hold 3 was open during the accident. General arrangement drawings (such as figure 56) show that the second deck had two scuttles (called RWTHs [raised watertight hatches] on the drawings), through the second deck to hold 3, at frame 163 on the starboard side and at frame 138.5 on the port side. Hold 2A also had two such accesses. Figures 57 and 58 show the scuttle on the starboard side of the second deck to hold 3 and the scuttle on the port side to hold 2A.

Figure 56. Second deck plan showing scuttles. (Starboard scuttle to hold 3 outlined in red)

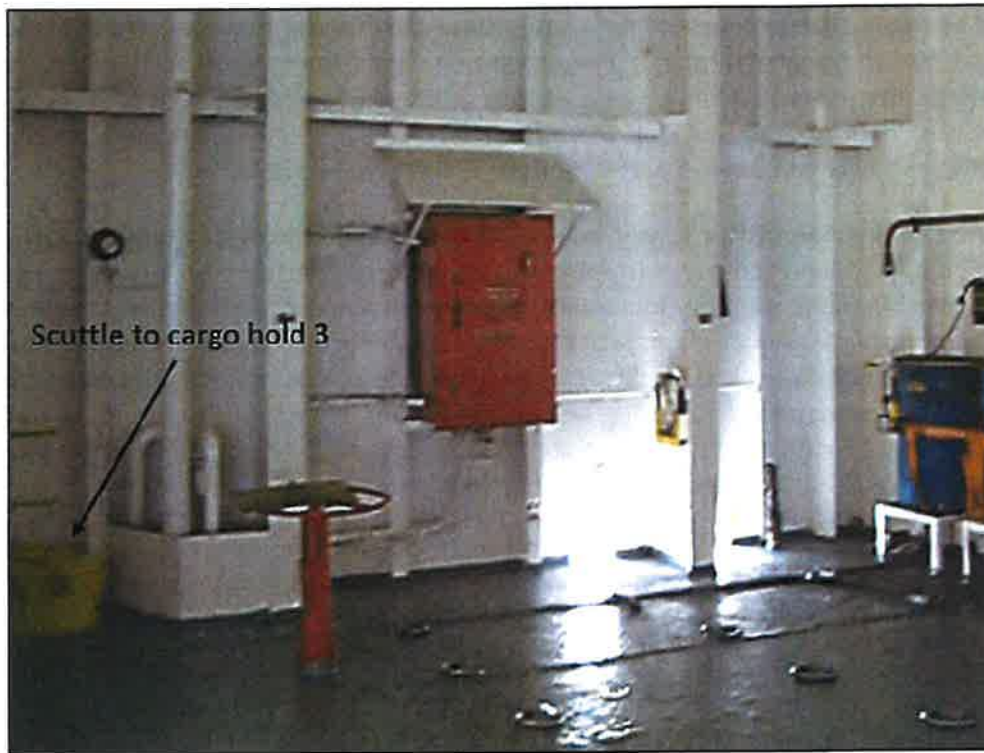
To achieve watertight integrity, a scuttle was secured by closing the steel cover (which had a gasket) and turning a wheel. Through a linkage system, the wheel moved four steel pegs (dogs) to seal the scuttle tight and prevent water from entering the hold. A former *El Faro* boatswain testified that a person could not tell by looking at a closed scuttle whether the wheel had been turned to engage the dogs and seal the hatch. A past chief mate and captain of *El Faro* stated, "You would have to grab the handle of it and see if it was locked or unlocked."

Figure 57. Second deck scuttle to hold 3. (Photo by former *El Faro* second mate)

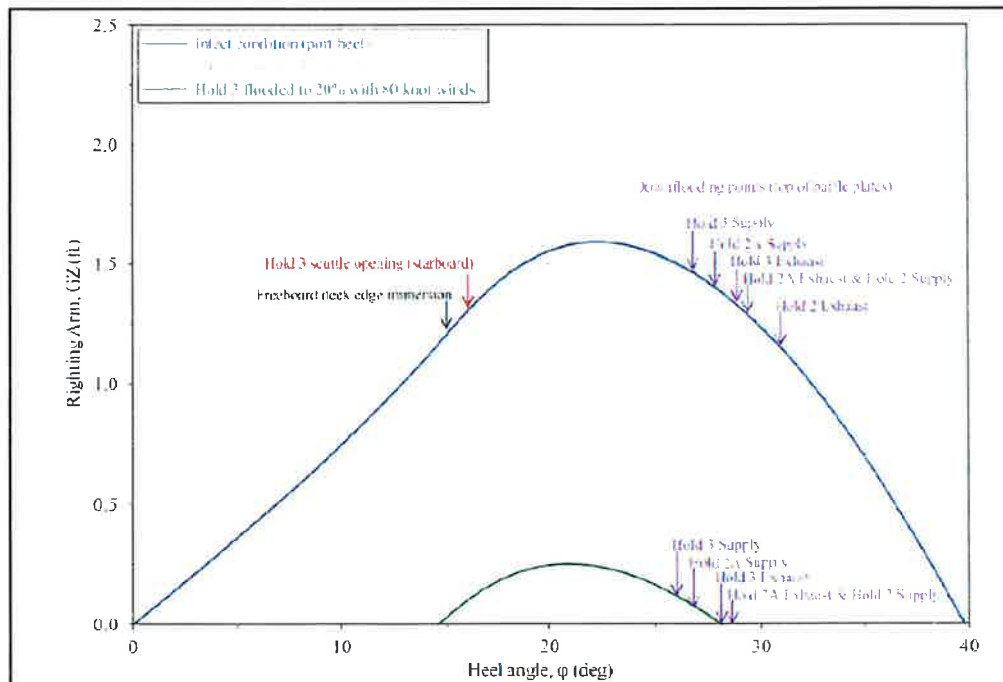
- Hold 3, starboard access scuttle: 16.2° (intact condition), 14.9° (hold 3 flooded to 20 percent).
- Hold 2, vent supply baffle: 29.°6 (intact), 28.9° (hold 3 flooded).
- Hold 2, aft and forward exhaust vent baffles: at least 30° in either condition.
- Hold 2A, vent supply baffle: 27.7° (intact), 26.9° (hold 3 flooded).
- Hold 2A, aft vent exhaust baffle: 29.8° (intact), 28.9° (hold 3 flooded).
- Hold 2A, forward vent exhaust baffle: 30.3° (intact), 29.4° (hold 3 flooded).
- Hold 3, vent supply baffle: 27.2° (intact), 26.3° (hold 3 flooded).
- Hold 3, aft vent exhaust baffle: 29.1° (intact), 28.1° (hold 3 flooded).
- Hold 3, forward vent exhaust baffle: 29.5°(intact), 28.6° (hold 3 flooded).
- The other three downflooding points, all in hold 1, required a heel angle of at least 42° to downflood in either condition.

Figure 60 shows the downflooding angles for the downflooding points described above, plus the angle at which the edge of the freeboard deck would have been immersed (about 15°). The downflooding angles are superimposed on two righting arm curves. The upper curve is the righting arm for *El Faro* in the intact condition on the morning of the sinking, before flooding began and with no wind. The lower curve is the righting arm for the vessel with hold 3 flooded to 20 percent and a sustained 80-knot beam wind. The smaller area under the lower righting arm curve, compared with the area under the upper curve, illustrates the severely reduced energy the vessel had available to right itself after hold 3 flooded and the ship lost power, with hurricane winds on its beam (blowing at a 90° angle to its starboard side).

**Figure 60.** Righting arm curves for *El Faro*, with annotated downflooding angles. Downflooding angles are indicated at various points on curves for convenience; they do not represent values used in righting-arm calculations. (Illustration by Coast Guard Marine Safety Center)

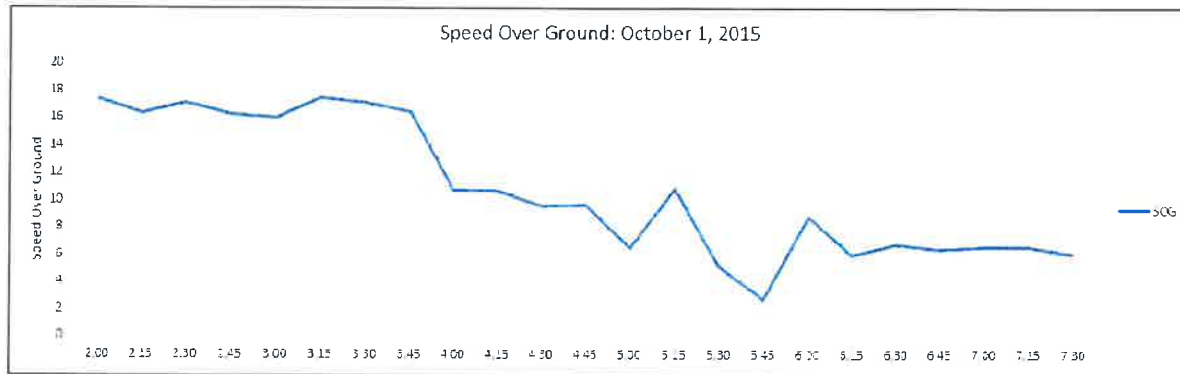
*El Faro* sank an hour and a half after it lost propulsion. From the time it left port the evening of September 29, the ship traveled at near-maximum speed, between 19 and 20 knots, for almost 30 hours. But it began to slow and develop a wind-driven starboard list when it came out of the protective lee of San Salvador Island about 0130 on October 1 and encountered the steadily increasing force of the wind. The ship's speed dropped quickly to 18 knots and fell more or less

steadily from then on, as shown in figure 62. (Engine speed, or propeller rpm, was not recorded by the vessel's VDR, but parametric data captured the ship's speed over ground.)

**Figure 62.** Ship's speed over ground from 0200 to 0730 on October 1.
