Sinking of US Cargo Vessel *SS El Faro*  
Atlantic Ocean, Northeast of Acklins and Crooked Island,  
Bahamas  
October 1, 2015

NTSB/MAR-17/01  
PB2018-100342

# Marine Accident Report

**Abstract:** On Thursday, October 1, 2015, the SS *El Faro*, a 40-year-old cargo ship owned by TOTE Maritime Puerto Rico and operated by TOTE Services, Inc., was on a regular route from Jacksonville, Florida, to San Juan, Puerto Rico, when it foundered and sank in the Atlantic Ocean about 40 nautical miles northeast of Acklins and Crooked Island, Bahamas. The ship had sailed directly into the path of Hurricane Joaquin, carrying a crew of 33, including 5 Polish contract repair workers. All those aboard perished in the sinking. As part of its accident investigation, the National Transportation Safety Board (NTSB) led a joint effort with the US Navy, Woods Hole Oceanographic Institution, and the National Science Foundation to locate the ship's wreckage and retrieve its voyage data recorder (VDR). The VDR was pulled from 15,250 feet below the ocean surface in August 2016 during the third undersea mission and yielded more than 26 hours of parametric data and audio files. The NTSB's accident investigatio

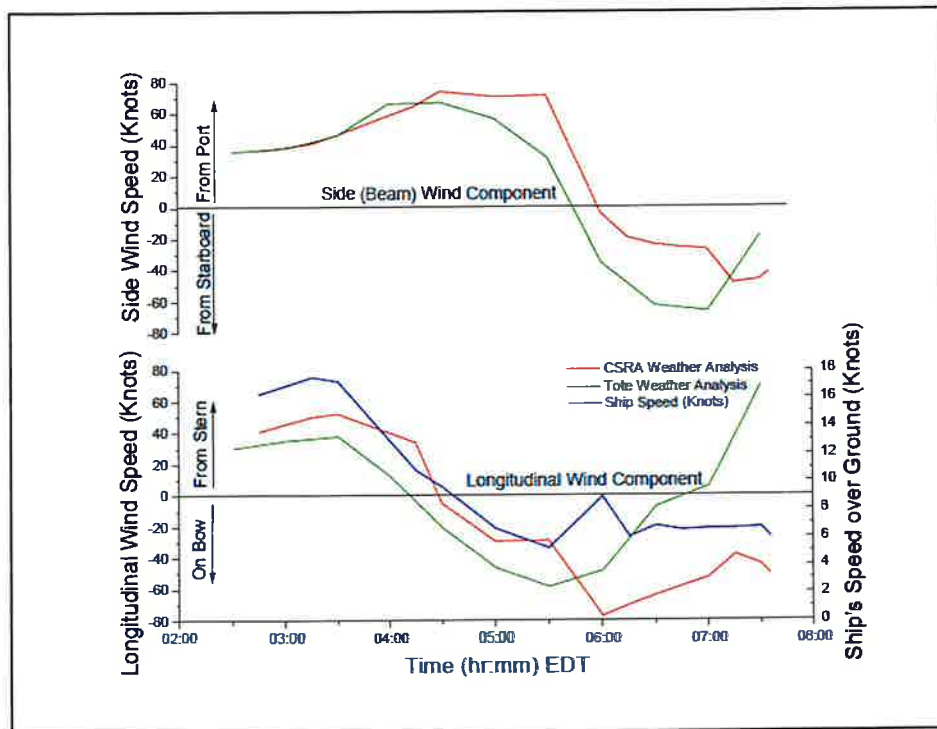
The graph in figure 63 demonstrates the relationship between ship's speed over ground and wind speed and direction, based on poststorm weather analyses. It shows that the increasing winds on the port side between 0400 and 0600 account for the vessel's starboard heel, while the shift of wind to the bow helps explain part of the vessel's slowing after 0400. The NTSB concludes that the initial list was caused by an increasing wind on the vessel's beam generated by Hurricane Joaquin.

**Figure 63.** Ship's speed over ground relative to wind direction. Wind directions obtained from NTSB-chartered dynamic analysis (by CSRA Inc.) and TOTE weather analysis submission.

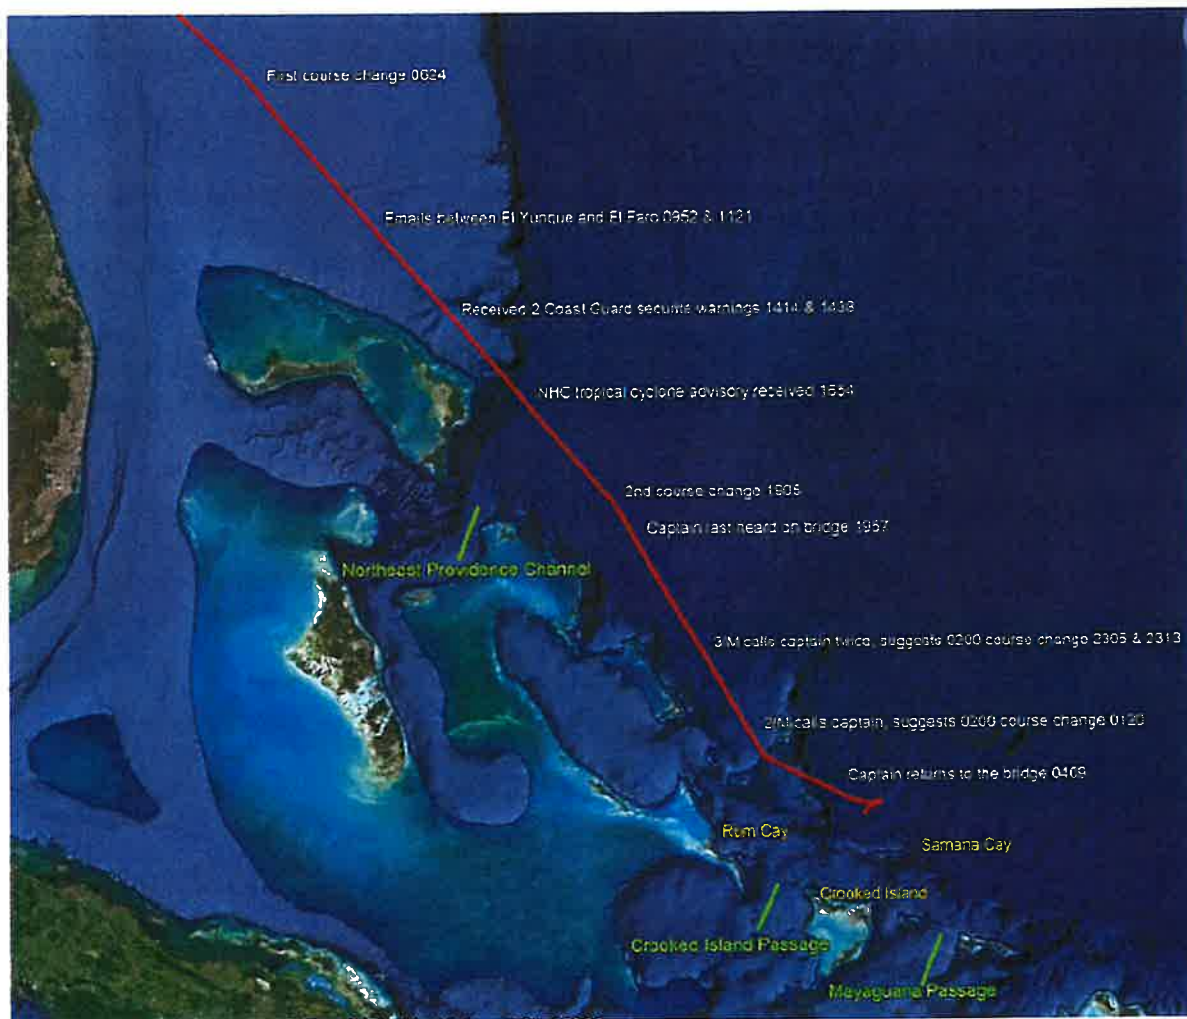
While the captain could have taken action at any time, there were several significant points along the accident route where the captain was provided with new information that gave him opportunities to adjust course and avoid heading into the storm (see figure 66). At 0624 on September 30, after reviewing the latest weather data from BVS, which showed the storm tracking west-southwest, the captain and chief mate decided to alter the vessel's path slightly southward. The captain described the course change as a "good little diversion" and suggested that Joaquin was not serious enough to warrant what the chief mate described as more "drastic" evasive action.

Figure 66. Significant opportunities for decision-making.

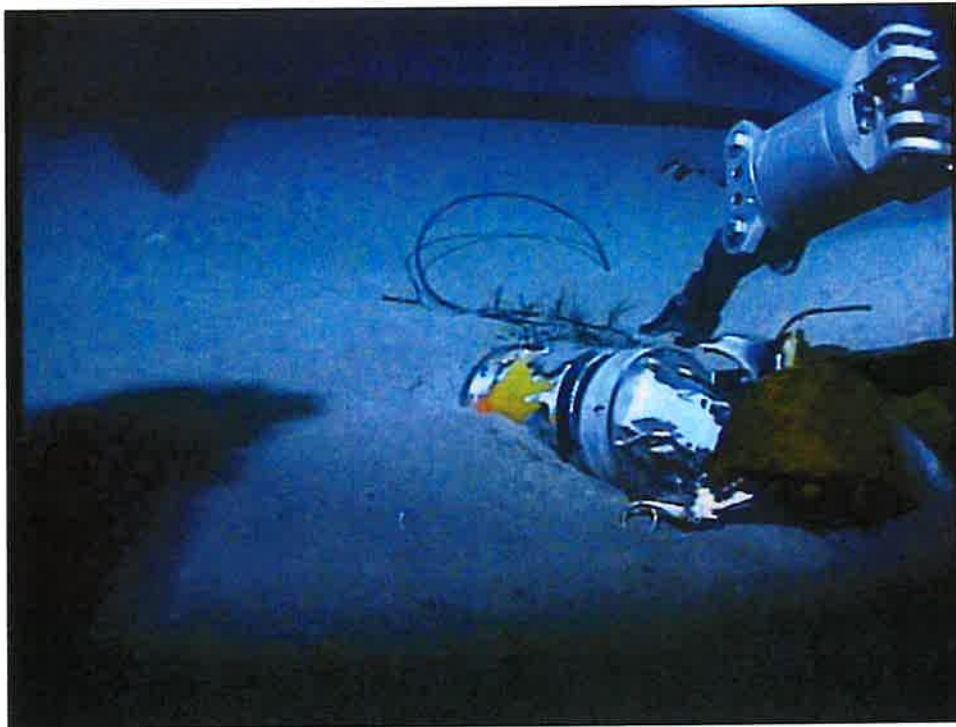
Figure C-2. CURV-21 freeing VDR capsule from seafloor. (US Navy photo)

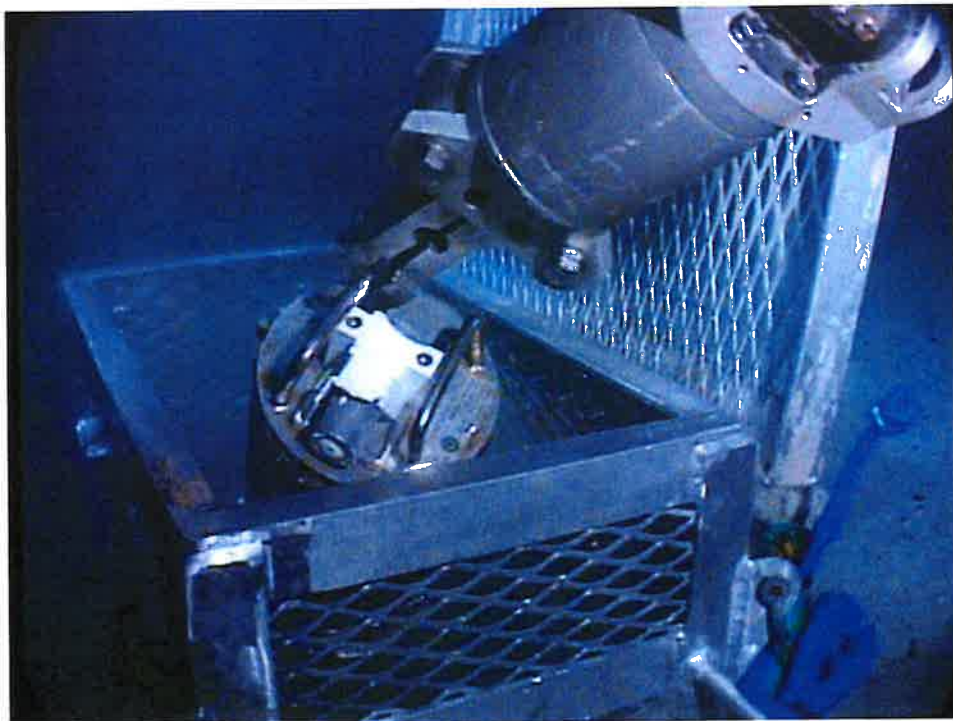
Figure C-3. CURV-21 placing VDR capsule in basket for transport to surface. (US Navy photo)

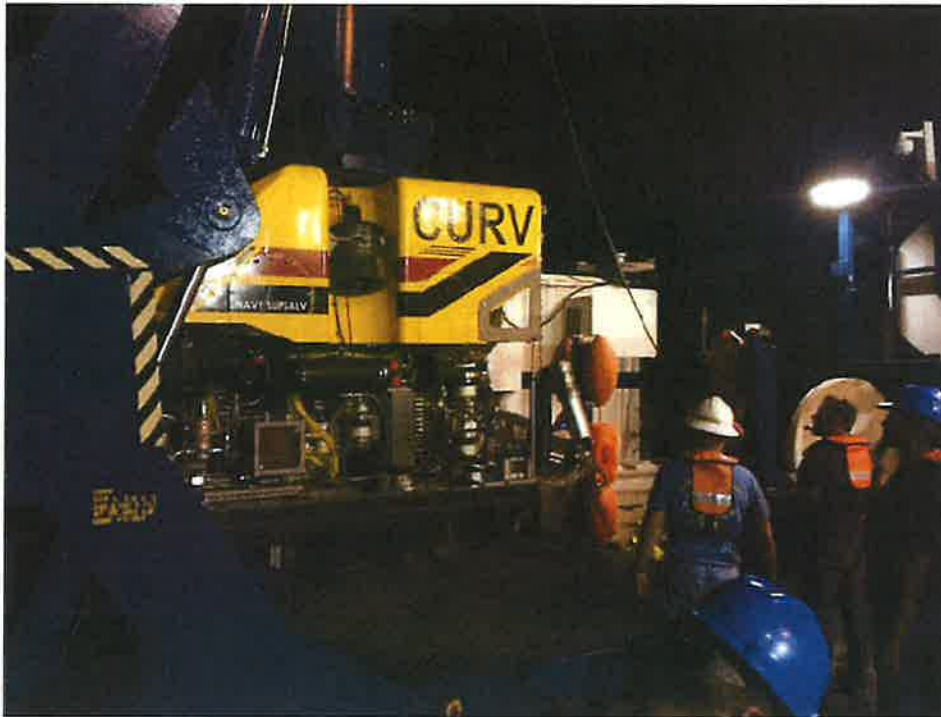
Figure C-4. CURV-21 landing on *Apache* deck after retrieving VDR.
