# National Transportation Safety Board

## Marine Accident Brief

### Contact of Bulk Carrier *Shandong Fu En* with Ergon-St. James Terminal Wharf

<b>Accident type</b>	Contact	No. DCA18FM020
<b>Vessel name</b>	<i>Shandong Fu En</i>	
<b>Location</b>	Lower Mississippi River near mile 161, Convent, Louisiana 30°01.82' N, 090°50.40' W	
<b>Date</b>	April 6, 2018	
<b>Time</b>	0637 central daylight time (coordinated universal time – 5 hours)	
<b>Injuries</b>	None	
<b>Property damage</b>	\$6.25 million est.	
<b>Environmental damage</b>	None	
<b>Weather</b>	Visibility 10 miles, mostly cloudy, winds south-southeast 11 knots; air temperature 70°F; morning twilight 0621, sunrise 0645, evening sunset 1723, evening twilight ends 1947	
<b>Waterway information</b>	Lower Mississippi River has a project depth of 45 feet at the accident location; high-water conditions were in effect, with the current about 5.4 mph (4.7 knots). The distance between the north end of the Ergon-St. James Terminal and the south end of the Convent Marine Terminal wharves is 1,479 feet (451 meters).

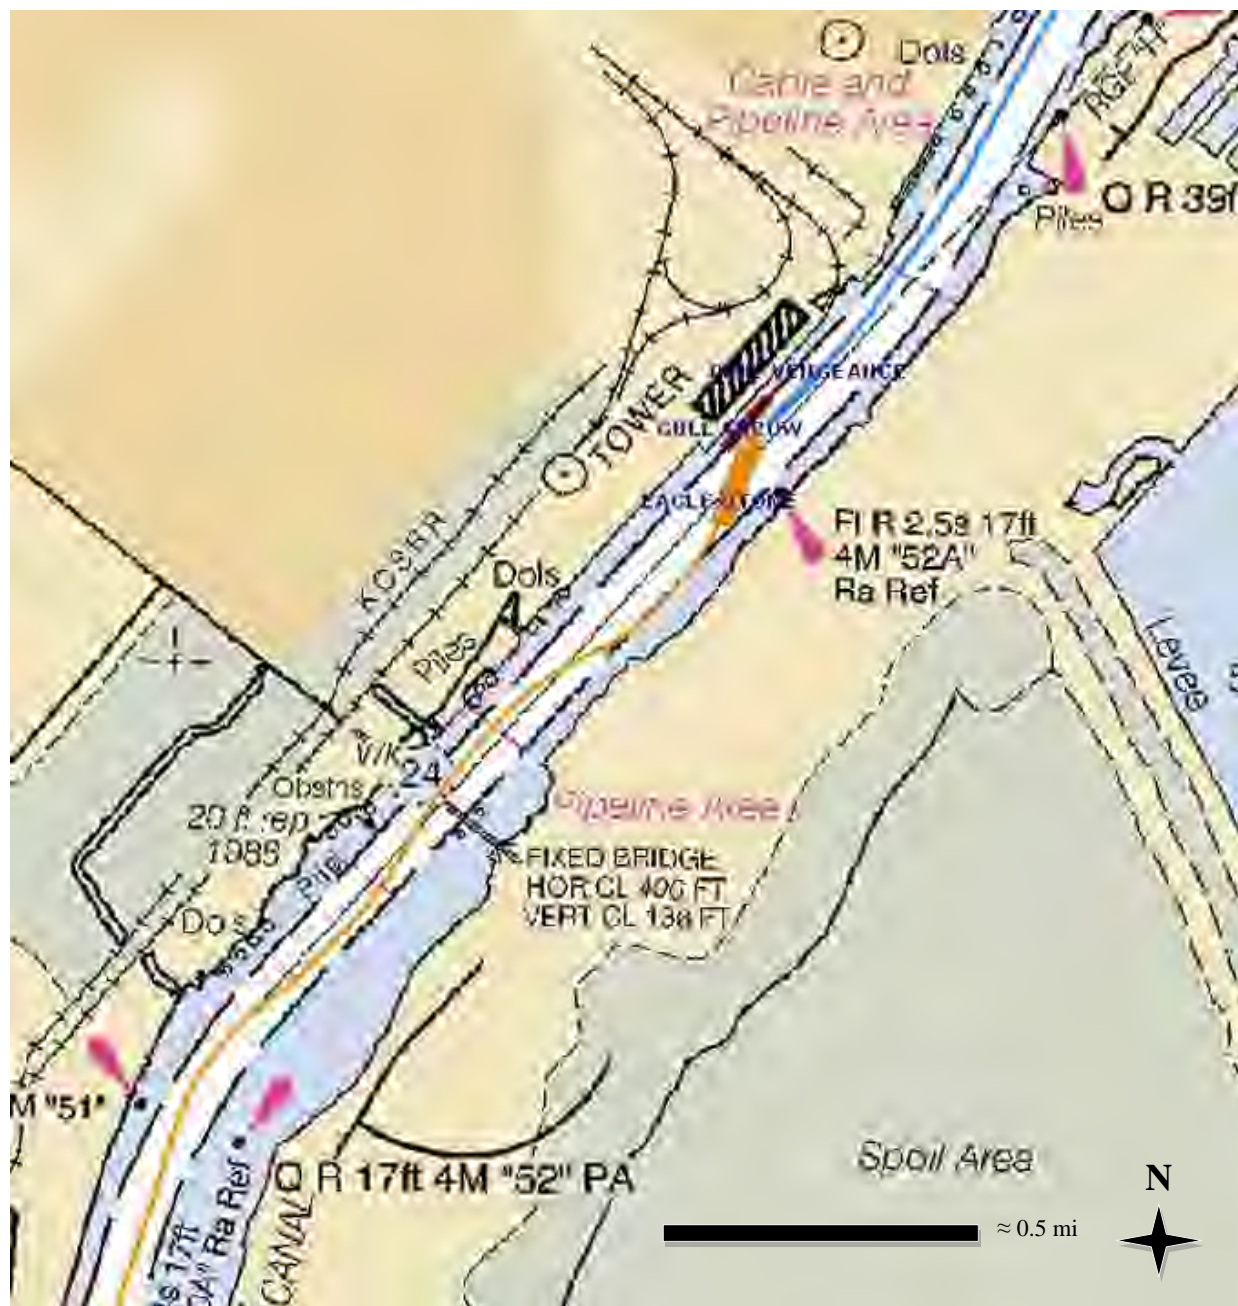
When the *Eagle Otome*'s starboard bow came close to the east bank, the tankship began sheering to port, despite the hard to starboard rudder command (figure 7). At 0933:14, the first pilot asked the second pilot, "Will you talk to this next tow?" The second pilot answered, "What do you want me to tell them? Just one whistle or look out here we come?" The first pilot replied, "One, yeah, look out, the one there is *Vengeance*." However, neither the S-VDR nor the VHF radio recordings indicated that the second pilot contacted the towboat as the first pilot instructed him to do.

**Figure 7.** Trackline of the *Eagle Otome*, obtained from the tankship's S-VDR, overlaid as an orange line on NOAA chart 11342, and trackline of the *Dixie Vengeance*, obtained from automatic identification system (AIS)<sup>21</sup> data, overlaid as a blue line.

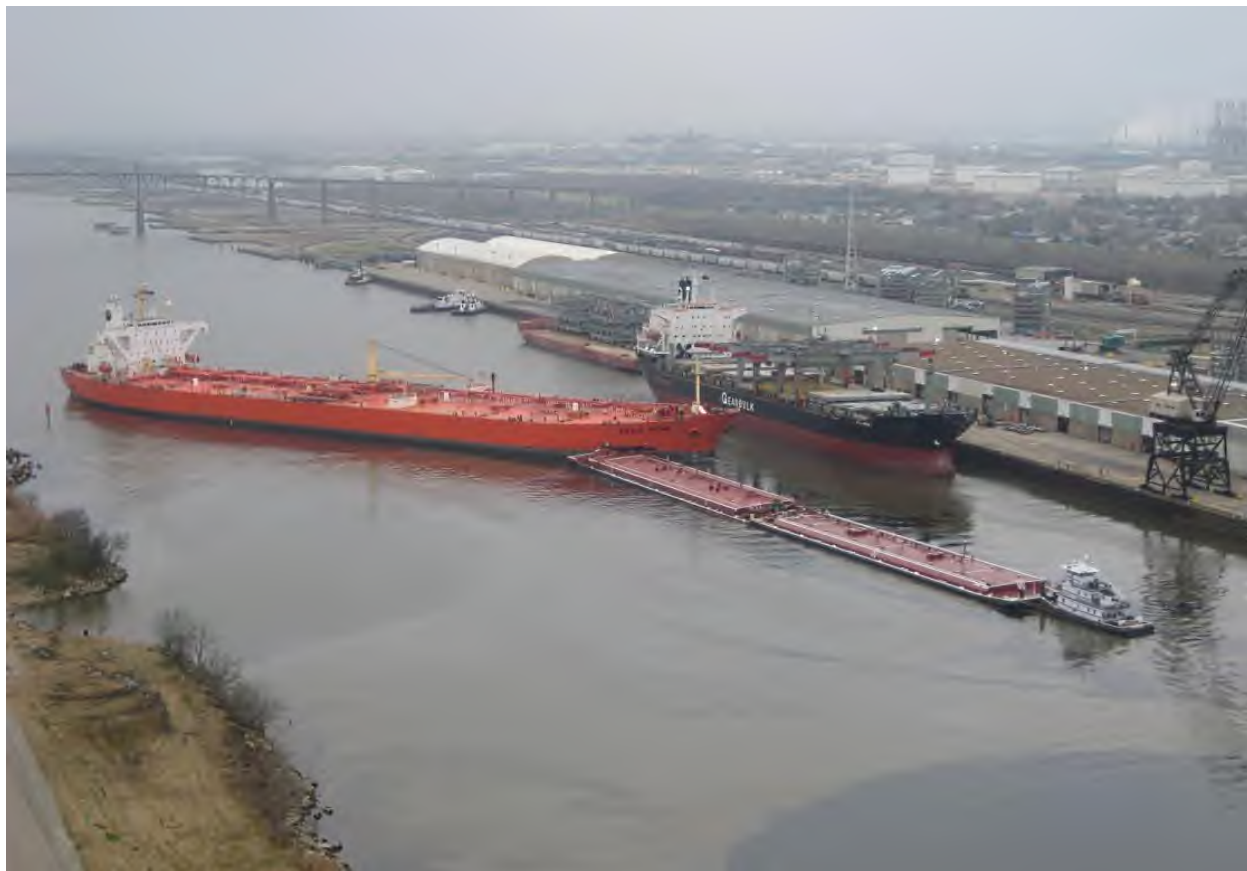
As a result of the breach, an estimated 462,000 gallons of crude oil spilled into the water. The vessels remained together in the center of the canal while pollution response procedures were initiated (figure 9). (For more information, see section “1.9 Oil Spill and Recovery Efforts.”)

**Figure 9.** The three vessels after the accident. Overflight photo by the Coast Guard, looking west-southwest.

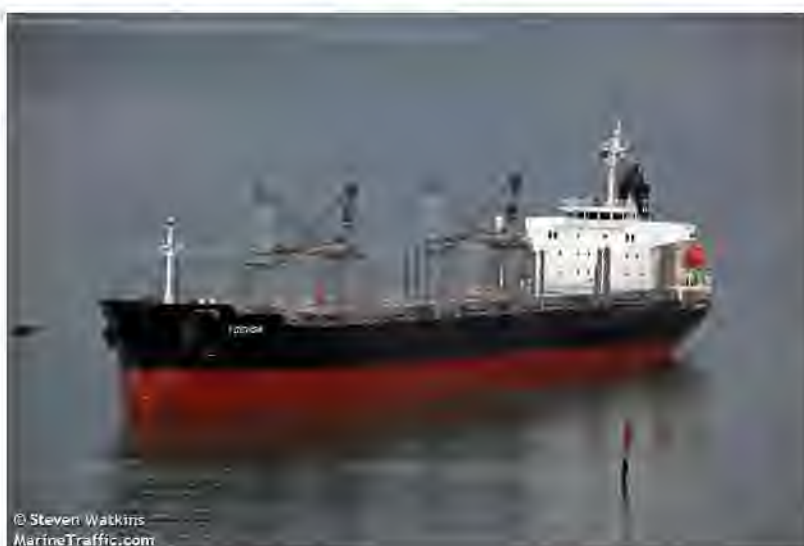
Bulk carrier *Yochow* under way.

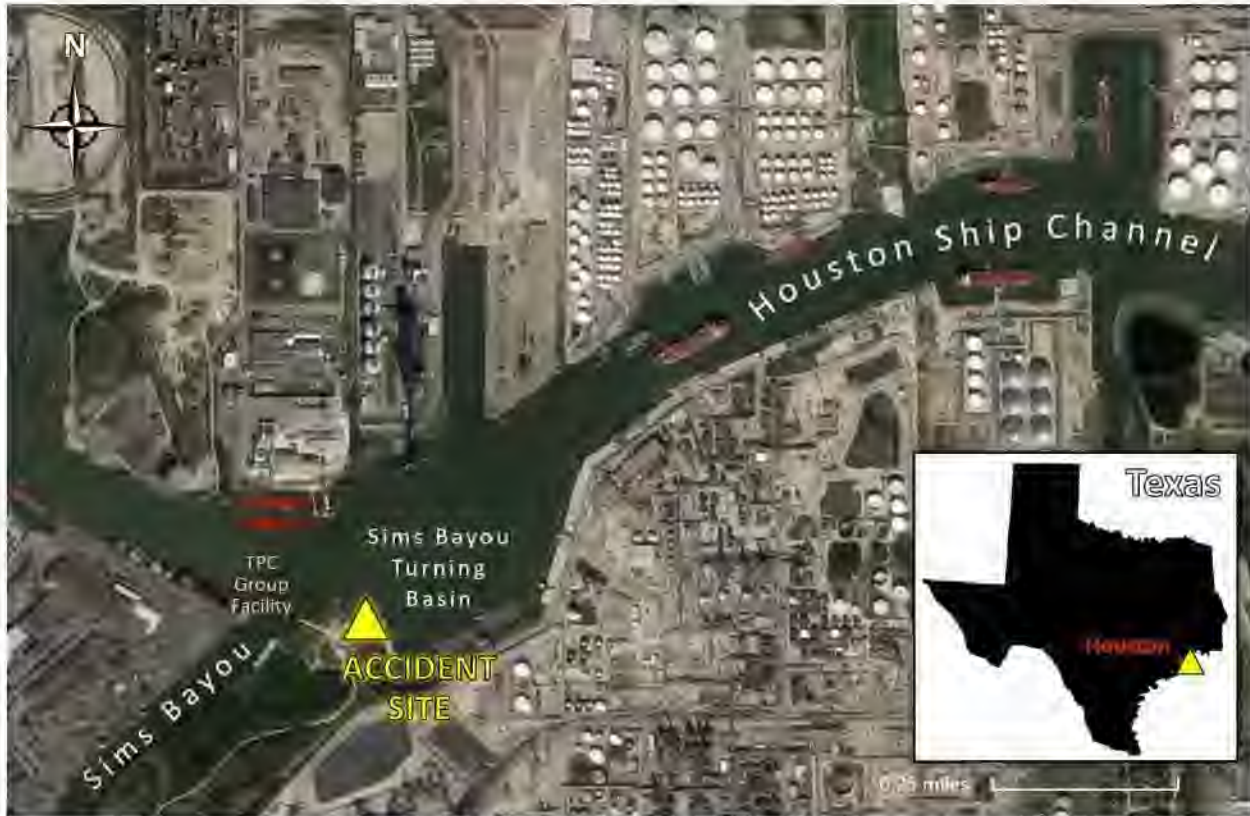
Location where *Yochow* collided with *OSG Independence's* barge, *OSG 243*, in the Houston Ship Channel. (Satellite image from Google Earth Pro)

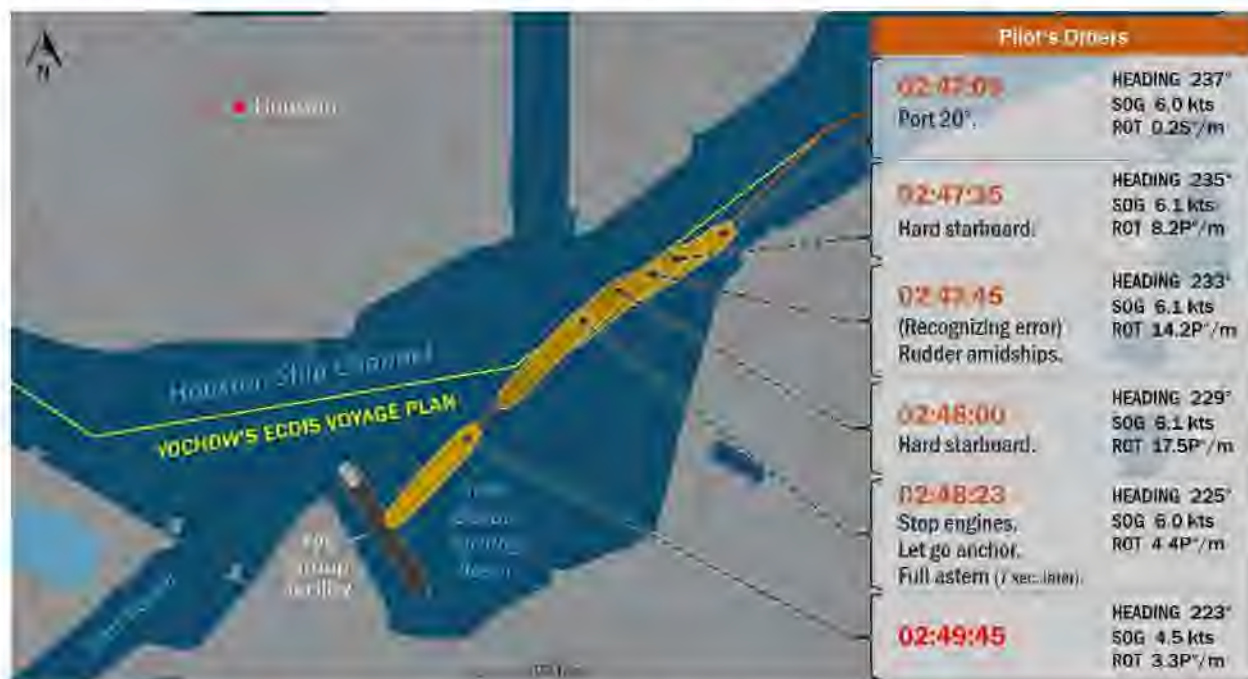
Ten seconds later, the pilot recognized the error and ordered midships while tapping with his fingers on the rudder angle indicator above his head to get the helmsman's attention. It took the steering gear 15 seconds to shift from hard port to midships, and then the pilot repeated his original hard-starboard order. The rudder reached hard starboard 12 seconds later, although the ship's heading was still falling to port at about 12 degrees per minute.

When the *Yochow* was about one ship's length away from the *OSG Independence/OSG 243*, the pilot ordered at 02:48:23, "Stop engines. Let go anchor," 48 seconds after his original order to starboard. He followed this order with full astern 7 seconds later and then ordered the whistle sounded. At this point the *Yochow* was making 6 knots, and its heading was still falling to port. The pilot told investigators that increasing the engine speed to power through the turn, as he had done earlier, would risk hitting the tug, which likely had a sleeping crew on board. He chose instead to attempt to stop the vessel and risk hitting the barge ahead of it.

According to electronic data, last 10 minutes of *Yochow's* trackline leading up to accident based on pilot's orders. (Background from Google Earth)

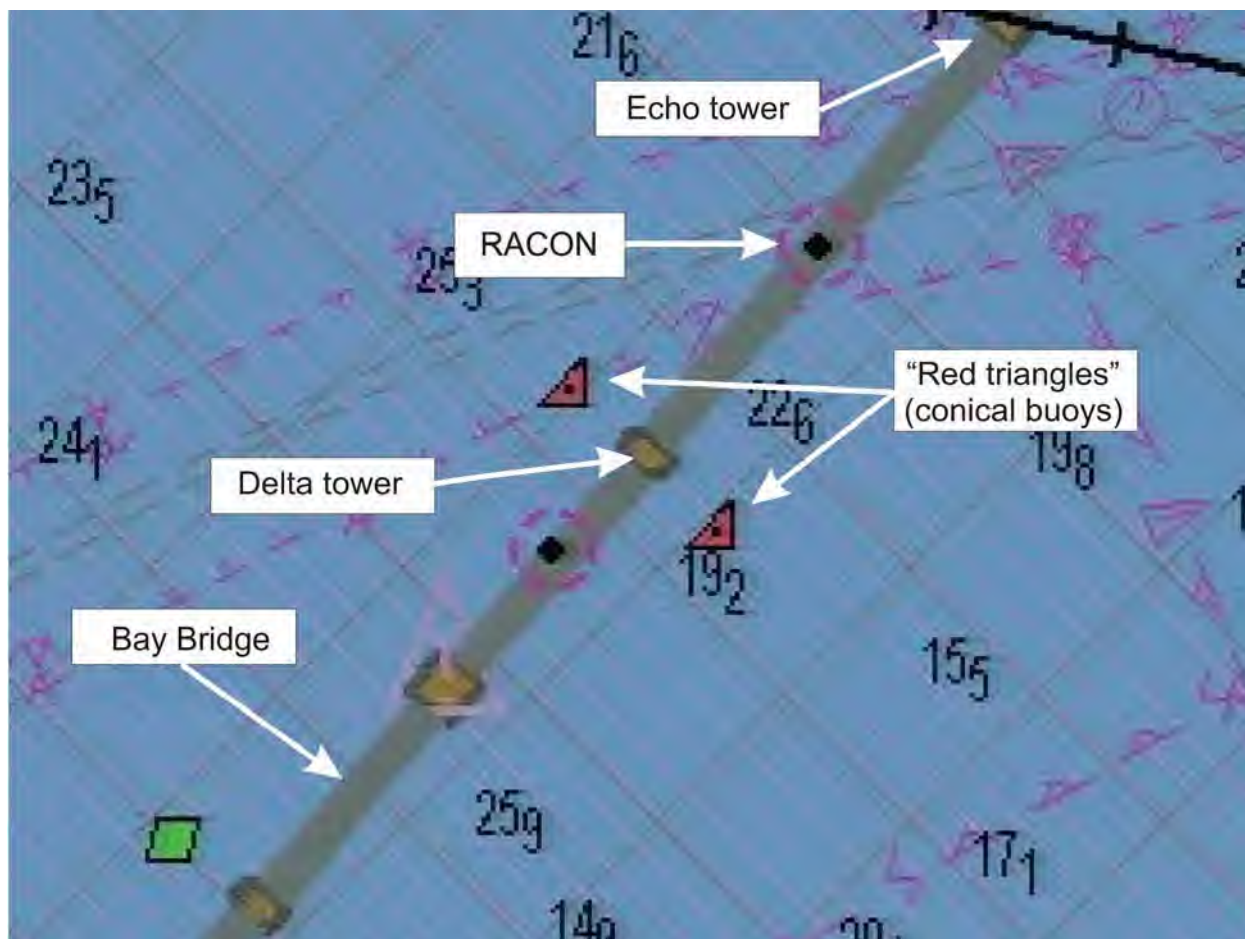
**Figure 2.** An enlarged section of the electronic chart on board the *Cosco Busan*. Two conical buoys, positioned on either side of the Delta tower, are displayed as red triangles on the electronic chart.

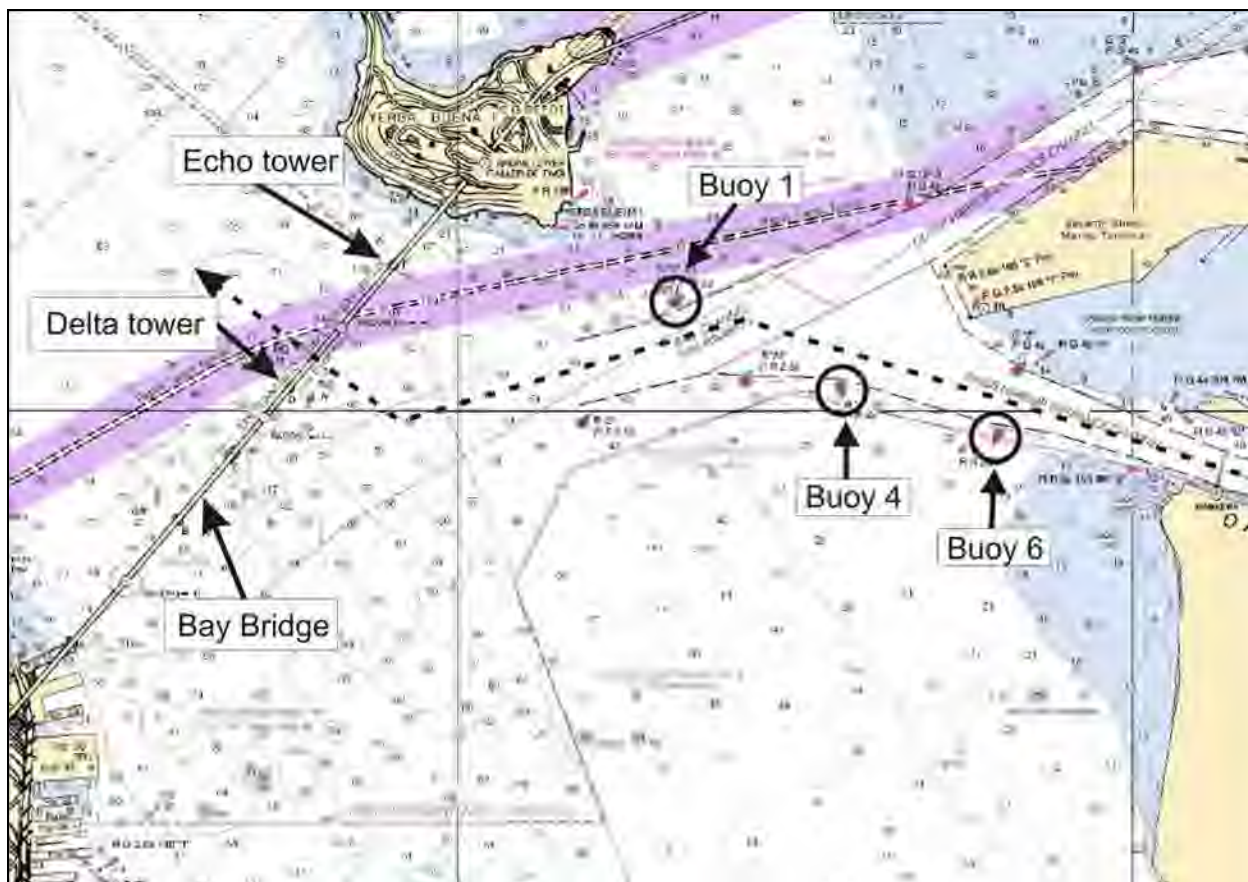
**Figure 3.** Navigation chart of the accident area with the approximate intended course of the *Cosco Busan* shown by the black dotted line.

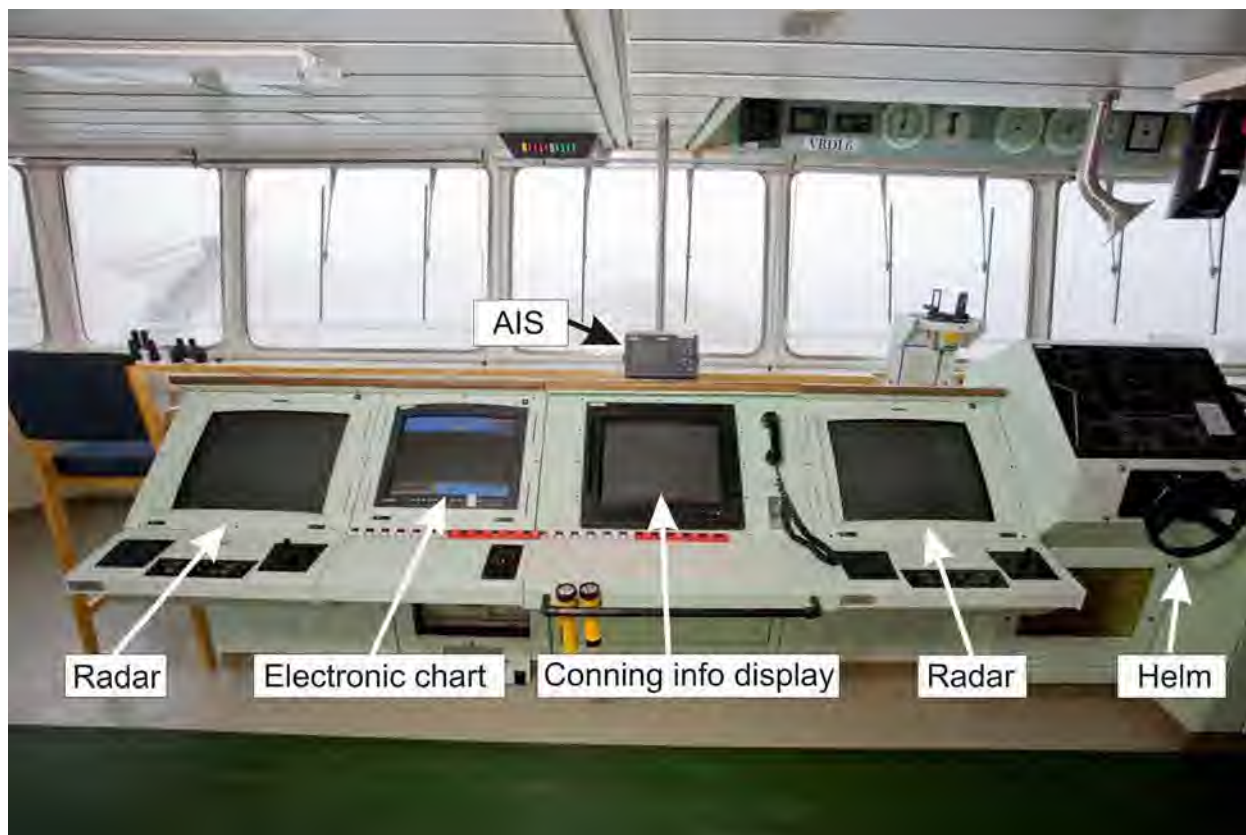
**Figure 7.** The bridge of the *Cosco Busan* showing primary navigation displays.

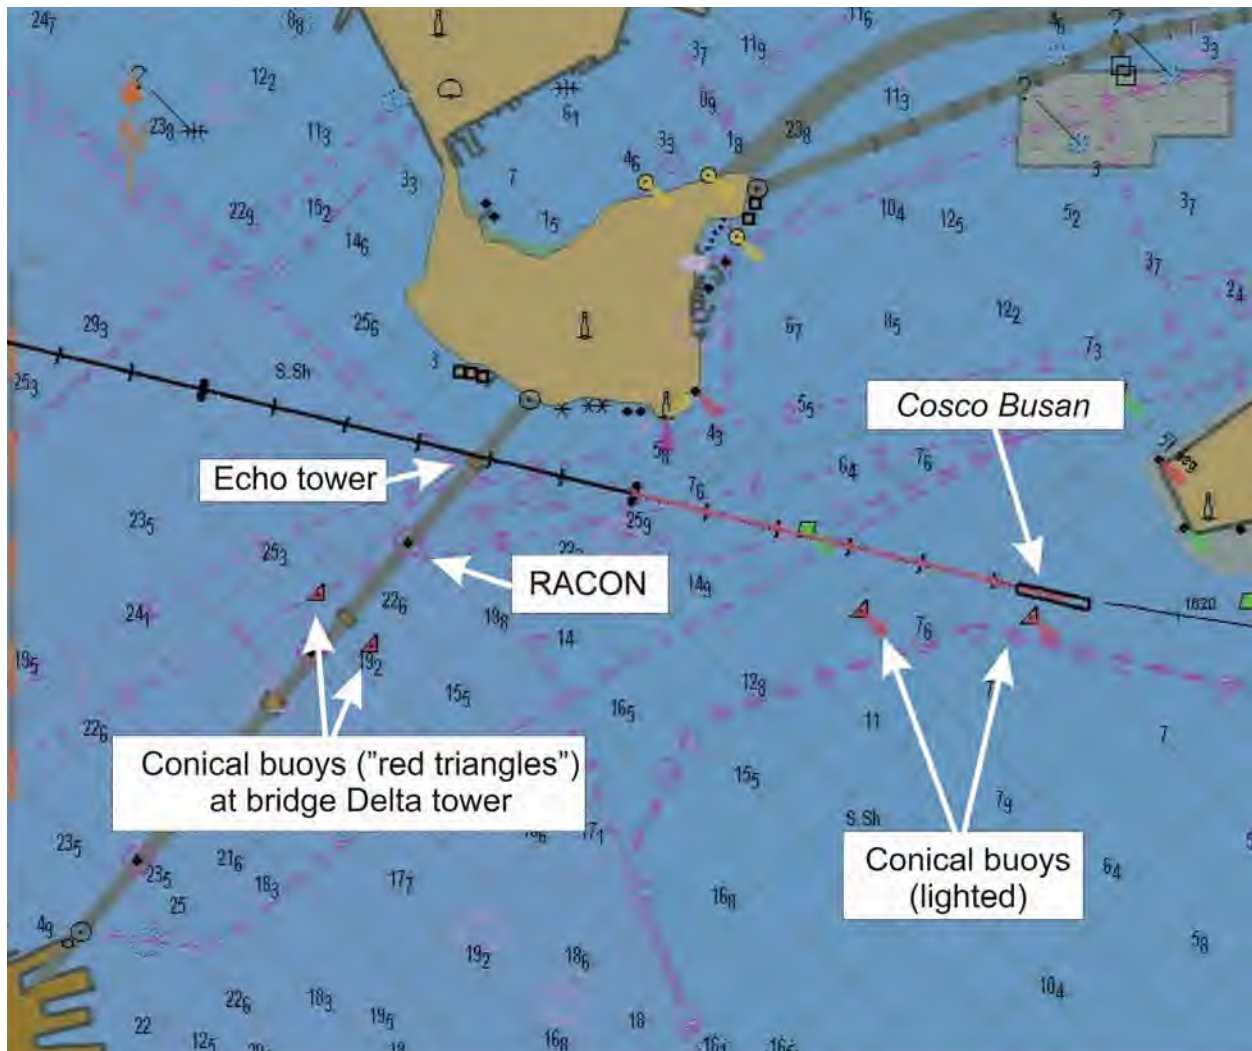
**Figure 8.** The Bay Bridge as displayed on the electronic chart on board the *Cosco Busan*. The chart display is from 0821:51, the approximate time the pilot questioned the ship's master about the meaning of the red triangles at the bridge.

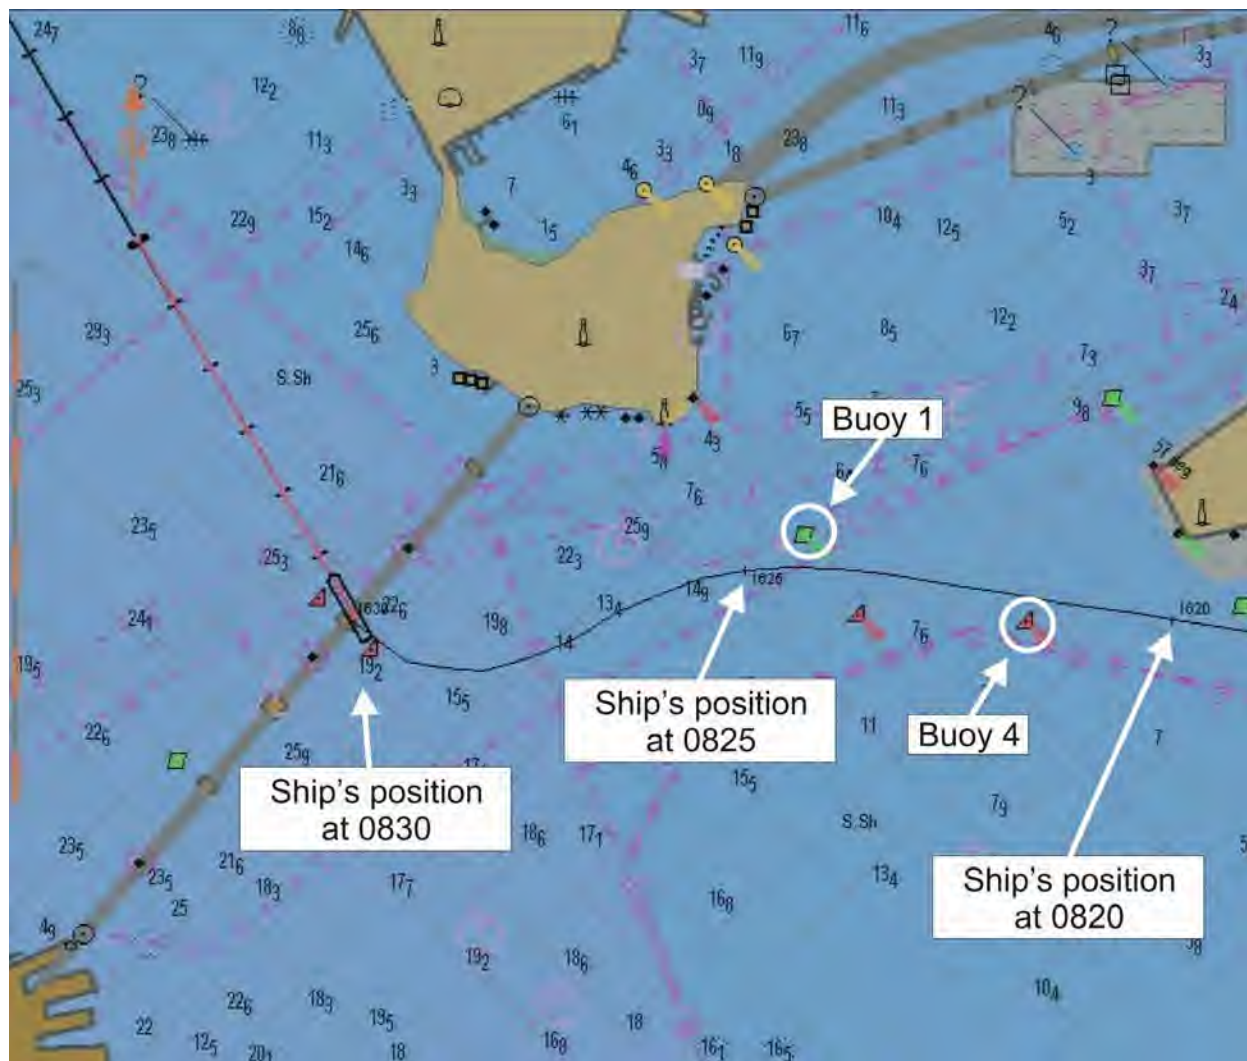
primary and secondary sensors provided a real-time plot of the ship's movement on the electronic chart with time markers at 5-minute intervals (figure 9).

**Figure 9.** Electronic chart from the *Cosco Busan* showing the vessel's track from the entrance channel to the bridge during the accident voyage. The ship's position was marked on the chart at 5-minute intervals.

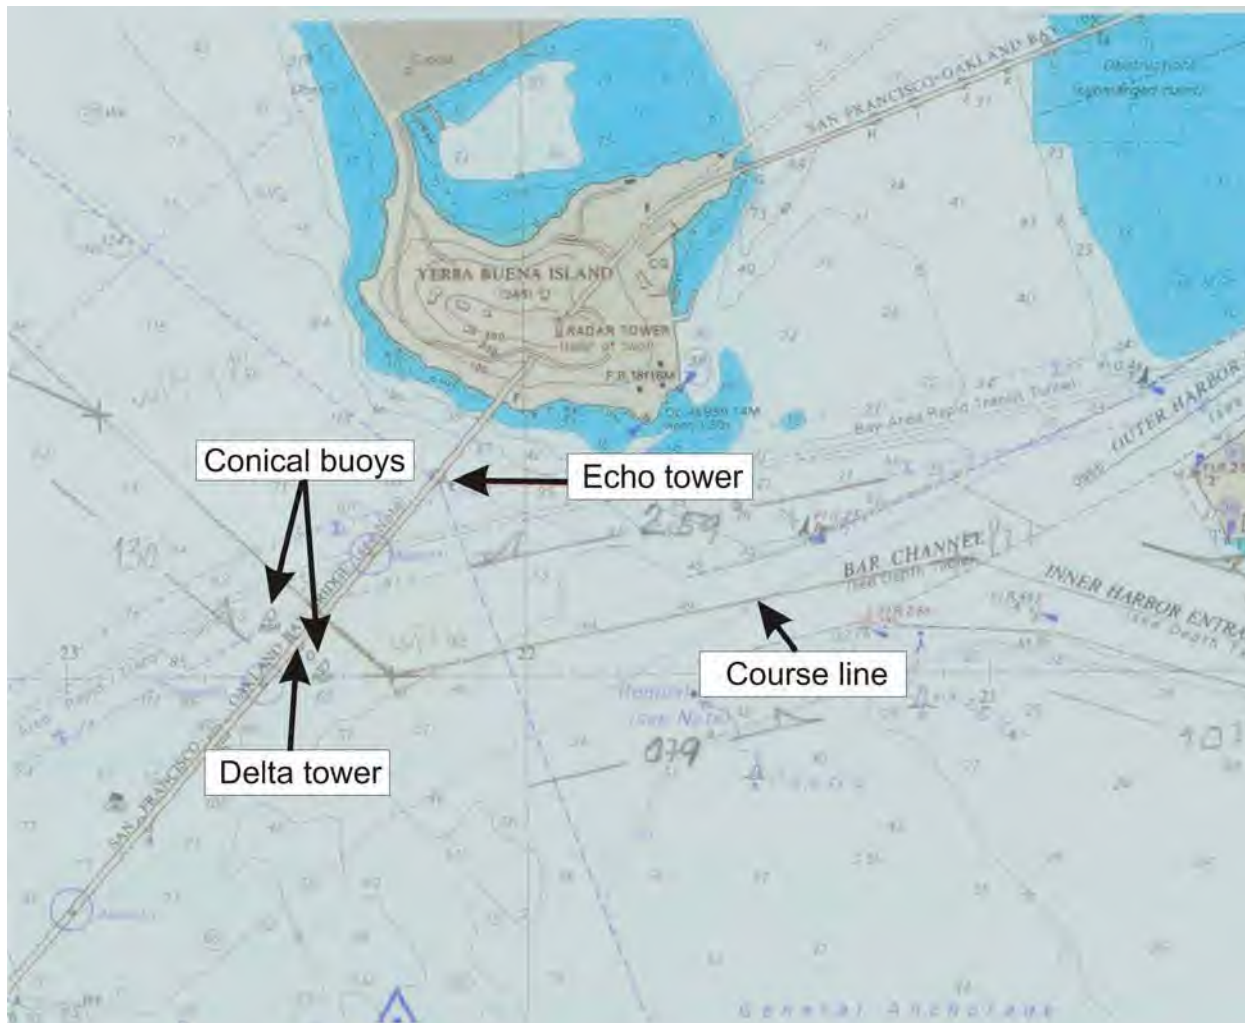
**Paper Chart.** The paper chart on the chart table on the morning of the allision was British Admiralty chart No. 588, Edition 5, dated November 29, 2001 (corrected through Notice to Mariners No. 38/07). A crewmember had drawn a single course line on the chart indicating the planned route through the Delta–Echo span of the Bay Bridge to and from berth 56 (figure 10).

**Figure 10.** A portion of the paper chart that was on the chart table on the bridge of the *Cosco Busan* at the time of the allision. The course line, with in- and outbound headings, had been plotted and added to the chart by the ship's crew.

Before arriving in Oakland, a crewmember re-traced the previous crew’s erased course line on the paper chart indicating the planned inbound route through the Delta–Echo span of the Bay Bridge to berth 56 (figure 10). The paper chart did not have a separate course line for the outbound route, but reciprocal headings on the single course line indicated that the same course could be used on the return to sea. Neither of the two VDR microphones in the area just to the left and right of the chart table picked up any conversation regarding the paper chart before the allision. Specifically, the pilot and the master were never heard talking about or referencing the paper chart until after the allision. Nor did the VDR capture any other conversation between the pilot and any other member of the bridge team referencing the intended route through the Delta–Echo span. In his postaccident interview, the pilot stated that he had not seen the paper chart.

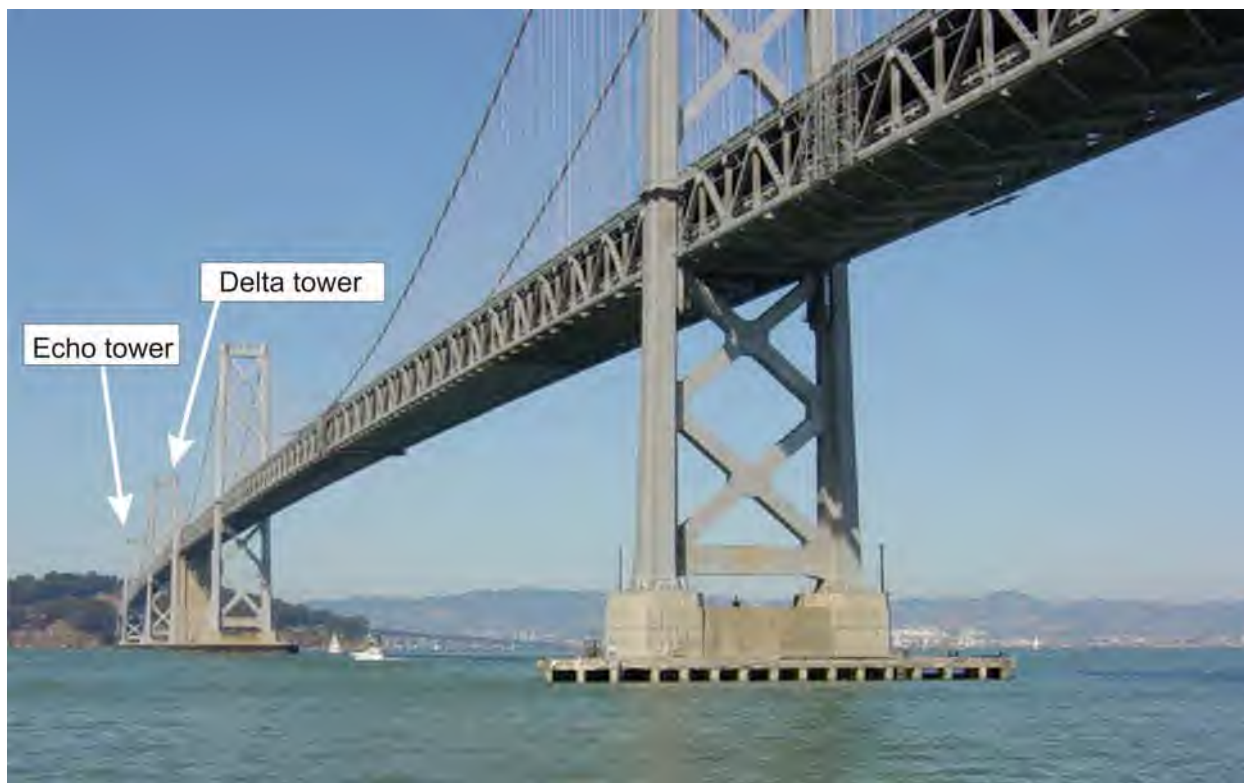
The Bay Bridge, which carries Interstate 80 (I-80) across San Francisco Bay, is owned, operated, and maintained by Caltrans. The bridge consists of two major spans connecting each shore with Yerba Buena Island, a natural island located mid-bay (figure 11). The western crossing, from San Francisco to the island, consists of two suspension bridges end-to-end with an anchorage, plus three shorter truss spans connecting the San Francisco landing to the western cable anchorage on Rincon Hill. The western bridge span at the site of the allision is double-decked, with westbound traffic using the upper deck and eastbound traffic the lower. At the time of the accident, average daily traffic across the bridge was more than 280,000 vehicles. Caltrans continuous traffic data sensors on the bridge showed that about 1,100 to 1,300 vehicles were on the west span at the time of the allision. The impact occurred at the bridge tower designated by Caltrans as pier W-5 (because it was the fifth pier west of the San Francisco end of the bridge) and designated on Coast Guard and other maritime charts as pier Delta. According to Caltrans records, the bridge was opened to traffic on November 12, 1936.

**Figure 11.** The western crossing of the San Francisco–Oakland Bay Bridge looking east.

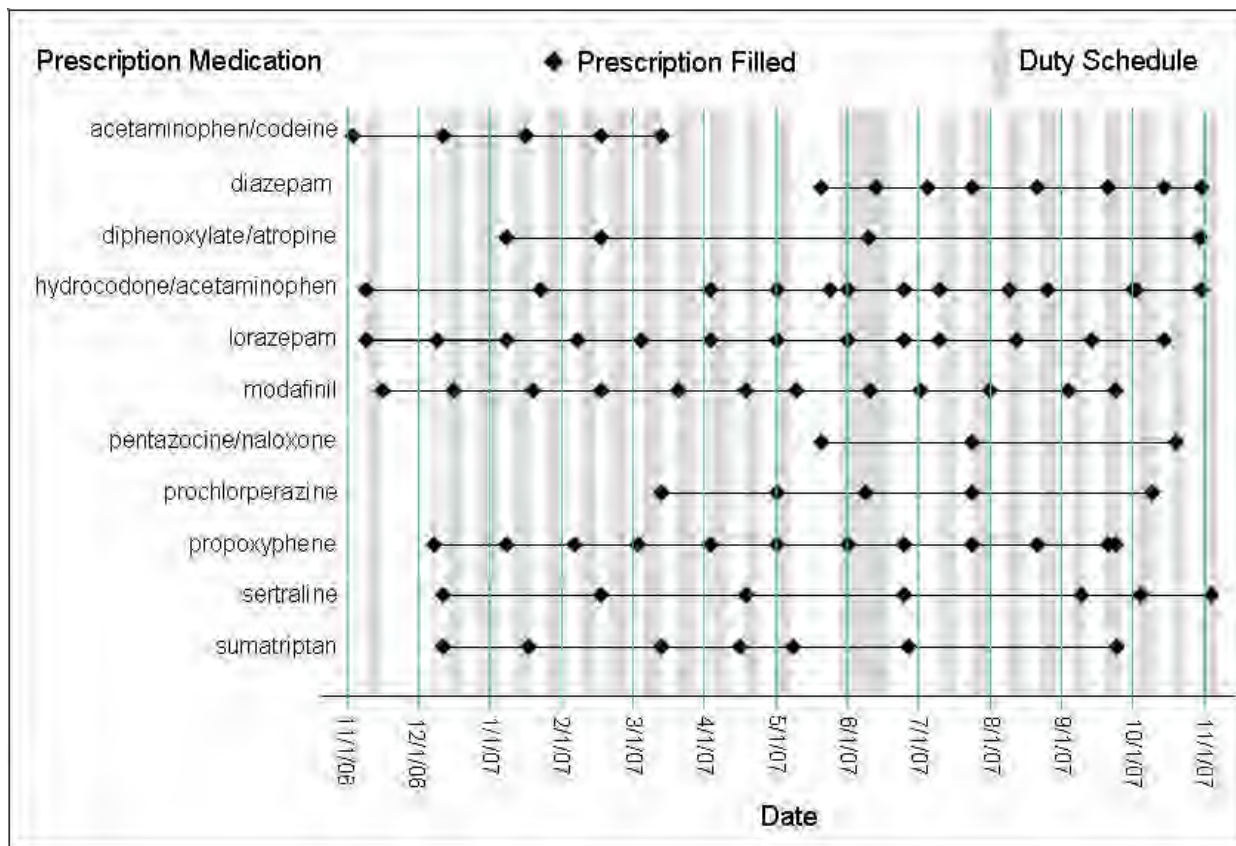
50 pentazocine<sup>62</sup>/naloxone<sup>63</sup> tablets, 100 diphenoxylate<sup>64</sup>/atropine<sup>65</sup> 2.5/0.025 mg tablets, 27 sumatriptan<sup>66</sup> 50 mg tablets, 90 modafinil<sup>67</sup> 200 mg tablets, and 90 sertraline<sup>68</sup> 50 mg tablets (figure 12).

**Figure 12.** Graphical display of the *Cosco Busan* pilot's prescription history and duty schedule for the year preceding the allision. Each diamond denotes the filling of a prescription for the medication indicated.

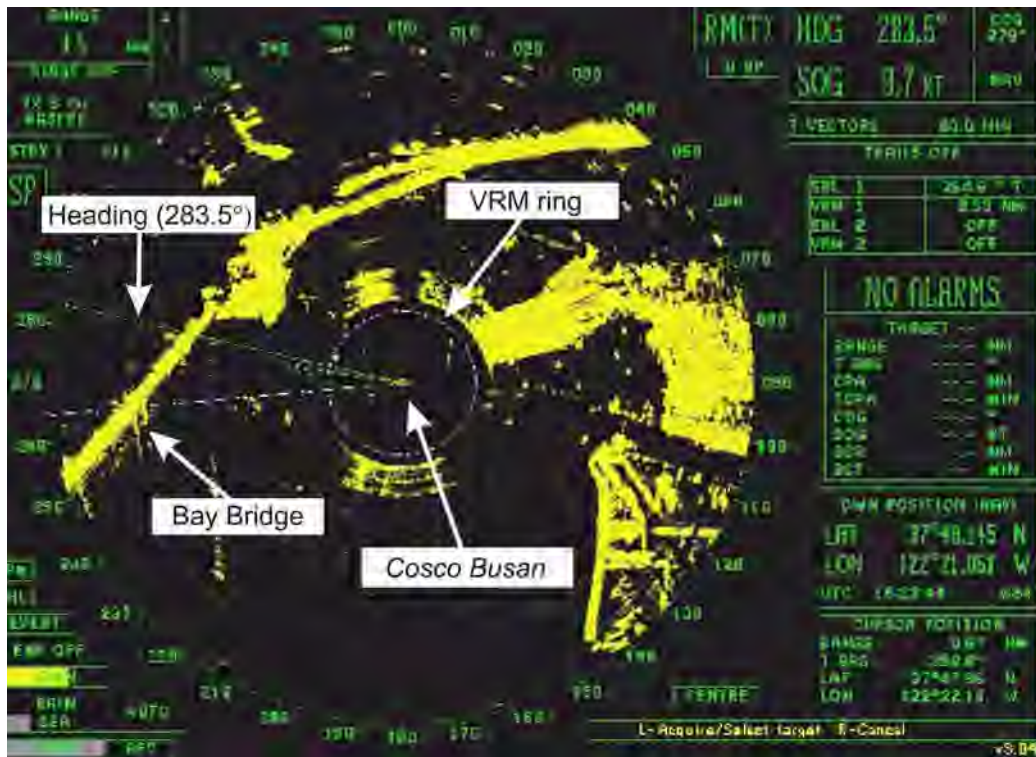
The *Cosco Busan* pilot told investigators that about the time the vessel began its initial turn to port (about 0823), “the radar picture of the bridge got distorted. It got wider. The bridge got wider. The RACON never appeared.” Investigators reviewed the radar images captured by the VDR and assessed the quality and consistency of the images that were displayed during the accident voyage (figure 13). This review revealed that the radar returns from the Bay Bridge did not change significantly from the time the bridge first became visible on the display about 0819 until about 0826 when the upper end of the bridge appeared to widen. The upper portion of the bridge appeared to widen on the radar image for about 1 minute before beginning to return to normal.

During the public hearing on this accident, the Sperry manager of product support and training reviewed the image and attributed the change in the bridge’s appearance to the *Cosco Busan* being almost abeam of the bridge at that point, with the top section of the bridge providing a much stronger radar return because the radar was “shooting . . . [radiofrequency] energy directly into the girders . . .” Figure 14 shows the radar image that was being displayed on the *Cosco Busan* at the time the radar image of the Bay Bridge became, in the words of the pilot, “distorted.” After about 2 minutes, the entire bridge began to appear thinner on the radar screen as the ship approached the bridge and more of its radar waves passed beneath the bridge instead of being reflected back. The signature of the RACON transponder at the midpoint of the Delta–Echo span also appeared on the radar screen at regular intervals throughout the voyage.

**Figure 13.** (Top) Radar image displayed on the bridge of the *Cosco Busan* at 0822:44, just before the vessel turned to port, and (bottom) the radar image at 0826:14, just after the vessel made the turn to port. In the bottom image, note the identifier for the RACON at the center of the Delta–Echo span of the bridge.

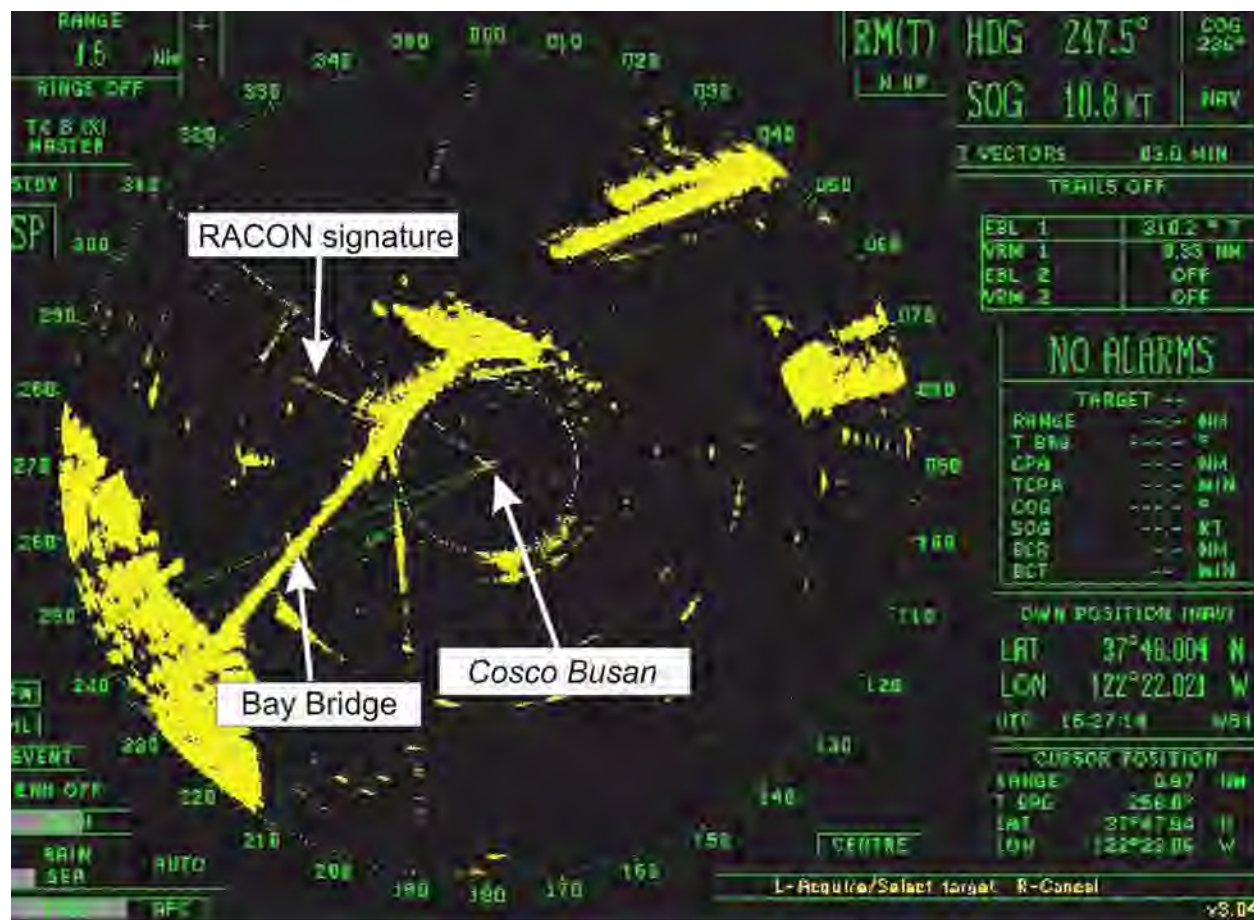
**Figure 14.** Radar image on board the *Cosco Busan* at 0827:14. According to investigators, 0827:14 was the time at which the upper portion of the bridge appeared the most enlarged on the radar image before returning to normal.

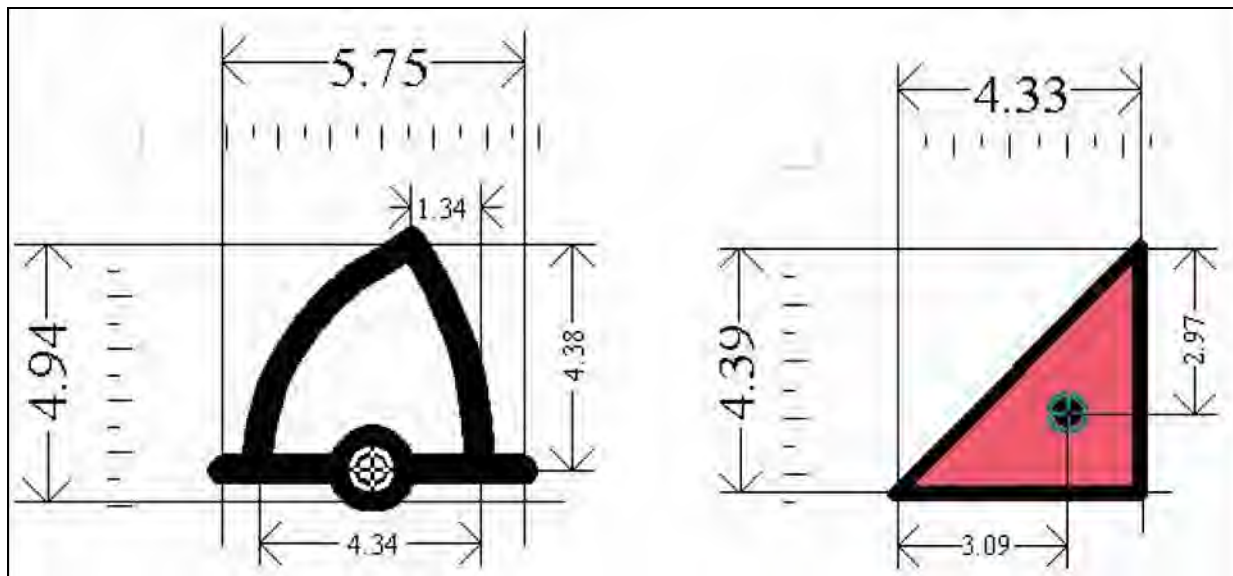
The electronic charts in use on the *Cosco Busan* were C-Map CM-93 vector charts. Although the vessel’s electronic chart system was not a certified ECDIS, the symbols used to signify conical buoys on the CM-93 charts were similar, if not identical, to the symbol for these buoys shown in the International Hydrographic Organization’s (IHO’s) *Presentation Library for ECDIS, Publication S-52, Appendix 2, Annex A*. The paper charts in use on the vessel also displayed conical buoys that appeared identical to those in the presentation library. Figure 15

shows the standard symbols for conical buoys used on IHO-compliant paper charts and on the CM-93 electronic charts (as well as on all ECDIS-certified S-57 charts).<sup>98</sup>

**Figure 15.** The International Hydrographic Organization (IHO) symbol used to represent conical buoys on paper charts (left) and the simplified symbol for the same buoys as represented, in red, on IHO S-57 electronic navigation charts (right).
