## **Report Reviewing CC Technologies**

### **Laboratory-based Evaluation of Failed Service Line Final Report, F4434-01G (Dated February 18, 2005)**

M.J. Schiff & Associates, Inc.  
Consulting Corrosion Engineers  
431 West Baseline Road  
Claremont, CA 91711  
(July 18, 2005)

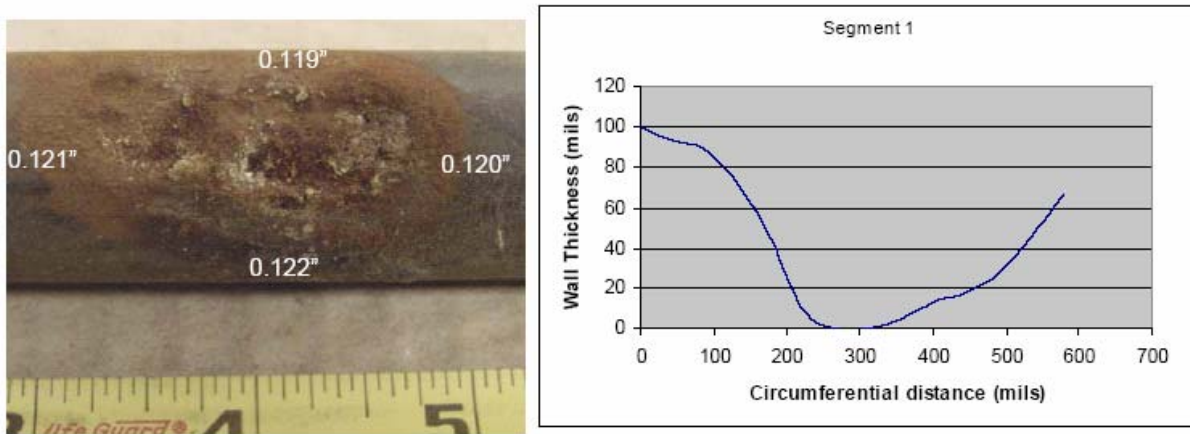
**Item 4: Figure 1 from Appendix L of CCTL Report, page 124 showing corrosion feature on segment 1 with circumferential ultrasonic testing results**

Of particular interest was the relatively large corrosion feature (1"x2") on segment 1. We have reproduced here in our Item 4. Note that the ultrasonic evaluation shows a virtual 100% through wall penetration (0 mils wall thickness near circumferential distance of 300 mils). No coating was present on segment 1 after removal so coating damage could not be determined based on visual inspection after removal. Subsequent metallographic examination revealed a thin ligament of metal remaining at the thinnest location (Item 5).

Figure 1. Circumferential profile of the anomaly at the 4-inch location of Segment 1.
