July 15, 2011

David Lykken - Director of Pipeline Safety Program
 State of Washington Utilities and Transportation Commission
 1300 S. Evergreen Park Dr. SW
 P.O. Box 47250
 Olympia, WA 98504-7250

Subject: Response to Docket PG-110020

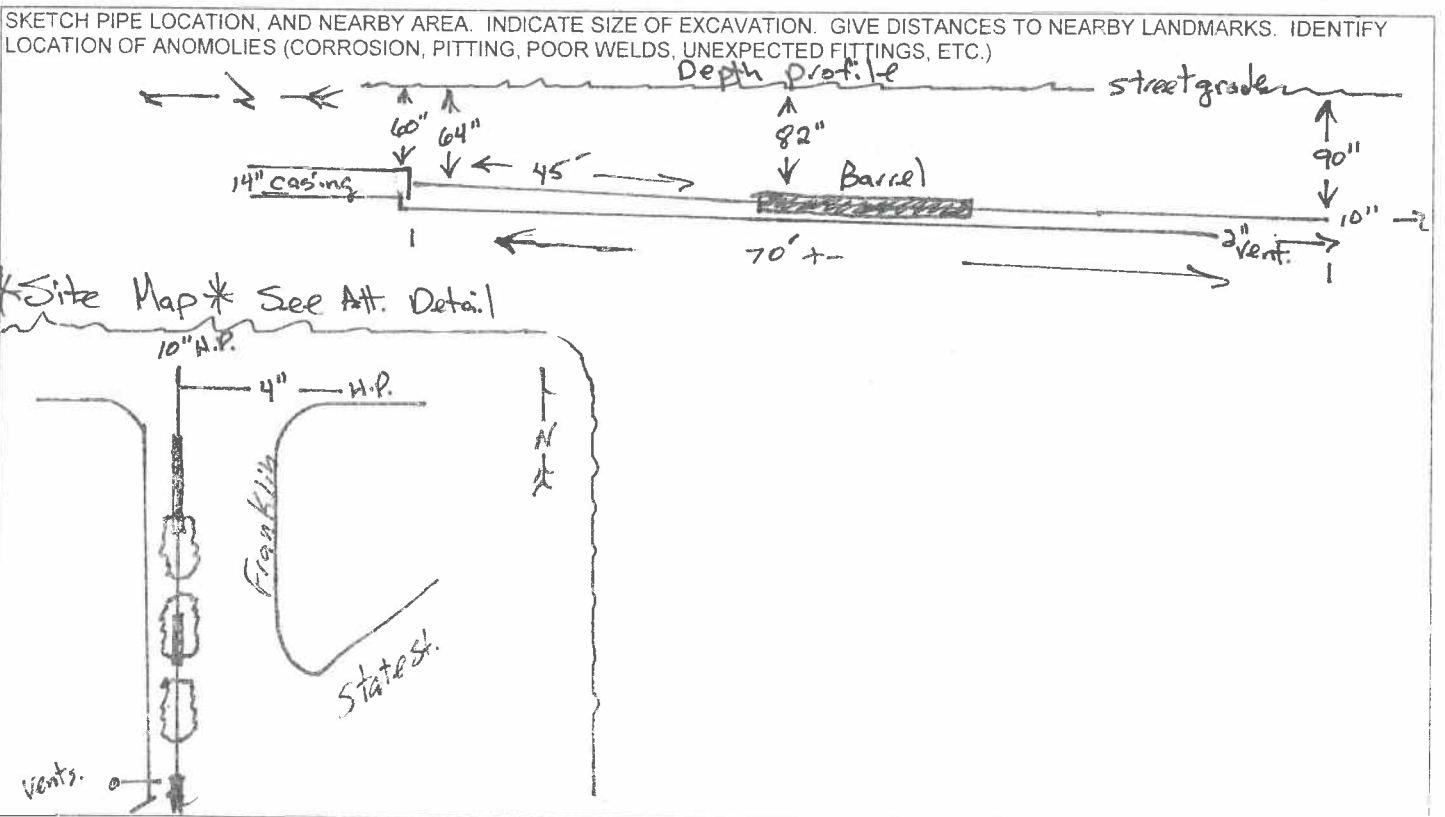
Franklin St. & State St., Bellingham repair documentation

Dug 3 sections of 10" H.P. line as noted on attached map. Purpose of Dig was to investigate possible leaking barrel and prior work @ casing ends. On 9/8 Dug to look for N. end of casing crossing State St. Did not find end. Wrapped pipe where exposed. Did find vent pipe pressed against 10" line. 9/9 Dug S. end of casing from Kansas st. found end shorted to Main w/ no seals. 9/10 Dug @ suspected barrel location. Found Plate style ends on barrel + fitting on barrel leaking. Backfilled pending engineering.

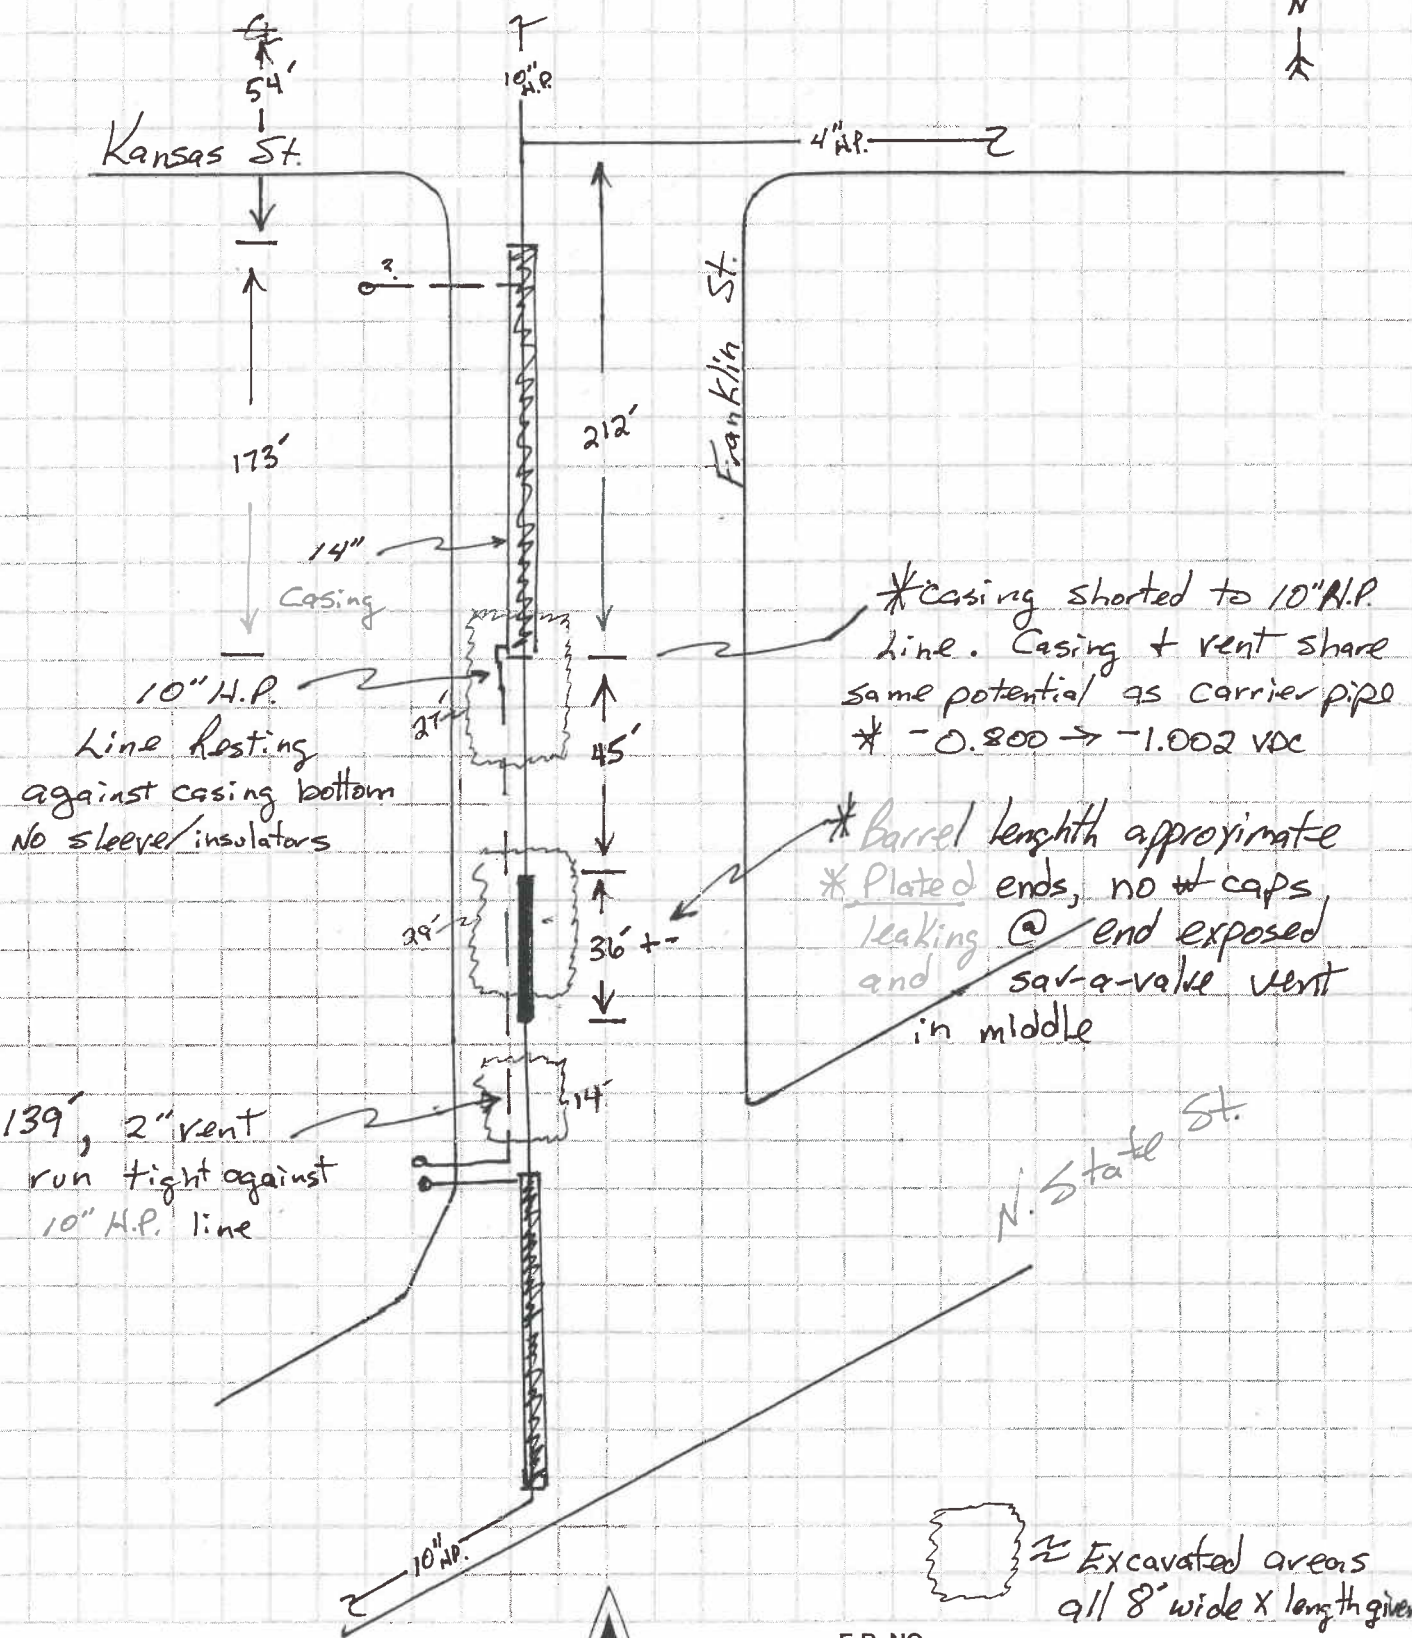
9/8-710/09 10" H.P. Leak investigation Dig Map Detail

We found that we have several casings in this 450 ft. stretch of 10" HP pipe that is part of the #2 HP Bellingham Distribution Line. In the 3 areas that we opened up, we found an unsealed end of casing, also an extremely long casing vent pipe that was packed tightly right along the side of the carrier pipe causing a short, and an unrecorded 14" barrel estimated to be approximately 36 ft. long, that had been plated on the ends. The end that we had exposed was leaking, as was the save a valve nipple in the middle. At 20 ft. we opted to button things up, versus excavating out more pavement to expose the other end, but would expect that there are problems there as well.

*Casing shorted to 10" H.P. line. Casing + vent share same potential as carrier pipe
* -0.800 → -1.002 VDC

* Barrel length approximate
* Plated ends, no caps, leaking @ end exposed and sav-a-valve vent in middle

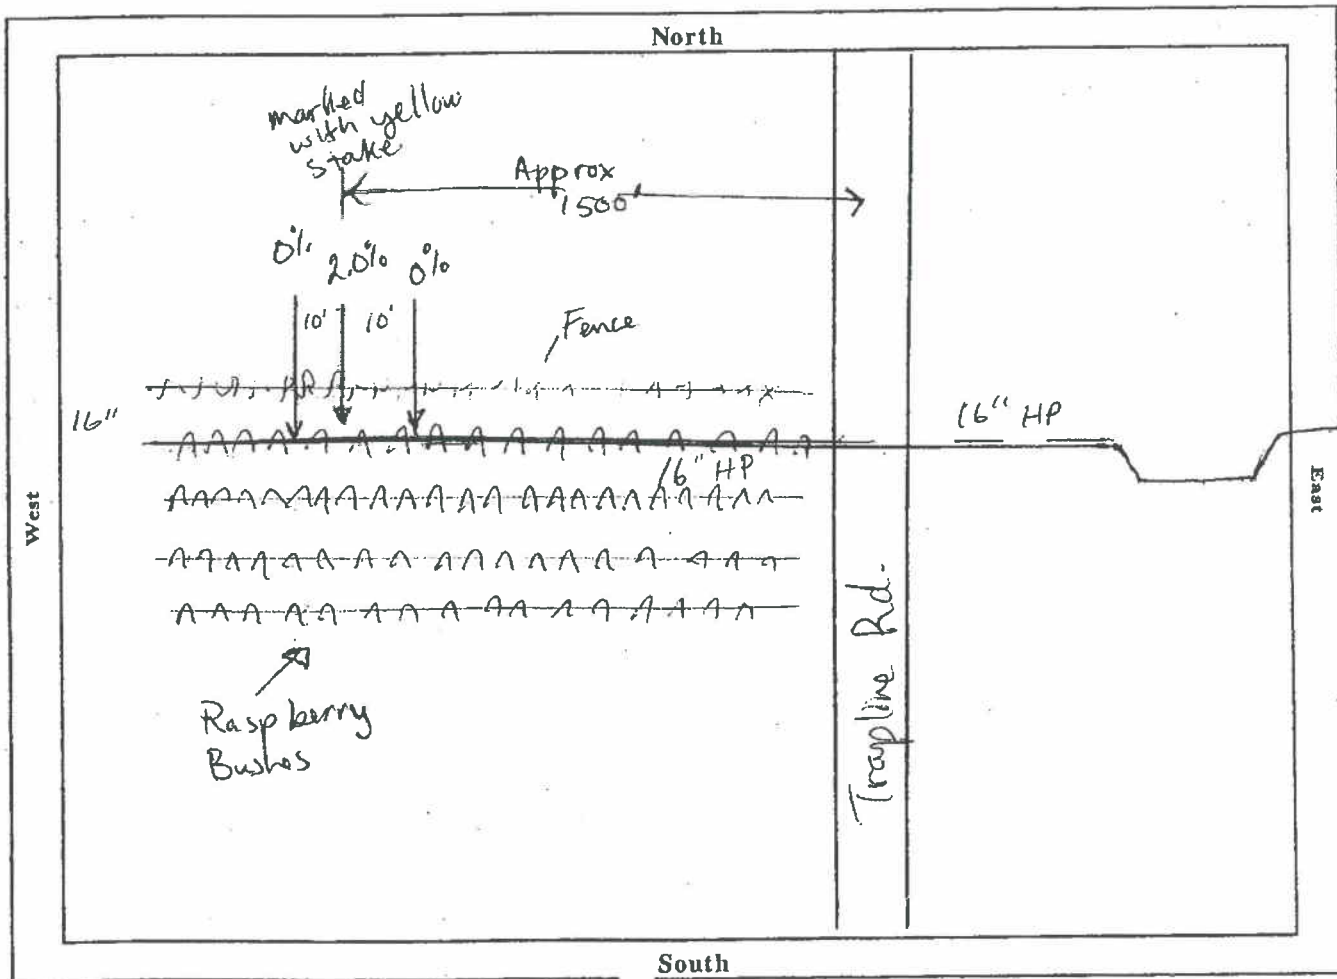
1-21-10 CURRENTLY NOT CONDUSIVE WEATHER WISE TO TACKLE - WILL DEFER 9 ADVISKO DAWKO @ DIVISION - MONITOR UNTIL BETTER WEATHER SPRING/SUMMER & SCHEDULE REPAIR. RK

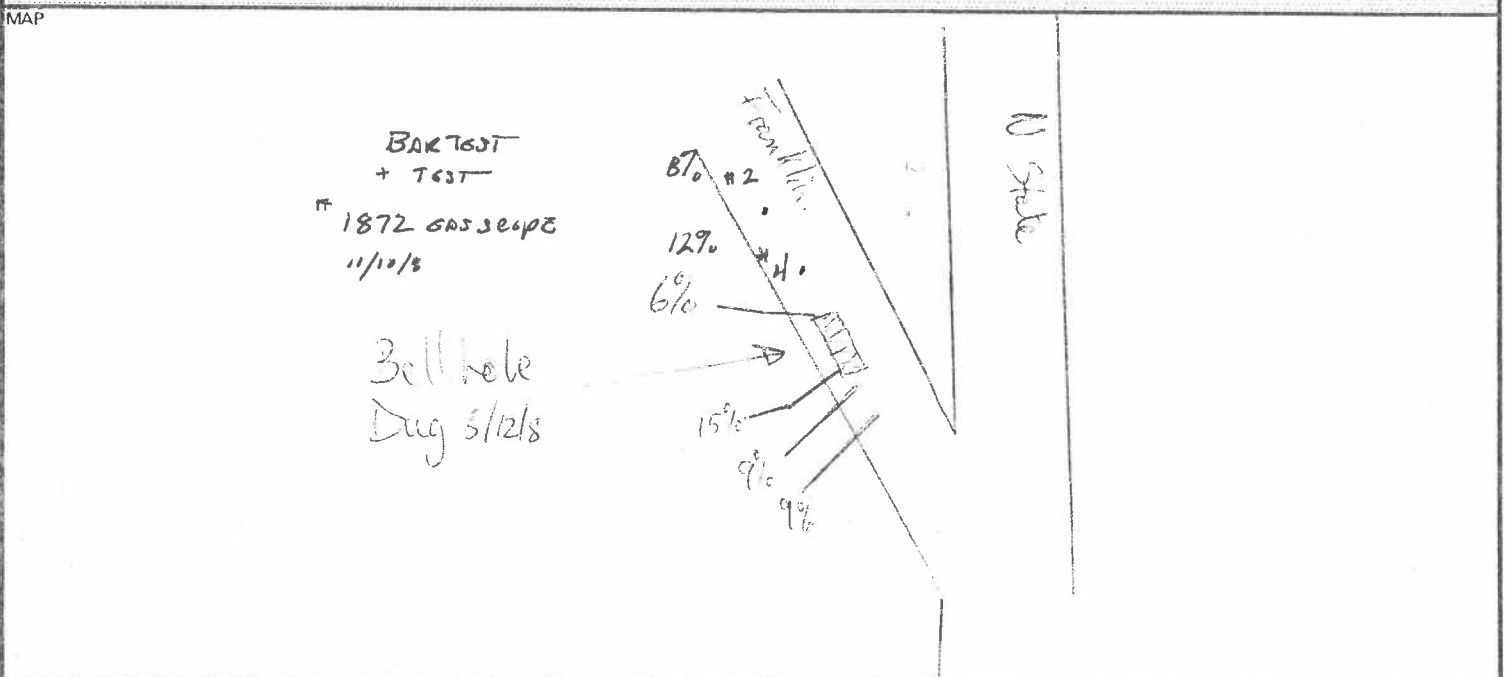
BARRED OUT TEST HOLES, TOOK READS IN AM AND 3:00 PM, FOUND 87% W TEST HOLE #2 18' NORTH OF NEW PATCH. FOUND 12% W #4, 6' NORTH OF NEW PATCH. NO READS SOUTH OF NEW PATCH TOWARDS N STATE ST.
