**RE: 2008 Standard Inspection of Pierce County Distribution System,
Docket PG-080031**

This letter is in response to the "2008 Standard Inspection of Pierce County Distribution System" report dated December 23, 2008. In this report Staff identified 11 probable violations and two areas of concern. Below are PSE's responses to these findings.

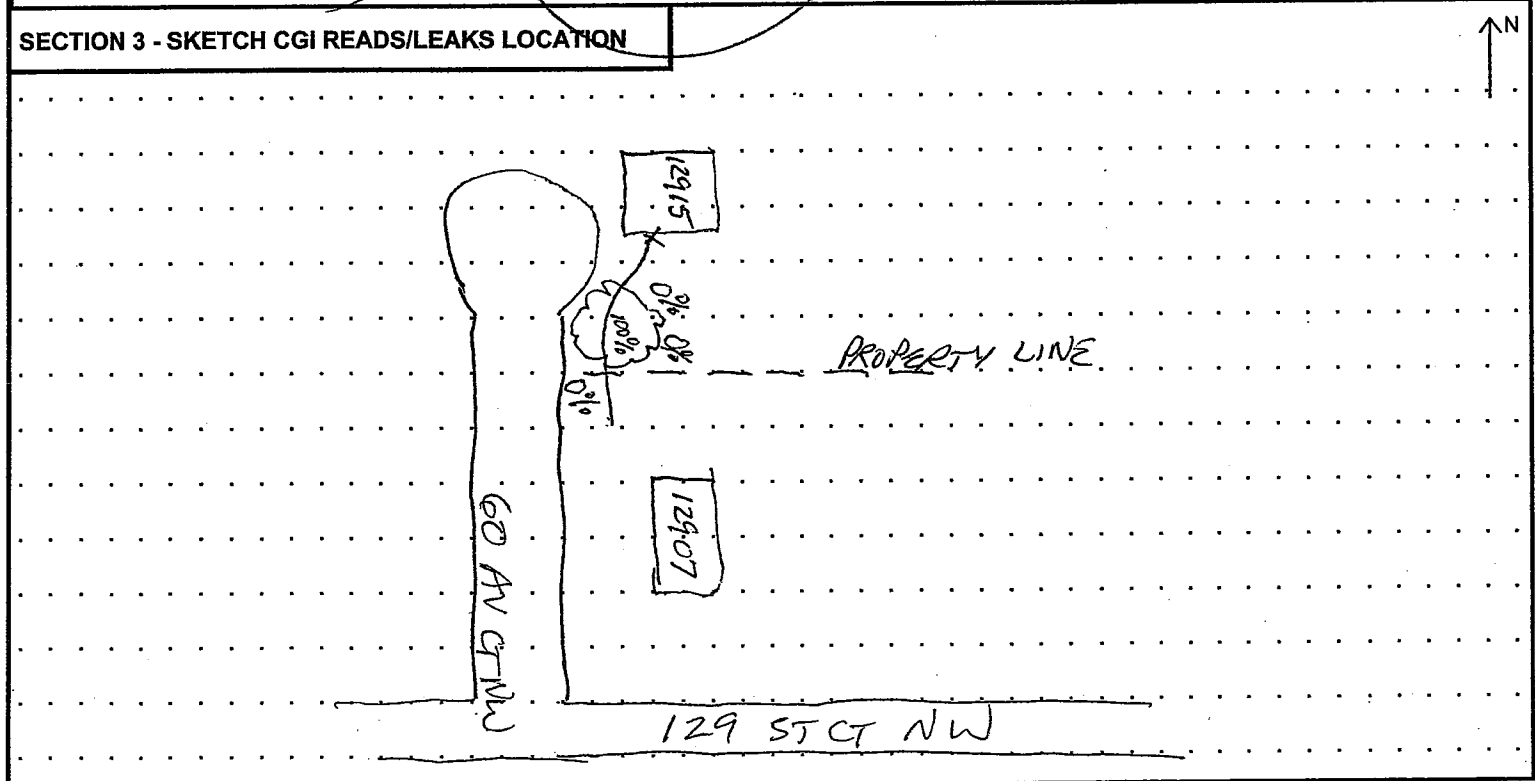
SECTION 1 - PROJECT DATA		PROJECT ID #0025250 <i>00101</i>	COMPLETE ON OR BEFORE	PLAT MAP 223-042
HOUSE 12915 60 AV CT NW	1/2 STREET GIG HARBOR	AREA		
INSTRUCTIONS				
LEAK HISTORY C.P. AREA: <input type="checkbox"/> YES <input type="checkbox"/> NO ORIG GRD _____ LK ORIG _____ METH DET _____ PRESS _____ RPT SOURCE _____ MAIN _____ SVC _____ BUS DIST? _____ U/P? _____ ORIG RPT DATE _____				
LOC/CGI READS

SECTION 2 - FIELD RESPONSE AND REPAIR DATA			FINAL REPAIR ONLY	
FIELD RESPONSE	GRADE FOUND A	GRADE LEFT 0	PIPE MATERIAL P	SIZE 58
RESPONSE TYPE L	RESPONSE COMPANY PSE	FACILITY TYPE E	YR INST	
RESPONDER NAME Chuck Mulholland Roy Mcomber	EQUIPMENT ID NUMBER 4829	BELOW GRADE <input checked="" type="checkbox"/> YES <input type="checkbox"/> NO	CP READS PSP	
ARRIVED DATE 3/2/07	ARRIVED TIME 17:05	LEAK COMPONENT A	CAUSE B	
FINISHED DATE 3/2/07	FINISHED TIME 8:40	RE-CHECK? <input type="checkbox"/> YES <input checked="" type="checkbox"/> NO	DATE 1 1	
REPAIR TYPE 0	QUANTITY	FOLLOW-UP? <input type="checkbox"/> YES <input checked="" type="checkbox"/> NO	DATE 1 1	
PRESSURE TEST BY	DATE	HRS	MIN	PRESSURE

LOC/CGI READS
 100% GAS IN HOLE OVER SERVICE THAT WAS NICKED WITH A SHOVEL
 25' EAST OF CENTER LINE OF 60 AV CT NW AND 15' NORTH OF PROPERTY LINE OF 12907 60 AV CT NW
 IN THE GARDEN AREA OF YARD - NO SPREAD

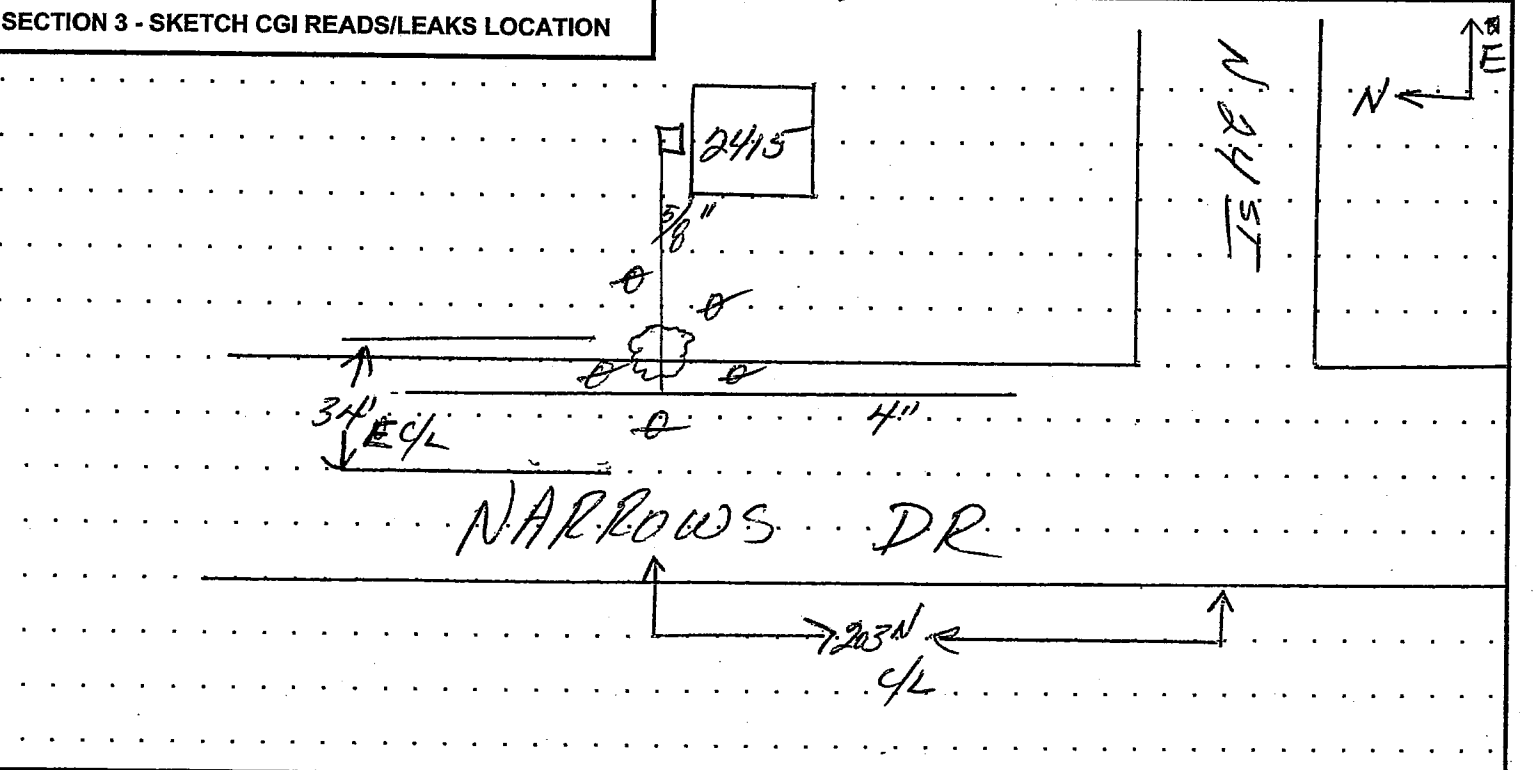
SECTION 1 - PROJECT DATA		PROJECT ID N0025673	COMPLETE ON OR BEFORE 4/30/07	PLAT MAP 238.051
HOUSE 2415	1/2 STREET NARROWS DR.			AREA TAC
INSTRUCTIONS				
LEAK HISTORY C.P. AREA: <input type="checkbox"/> YES <input checked="" type="checkbox"/> NO ORIG GRD <u>A</u> LK ORIG <u>B</u> METH DET <u>B/A</u> PRESS <u> </u> RPT SOURCE <u>W</u> MAIN <u> </u> SVC <u>X</u> BUS DIST? <u>N</u> U/P? <u> </u> ORIG RPT DATE <u>4/30/07</u>				
LOC/CGI READS

SECTION 2 - FIELD RESPONSE AND REPAIR DATA				FINAL REPAIR ONLY	
FIELD RESPONSE	GRADE FOUND A	GRADE LEFT 0	PIPE MATERIAL PE	SIZE 5/8	
RESPONSE TYPE R	RESPONSE COMPANY PSE		FACILITY TYPE SVC	YR INST 1975

RESPONSE NAME F. MILLER	EQUIPMENT ID NUMBER 5413		BELOW GRADE <input checked="" type="checkbox"/> YES <input type="checkbox"/> NO	CP READS PSP	
ARRIVED DATE 04/30/07	ARRIVED TIME 11:10		LEAK COMPONENT A	CAUSE B	
FINISHED DATE 04/30/07	FINISHED TIME 13:10		RE-CHECK? <input type="checkbox"/> YES <input checked="" type="checkbox"/> NO	DATE 04/30/07	
REPAIR TYPE D	QUANTITY 1		FOLLOW-UP? <input type="checkbox"/> YES <input checked="" type="checkbox"/> NO	DATE 04/30/07	
PRESSURE TEST BY	DATE	HRS	MIN	PRESSURE	AIR <input type="checkbox"/> GAS <input type="checkbox"/> WATER <input type="checkbox"/> NITROGEN <input type="checkbox"/> SOAP
LOC/CGI READS LEFT REPLACED 4' 5/8 PE @ 203' N & 34' E & (N2435) (NARROWS DR.)

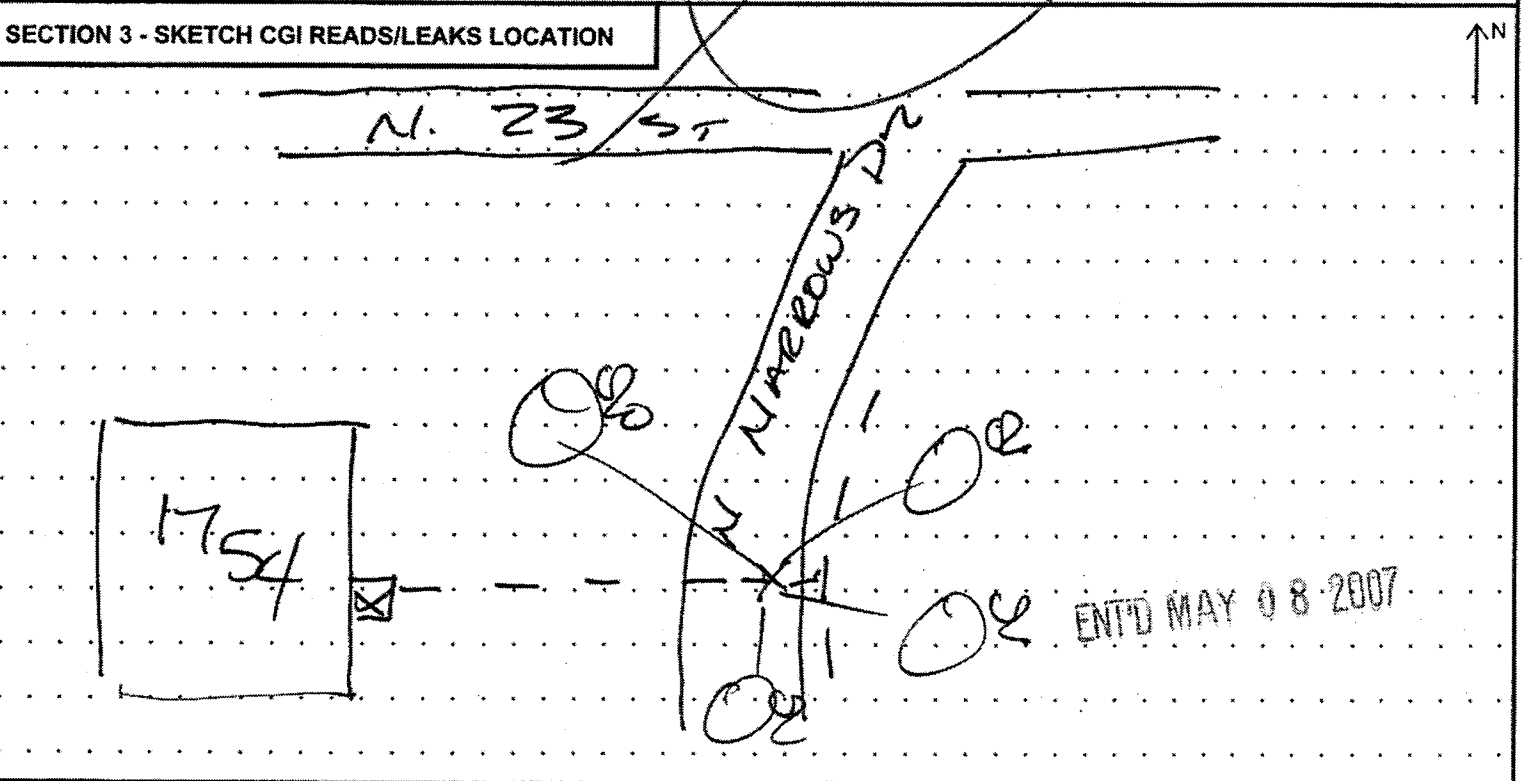
SECTION 1 - PROJECT DATA	PROJECT ID N0025962-001	COMPLETE ON OR BEFORE 05-03-07	PLAT MAP 238-051
HOUSE 1754 N. Narrows Dr.	1/2 STREET	AREA 315	
INSTRUCTIONS			
LEAK HISTORY C.P. AREA: <input type="checkbox"/> YES <input type="checkbox"/> NO ORIG GRD _____ LK ORIG _____ METH DET _____ PRESS _____ RPT SOURCE _____ MAIN _____ SVC _____ BUS DIST? _____ U/P? _____ ORIG RPT DATE _____			
LOC/CGI READS Broken svc

SECTION 2 - FIELD RESPONSE AND REPAIR DATA				FINAL REPAIR ONLY			
FIELD RESPONSE	GRADE FOUND A	GRADE LEFT 0	PIPE MATERIAL P	SIZE 58			
RESPONSE TYPE R	RESPONSE COMPANY PSE		FACILITY TYPE E	YR INST 1979			
RESPONDER NAME W. Marshall	EQUIPMENT ID NUMBER 3759		BELOW GRADE <input checked="" type="checkbox"/> YES <input type="checkbox"/> NO	CP READS PSP			
ARRIVED DATE 05/03/07	ARRIVED TIME 15:14		LEAK COMPONENT A	CAUSE B			
FINISHED DATE 05/03/07	FINISHED TIME 15:59		RE-CHECK? <input type="checkbox"/> YES <input checked="" type="checkbox"/> NO	DATE 1 1			
REPAIR TYPE D	QUANTITY		FOLLOW-UP? <input type="checkbox"/> YES <input checked="" type="checkbox"/> NO	DATE 1 1			
PRESSURE TEST BY	DATE	HRS	MIN	PRESSURE	<input type="checkbox"/> AIR <input type="checkbox"/> GAS <input type="checkbox"/> WATER <input type="checkbox"/> NITROGEN <input type="checkbox"/> SOAP

LOC/CGI READS
0 READS REMAIN. REPLACED 1' of 5/8" PE @ 551' S E of N 23 ST & 14' E of 1754 N. Narrows Dr.
