**ATTACHMENT "B"**

**PSE's February 6, 2015, Comments in Docket No U-140621**

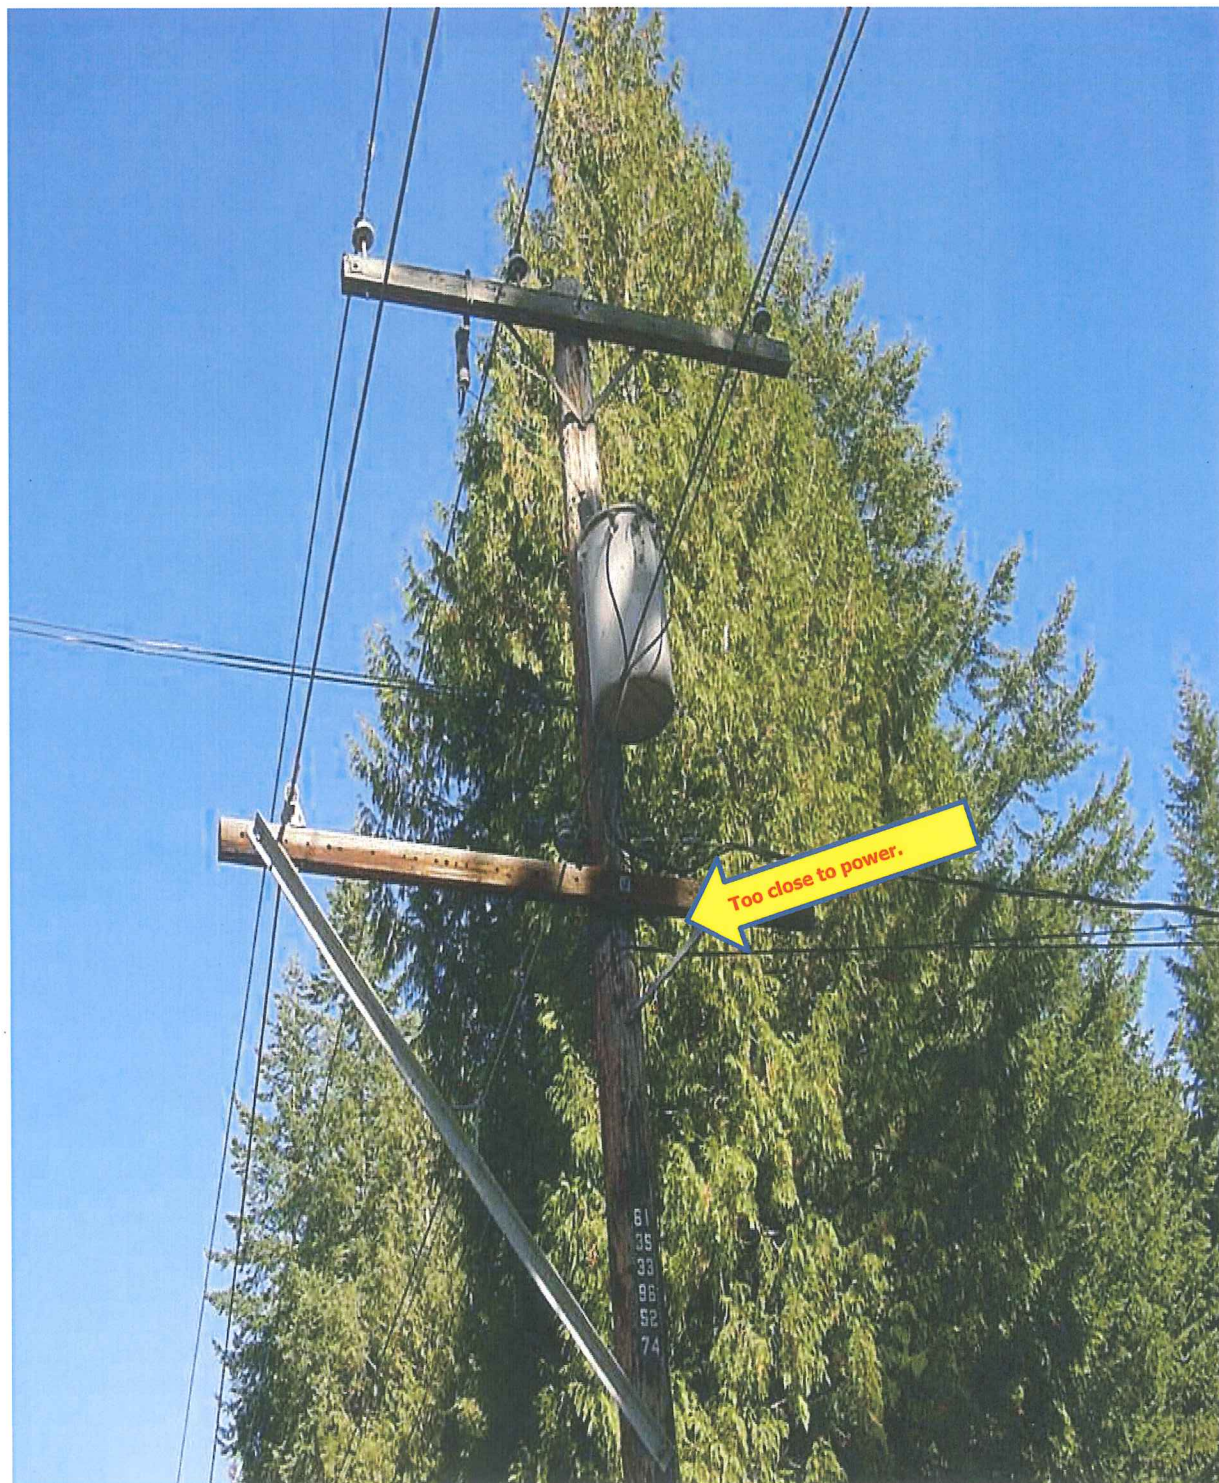
Both communications are too close to power. Lowest power is the bottom of the drip loop. Overlashing had occurred one week prior to this picture being taken.

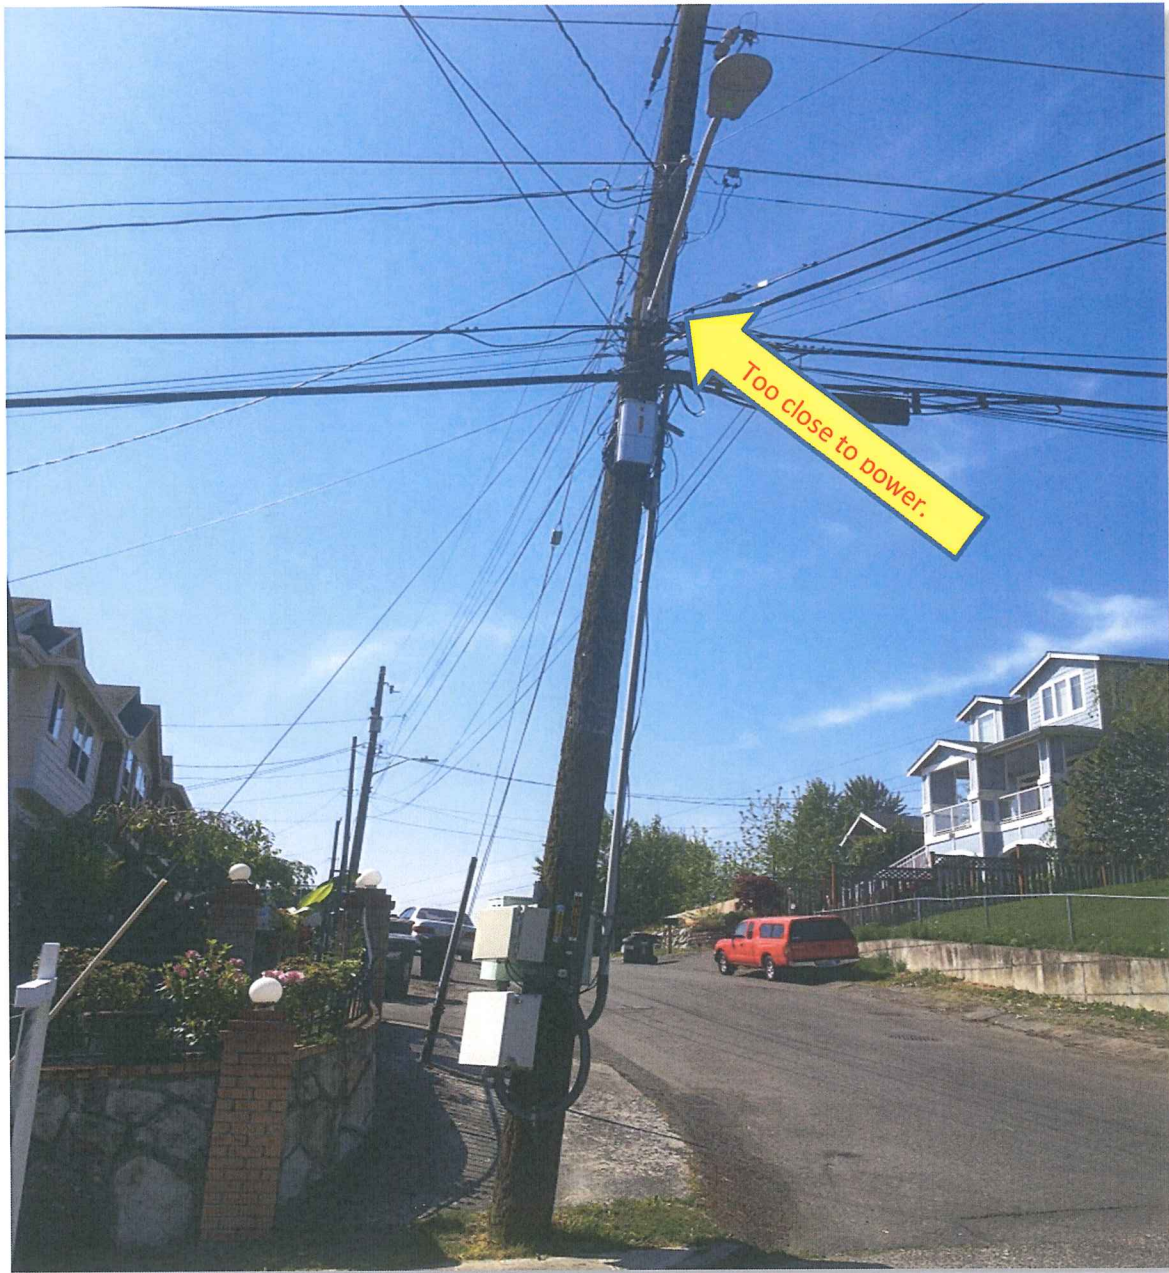
Too close to power. Incorrect build/install.
