**BEFORE THE  
WASHINGTON UTILITIES AND TRANSPORTATION COMMISSION**

**THIRD EXHIBIT TO THE PREFILED DIRECT TESTIMONY OF  
JAMES HOGAN (NONCONFIDENTIAL)  
ON BEHALF OF PUGET SOUND ENERGY, INC.**

**PUGET SOUND ENERGY  
PIPE SEGMENT INTEGRITY STUDY  
IN THE VICINTIY OF THE VASA PARK RECTIFIER**

**June 21, 2005**

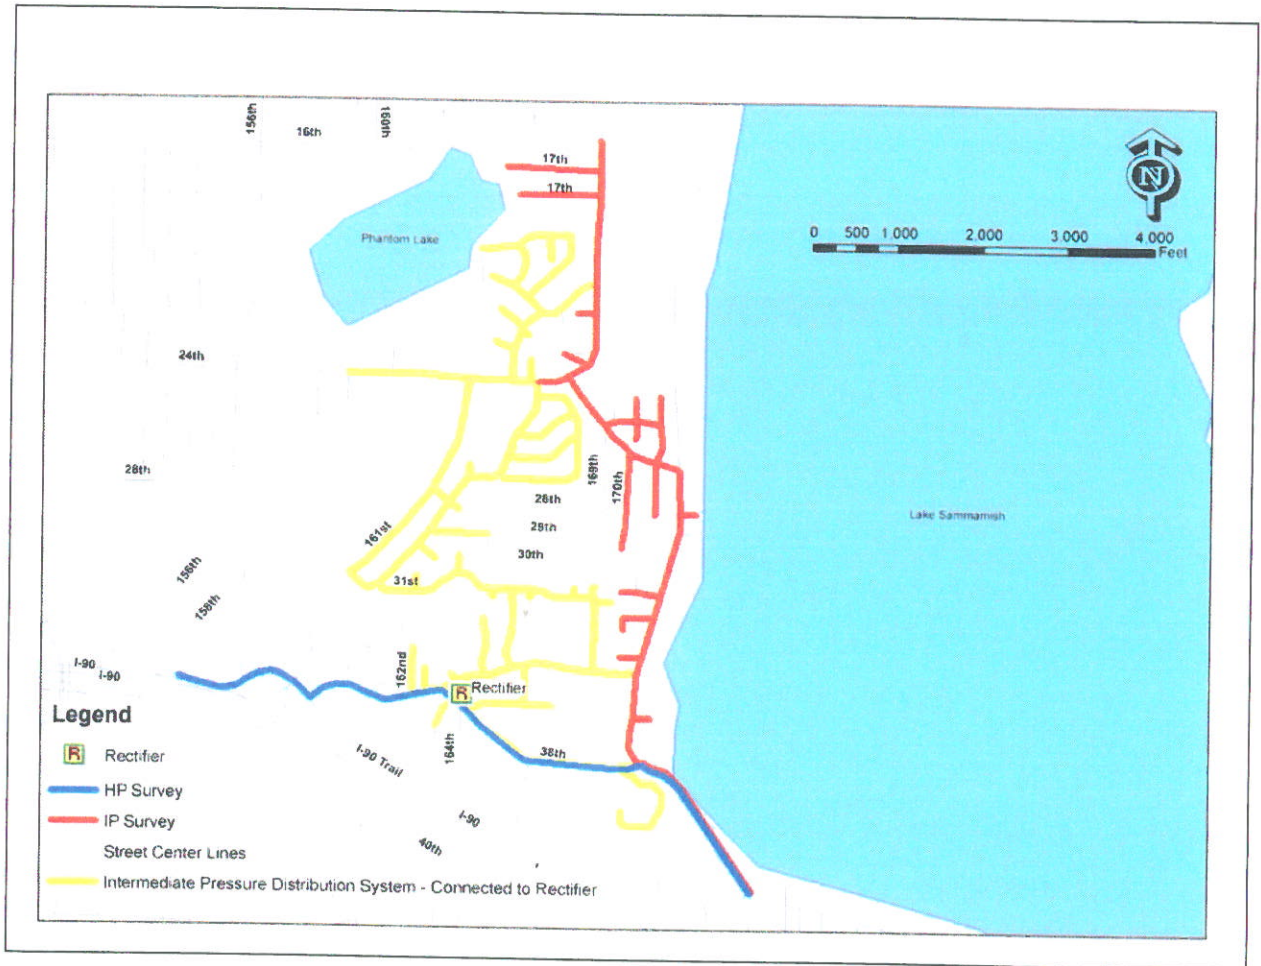
Figure 1 Site Plan – Survey Area

**Area Surveyed** Six thousand feet of high pressure main, 9,000 feet of intermediate pressure main and 140 services were investigated in this study. The field work began in March and ended in May 2005.

The pipe is shown in *Appendix A, Figure 1*.

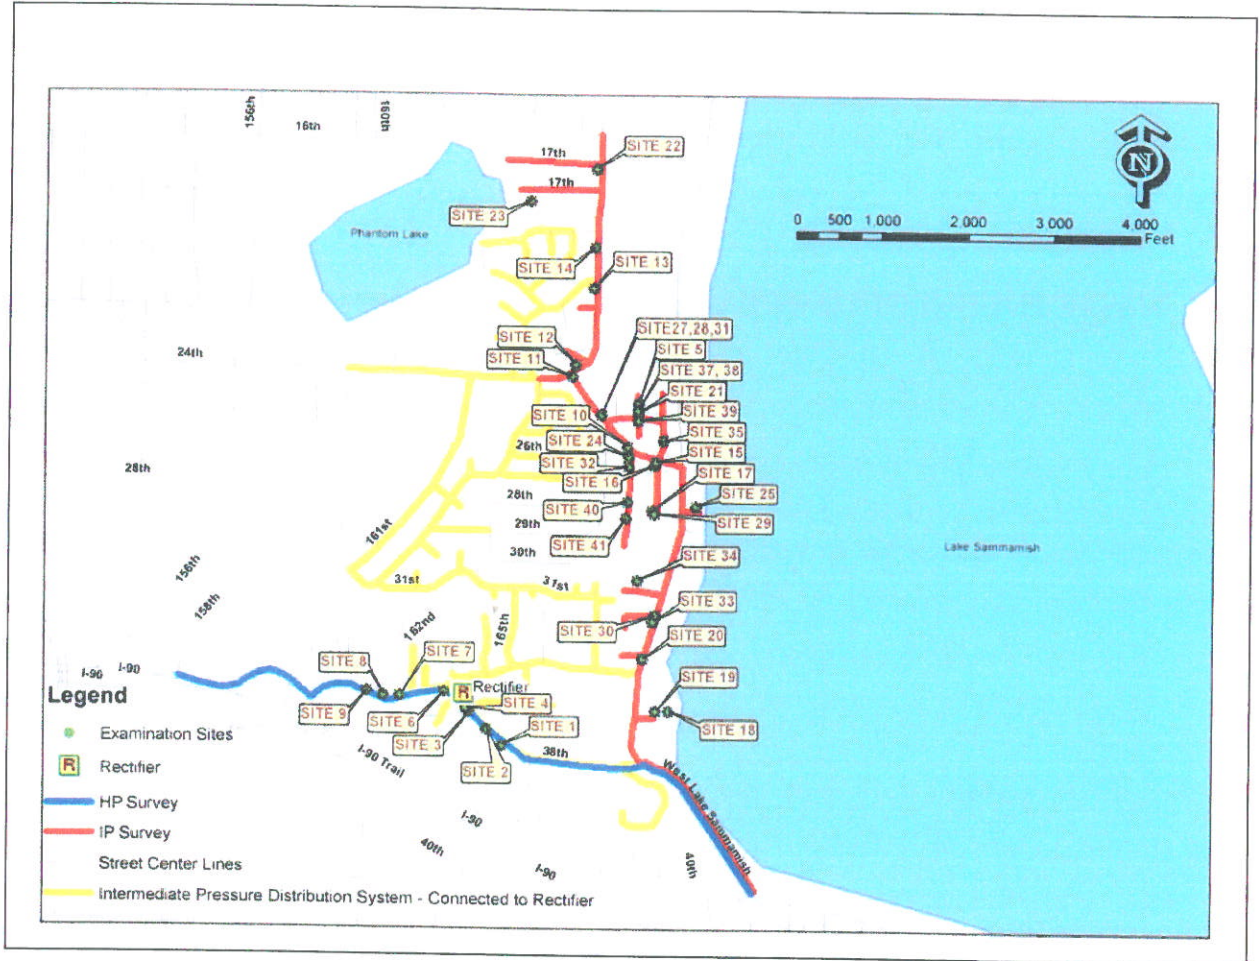
Figure 2 Examination Sites

Forty sites were selected for excavation based on coating or pipe potential indications warranting further examination, including the twelve confirmatory examinations. A confirmation excavation at one of the sites was relocated due to landscape conflicts, resulting in forty-one entries listed in *Appendix B, Table 1*, List of Examination Sites. Seven of the entries were not examined, five after reevaluating the data, one was a duplicate entry and another was a service which was replaced. The site locations are shown in *Appendix A, Figure 2*, Examination Sites.
