**SECOND EXHIBIT TO THE PREFILED DIRECT TESTIMONY OF
KEVIN C. GARRITY (NONCONFIDENTIAL)
ON BEHALF OF PUGET SOUND ENERGY, INC.**

FINAL REPORT

**LABORATORY-BASED EVALUATION OF FAILED SERVICE LINE
BELLEVUE, WASHINGTON**

PREPARED BY
CC TECHNOLOGIES LABORATORIES, INC.

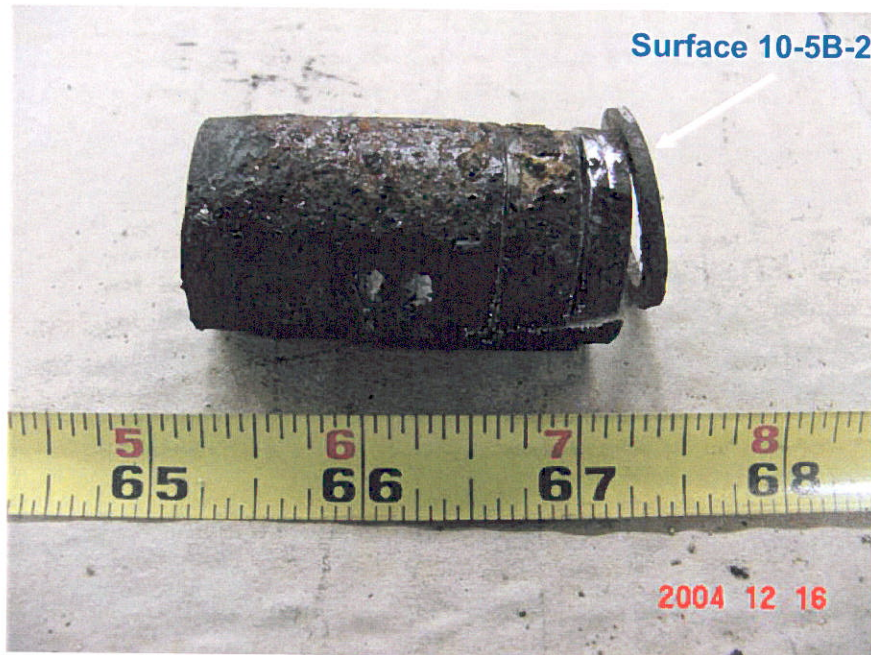
Figure 20. Segment 10 showing Surface 10-5B-2.

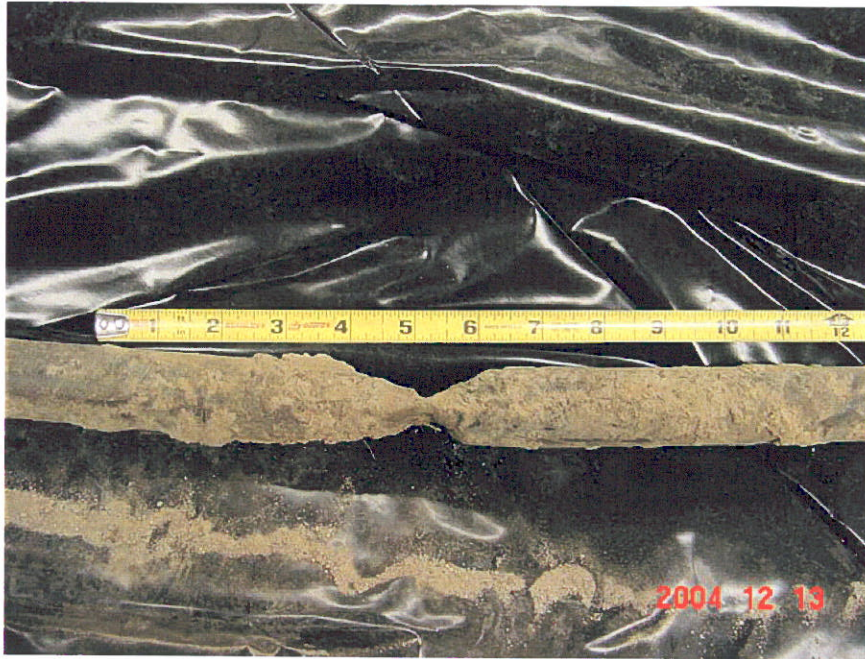
Figure 7. Photograph of unwrapped Segment 2 showing a crimp in the pipe located at 57.5-inches downstream from the end of the cut.

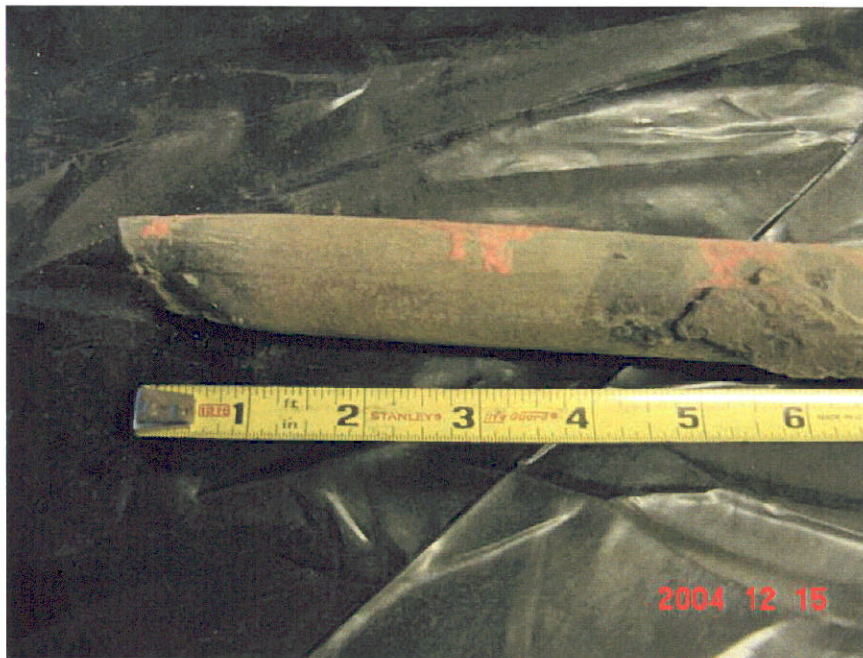
Figure 2. Photograph of Segment 2 showing a crimp at the 0-inch location of the pipe and an area of bare pipe from 0 to 8-inches.

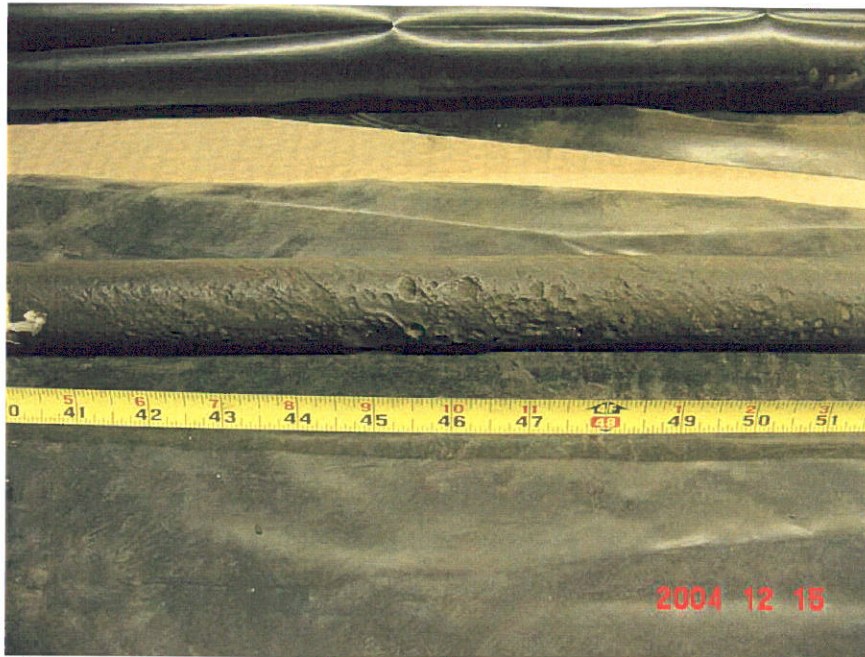
Figure 3. Photograph of Segment 2 showing deformations in the coating from the 40-inch mark to the 53-inch location.

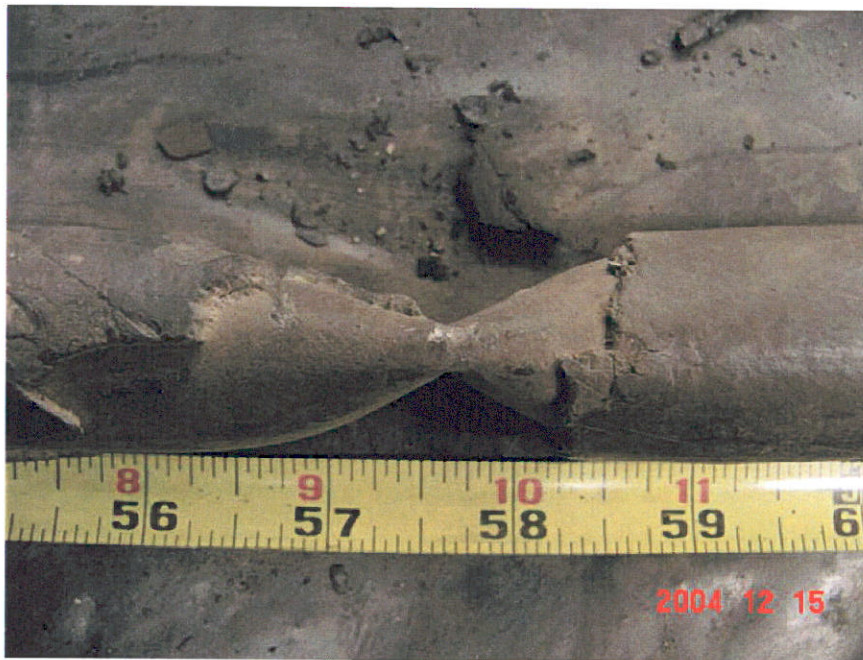
Figure 4. Photograph of Segment 2 showing a crimp in the pipe at the 57.5-inch location.

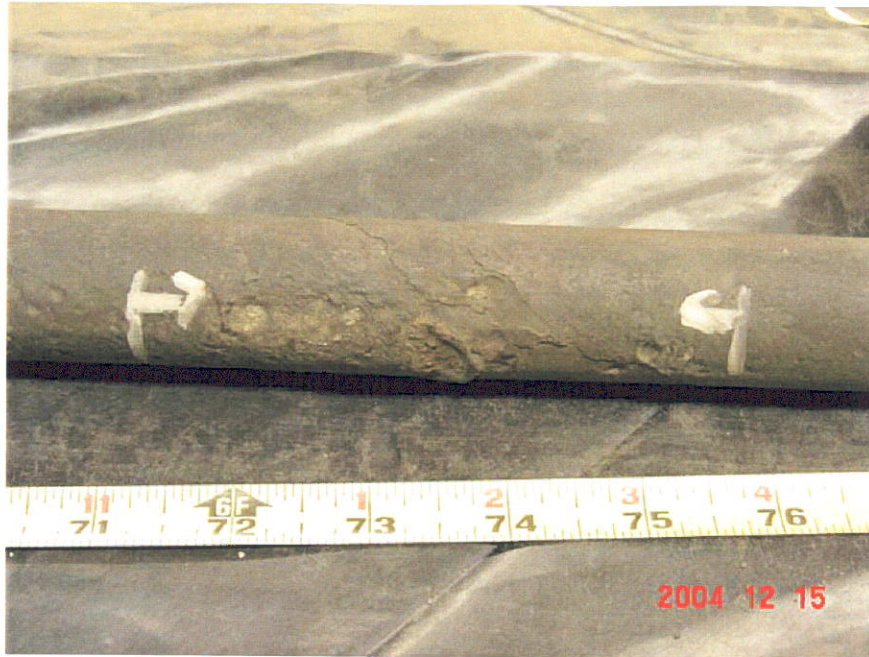
Figure 5. Photograph of Segment 2 showing scratches in the coating between the 71-inch and 75.5-inch locations with a dent in the coating at the 73.5-inch location.

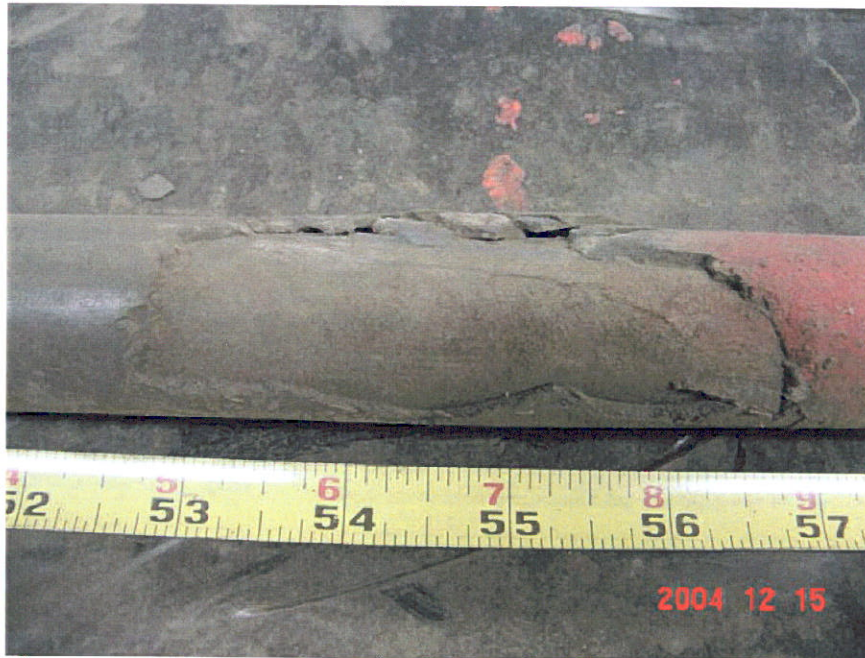
Figure 6. Photograph of Segment 3 showing an area of bare pipe located between the 52.5-inch and 57-inch locations.

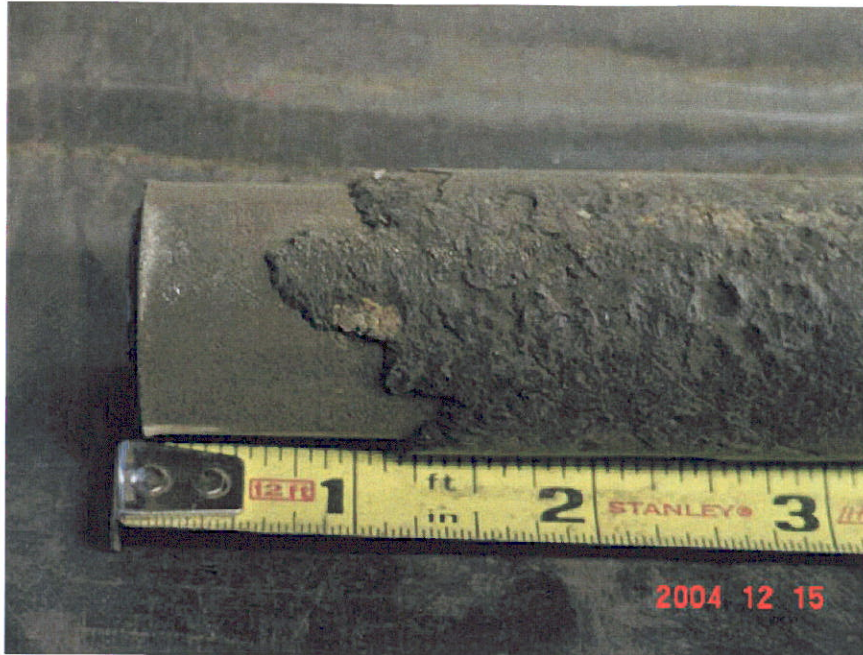
Figure 7. Photograph of Segment 4 showing an area of bare pipe between the 0-inch and 1.5-inch locations.

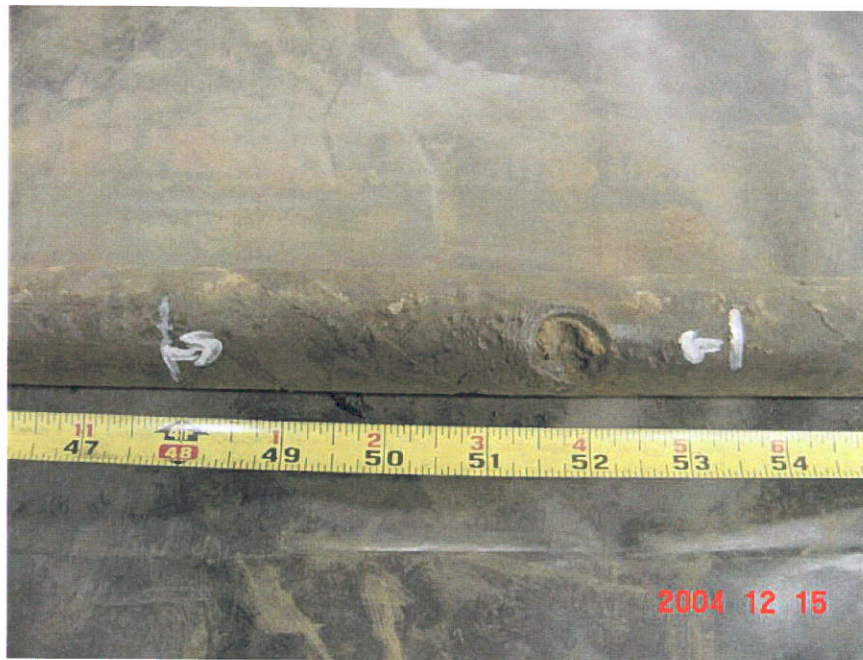
Figure 8. Photograph of Segment 4 showing a coating deformation at the 52-inch location.

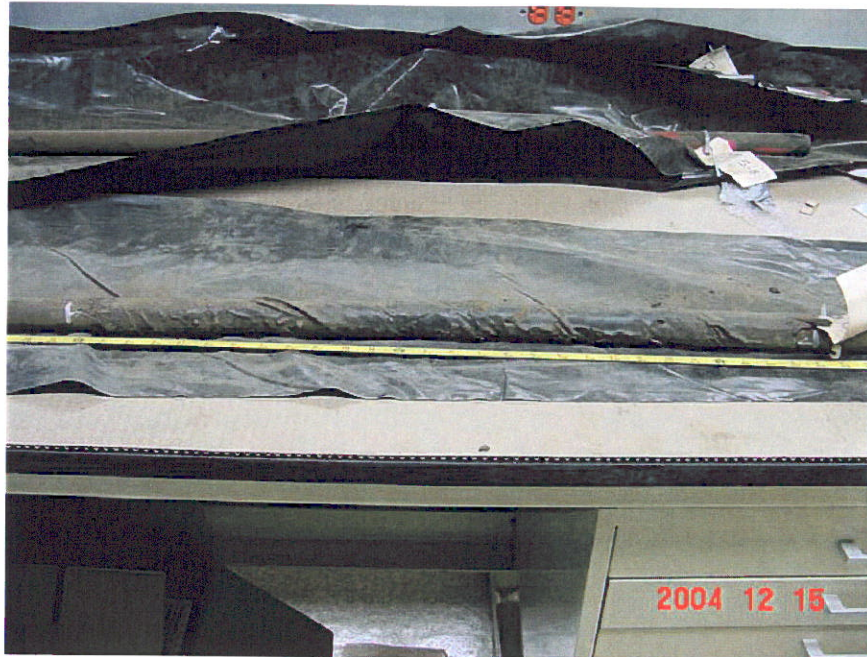
Figure 9. Photograph of Segment 4 showing a field applied outer wrap that covered the pipe between the 60.5-inch to 88-inch locations.

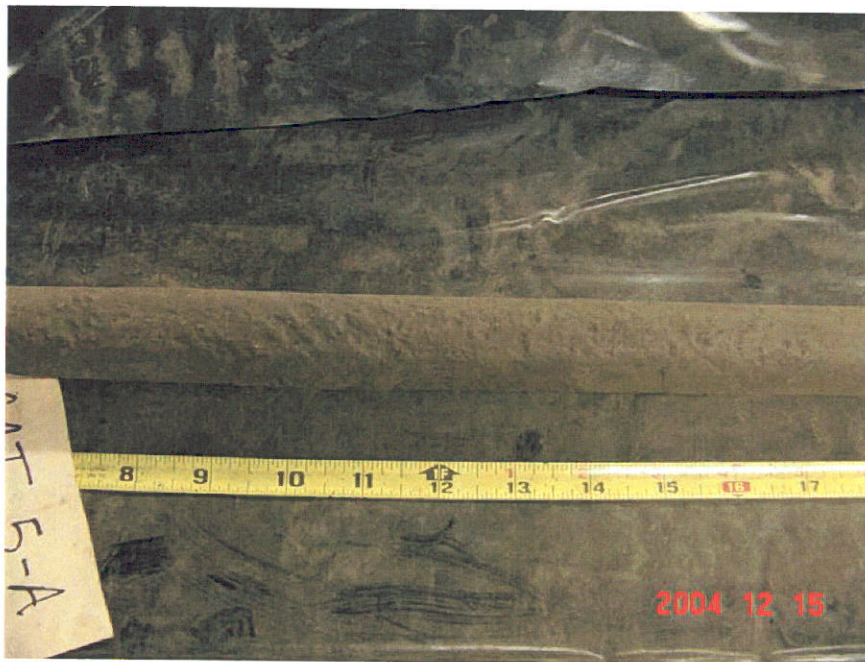
Figure 10. Photograph of Segment 5 showing an area with coating deformations that extended from the 5-inch location to the 19-inch location.

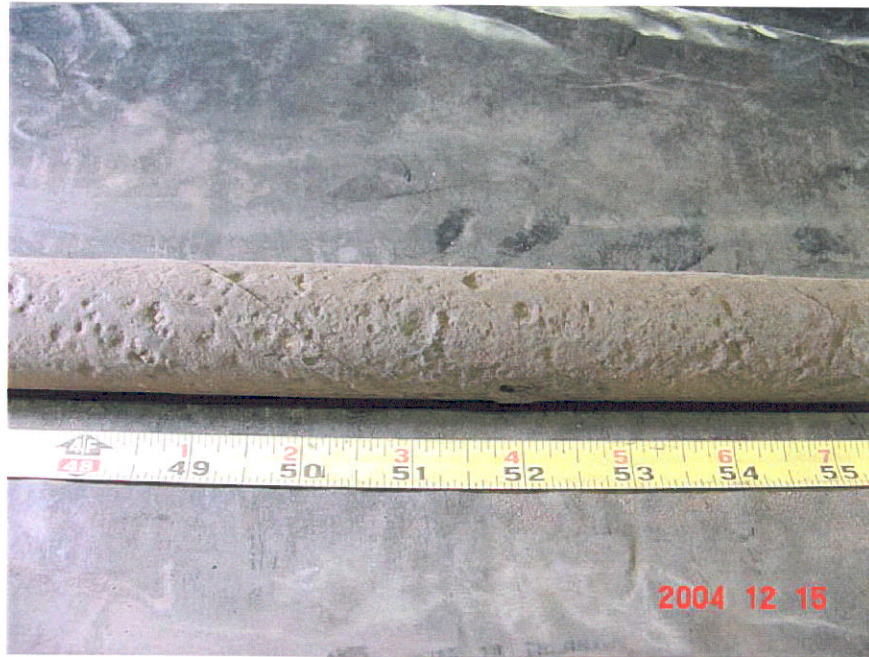
Figure 11. Photograph of Segment 5 showing an area of coating deformations that extended from the 45-inch location to the 62-inch location.

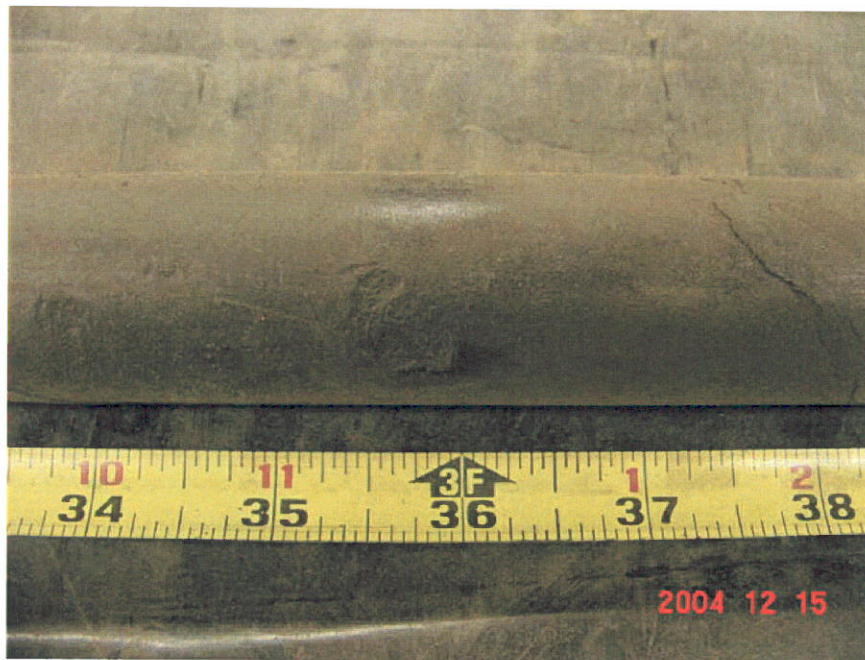
Figure 12. Photograph of Segment 6 showing a coating deformation at the 36-inch location.

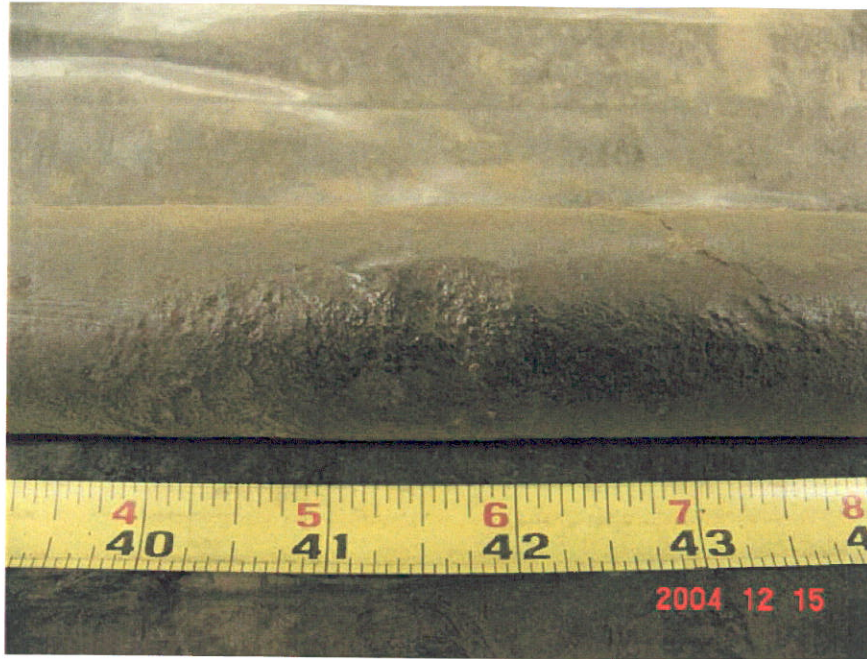
Figure 13. Photograph of Segment 6 showing a dent in the coating at the 41.5-inch location.

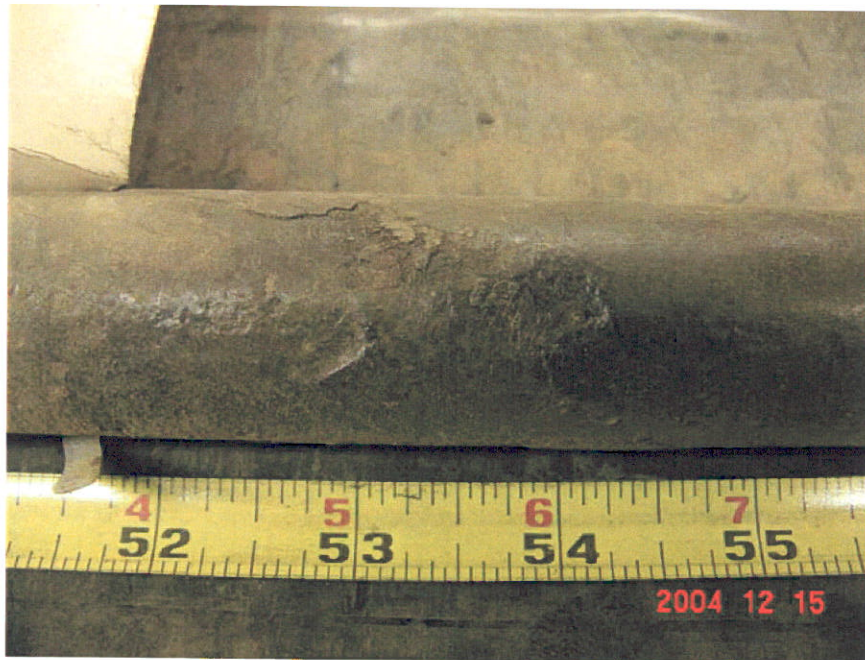
Figure 14. Photograph of Segment 6 showing a coating deformation at the 54-inch location.

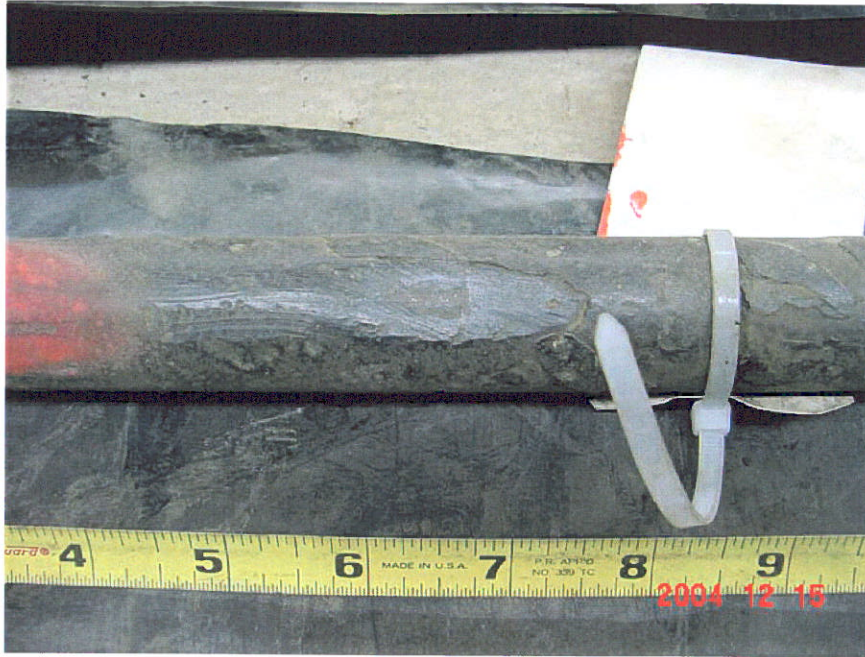
Figure 15. Photograph of Segment 7 showing a gouge in coating from the 6-inch location to the 7.5-inch location.

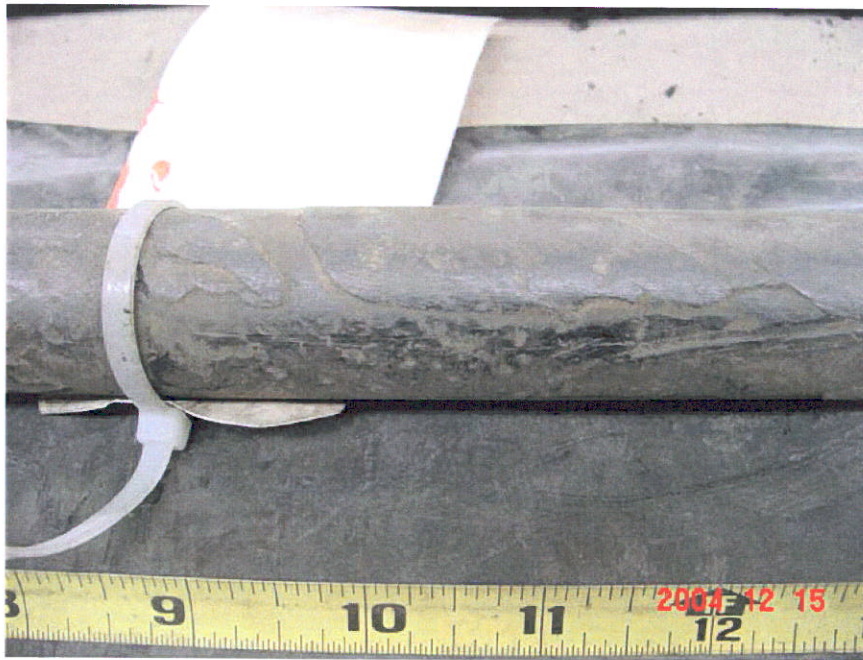
Figure 16.	Photograph of Segment 7 showing scratched coating from the 7-inch location to the 19-inch location.	37
Figure 17.	Photograph of Segment 7 showing a gouge in the coating from the 25-inch to 28-inch locations.	38
Figure 18.	Photograph of Segment 7 showing coating deformations and dents in the coating that extended between the 41.5-inch to 55-inch locations.	38
Figure 19.	Photograph of Segment 7 showing a deformation in the coating at the 66-inch location.	39
Figure 20.	Photograph of Segment 8 showing a coating wrap located between the 6-inch to 29-inch location.	39
Figure 21.	Photograph of Segment 8 showing an area of coating deformations and dents in the coating located at the end of the coating wrap to the end of the pipe at the 88-inch location (Figure 22 and Figure 23 detail some of the features).	40
Figure 22.	Left side of the photograph in Figure 21 showing coating deformations to at the 43-inch, 45.75-inch, and 48-inch locations.	40

Figure 16. Photograph of Segment 7 showing scratched coating from the 7-inch location to the 19-inch location.

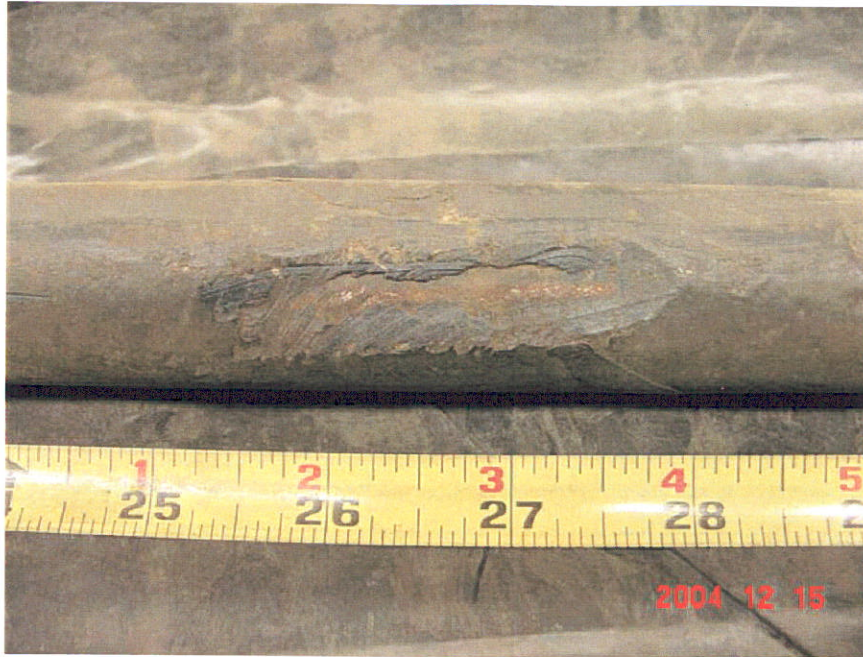
Figure 17. Photograph of Segment 7 showing a gouge in the coating from the 25-inch to 28-inch locations.

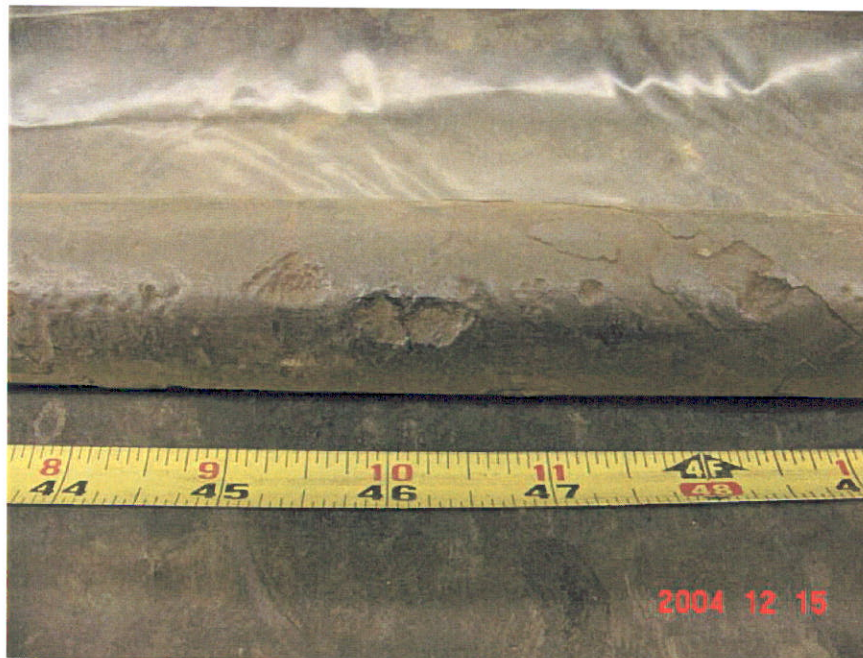
Figure 18. Photograph of Segment 7 showing coating deformations and dents in the coating that extended between the 41.5-inch to 55-inch locations.

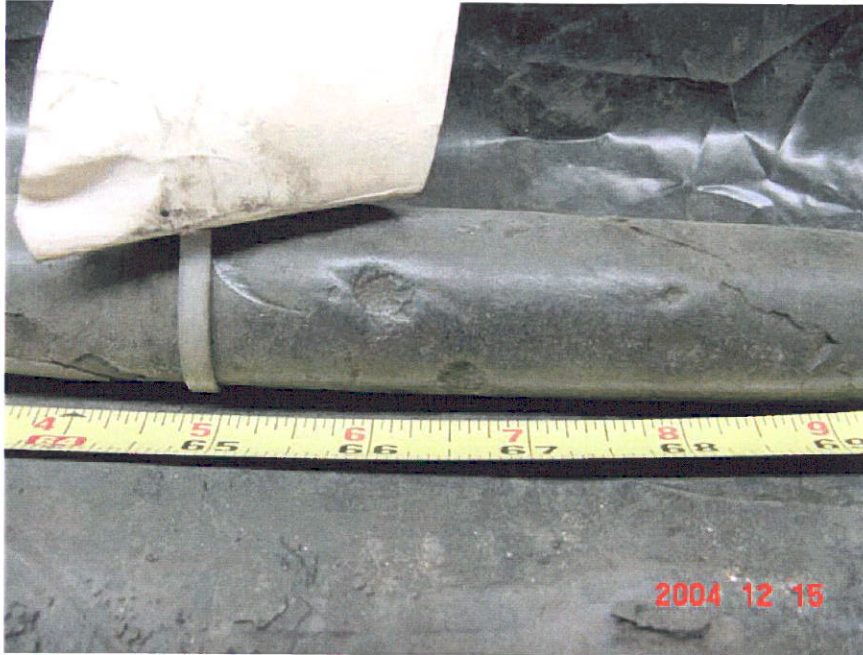
Figure 19. Photograph of Segment 7 showing a deformation in the coating at the 66-inch location.

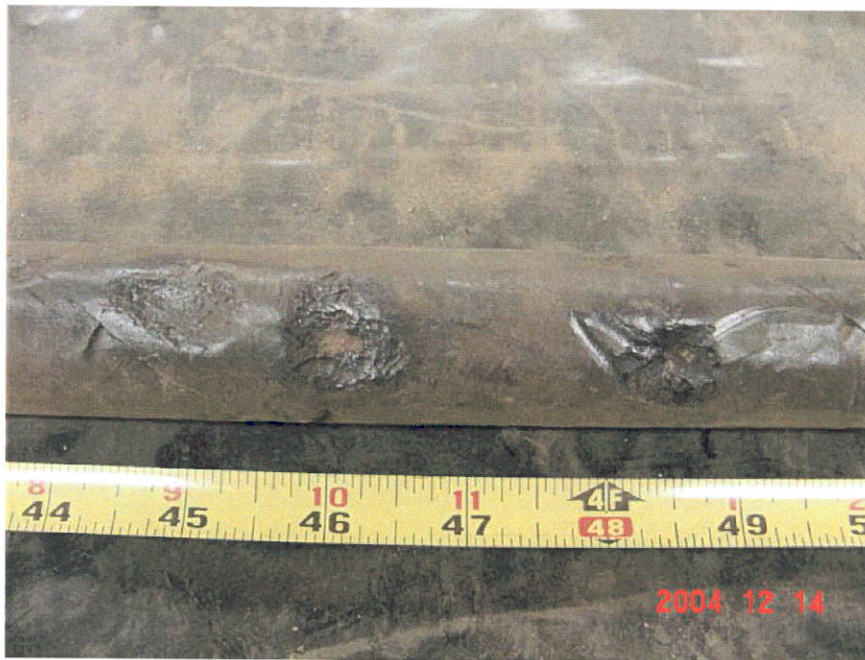
Figure 24. Photograph of Segment 8 showing two of the coating deformations to bare metal.

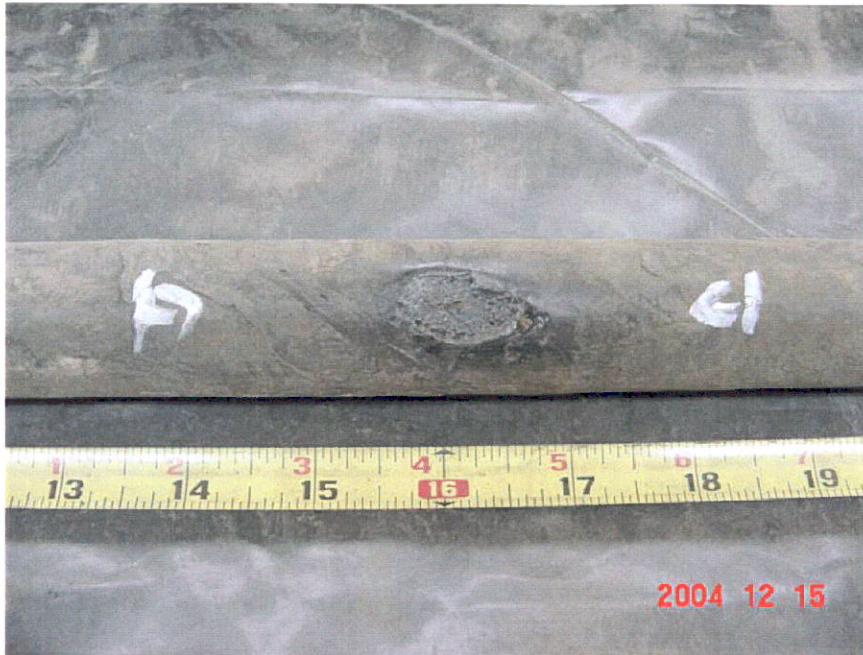
Figure 25. Photograph of Segment 9 showing a 1-inch deformation in the coating at the 16-inch location.

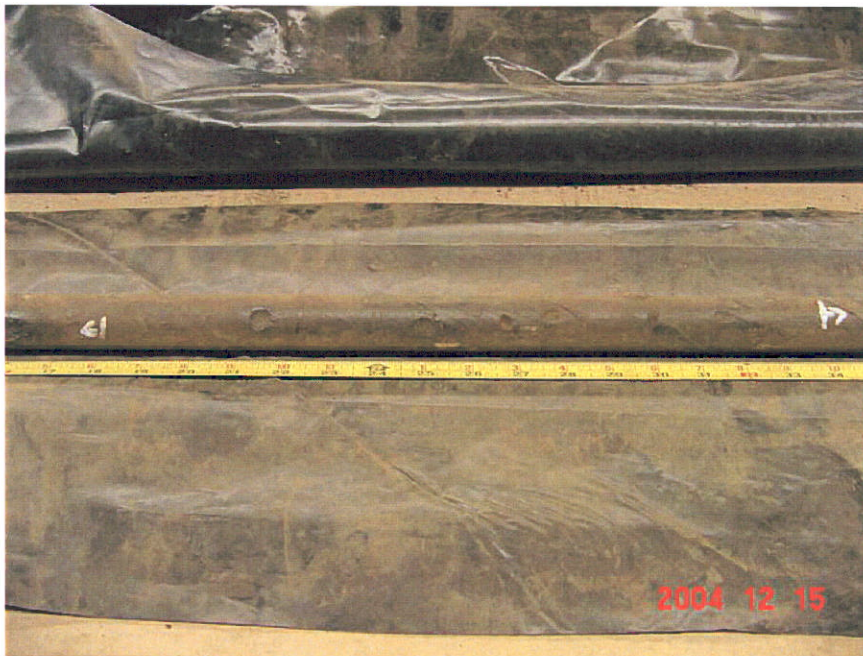
Figure 26. Photograph of Segment 9 showing an area of scratches and dents in the coating between the 21-Inch location and the 34-inch location.

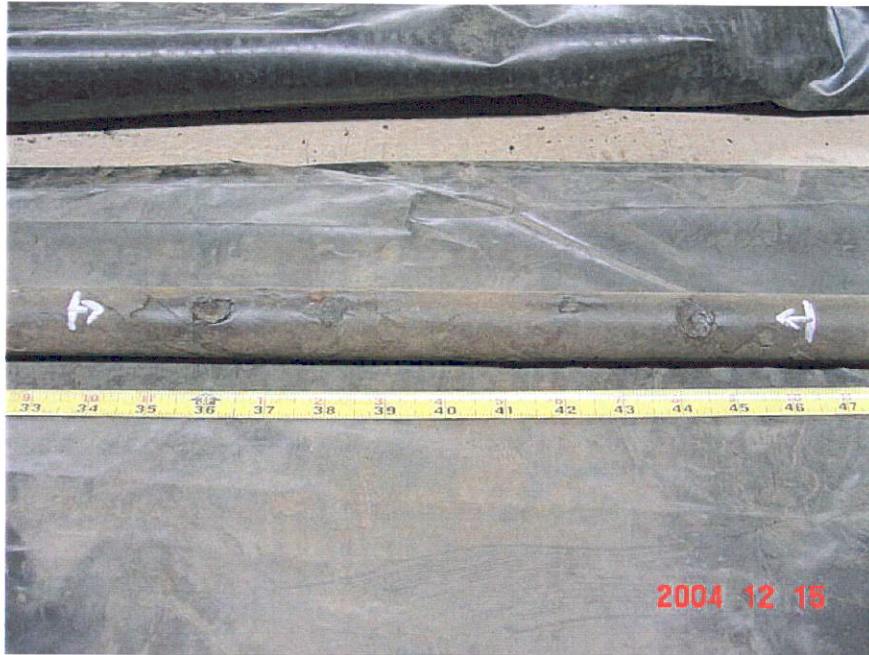
Figure 27. Photograph of Segment 9 showing deformations and dents in the coating between the 34-Inch location and the 46-inch location.

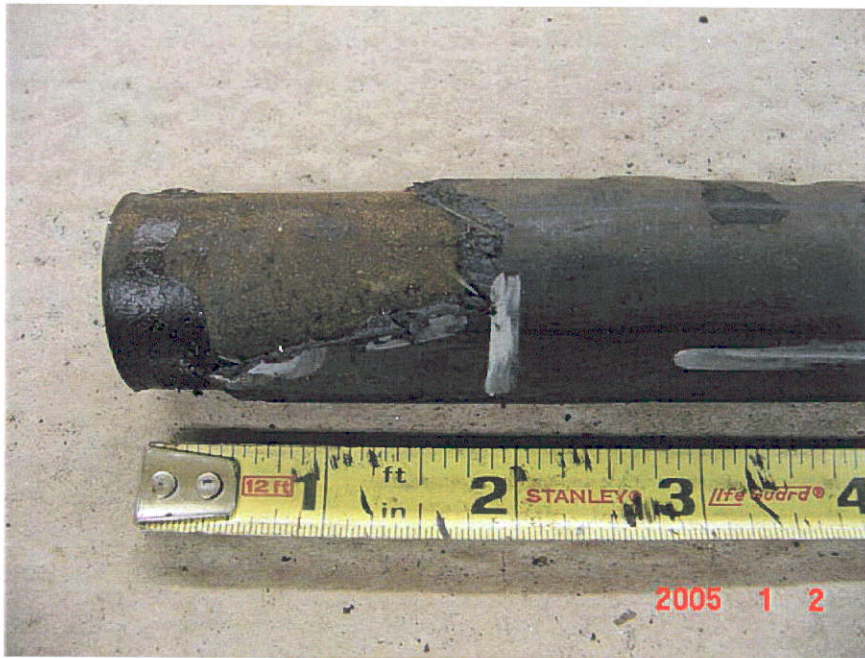
Figure 28. Photograph of Segment 10 showing a 2-inch area of bare pipe at the 0-inch location.

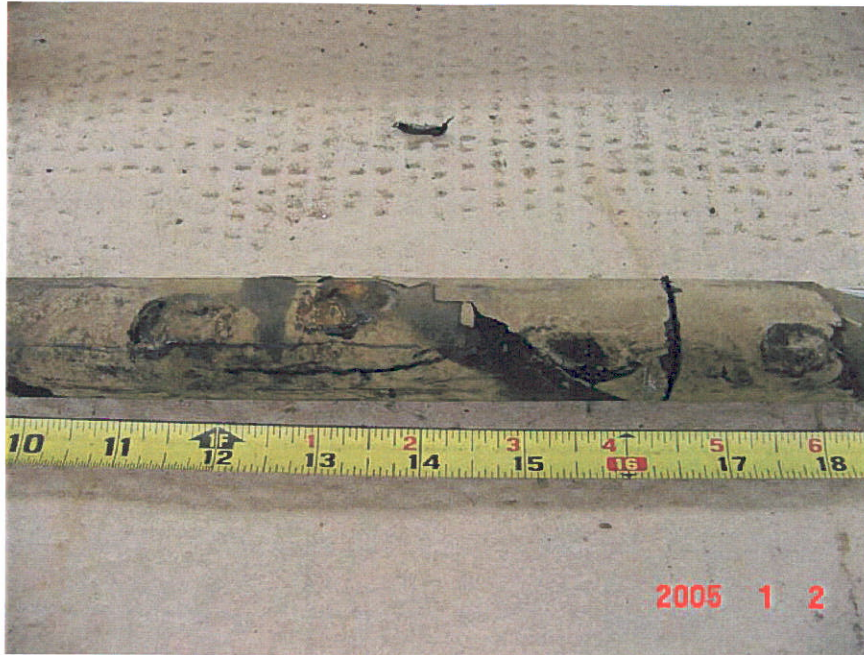
Figure 29. Photograph of Segment 10 showing coating deformations ranging from 0.5 to 2-inches long between the 11 and 24-inch locations.

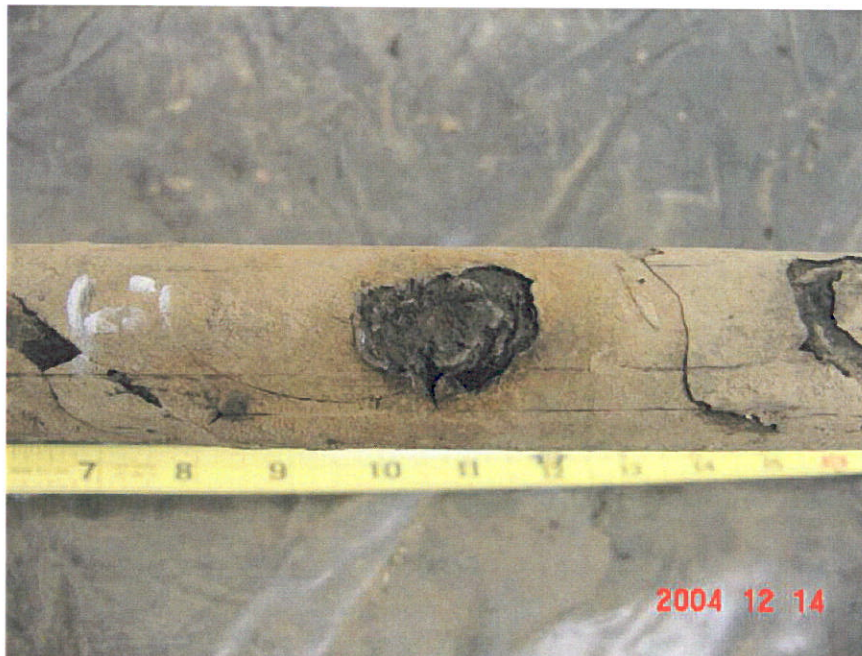
Figure 30. Photograph of Segment 10 showing a 2-inch coating deformation at the 21-inch location.

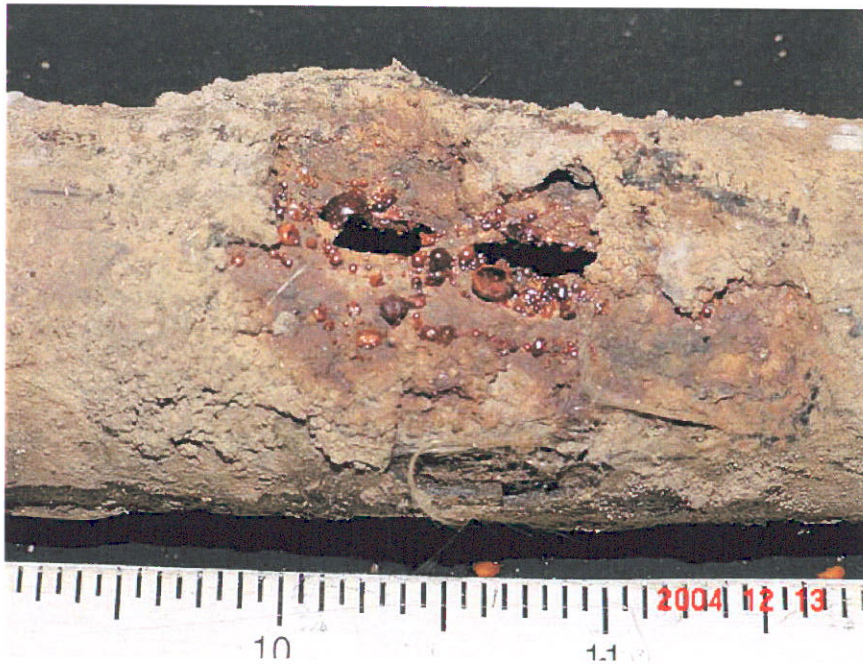
Figure 32. Photograph of Segment 10 showing a 1-inch through wall indication at the 48-inch location with granules around the indication.

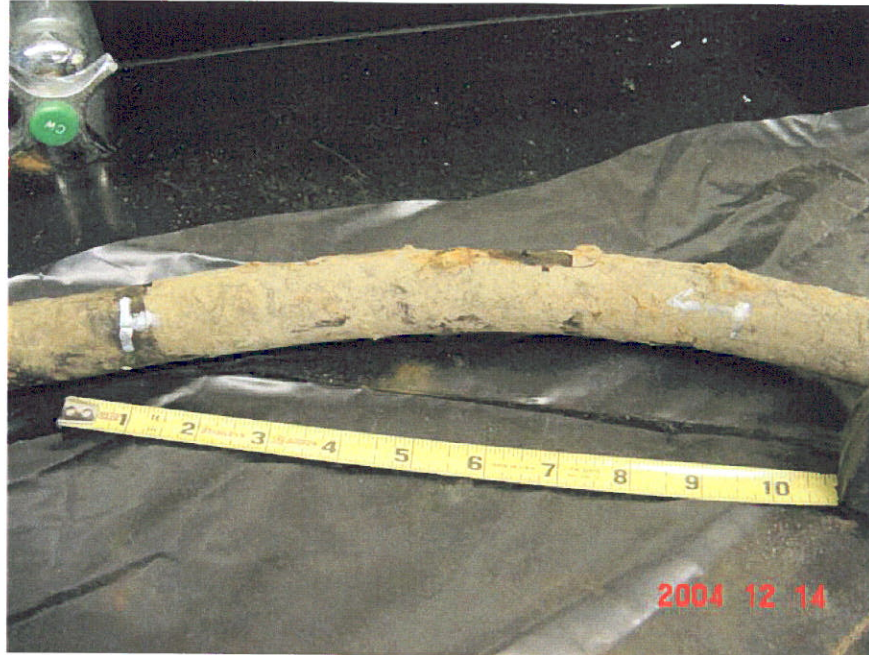
Figure 33. Photograph of Segment 10 showing the bend in the pipe that contained 6 areas of coating deformations on the extrados starting at the 57.75-inch location.

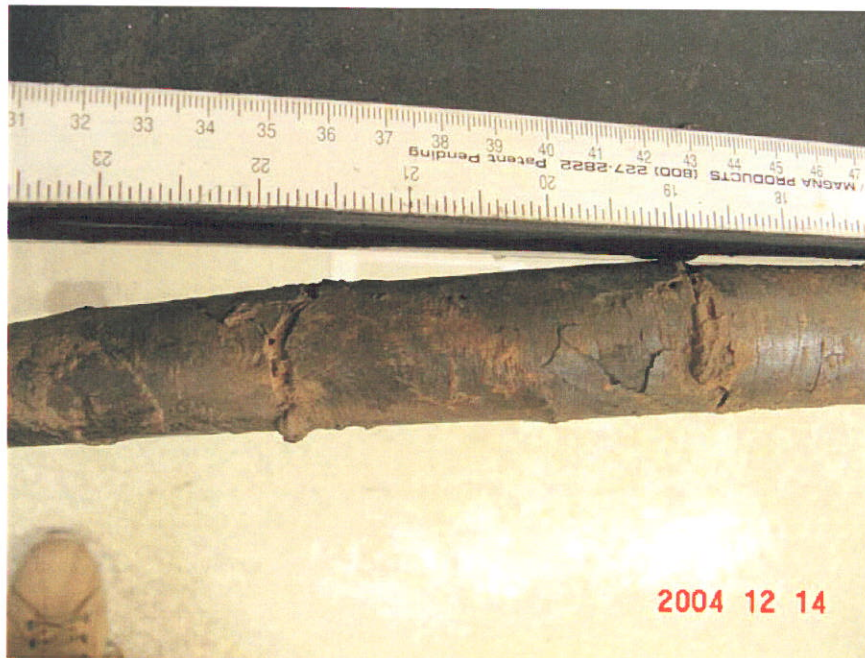
Figure 34. Photograph of Segment 10 showing an example of the coating deformations that occurred on the extrados of the bend.

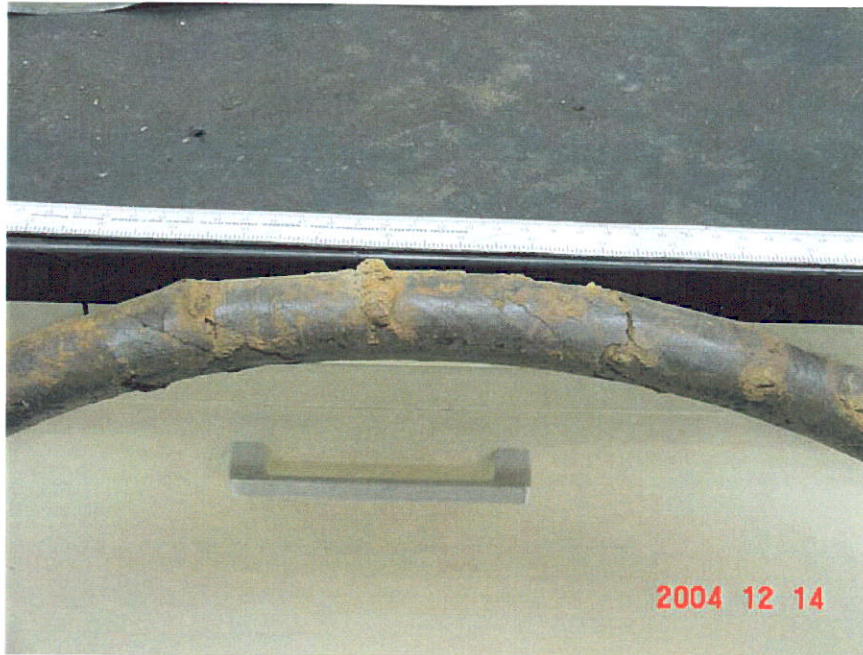
Figure 35. Photograph of Segment 10 showing the nodules that were in coating deformations on the extrados of the pipe.

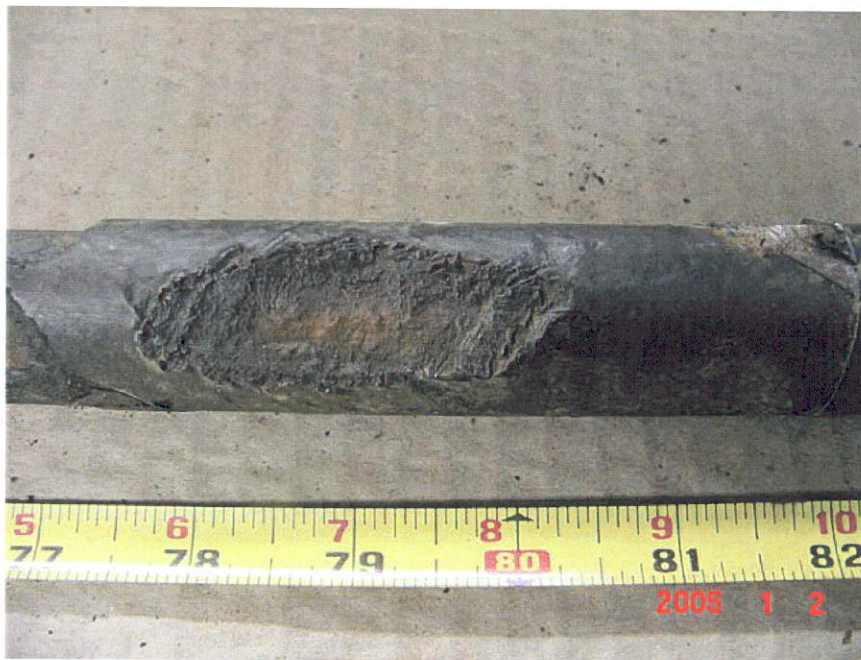
Figure 36. Photograph of Segment 10 showing a 2-inch long gouge to bare metal in the coating at the 78-inch location.

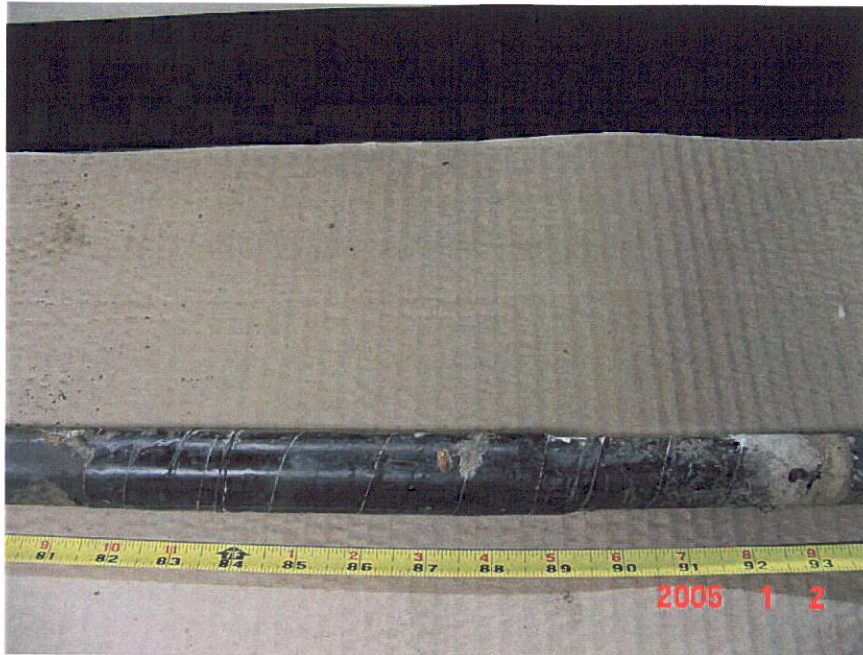
Figure 37. Photograph of Segment 10 showing a "transition" coating between the 82 to 93-inch locations.

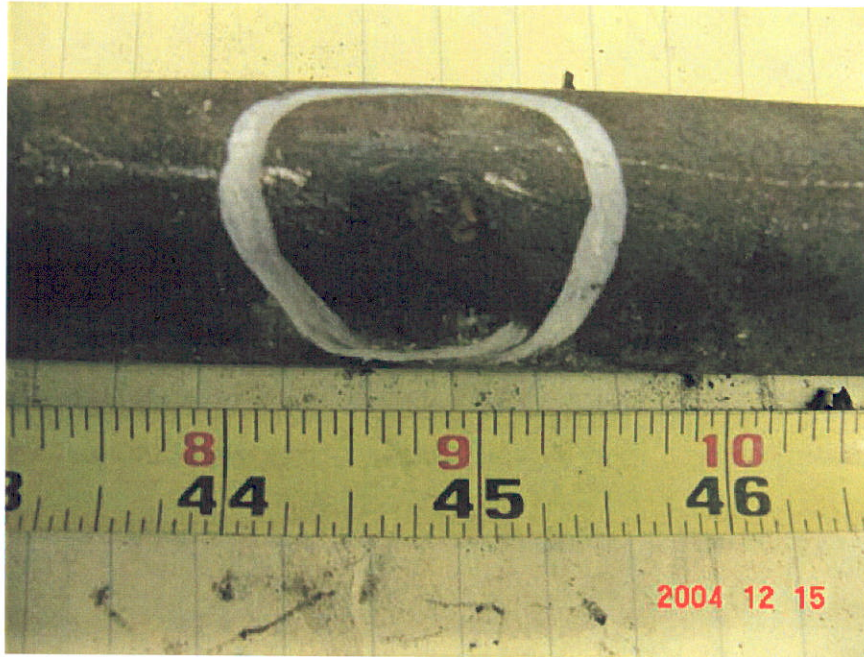
Figure 1. Photograph of Segment 2 after a portion of the coating was removed showing 3 small anomalies at the 45-inch location.

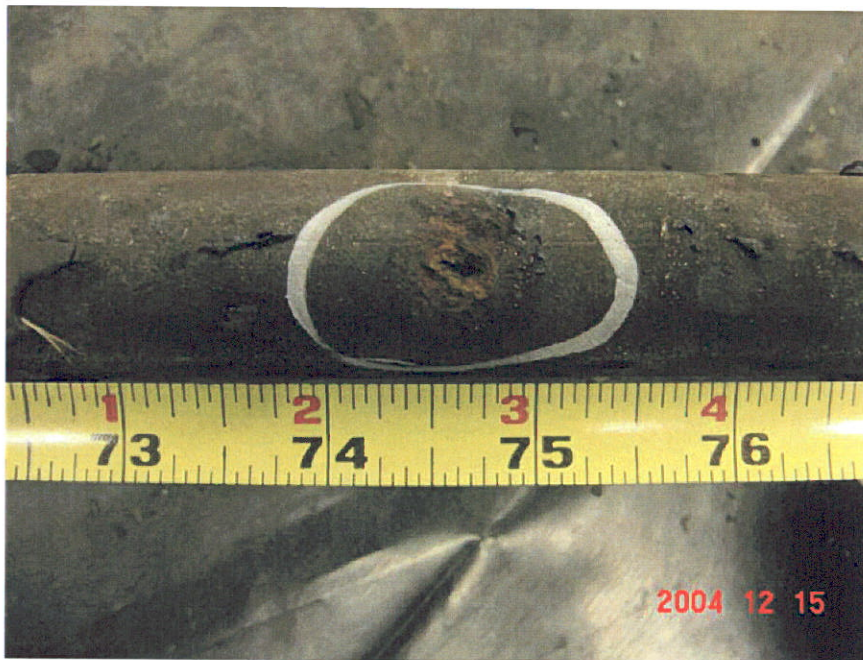
Figure 2. Photograph of the Segment 2 after a portion of the coating was removed showing a 0.25-inch anomaly at the 74.5-inch location.

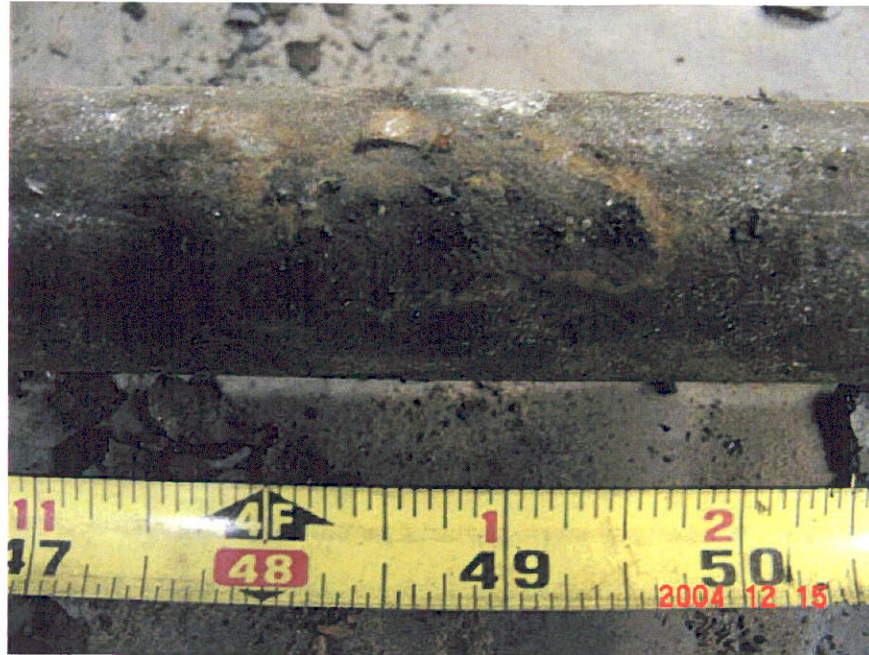
Figure 3. Photograph of Segment 4 after a portion of the coating was removed showing 1.5-inch anomaly area under disbonded coating.

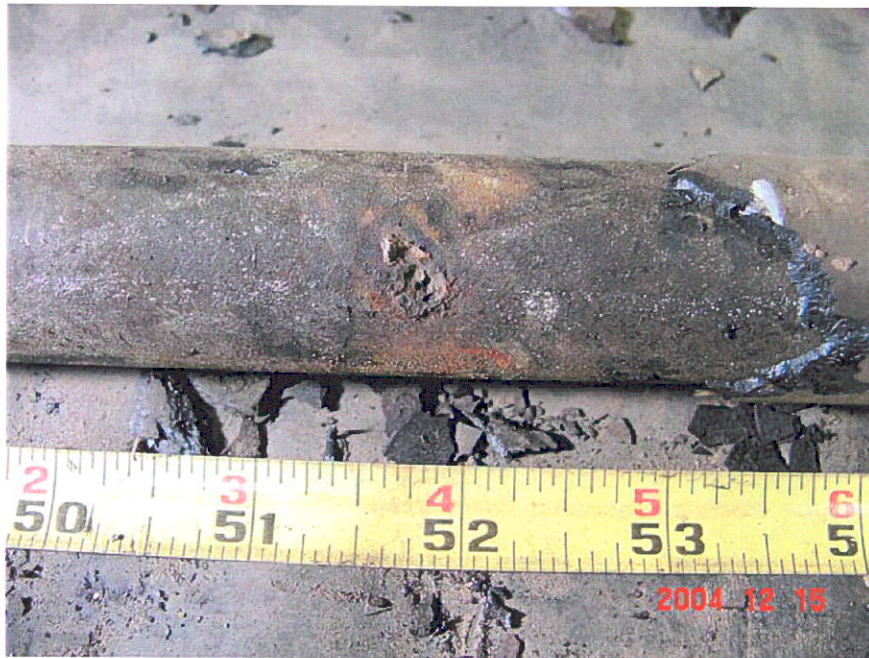
Figure 4. Photograph of Segment 4 after a portion of the coating was removed showing a 0.25-inch anomaly at the 51.75-inch location.

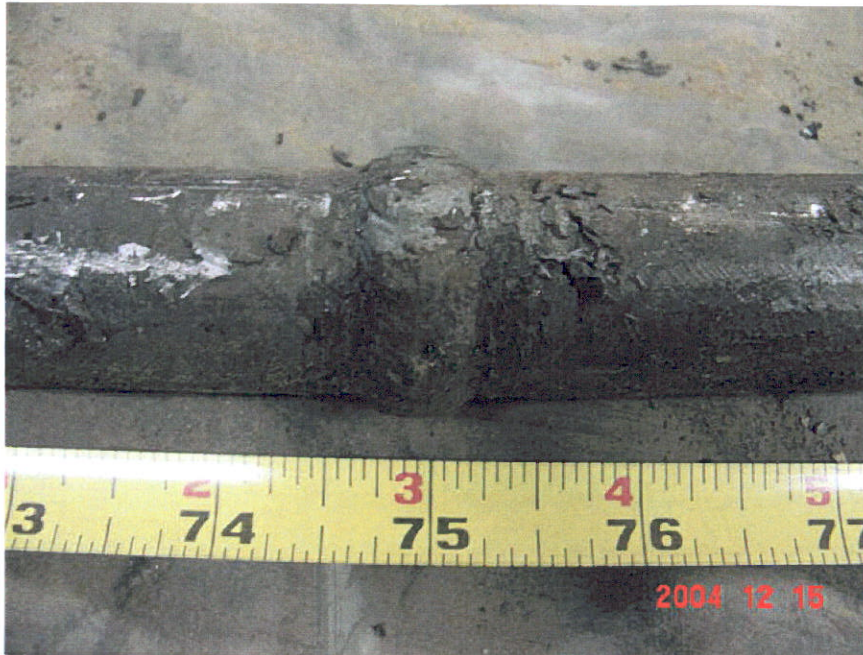
Figure 5. Photograph of Segment 4 after the field applied outer wrap and coating was removed revealing a weld at the 75-inch location.
