**SECOND EXHIBIT TO THE PREFILED DIRECT TESTIMONY OF
KEVIN C. GARRITY (NONCONFIDENTIAL)
ON BEHALF OF PUGET SOUND ENERGY, INC.**

FINAL REPORT

**LABORATORY-BASED EVALUATION OF FAILED SERVICE LINE
BELLEVUE, WASHINGTON**

PREPARED BY
CC TECHNOLOGIES LABORATORIES, INC.

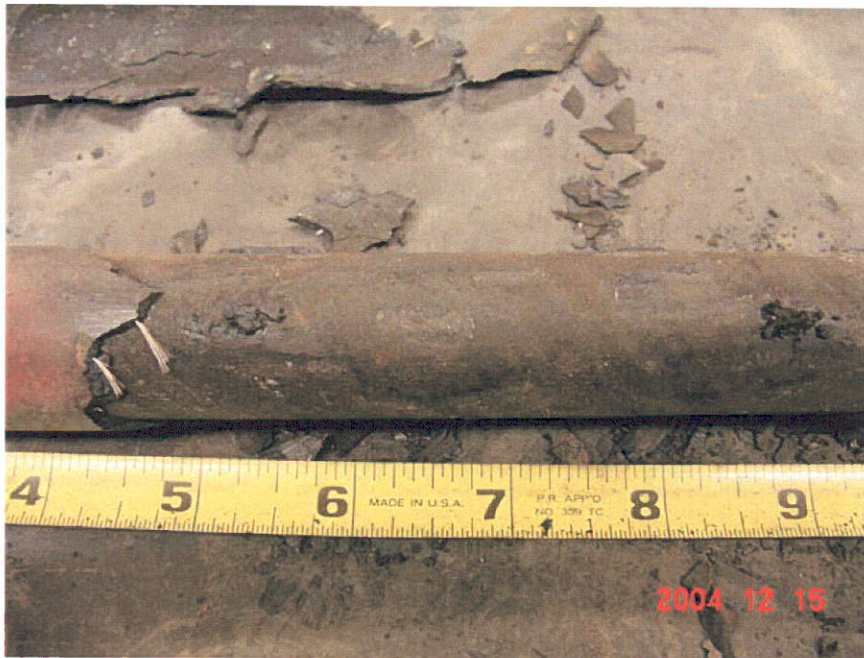
Figure 6. Photograph of Segment 4 after removal of a portion of the coating showing no corrosion underneath the coating holidays at the 6-inch location.

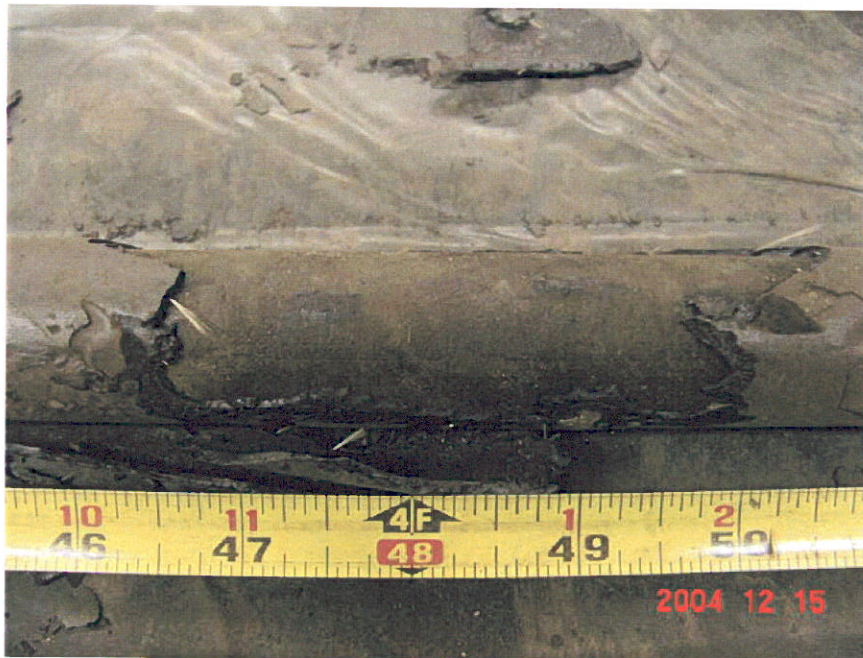
Figure 8. Photograph of Segment 7 after removal of a portion of the coating showing no corrosion in the pipe underneath the coating holiday at the 48-inch location.

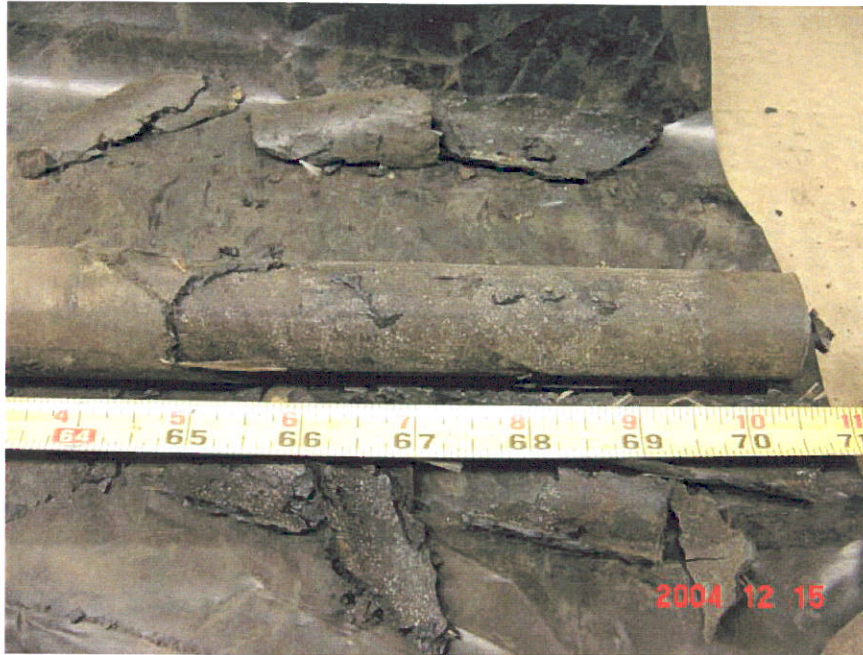
Figure 9. Photograph of Segment 7 after removal of a portion of the coating showing no corrosion underneath the coating holiday that was at the 66-inch location.

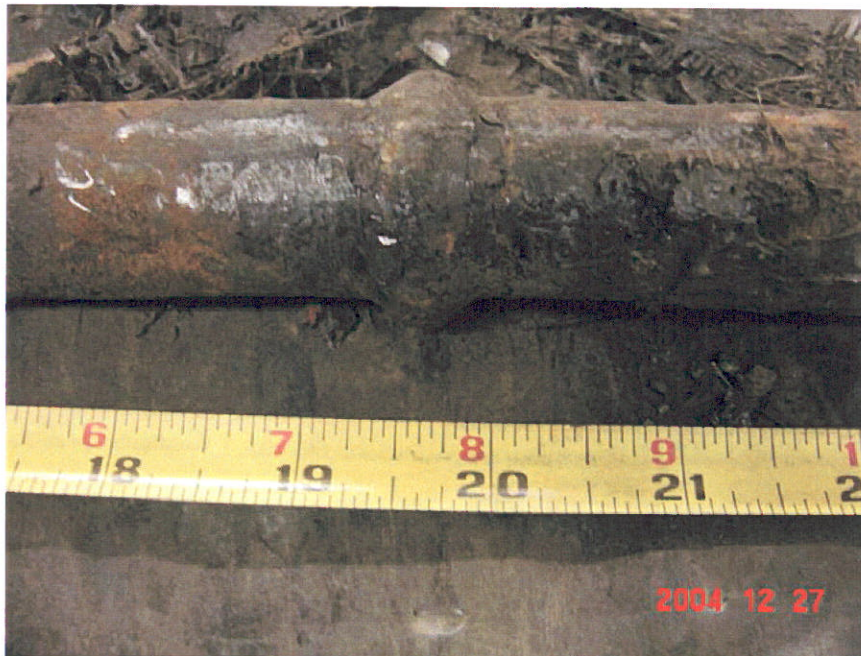
Figure 10. Photograph of Segment 8 after the coating wrap and coating was removed revealing a weld at the 19.5-inch location.

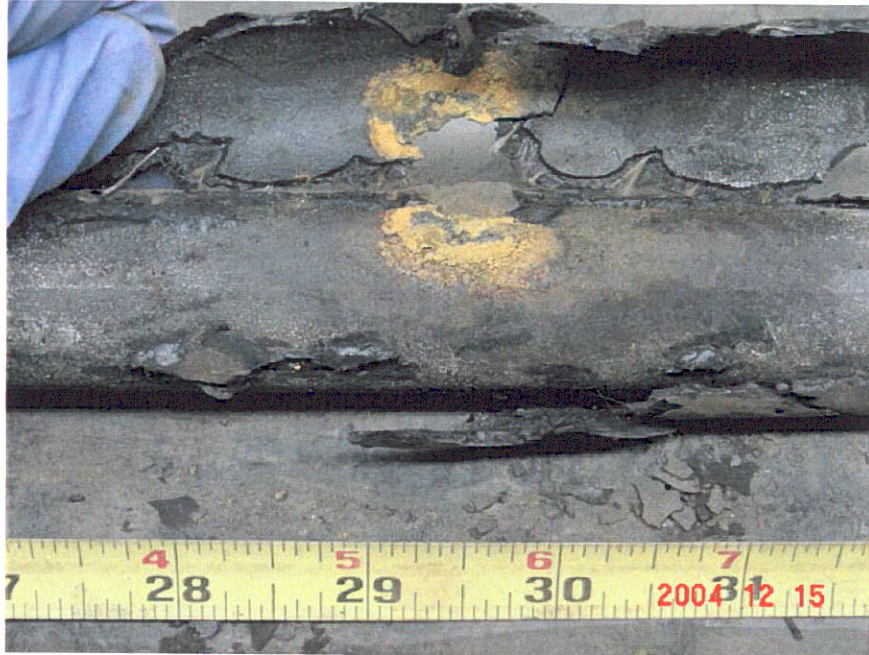
Figure 11. Photograph of Segment 9 after a portion of the coating was removed revealing an anomaly at the 29.5-inch location.

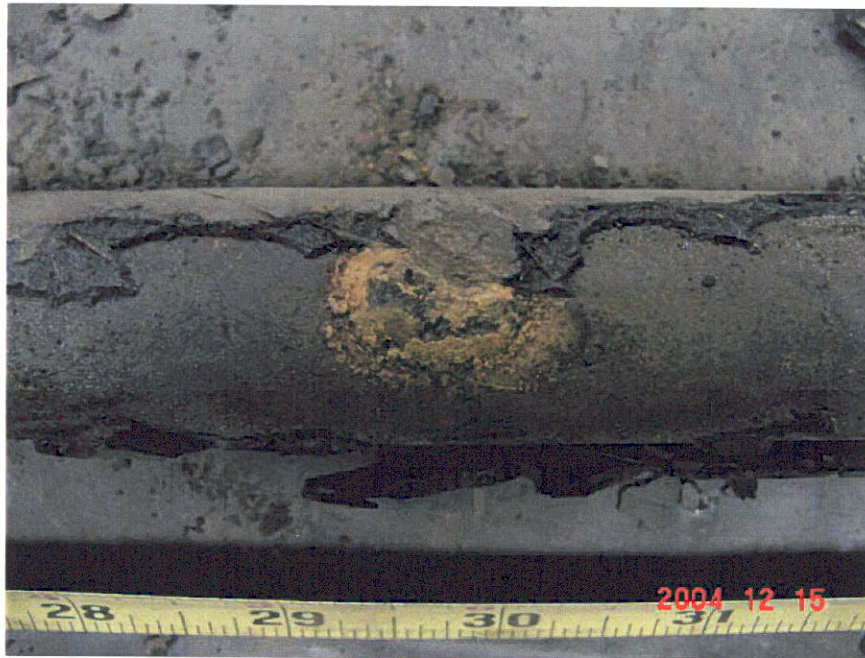
Figure 12. Photograph of Segment 9 after a portion of the coating was removed showing the top of the anomaly at the 29.5-inch location.

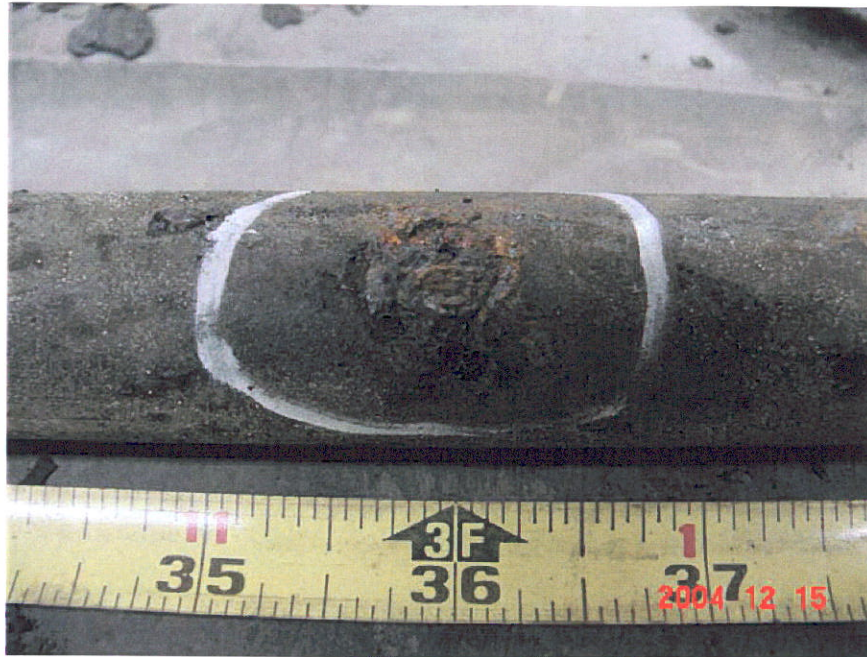
Figure 13. Photograph of Segment 9 after a portion of the coating was removed showing an anomaly at the 36-inch location.

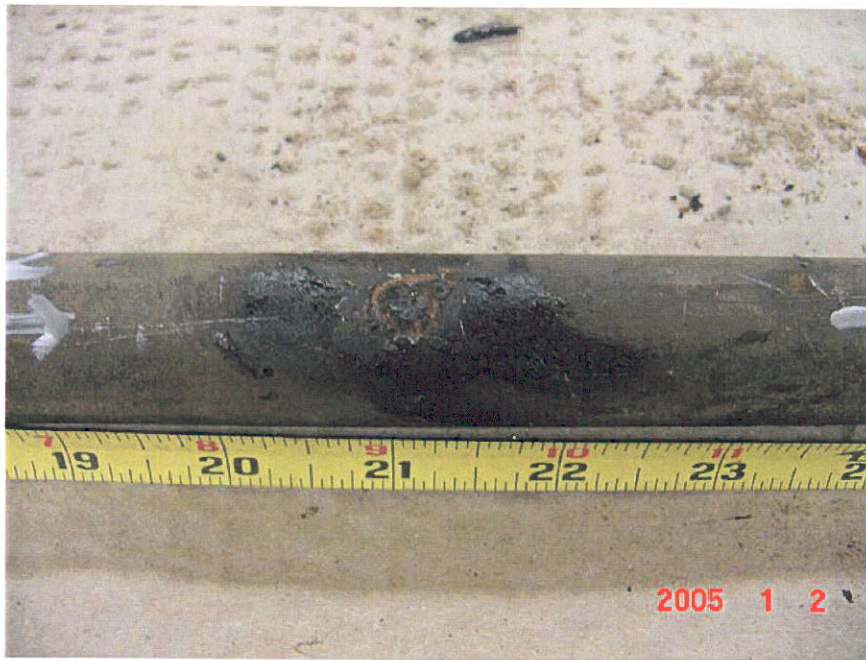
Figure 14. Photograph of Segment 10 after a portion of the coating was removed showing an anomaly at the 21-inch location.

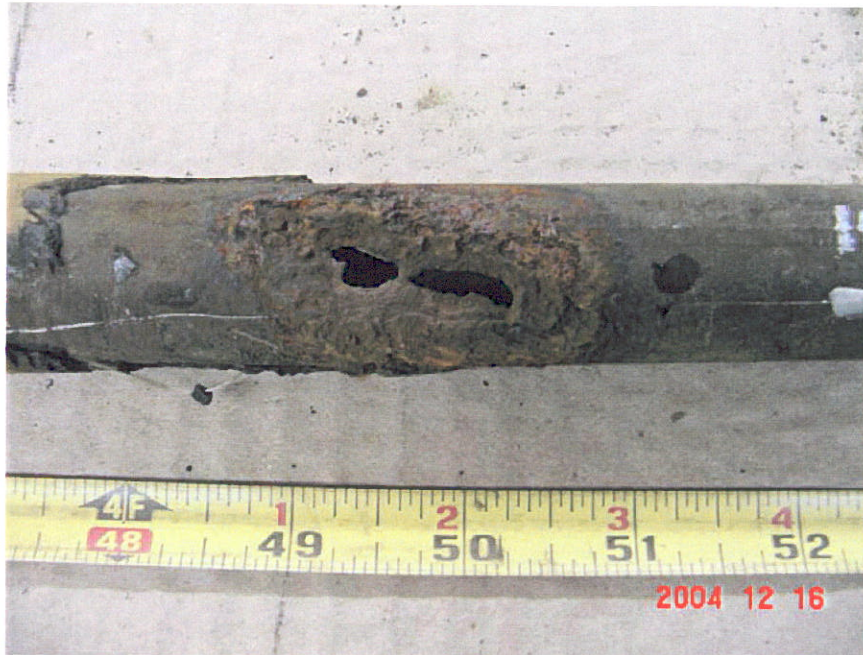
Figure 15. Photograph of Segment 10 after a portion of the coating was removed showing a through wall penetration at the 49-inch location.

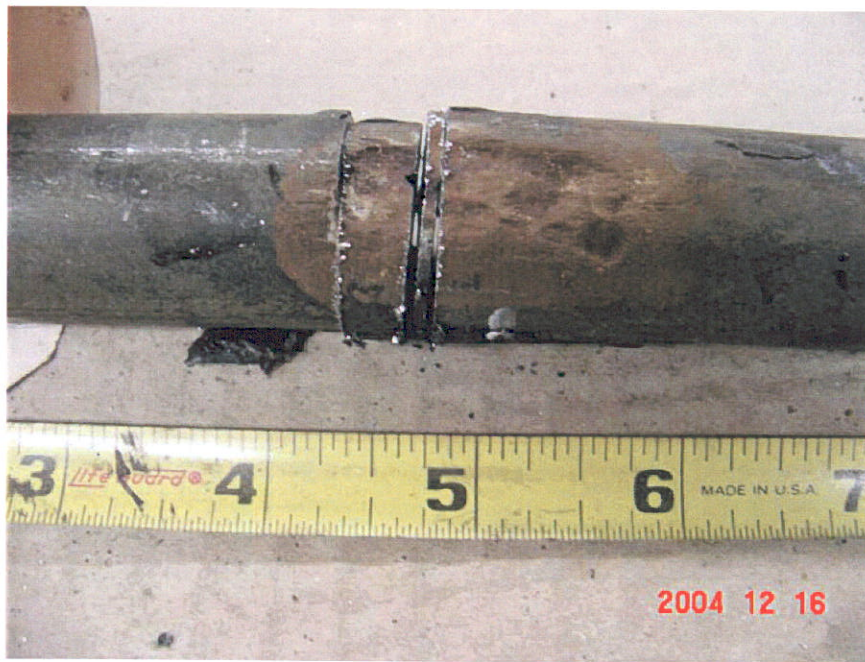
Figure 2. Photograph of Segment 1 showing where Mount 1-B (2nd piece from left) and Surface 01-C (3rd piece from left) were cut out of the pipe.

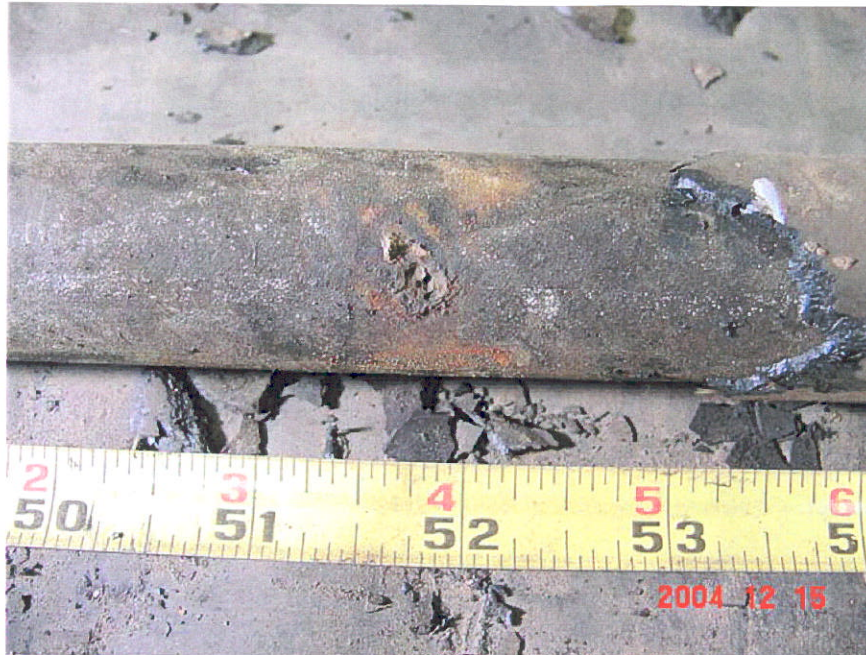
Figure 3. Photograph of Segment 1 showing an anomaly at the 51.75-inch location.

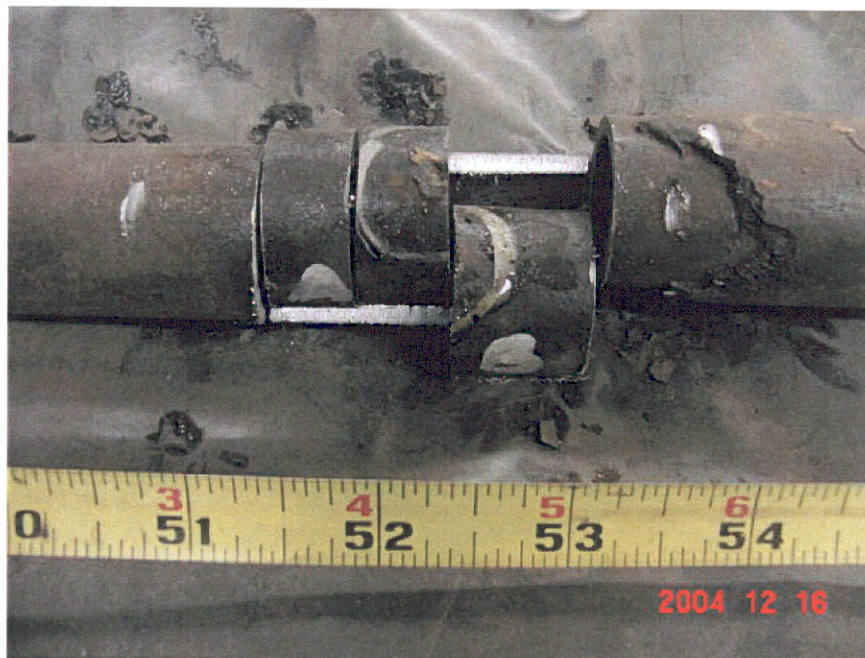
Figure 4. Photograph of Segment 4 showing where Mount 4-B (3rd piece from left) was cut out of the pipe.

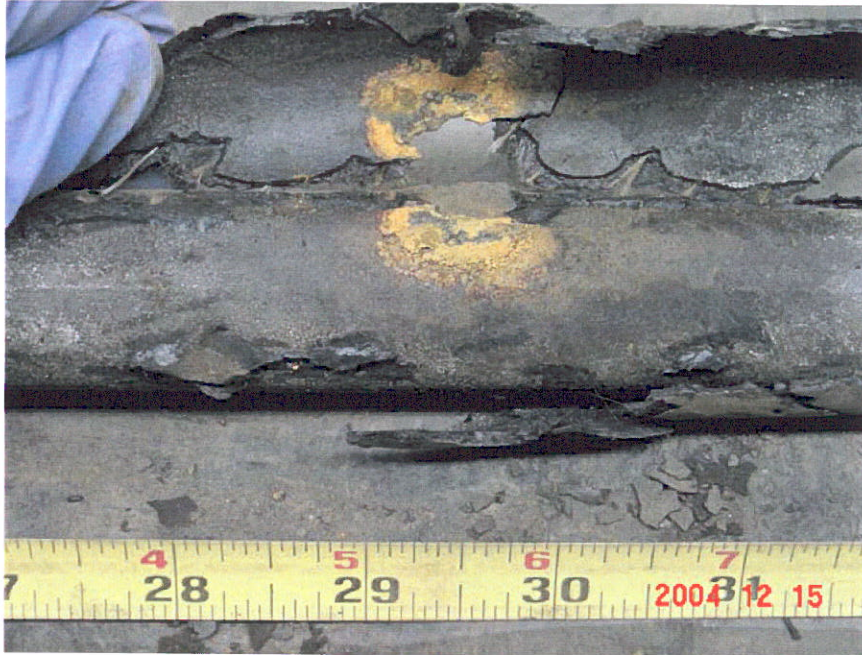
Figure 5. Photograph of Segment 9 showing an anomaly at the 29.5-inch location.

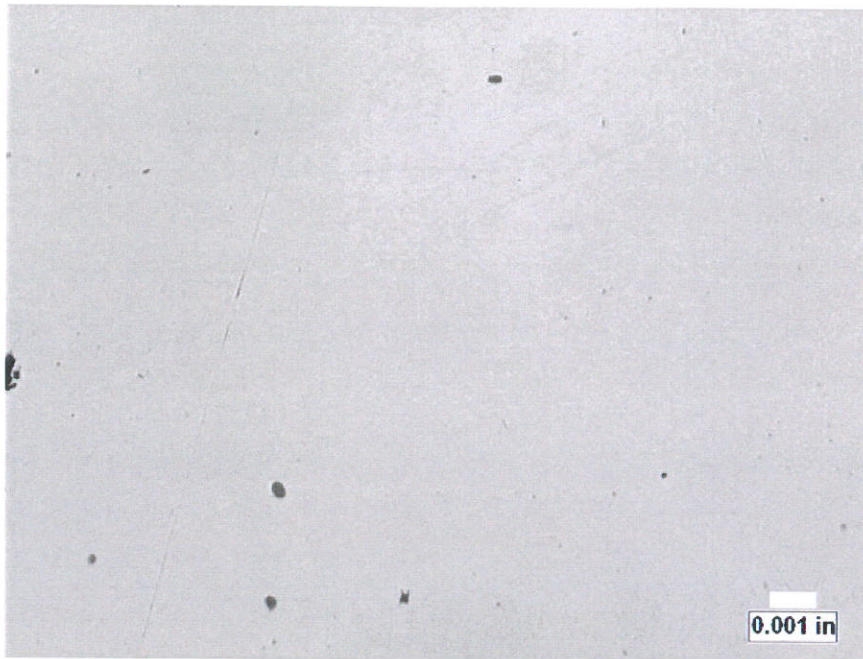
Figure 7. Light photomicrograph of as-polished Mount 4-B near maximum wall loss taken at 200X.

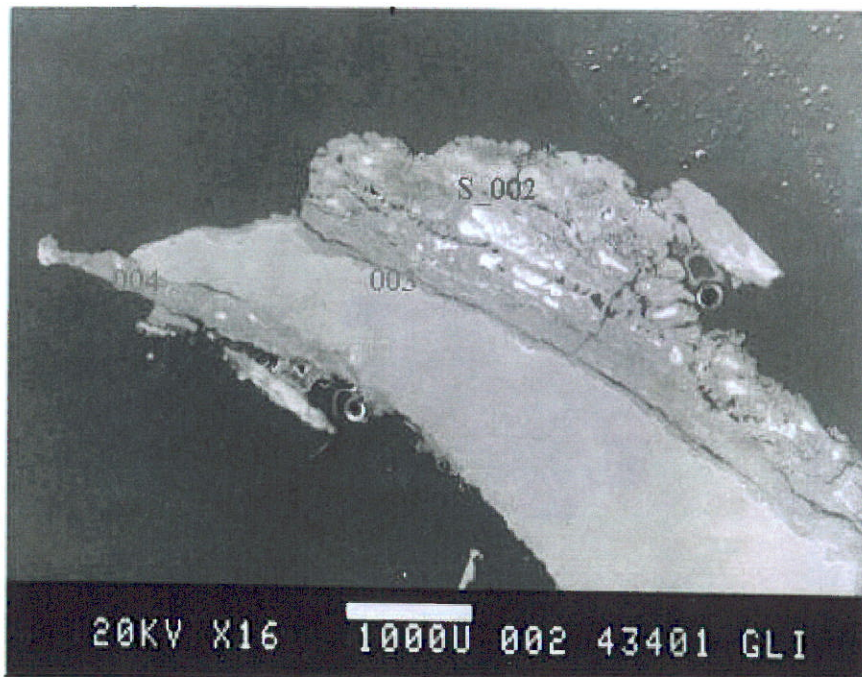
Figure 10. SEM photomicrograph 002 of Mount 10-4B showing the debris on the OD of the penetration plus the locations of photomicrographs 003 and 004 and EDS scan S-002.
