National Transportation Safety Board

Marine Accident Brief

Contact of Liquid Petroleum Gas Carrier *Levant* with Mooring Dolphin

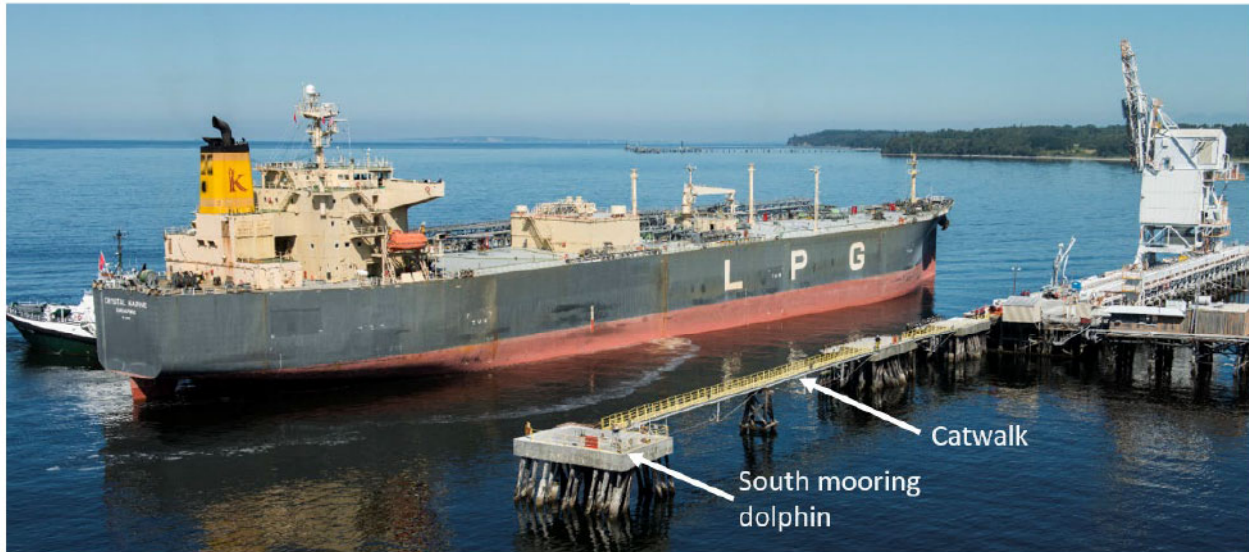
The Petrogas Wharf with a tanker of similar size to the *Levant* docking starboard side to the wharf. (Source: Petrogas, LLC)
