## **MARINE TRANSPORTATION SAFETY INVESTIGATION REPORT M19P0020**

### **STRIKING OF BERTH AND SHORE GANTRY CRANE**

#### **CONTAINER VESSEL *EVER SUMMIT***

Vanterm, Port of Vancouver  
Vancouver, British Columbia  
28 January 2019

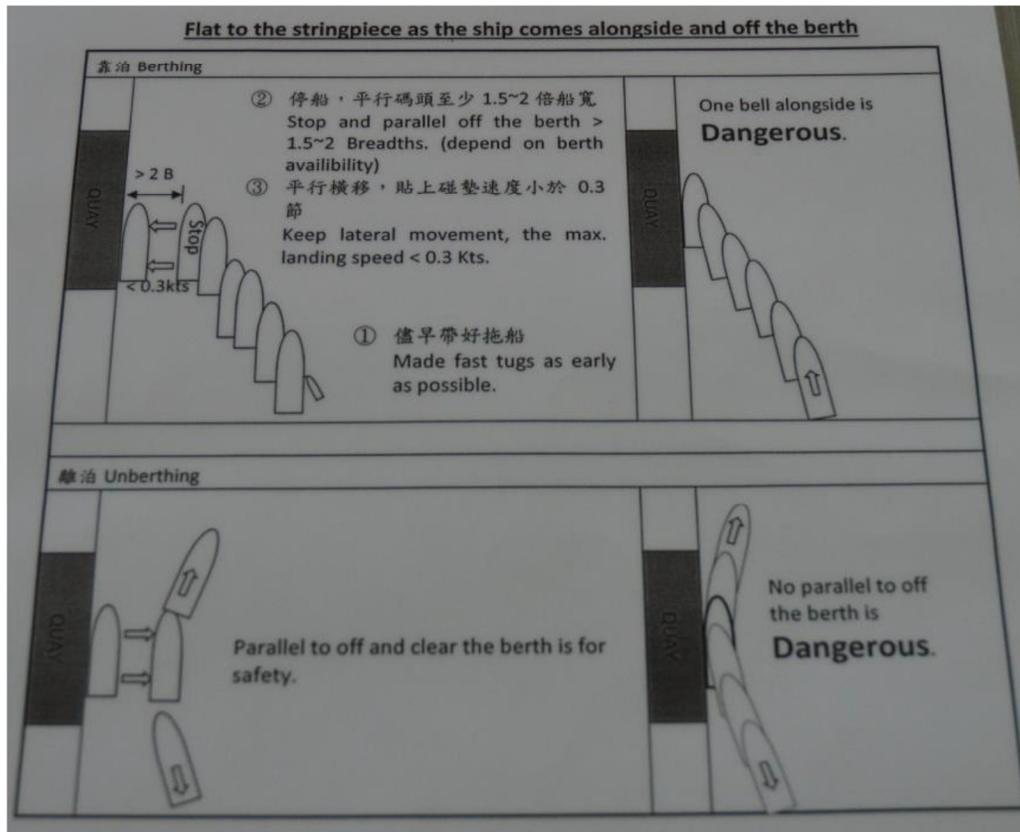
Figure 2. Photograph of berthing guidance on the pilot card (Source: TSB)

The back of the pilot card included brief guidance for approaching and leaving a berth (Figure 2). The guidance indicated that, for berthing, the vessel was to be stopped parallel to the berth at a distance of approximately 1.5 to 2 vessel breadths (64 to 86 m). Tugs were to be made fast as early as possible, and the vessel was to be manoeuvred laterally into the berth at a maximum landing speed of less than 0.3 knots (15.4 cm/s). The guidance also highlighted manoeuvres for berthing and unberthing that were considered dangerous for this particular vessel.

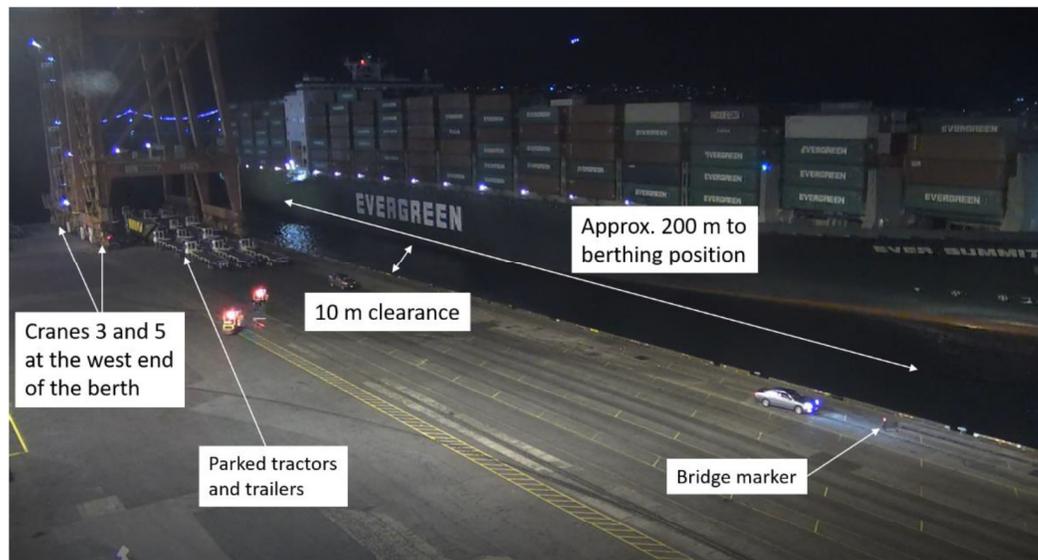
Figure 4. Capture from the closed-circuit television footage of the *Ever Summit* approaching Vanterm (Source: GCT Canada, with TSB annotations)

The pilot and tugs were all using VHF channel 17 for communications. At approximately 0343, after experiencing some disturbance on this channel, they switched over to another working channel. At this time, the *Ever Summit* was approaching the berth on a course that was nearly parallel to it and approximately 10 m off (Figure 4).

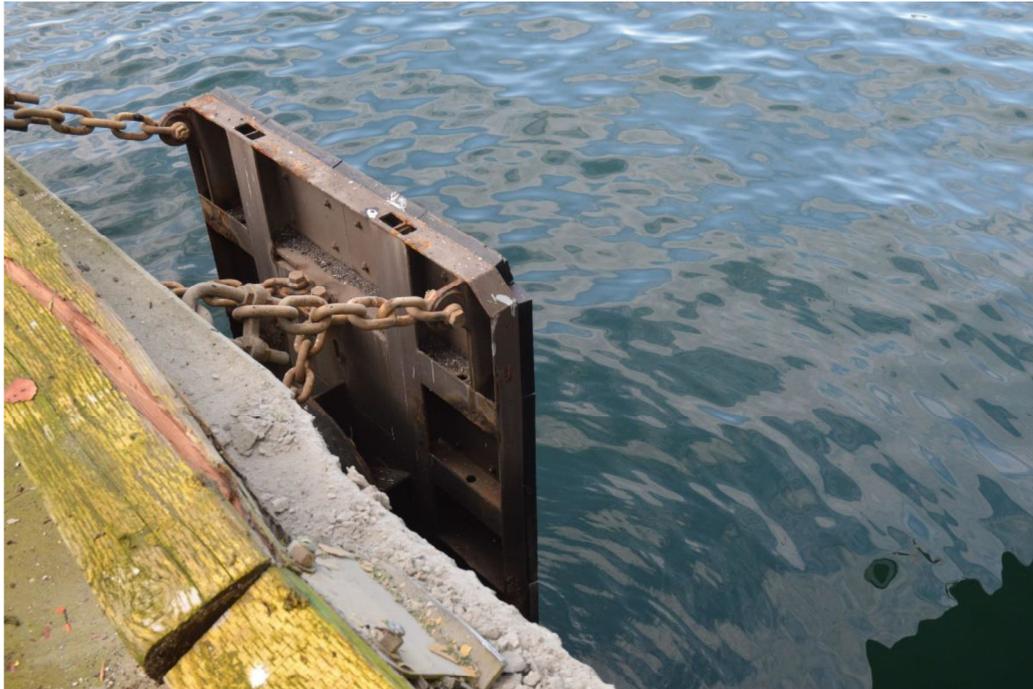
Figure 9. Cone fenders on Vanterm berth 6 extension (Source: TSB)

The fender system installed on the berth 6 extension differed from the fenders on berth 5 and the original part of berth 6. The fenders on the berth extension are cone fenders fitted with fender panels and support chains (Figure 9). The energy absorption capacity of these fenders is rated at 799 kN-m.

The fendering system for the berth extension was intended to accommodate berthing of design vessels based on the following criteria:

- A maximum velocity perpendicular to the berth face of 15 cm/s
- A maximum angle of approach of 10°
- A maximum hull pressure of 20 t/m<sup>2</sup>

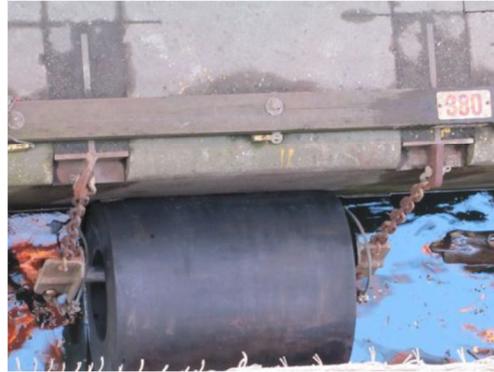
Figure 10. Fender at Vanterm (Source: TSB)

The review concluded that the damage was a result of the existing fendering system not having sufficient capacity to absorb the kinetic energy of the large vessels berthing at the terminal. Specifically, when the fenders are compressed to their maximum, large vessels can make contact with the berth face, causing impact damage to both the berth and the vessels.

The review also identified that the existing cylinder fender system was inappropriate for the size of container vessels that dock at the berth. The energy absorption capacity of the fenders was significantly less than the required energy absorption for the maximum design vessel<sup>30</sup> (1662 kN-m). The fender stand-off distance<sup>31</sup> was inadequate, and the fender spacing was too far apart considering the size of the fenders and the heavy loads placed on them.

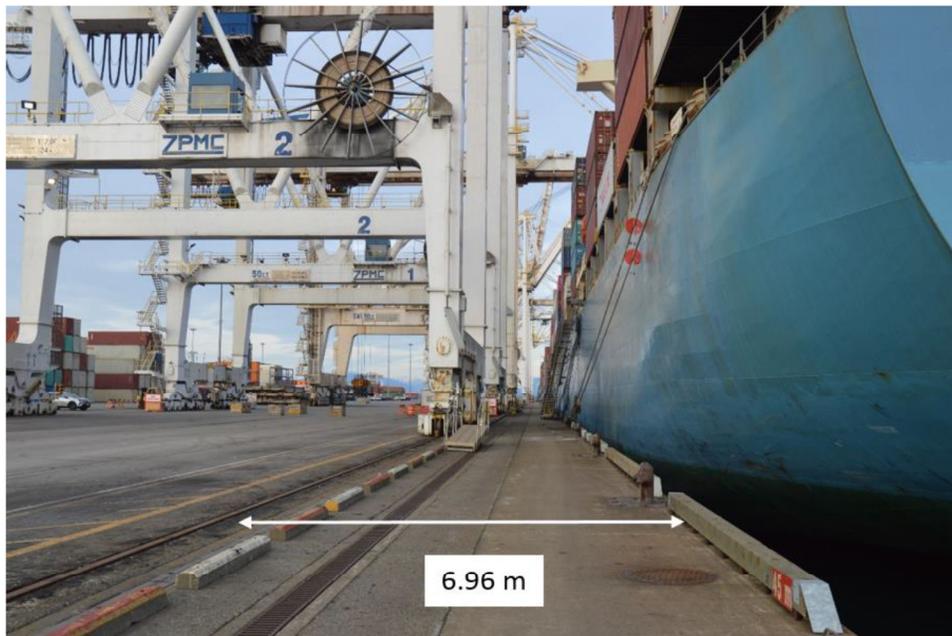
Figure 13. Distance between the berth line and the crane rail at Deltaport 3 (Source: TSB)

Deltaport 3 was designed for a maximum approach angle of 5° at a velocity of 12.5 cm/s. The bollards are rated for 125 tonnes safe working load, with 200 tonnes safe working load bollards at the ends of the berth. The distance from the waterside crane rail to the berth line is approximately 6.96 m at Deltaport 3, whereas the distance from the crane rail to the berth line at Vanterm is 2.13 m (Figure 12 and Figure 13).

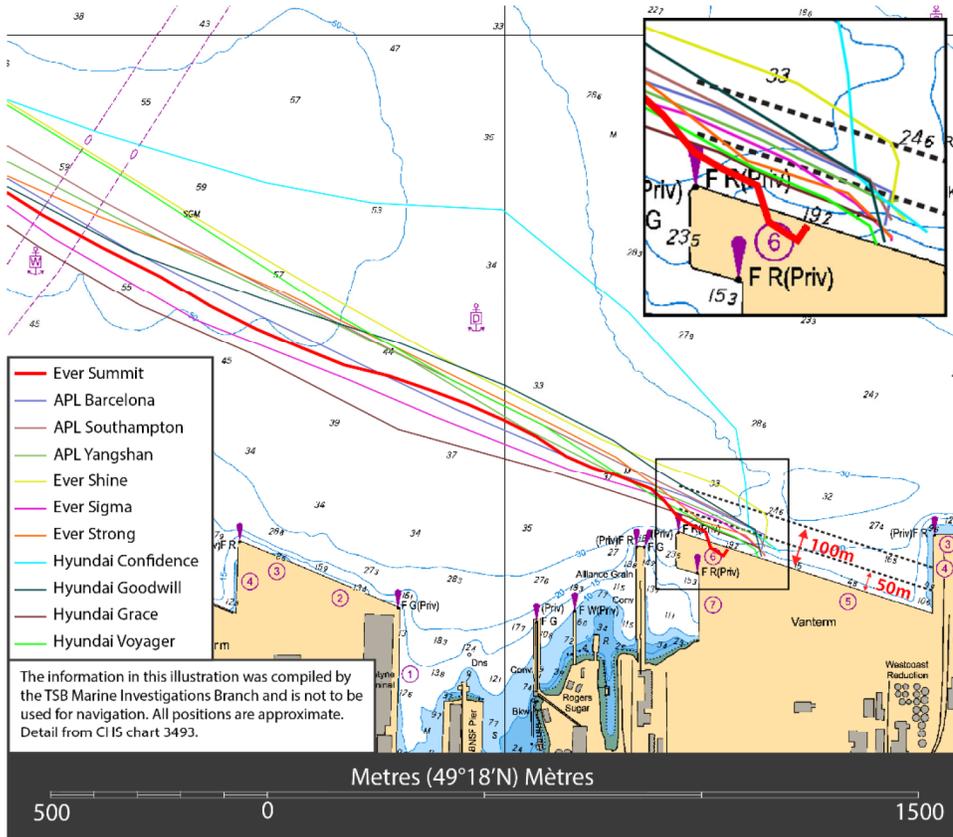
Figure 16. Tracks of vessels berthing at Vanterm berth 6 in January 2019 (Source: Canadian Hydrographic Service, with TSB annotations)

Information about the approaches taken by vessels<sup>40</sup> berthing at Vanterm in January 2019 has been compiled in the figure below (Figure 16). All of the vessels were successfully berthed. A total of 4 vessels transited the berth face at a distance

of 50 m or less while approaching the berth. On approach, the *Ever Summit* was the closest of the 4 to the berth.
