Subject: Annual Flow Meter and Outfall Inspections, NW Natural Source Control Groundwater Treatment Facility, 7900 NW St. Helens Road, Portland, NPDES Permit Number 103061 (permit renewal pending with DEQ)

DIVE INSPECTION REPORT

NW Natural - Gasco Willamette River Outfall Diffuser
Inspection

REPORT DATE: October 3, 2019

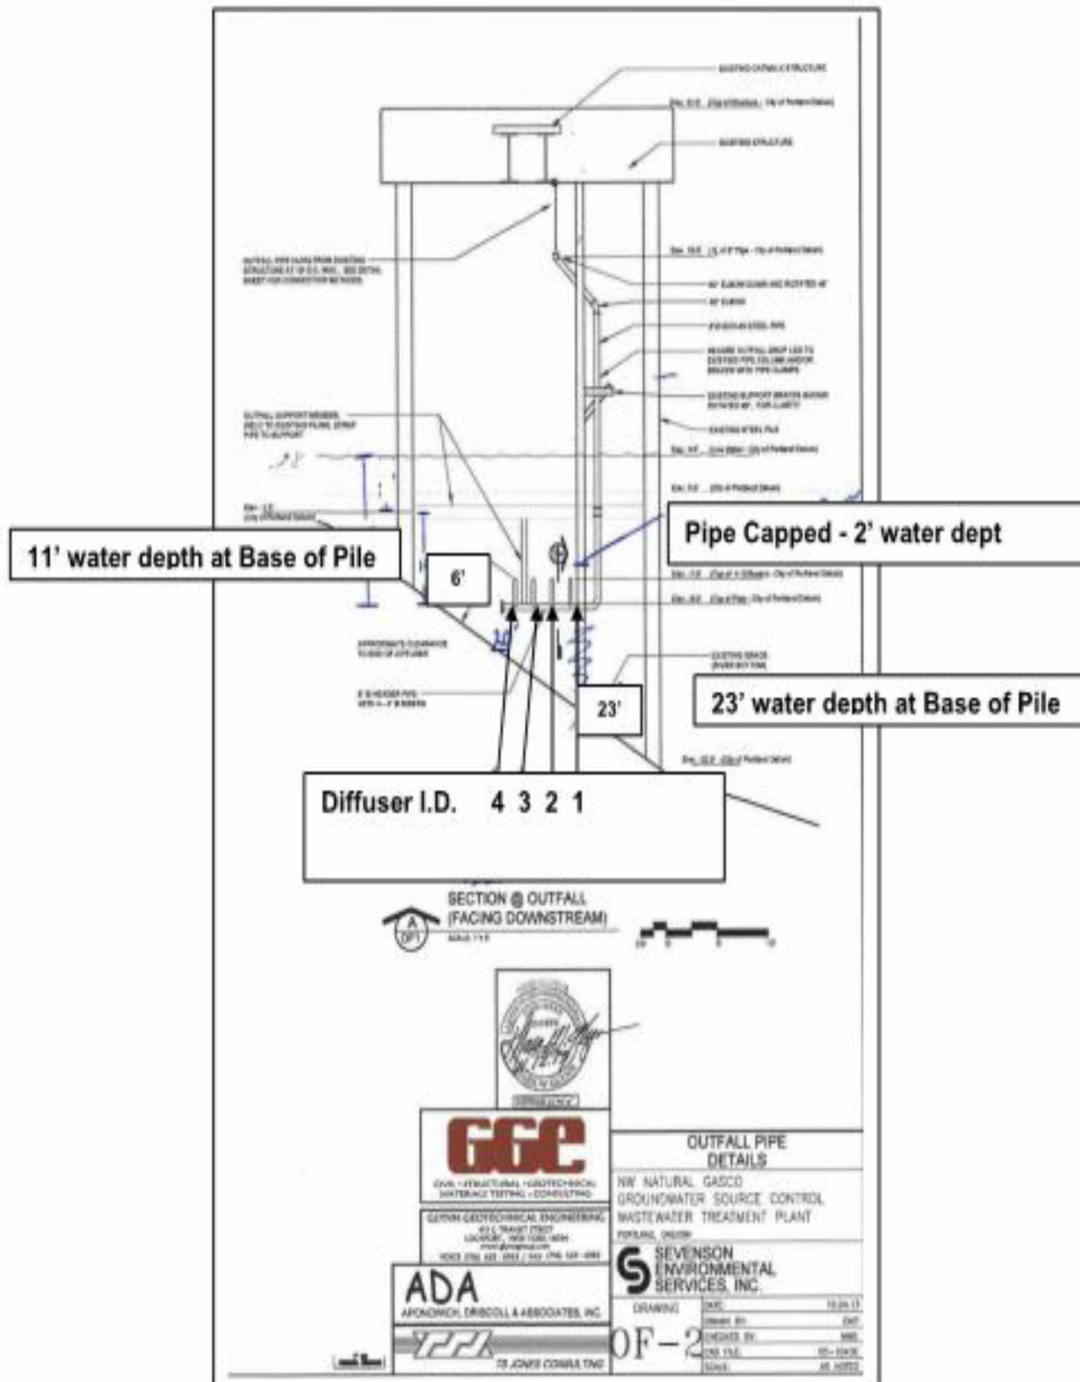
Figure 1- Severson Environmental Services, Inc Outfall Pipe Details. Dwg. No. OF-2 Section A

Background: The outfall consists of an 8" diameter steel pipe that extends downward into the water. A flange connection then directs the pipe 90 degrees to the horizontal direction inshore. Four - 2" diffuser ports are attached to the crown of the main outfall pipe and have a 24" spacing, extending 22" vertically with a 45-degree bend at the top pointing downstream. At the end of the outfall pipe is a blind flange bolted to the pipe. The main pipe is welded to a horizontal member above surface for support. Additionally, a piece of vertical channel extends down into the water and is welded to the main outfall pipe between diffusers #3 and #4. See figure 1 for outfall details.
