Investigation Report

CenturyTel of Inter Island d/b/a CenturyLink

UT-132234

Staff Investigation
Consumer Protection
Regulatory Services

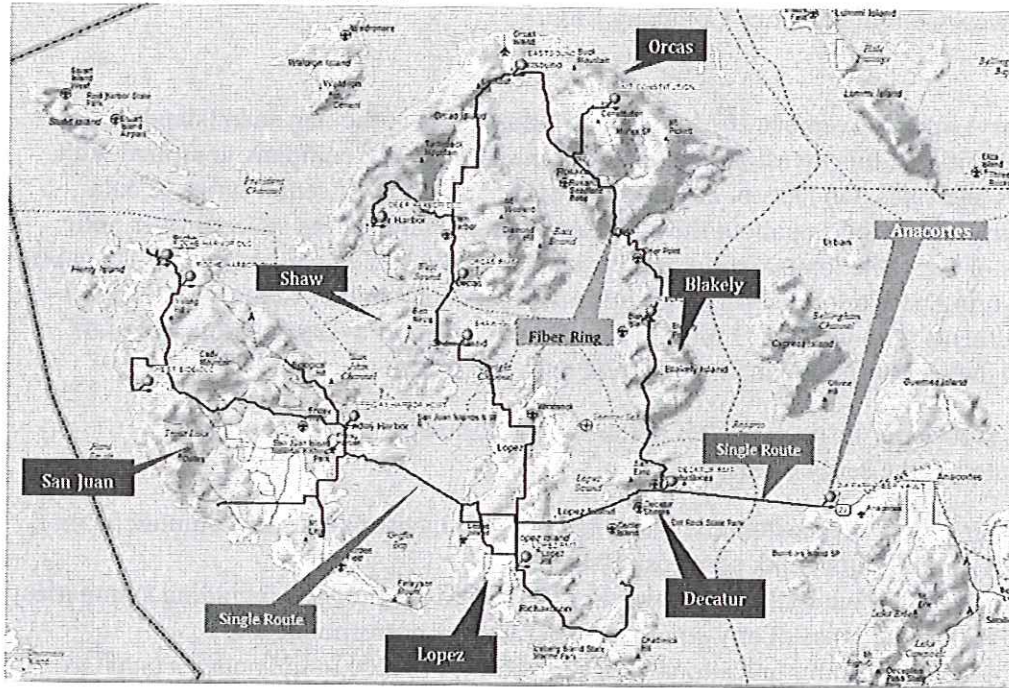
CenturyLink provides voice services in the San Juan Islands through one central office host switch (located in Friday Harbor on San Juan Island) and a number of remote line switches⁴ connected by underground and submarine fiber optic links. The map below, prepared by CenturyLink and modified by staff, illustrates the network that provides voice, E911, and data services to the San Juan Islands.

Long distance calling and E911 services require a connection between the central office host switch in Friday Harbor (located on San Juan Island) and the remote line switches located on the other islands. The two fuchsia flags identified as “single route” on the chart above represent the two connections that, if severed, would isolate the central office host switch in Friday Harbor.

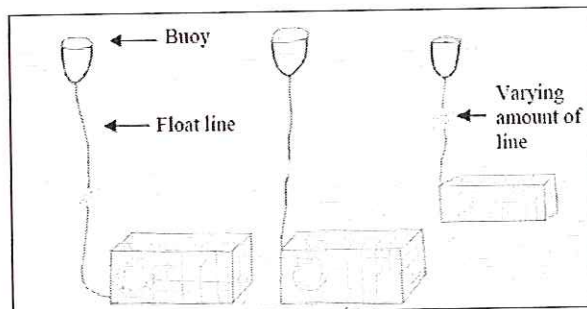
Figure 26- Crab Pots with One Pot per Buoy Line

Crab pot fishing depths in the area are usually shallower than 100', although 200' is not unheard of. The breaking strength of a crab pot buoy line is much lower than that of an armored fiber optic cable of this diameter. Buoys are usually attached with synthetic line about 1/2" diameter, with a maximum breaking strength on the order of 3,700 – 7,000 lb. Even if doubled it may not reach the breaking load of an armored cable such as this. That said, it is possible for multiple strands to tangle a cable. If a tangled pot and line were dragged across the seabed by a snagged piece of towed gear, it could cause significant damage.

There are 249 commercial crab licenses in the Sound, and each one can fish 100 pots. With hundreds of vessels, and tens of thousands of pots, a great many scenarios can be envisioned.

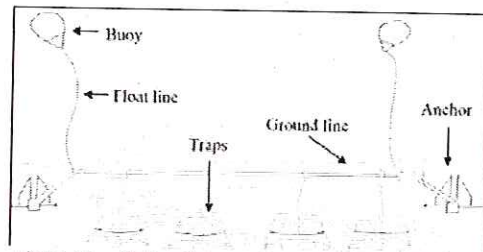
Figure 27 -- Shrimp Pots on a Common Ground Line

Shrimp pots are fished by fewer than 20 State licensed vessels in Puget Sound, as well as an undetermined number of Treaty fishermen. The pots are similar in size to crab pots but they may be fished on "ground lines", with many pots tied along a line on the seabed, and a buoy at each end of the line. This means that if the buoys are lost, fishermen are more likely to try to recover them with grapnels. In other regions this has caused cable faults. Fishing depths are typically 200' to 400', encompassing the fault range. However, the pots shown in the ROV video are clearly crab pots, not shrimp pots. Moreover, shrimp pot fishing at night is prohibited.

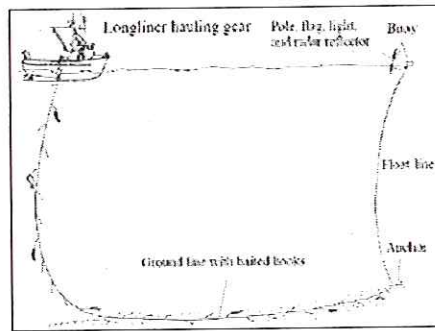
Figure 28 - Bottom Longline

Bottom longlines are used for halibut in Puget Sound. A long ground line or main line has a series of branch lines attached, with a baited hook on the end of each branch line. Their breaking strength is generally well below that of a FO cable. However in rare cases they have caused cable faults in other regions, either by tangles, grapnel recovery, or hook point penetration of cable insulation.

In summary, the types of gear described above have caused occasional fiber optic cable faults in other regions. However, given the time of the fault, seabed characteristics, and technical characteristics of local fishing methods, there is no clear evidence that this fault was caused by fishing. It is possible that illegal night fishing or other human activity caused the break, but to date no clear evidence has emerged to support a clear cause. In any case, it would be prudent to ensure that local authorities, research vessel operators, passenger vessels, vessel traffic controllers, fishing agencies and fishermen are aware of the cable and the importance of avoiding damage.

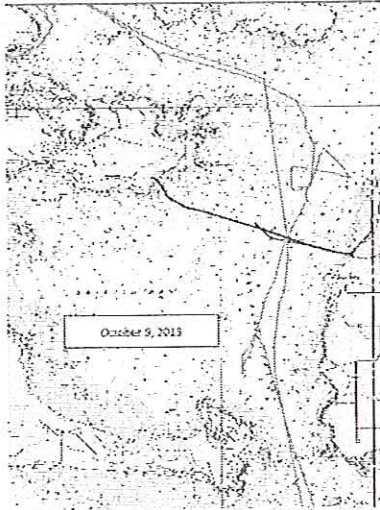
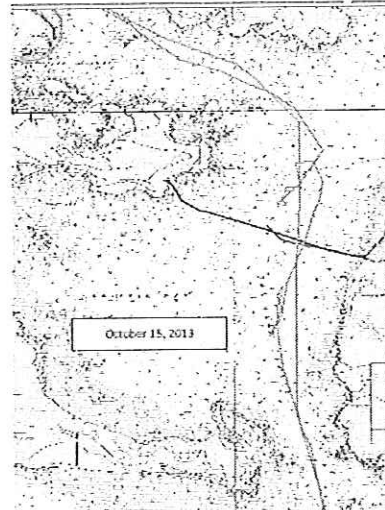
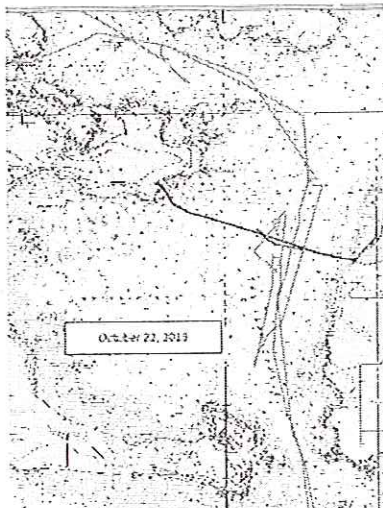
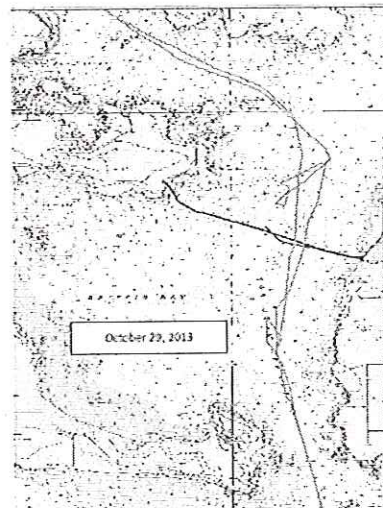
The RV Centennial calendar (available in the Friday Harbor Laboratory's website) indicated that the RV Centennial made similar cruises on October 9, October 15, October 22 and October 29 of 2013. Historical vessel tracks to the RV Centennial for those dates all show changes in speed and heading in the vicinity of the cable areas.

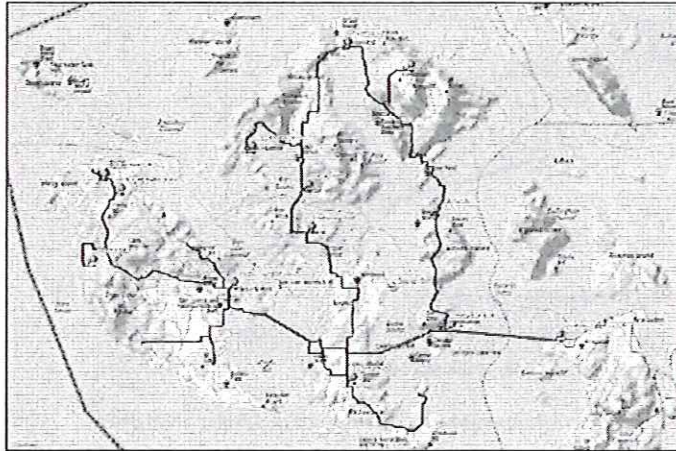
Figure 37 - Century Link Submarine Cables in the San Juan Islands

Century Link owns and operates several other submarine cables in the State of Washington. A map of Century Link fiber optic network is provided below. The submarine cable sections of the network have been highlighted in red.

NOAA nautical charts clearly show the cable areas associated with all of the Century Link cables in the San Juan Islands. Most of the cable crossings are in relatively shallow water and the threats from anchors and bottom fishing are low. The cable from Anacortes to Decatur Island crosses the Rosario Strait, which is a major shipping channel. More than 500 oil tankers pass through the strait each year, to and from the Cherry Point Refinery and refineries near Anacortes. The strait is in constant use by vessels bound for Cherry Point, Bellingham, Anacortes, and the San Juan Islands. There is a low risk of a large vessel dropping anchor, unintentionally or in an emergency situation. Should an anchor ever cause a break in the cable, a repair operation would be extremely difficult as the repair vessel would have to work in the middle of the shipping lanes. The company should contact Port Authorities to inquire about restrictions to performing repair operations in the Rosario Strait. Any such restriction would require special repair operations, possibly abandoning the cable in the shipping lanes and installing a new section of cable.
