**Test Report No. 607531-02-1-11**

**STANDARD DELINEATOR TESTING SPECIFIC TO  
MANAGED LANE USE FOR OPTIMIZATION OF  
SERVICE LIFE – PHASE 2**

**State of Florida Department of Transportation**

**TEXAS A&M TRANSPORTATION INSTITUTE PROVING GROUND**

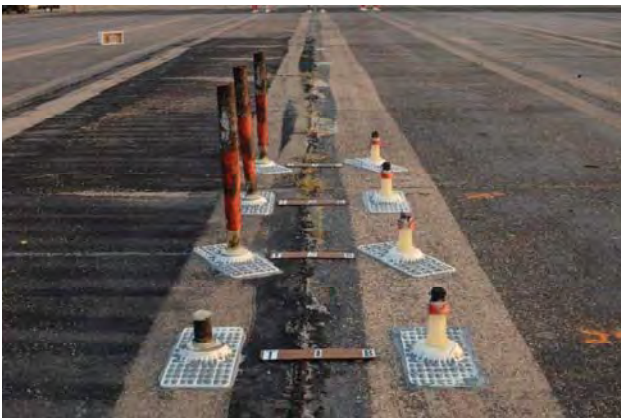
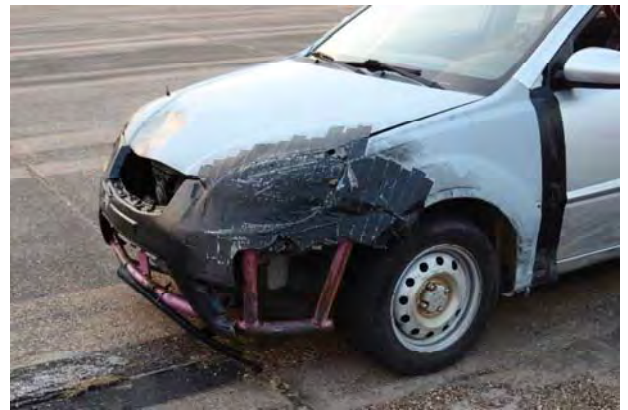
**Figure 3.36. 607531-02-9 Delineators and Test Vehicle after Testing (Concrete Surface).**

Table 3.8 documents the list/lean and failure modes witnessed under Test No. 607531-02-9. Testing was discontinued after Run 168, due to observed failure for the bumper impacts. Eleven of the samples failed to resist 168 impacts. A failure to restore to within 15 degrees of vertical was observed for delineator #6B on run 4, delineator #1B on run 19, delineator #7B on run 34, delineator #1T on run 121, and delineator #7T on run 127. A complete post tear was observed for delineator #8B on run 12, delineator #2B on run 16, delineator #5B on run 27, delineator #3B on run 28, and delineator #4B on run 32. A tear of more than 50% of the cross section was observed for delineator #5T on run 62, and delineators #2T, #3T, #4T, #6T, and #8T completed 168 runs without failure. Ambient temperature was greater than or equal to 82°F throughout the conducted test.

The primary mode of failure was exceeding the maximum allowable degree of list/lean and post fracture near the bolt connections.

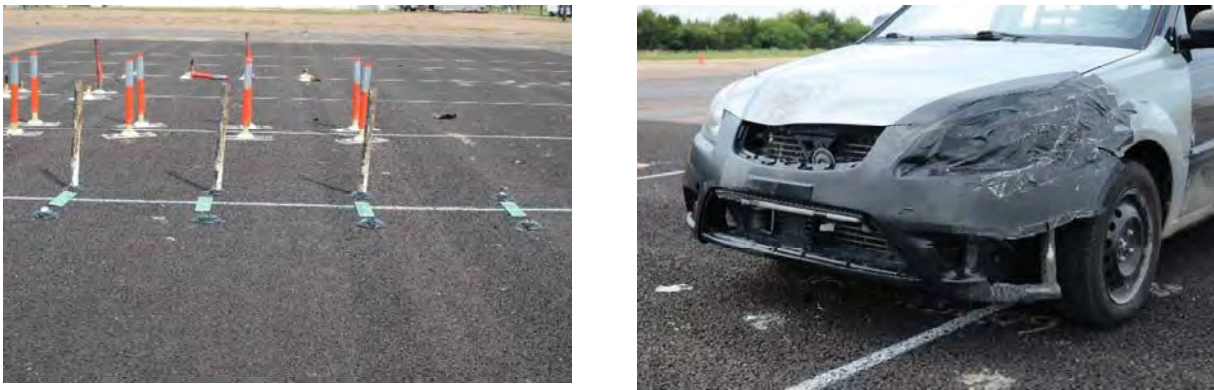
Figure 3.41. 607531-02-10 Delineators and Test Vehicle after Testing.

Table 3.9 documents the list/lean and failure modes witnessed under Test No. 607531-02-10. Five samples failed to resist 200 impacts. A failure to restore to within 15 degrees of vertical was observed for delineator #2B on run 33, delineator #4B on run 39, delineator #3B on run 58, delineator #1B on run 62, and delineator #4T on run 108. Delineators #1T, #2T, and #3T completed 200 runs without failure. Ambient temperature was greater than or equal to 82°F throughout the conducted test.

The primary mode of failure was exceeding the maximum allowable degree of list/lean and tearing of the post.

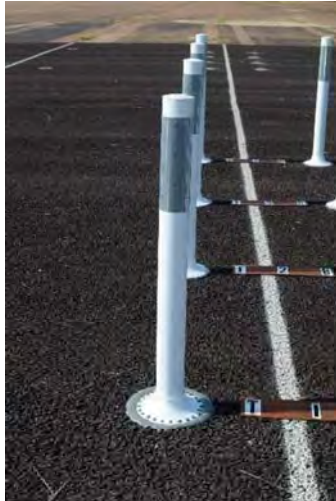
Figure 3.50. 607531-02-1 Product Sample.

Test No. 607531-02-1, performed on July 17, 2017, was an impact durability test on 36-inch Pexco – Davidson Traffic Control Products’ City Post 8GD36ORG101 Glue Down Samples secured with FIRMmarker™ #18M900C20 2-part epoxy adhesive on asphalt as shown in Figure 3.50. The product resisted an average of 186 tire impacts, and an average of 32 bumper impacts. Table 3.11 shows a summary of the results. The primary mode of failure was fracturing of the samples near the base and exceeding the maximum allowable degree of list/lean.

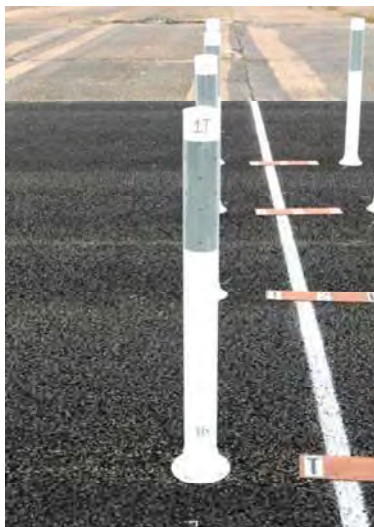
Figure 3.51. 607531-02-2 Sample.

Test No. 607531-02-2, performed on September 20 and 22, 2017, was an impact durability test on 36-inch tall Pexco City Post 8SM36ORG101 mechanical anchor samples secured with BOLTHOLD™ Asphalt Anchors Model SP-10 on asphalt, as shown in Figure 3.51. The product resisted an average of 141 tire impacts, and an average of 91 bumper impacts. Table 3.12 shows a summary of the results. The primary mode of failure was fracturing of the samples near the base and exceeding the maximum allowable degree of list/lean.

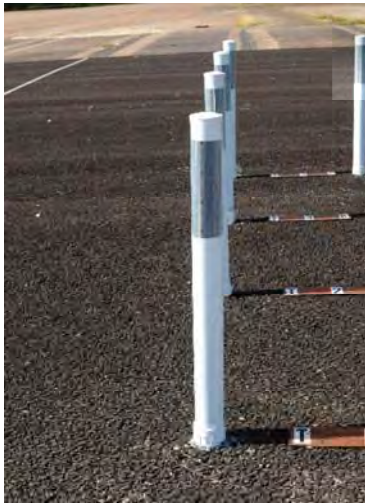
Figure 3.52. 607531-02-3 Sample.

Test No. 607531-02-3, performed on July 19, 2017, was an impact durability test on 36-inch Pexco City Post Samples secured with embedded anchor cups as shown in Figure 3.52. The product resisted an average of 74 tire impacts, and an average of 14 bumper impacts.

Table 3.13 shows a summary of the results. The primary mode of failure was exceeding the maximum allowable degree of list/lean and post fracture near the base.

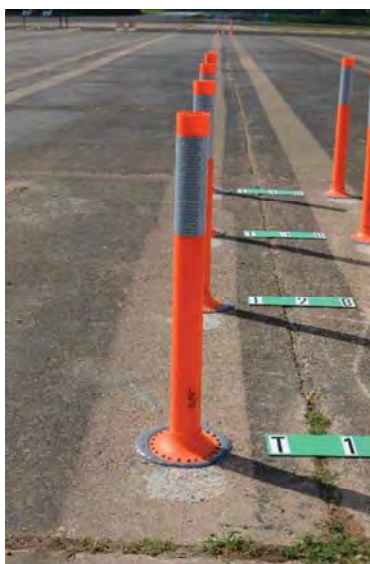
**Figure 3.53. 607531-02-4 Sample  
(Concrete Surface).**

Test No. 607531-02-4, performed on September 19, 2017, was an impact durability test on Pexco City Post 8GD36ORG101 Glue Down samples secured by E-BOND 1240/1241 2-part epoxy adhesive, 8 each on concrete surface and 8 each on asphalt surface, as shown in Figures 3.53 and 3.54. The 36-inch delineators resisted an average of 102 tire and 106 bumper impacts on the concrete surface and 130 tire and 75 bumper impacts on the asphalt surface. Tables 3.14 and 3.15 show a summary of the results for each surface. The primary mode of failure was tearing of the post approximately one foot above the base and fracture of the post at the base.

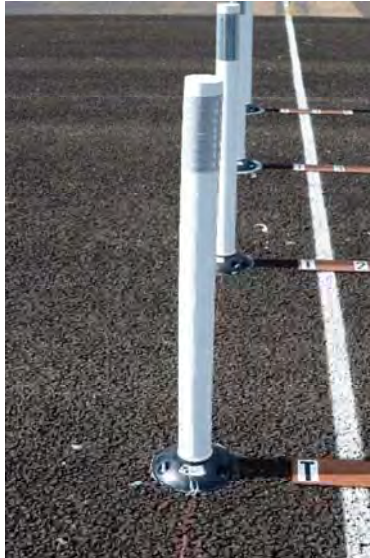
Figure 3.55. 607531-02-5 Sample (SHEPX-13-K1).

The primary mode of failure was post separation at the base. This was mainly caused by the pin tearing through the bottom of the post.

Test No. 607531-02-5, performed on July 13, 2017, was an impact durability test on Safe-Hit® Dura-Post™ Surface Mount samples, 4 each secured by SHEPX-13-K1 epoxy, and 4 each by FIRMmarker™ #18M900C20 2-part epoxy adhesive, as shown in Figures 3.55 and 3.56. With the SHEPX-13-K1 epoxy, the product resisted an average of 200 tire impacts, and an average of 24 bumper impacts. With the FIRMmarker™ epoxy, the product resisted an average of 200 tire impacts, and an average of 22 bumper impacts. Tables 3.16 and 3.17 show a summary of the results for each epoxy. The primary mode of failure was post separation at the base. This was mainly caused by the pin tearing through the bottom of the post.

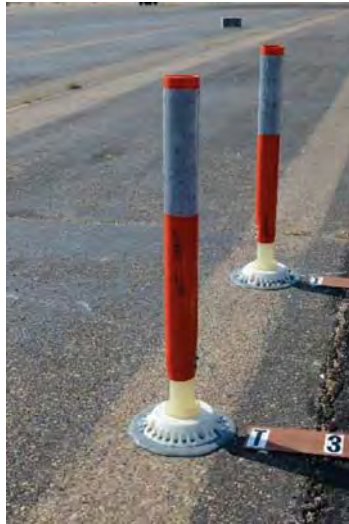
Figure 3.57. 607531-02-7 Sample (Concrete Surface).

The primary mode of failure was tearing of the posts near the bolt connections.

Test No. 607531-02-7, performed on September 4 and September 18, 2017, was an impact durability test on Flexstake 780 Series 9-inch Base Tubular Surface Mount samples secured to the concrete and asphalt surfaces using E-BOND 1240/1241 2-part epoxy adhesive, 8 each on concrete surface and 8 each on asphalt surface, as shown in Figures 3.57 and 3.58. The tested delineators resisted an average of 110 tire and 26 bumper impacts on the concrete surface and 102 tire and 30 bumper impacts on the asphalt surface. Tables 3.18 and 3.19 show a summary of the results for each surface. The primary mode of failure was tearing of the posts near the bolt connections.

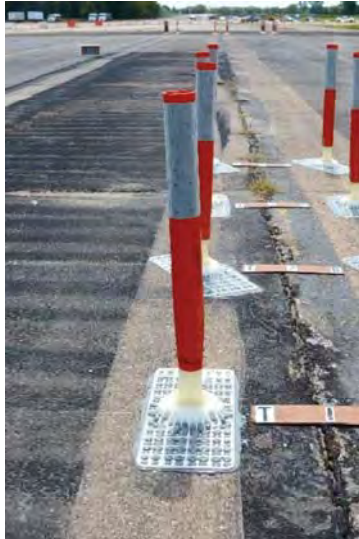
Figure 3.59. 607531-02-9 Sample (Concrete Surface).

Test No. 607531-02-9, performed on September 5, 2017, was an impact durability test on Flexstake 780 Series 10-inch × 24-inch Base Tubular Surface Mount samples secured to the concrete and asphalt surfaces using E-BOND 1240/1241 2-part epoxy adhesive, 8 each on concrete surface and 8 each on asphalt surface, as shown in Figures 3.59 and 3.60. The tested delineators resisted an average of 156 tire and 24 bumper impacts on the concrete surface and 131 tire and 19 bumper impacts on the asphalt surface. Tables 3.20 and 3.21 show a summary of the results for each surface. The primary mode of failure was exceeding the maximum allowable degree of list/lean and post fracture near the bolt connections.

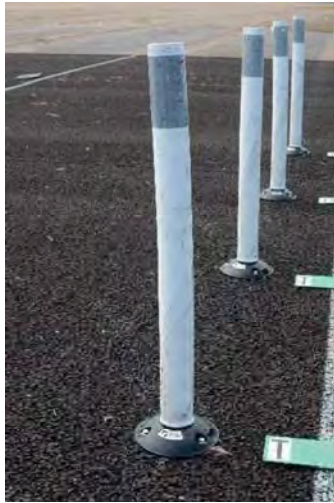
**Figure 3.61. 607531-02-10 Sample (Powers Wedge-Bolt).**

Test No. 607531-02-10, performed on September 26, 2017, was an impact durability test on Safe-Hit® Dura-Post® Surface Mount Mechanical Anchor samples, 4 each secured by Powers Wedge-Bolt anchors, and 4 each by Coupling Nut and Bolt anchors, and shown in Figures 3.61 and 3.62. With the Powers Wedge-Bolt anchors, the product resisted an average of 200 tire impacts, and an average of 48 bumper impacts. With the Coupling Nut and Bolt anchors, the product resisted an average of 154 tire impacts, and an average of 49 bumper impacts. Tables 3.22 and 3.23 show a summary of the results for each mechanical anchor. The primary mode of failure was exceeding the maximum allowable degree of list/lean and tearing of the post.

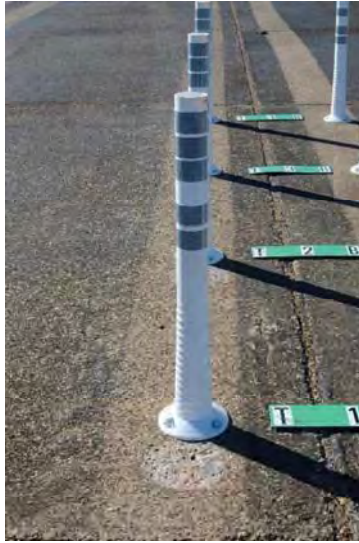
**Figure 3.63. 607531-02-11 Sample (Concrete Surface).**

Test No. 607531-02-11, performed on October 26, 2017, was an impact durability test on eNdoto Evelux Flexible Rib-Post Samples secured, 8 each on concrete and 8 each on asphalt. The base of the eNdoto Evelux Flexible Rib-Post Delineator with 3 Point Anchor Base (Part #EV-12221-36) was anchored to the concrete surface using a 3-point pin system. The base of the eNdoto Evelux Flexible Rib-Post Delineator and Base (Part #EV-12231-36) was anchored to the asphalt surface using FIRMmarker™ #18M900C20 2-part epoxy adhesive. Figures 3.63 and 3.64 show the two different product samples. The tested delineators resisted an average of 1 tire and 1 bumper impacts on the concrete surface and 43 tire and 9 bumper impacts on the asphalt surface. Tables 3.24 and 3.25 show a summary of the results for each surface. The primary

mode of failure was pull out of the mechanical anchors for the delineators on the concrete surface and exceeding the maximum allowable degree of list/lean for the delineators on the asphalt surface.
