February 16, 2012

RE: Puget Sound Energy- Ingham Fire
SEAL Job No. 21151.

12040 8th Avenue NE (gas line crossing oil vent line):

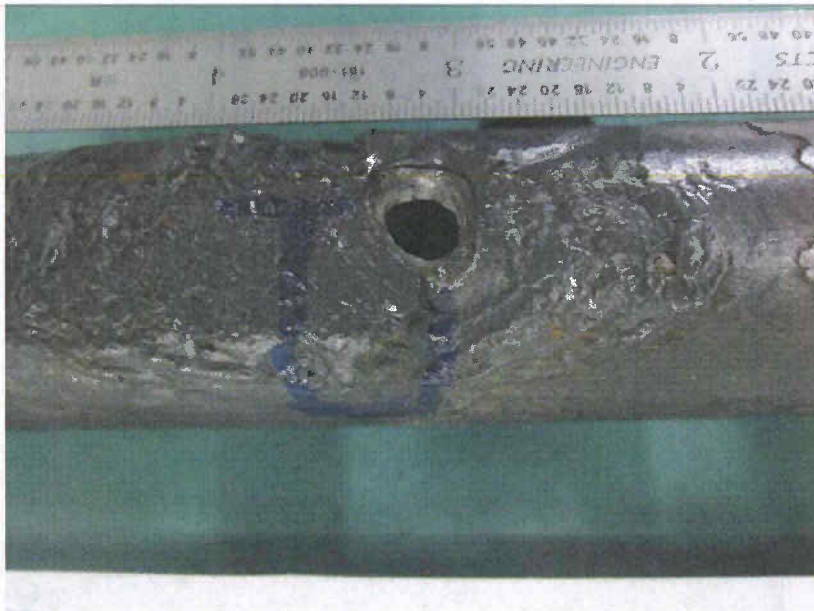
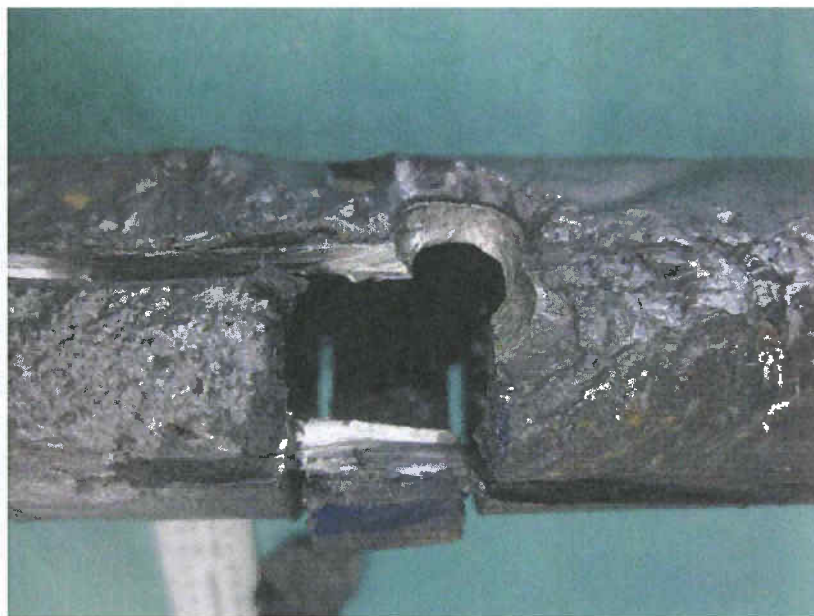
Figure 4. Detailed color photographs showing the marking at the hole and after cutting a portion of the hole from the gas line from 12040 8th Avenue NE.

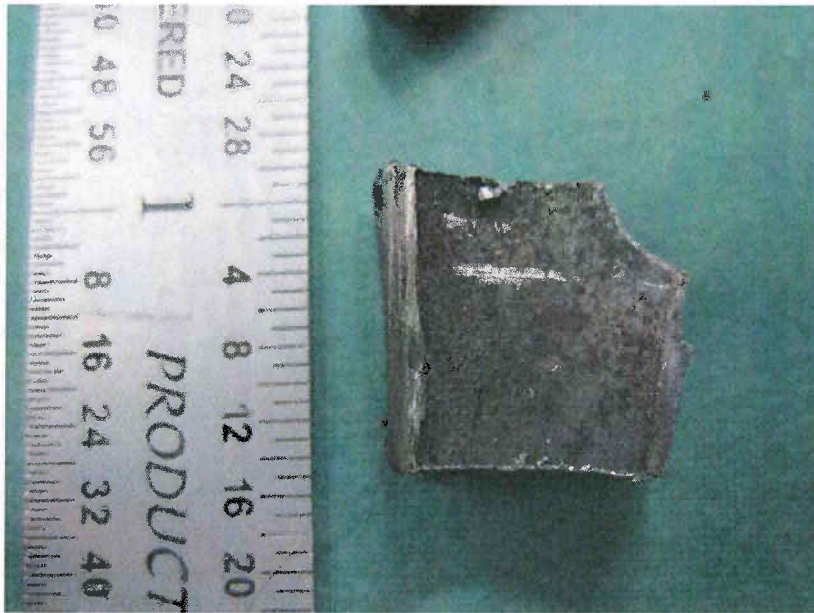
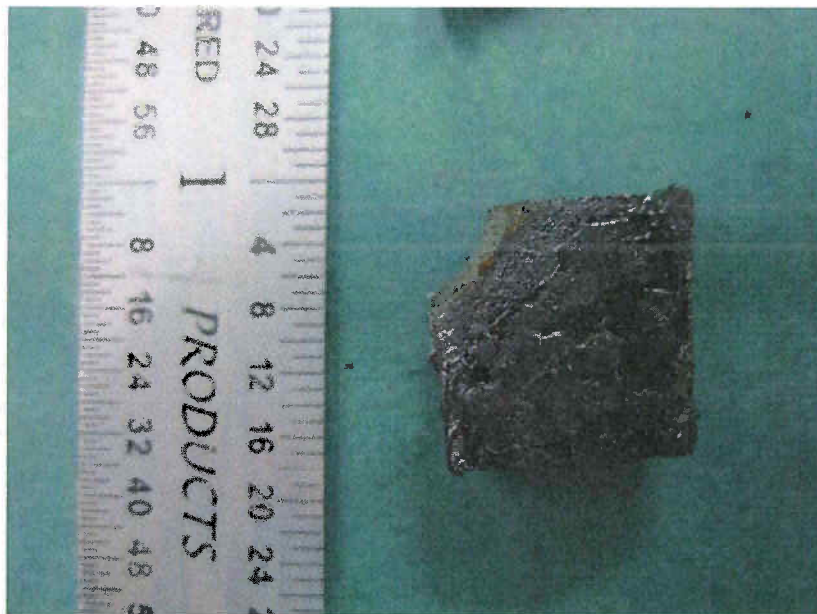
Figure 5. Detailed color photographs showing a section of the hole removed from the gas line from 12040 8th Avenue NE. (a) ID surface; (b) OD surface.

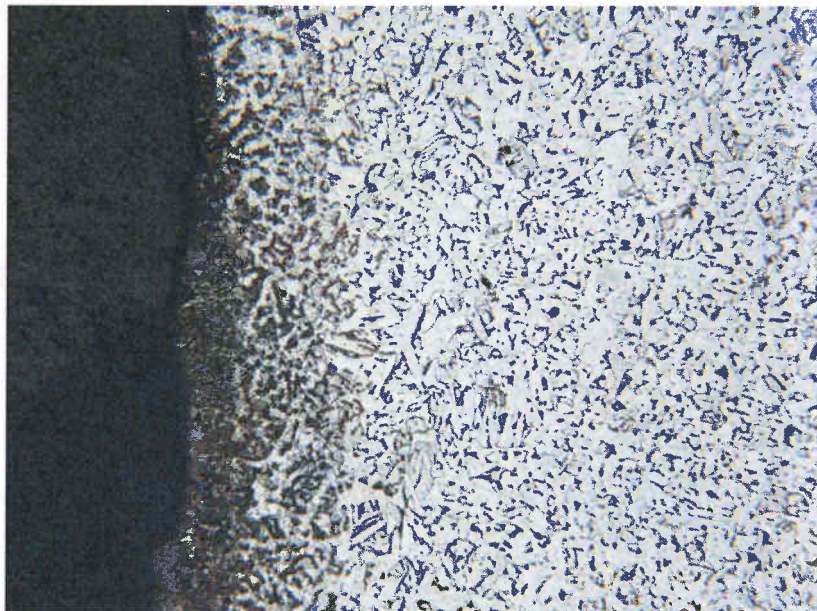
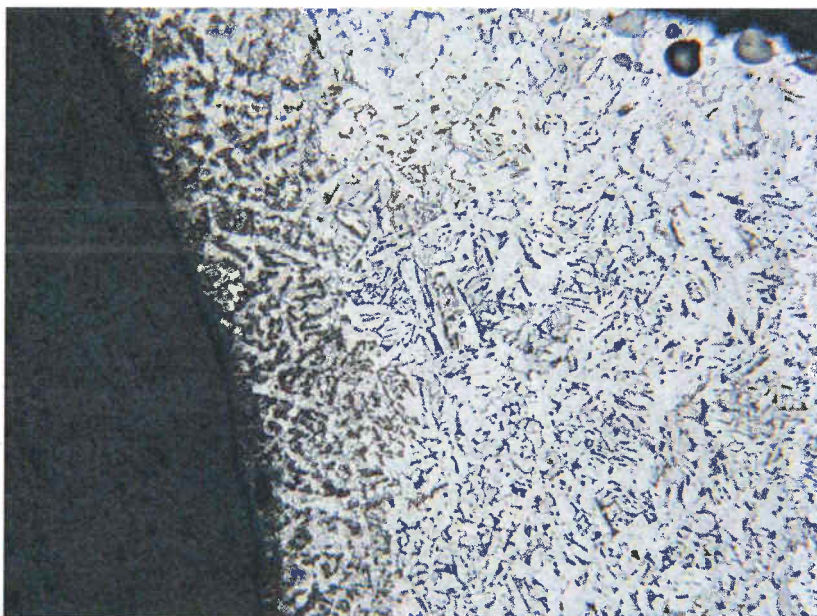
A metallographic mount was made with the hole wall in cross section. The mount was ground, polished and etched using standard metallographic procedures. The etched mount was examined using an optical microscope and the micrographs are presented in Figures 8-11. The surface of the hole from ID to OD revealed an altered microstructure due to melting and re-solidification of the surface; Figures 8-10. The hole surface also revealed a small void; Figure 10(a). The general microstructure of the steel indicates a low to medium carbon steel; Figure 11.

Figure 9. Detailed optical micrographs showing the hole surface in cross section of the sample removed from the gas line from 12040 8th Avenue NE. (a) Near OD surface, etched, 50X; (b) Away from OD surface, etched, 50X.

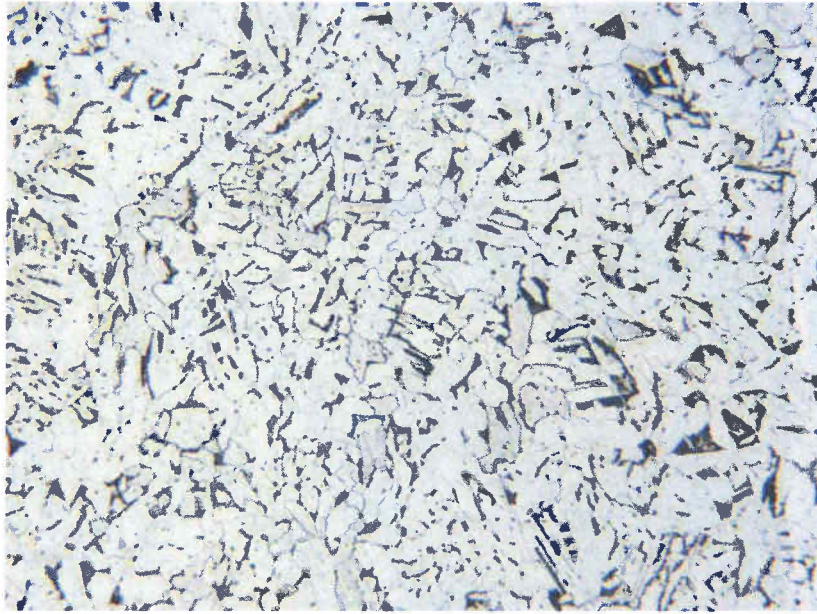
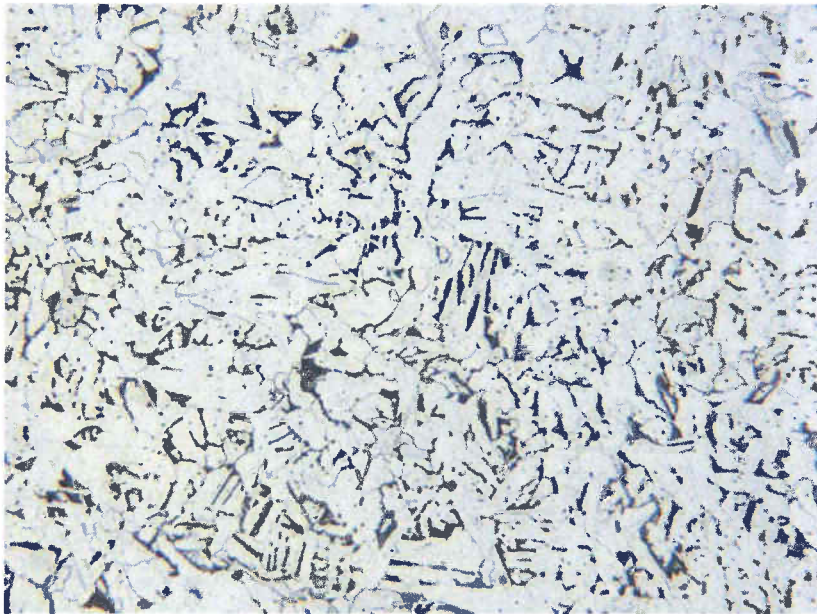
Figure 11. Detailed optical micrographs showing the metallurgical microstructure of steel section removed from the gas line from 12040 8th Avenue NE. (a) Etched, 100X; (b) Etched, 100X.

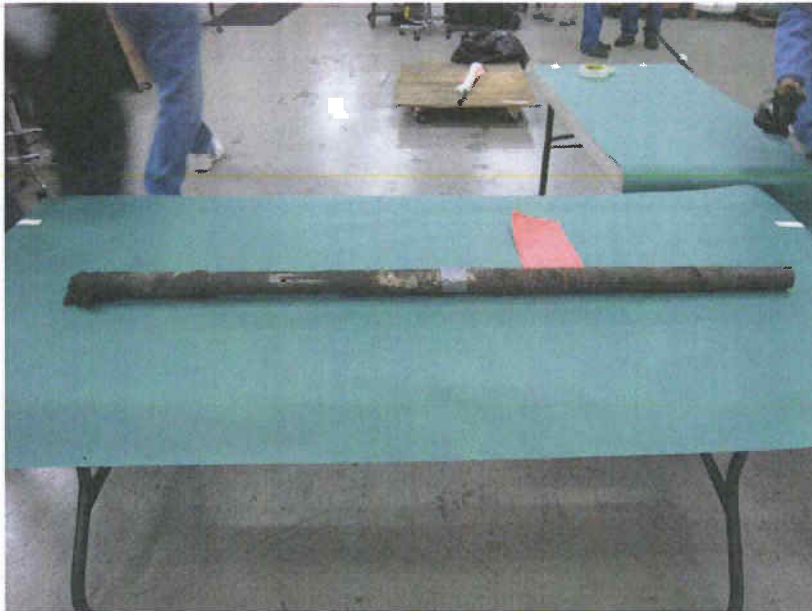
This pipe section was collected by Infrasource on 9-27-11, as evidenced by the tag attached to the pipe section; Figure 12. The gas service line pipe was made from steel, was 53 inches long with 1.69 inch outer diameter and wall thickness of 0.135 inch. The pipe contained a slightly oval hole with major and minor diameters as 0.48 inch and 0.40 inch; Figure 13. A section of the pipe was cut containing $\frac{1}{4}$ of the hole wall, as shown in Figure 14. The removed section contained the $\frac{1}{4}$ hole in a corner and is shown from the ID and OD side in Figure 15. The hole was clearly created from OD toward the ID, as seen by the missing material at the hole wall. The hole surface appeared smooth with no fracture features and re-solidified surface; Figure 16.

Figure 12. Color photographs showing the gas line from 913 NE 122nd Street and the attached tag.

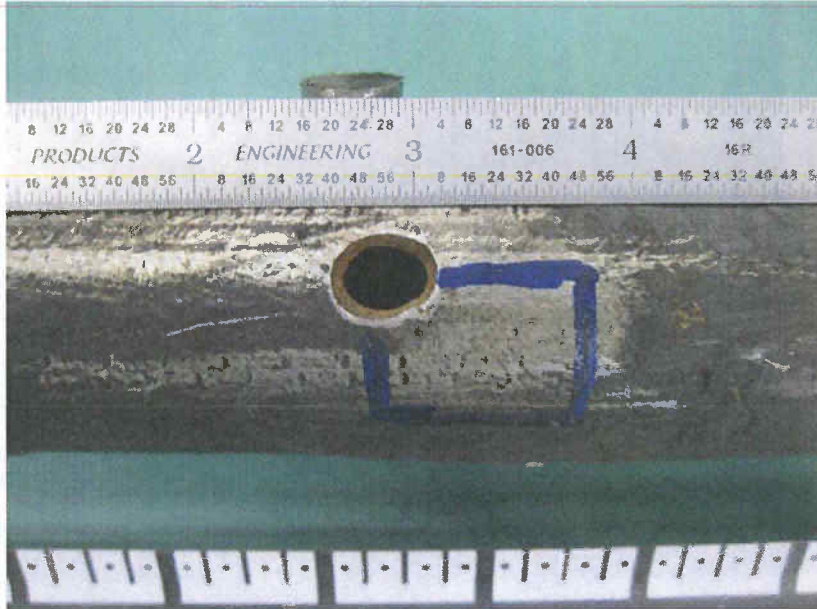
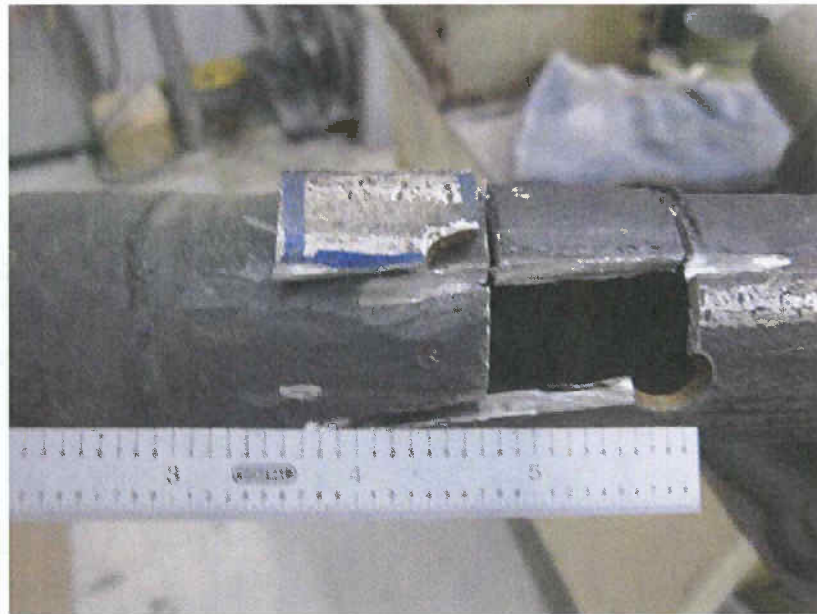
Figure 14. Detailed color photographs showing the marking at the hole and after cutting a portion of the hole from the gas line from 913 NE 122nd Street.

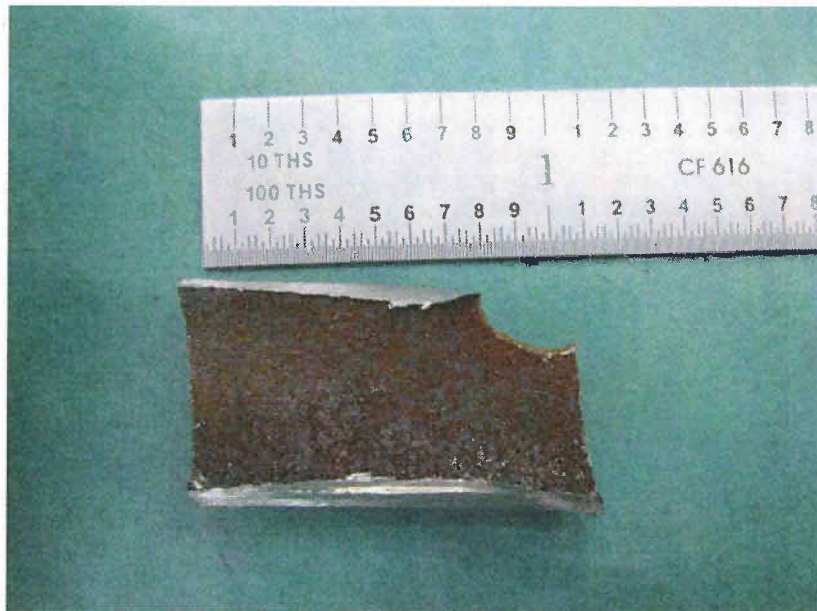
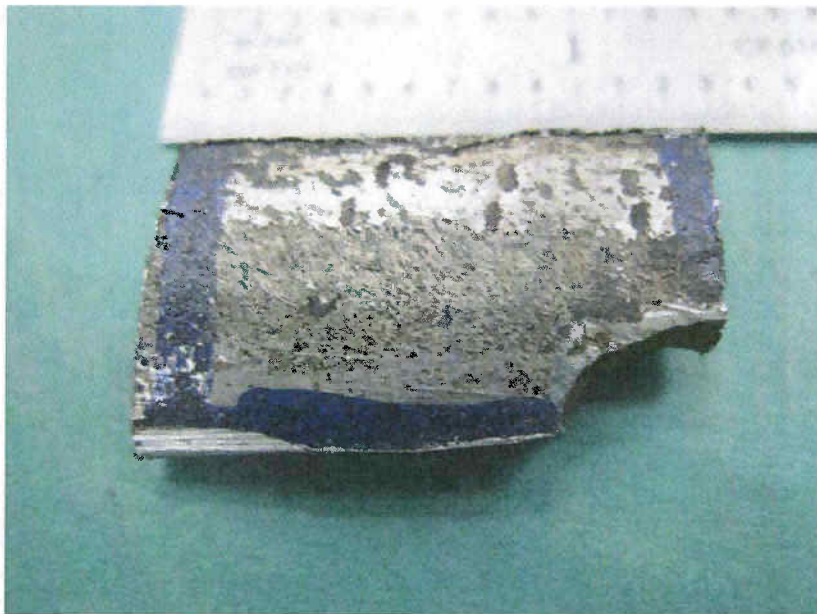
Figure 15. Detailed color photographs showing a section of the hole removed from the gas line from 913 NE 122nd Street. (a) ID surface; (b) OD surface.

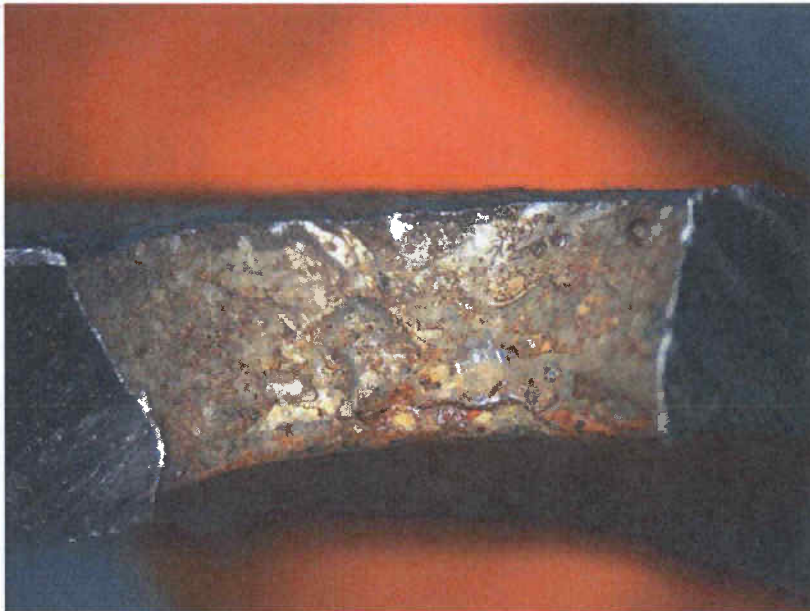
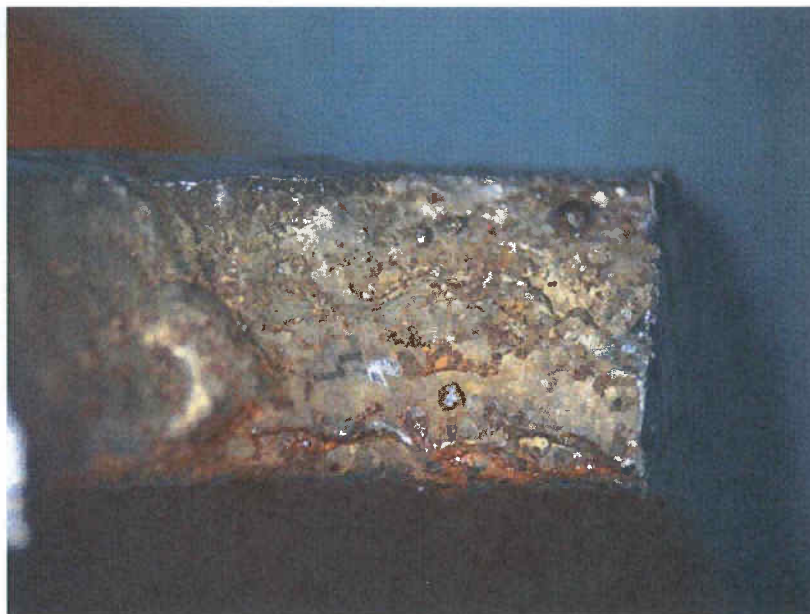
Figure 16. Detailed color photographs showing the hole surface of the section removed from the gas line from 913 NE 122nd Street. (a) Hole surface, 15X; (b) Hole Surface, 20X.

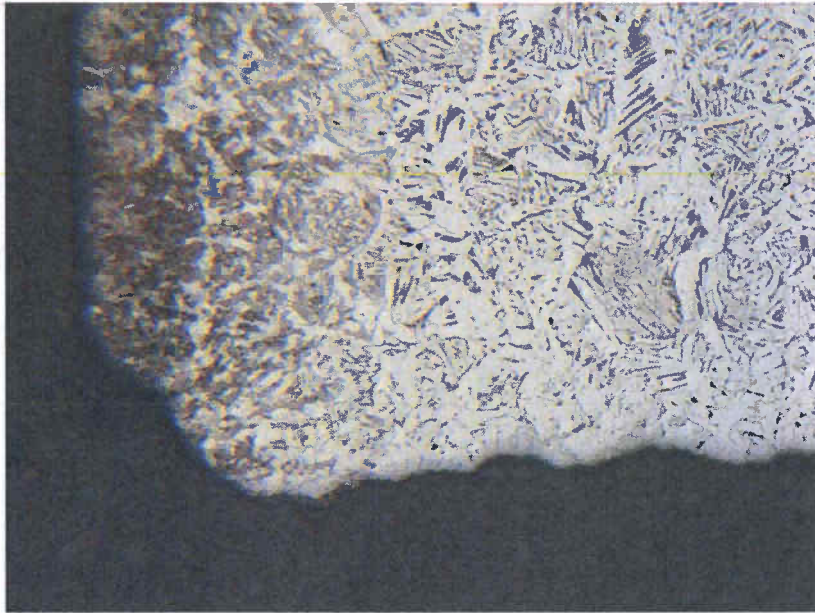
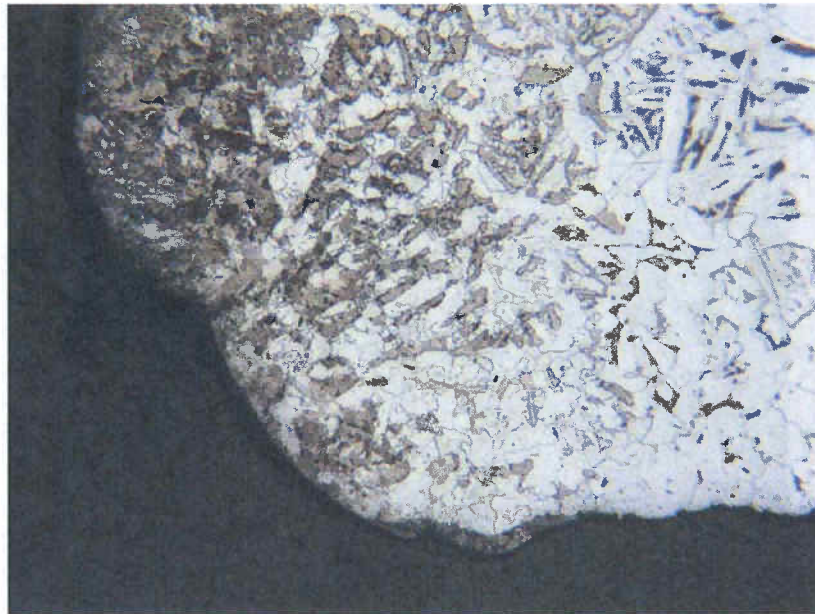
A metallographic mount was made with the hole wall in cross section. The mount was ground, polished and etched using standard metallographic procedures. The etched mount was examined using an optical microscope and the micrographs are presented in Figures 17-20. The surface of the hole from ID to OD revealed an altered microstructure due to melting and re-solidification of the surface; Figures 17-19. The general microstructure of the steel indicates a medium carbon steel; Figure 20.

Figure 18. Detailed optical micrographs showing the hole surface in cross section of the sample removed from the gas line from 913 NE 122nd Street. (a) ID surface, etched, 50X; (b) ID surface, etched, 100X.

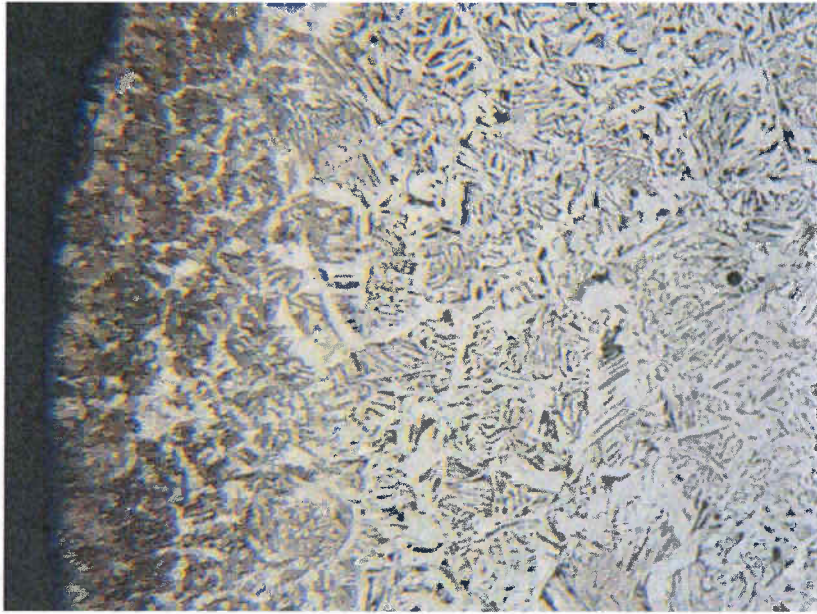
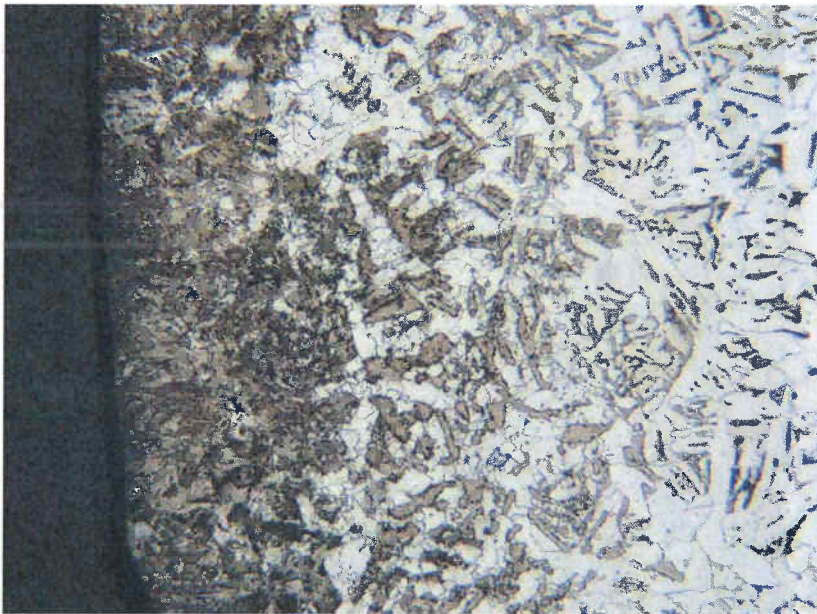
Figure 19. Detailed optical micrographs showing the hole surface in cross section of the sample removed from the gas line from 913 NE 122nd Street. (a) Near ID surface, etched, 50X; (b) Near ID surface, etched, 100X.

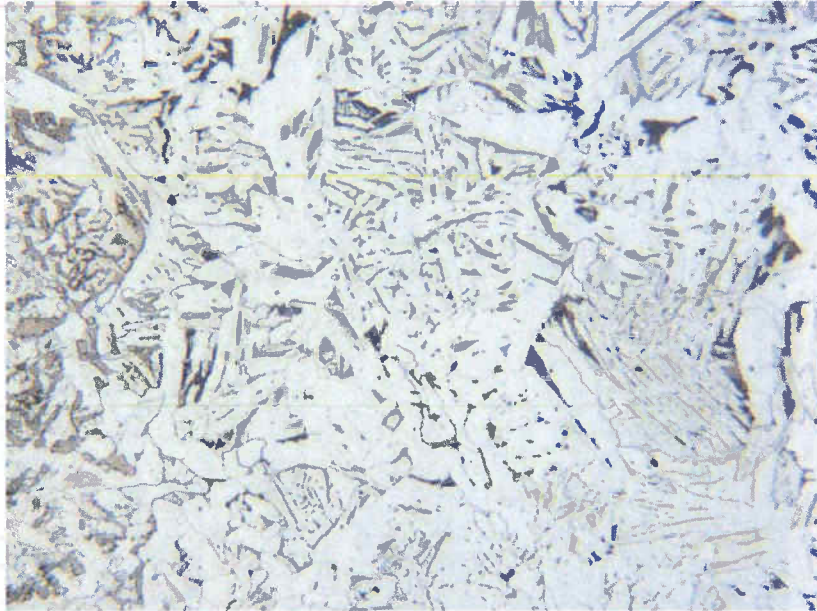
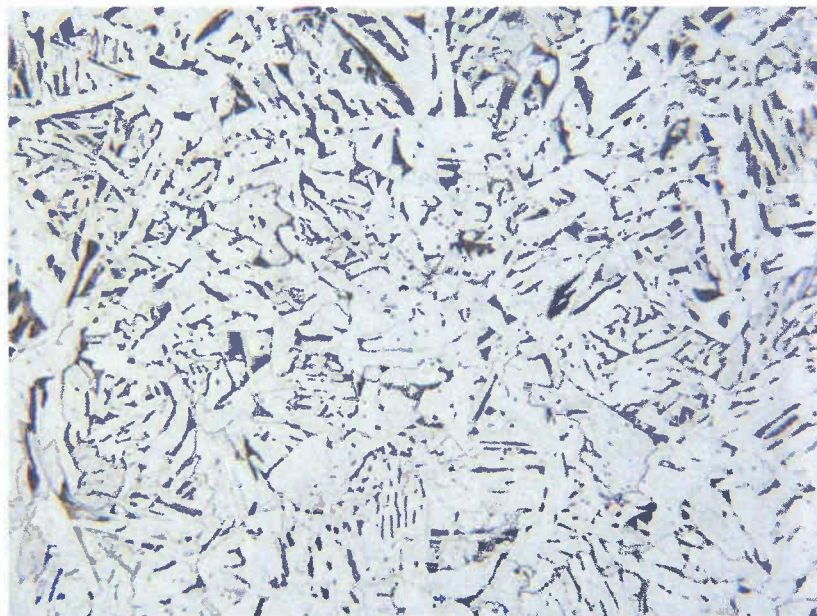
Figure 20. Detailed optical micrographs showing the metallurgical microstructure of steel section removed from the gas line from 913 NE 122nd Street E. (a) Etched, 100X; (b) Etched, 100X.

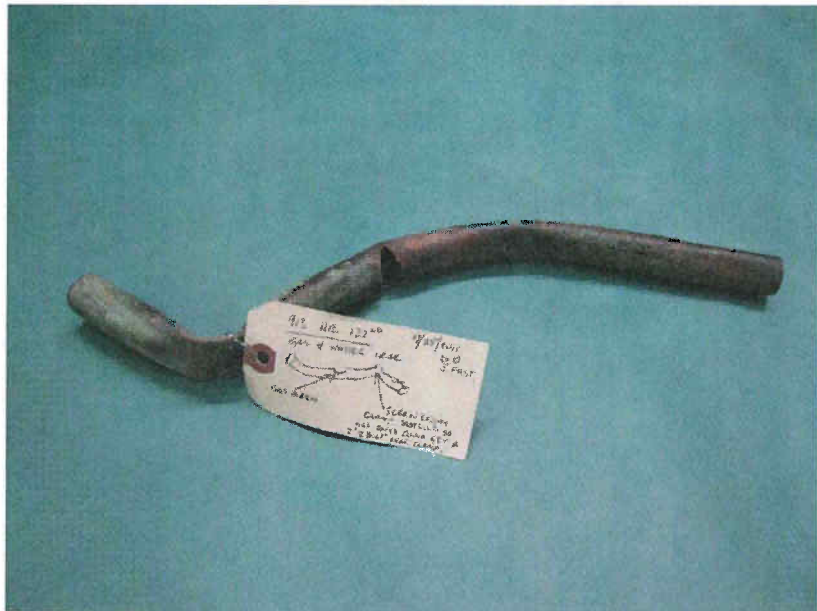
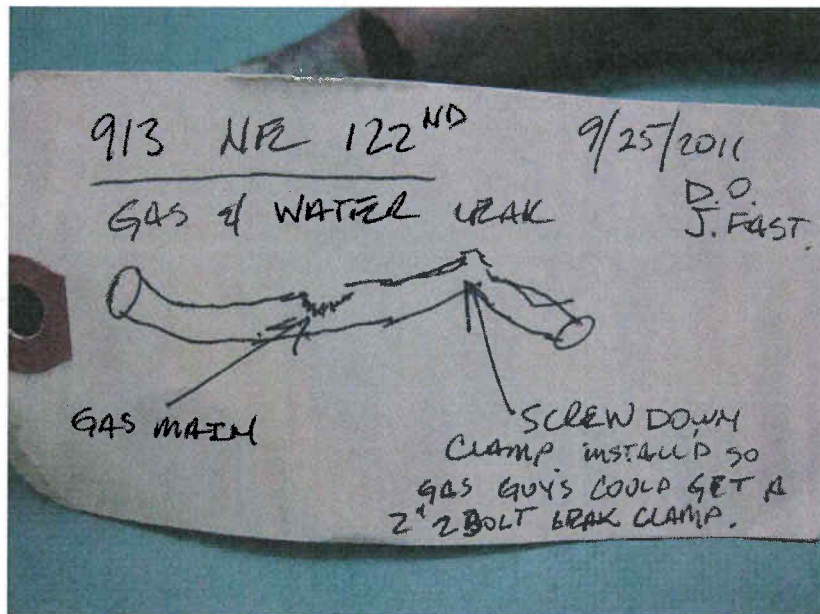
The copper water line that was allegedly in contact with the gas line is shown in Figure 21(a). The attached tag to the water line is shown in Figure 21(b). The periphery of the hole in the copper line shows melted copper balls, indicating it is caused by arcing; Figures 22 and 23. The line was clamped and pinched at a location adjacent to the hole; Figure 24.

Figure 21. Color photographs showing the copper water line from 913 NE 122nd Street and the attached tag.

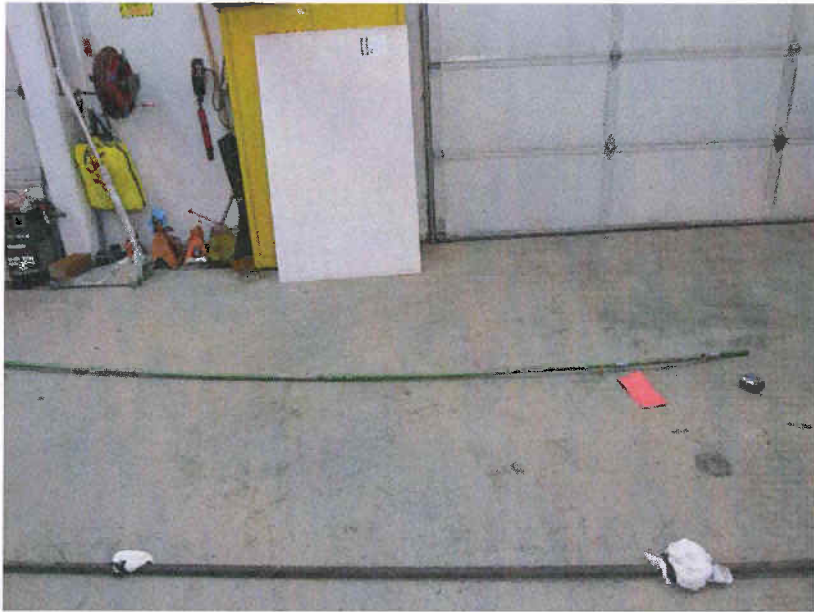
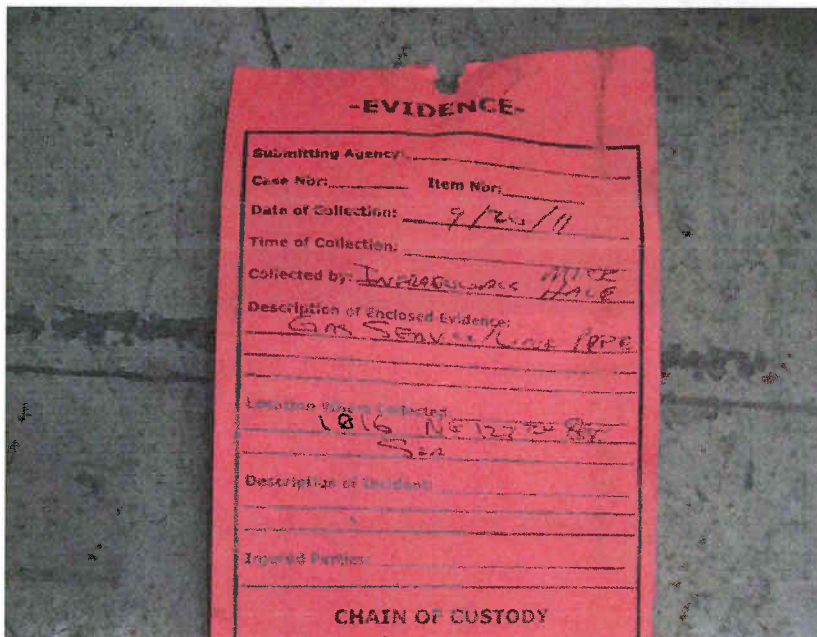
This pipe section was collected by Infrasource on 9-26-11, as evidenced by the tag attached to the pipe section; Figure 25. The gas service line pipe was made from steel, coated with green epoxy Scotchkote 101, was 158 inches long with 1.15 inch outer diameter and wall thickness of 0.11 inch. The pipe contained an irregular shaped oval hole with major diameter as 1.0 inch and minor diameter as 0.6 inch; Figure 26. The green coating had melted and evaporated or flaked off around the hole. A section of the pipe was cut containing $\frac{1}{4}$ of the hole wall, as shown in Figure 27. The removed section contained the $\frac{1}{4}$ hole in a corner and is shown from the ID and OD side in Figures 28-30. The hole was clearly created from OD toward the ID, as seen by the missing material at the hole wall. The hole surface appeared smooth with no fracture features and re-solidified surface; Figure 30.

Figure 25. Color photographs showing the gas line from 1016 NE 127th Street and the attached tag.

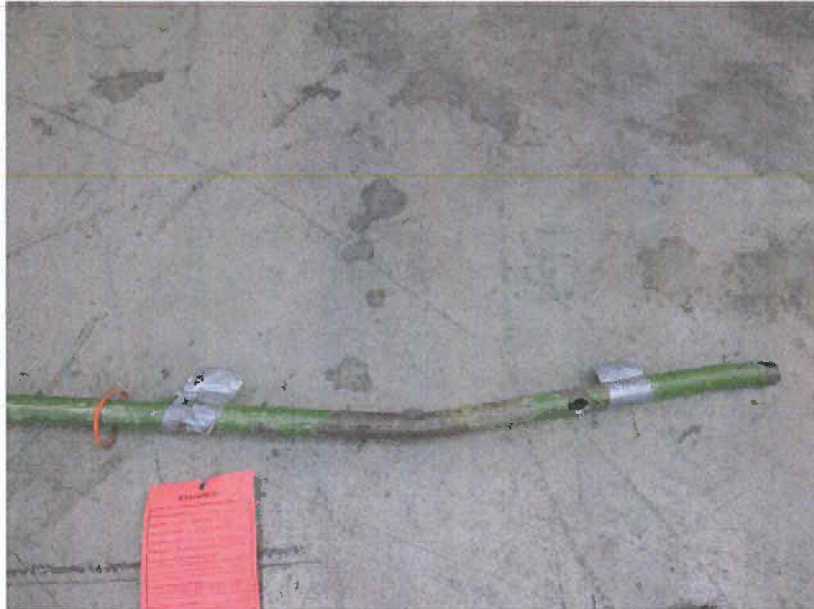
Figure 26. Detailed color photographs showing a hole in the gas line from 1016 NE 127th Street.

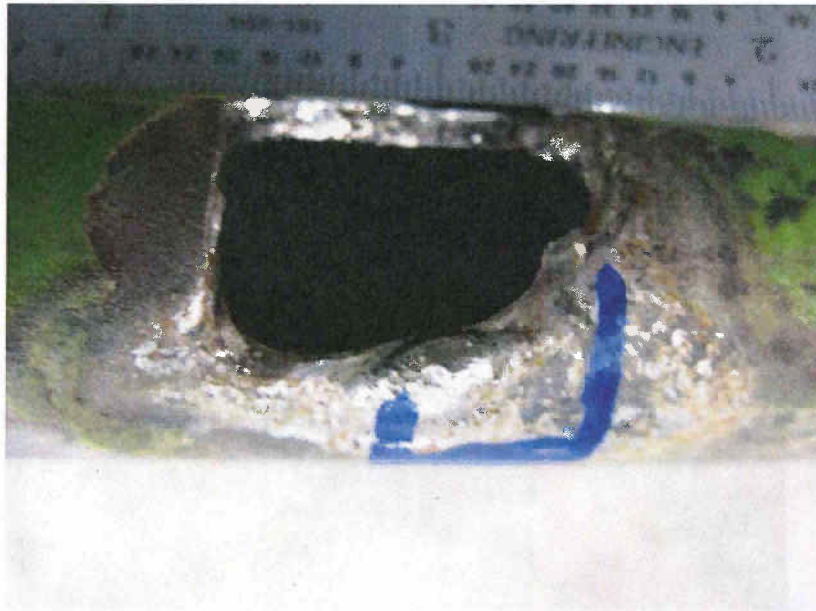
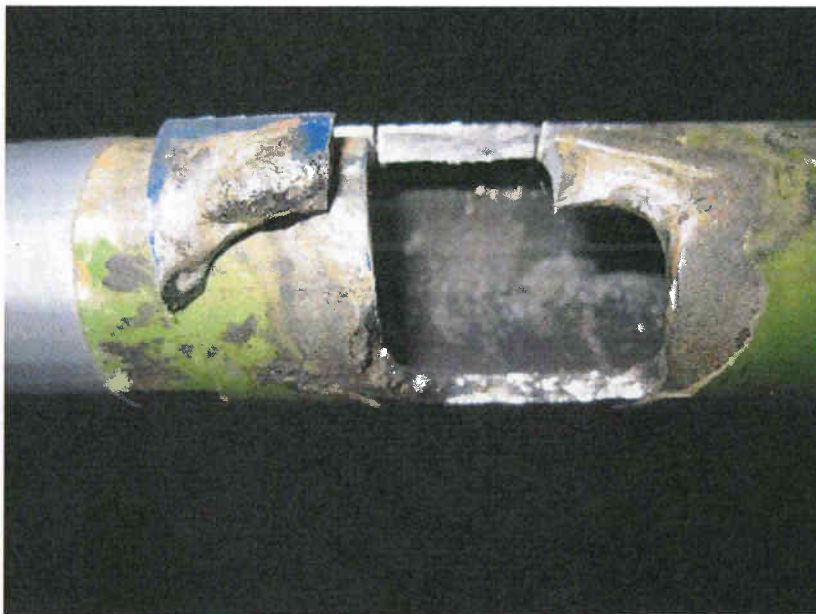
Figure 27. Detailed color photographs showing the marking at the hole and after cutting a portion of the hole from the gas line from 1016 NE 127th Street.

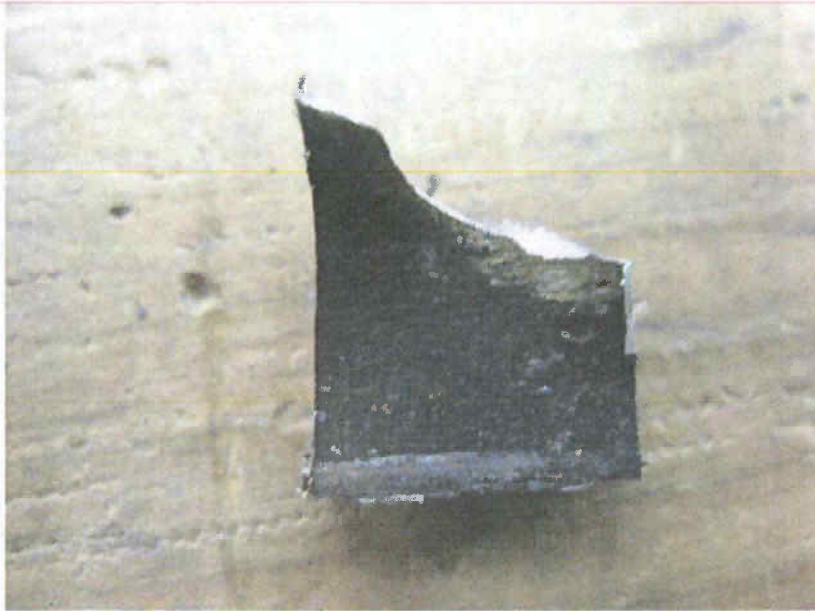
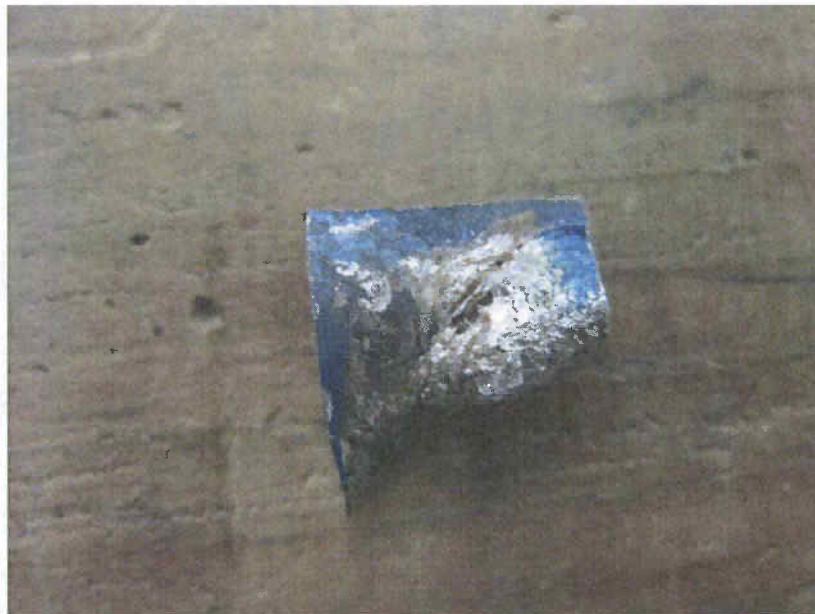
Figure 28. Detailed color photographs showing a section of the hole removed from the gas line from 1016 NE 127th Street. (a) ID surface; (b) OD surface.

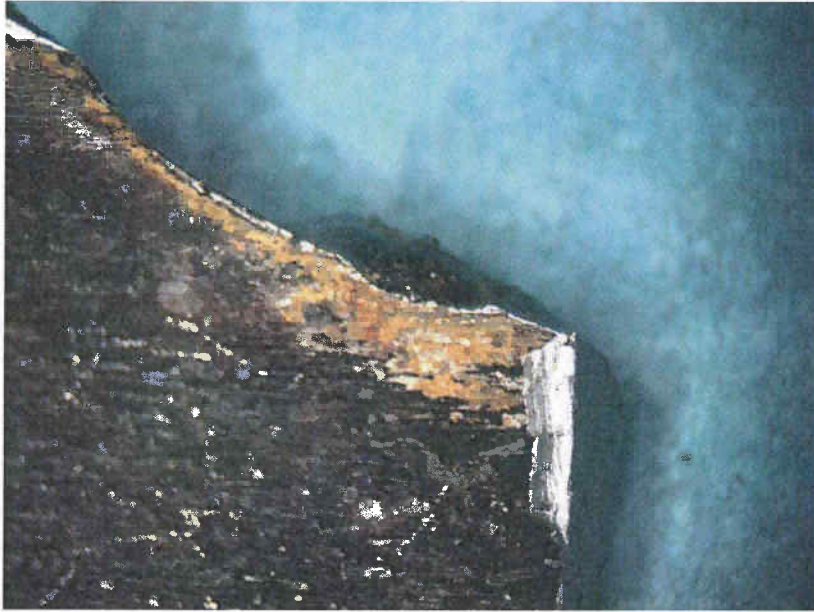
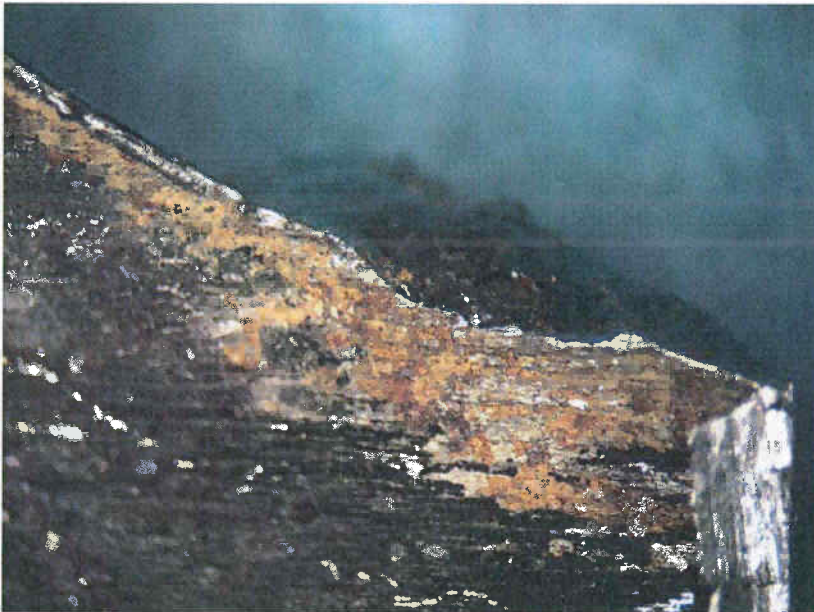
Figure 29. Detailed color photographs showing the ID surface near the hole of the section removed from the gas line from 1016 NE 127th Street. (a) ID surface, 10X; (b) ID Surface, 20X.

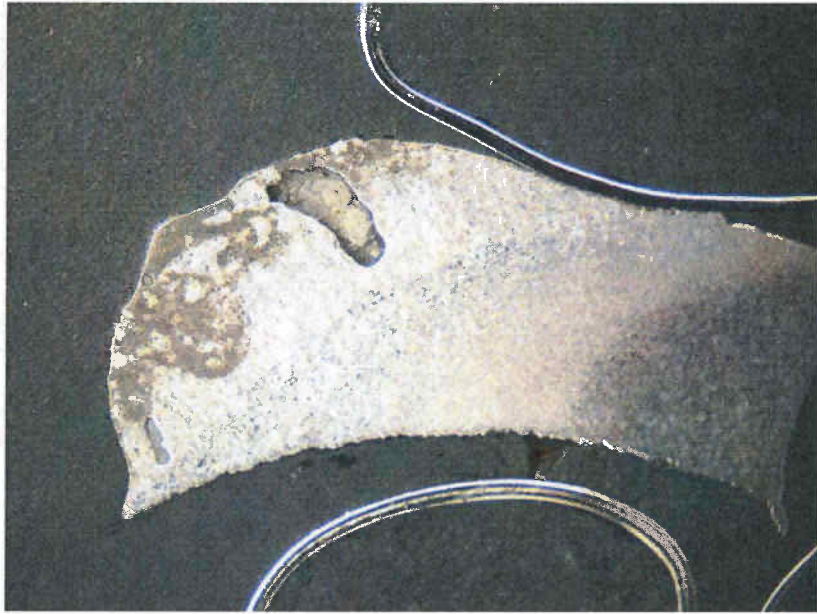
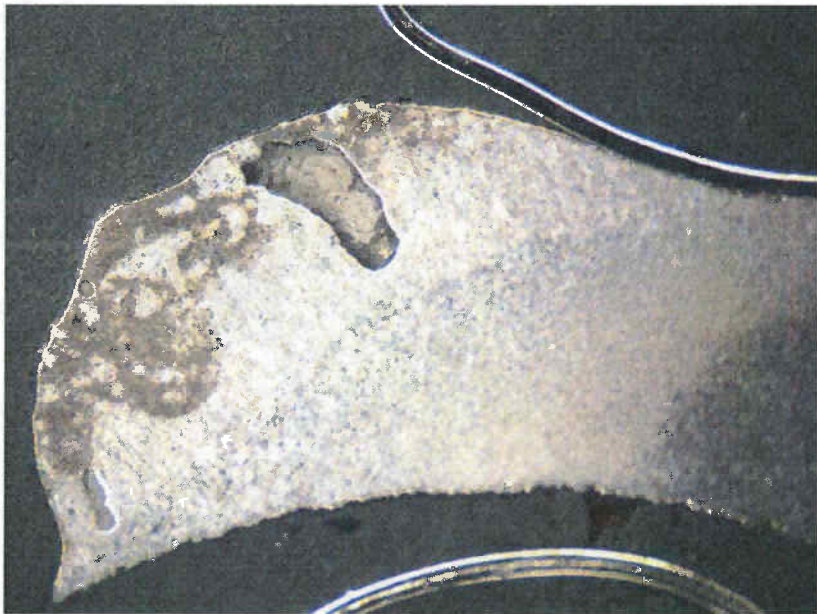
A metallographic mount was made with the hole wall in cross section. The mount was ground, polished and etched using standard metallographic procedures. The etched mount was examined using an optical microscope and the micrographs are presented in Figures 31-33. A large void (gas bubble) was present near the hole surface that was created during the arcing, melting and re-solidification process; Figure 31. The surface of the hole from ID to OD revealed an altered microstructure due to melting and re-solidification of the surface; Figure 32. The general microstructure of the steel indicates a medium carbon steel; Figure 33.

Figure 31. Optical micrographs showing the hole surface in cross section of the sample removed from the gas line from 1016 NE 127th Street. (a) Overall, etched, 15X; (b) Overall, etched, 20X.

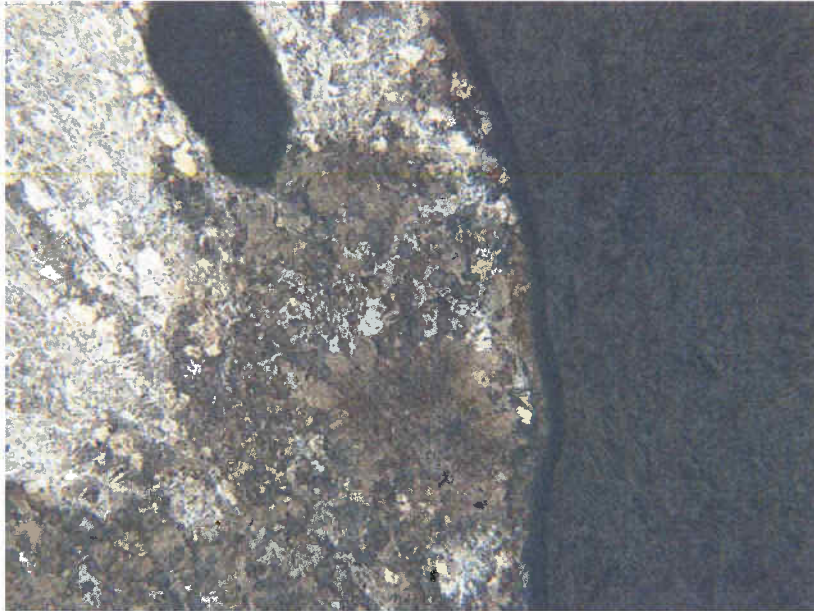
Figure 32. Detailed optical micrographs showing the hole surface in cross section of the sample removed from the gas line from 1016 NE 127th Street. (a) ID surface, etched, 50X; (b) ID surface, etched, 100X.

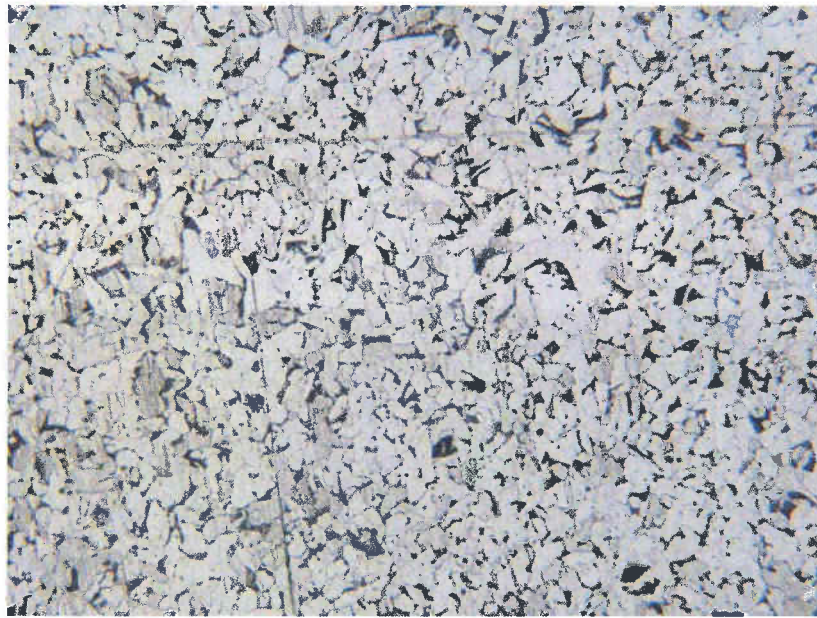
Figure 33. A detailed optical micrograph showing the metallurgical microstructure of steel section removed from the gas line from 1016 NE 127th Street. Etched, 100X.

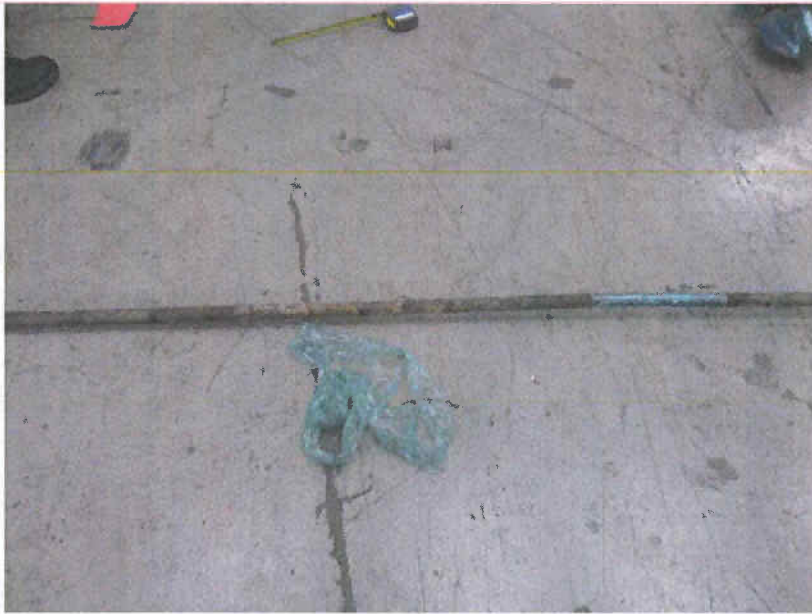
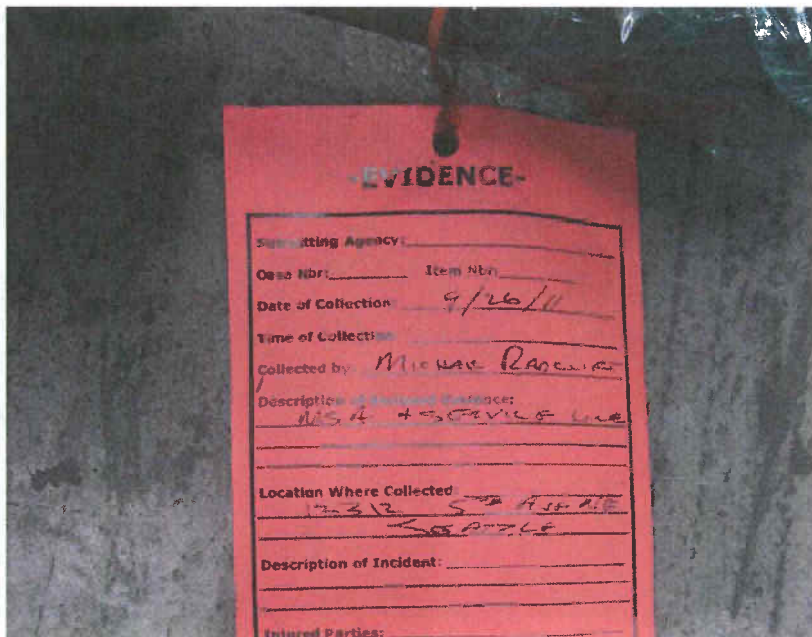
This pipe section was collected by Michael Radcliff on 9-26-11, as evidenced by the tag attached to the pipe section; Figure 34. The gas service line pipe was made from steel, surface coated, was 225 inches long with gas meter attached to one end of the pipe. The pipe has 1.08 inch outer diameter and wall thickness of 0.11 inch. The pipe contained a round hole on the bottom of the pipe with an average diameter of 0.25 inch on the OD surface. A small section of the pipe containing the hole was sectioned; Figure 35. Another section of the pipe containing the hole was marked and cut as shown in Figure 36. The removed section was further cut to expose the hole on the ID surface as shown from the ID and OD side in Figures 37. The hole surface on the OD appeared smooth with no fracture features and re-solidified surface.

Figure 34. Color photographs showing the gas line from 12312 5th Avenue NE and the attached tag.

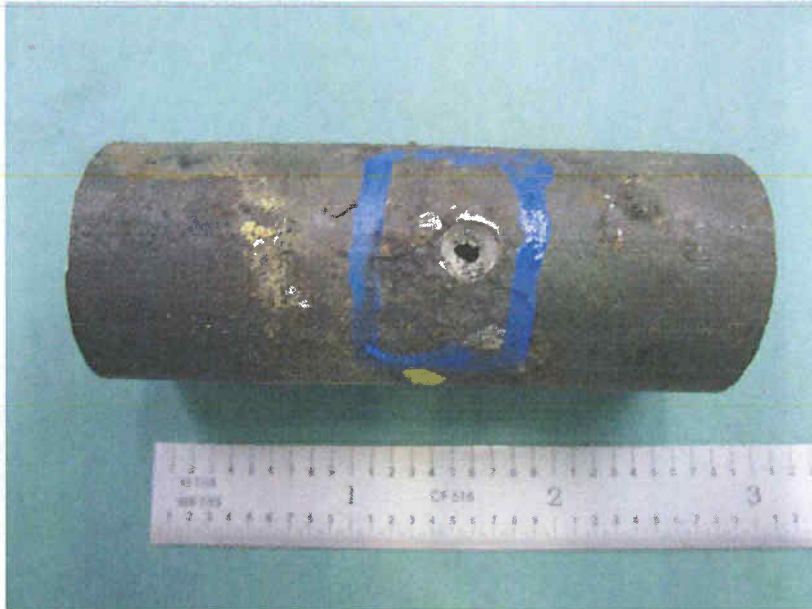
Figure 35. Detailed color photographs showing a hole in the gas line from 12312 5th Avenue NE.

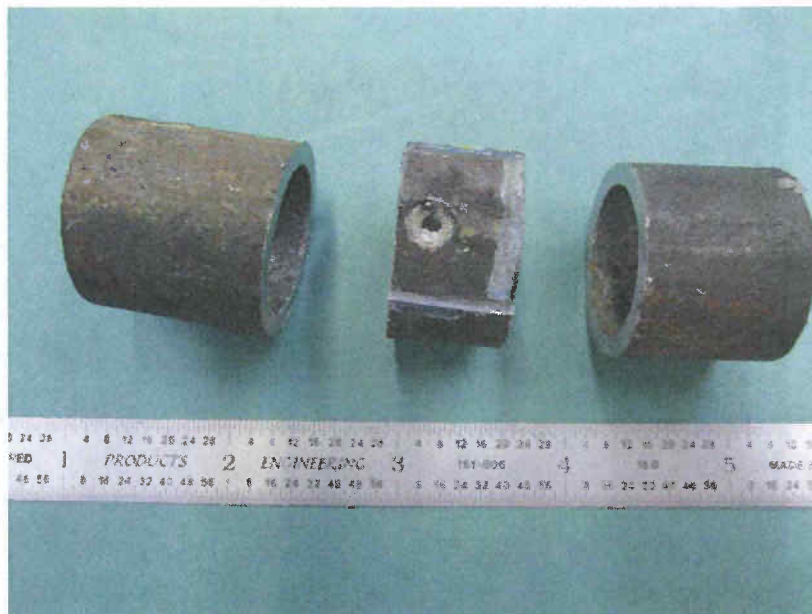
Figure 36. Detailed color photographs showing the marking around the hole and after cutting a portion of the pipe with the hole from the gas line from 12312 5th Avenue NE.
