February 16, 2012

RE: Puget Sound Energy- Ingham Fire
SEAL Job No. 21151.

12040 8th Avenue NE (gas line crossing oil vent line):

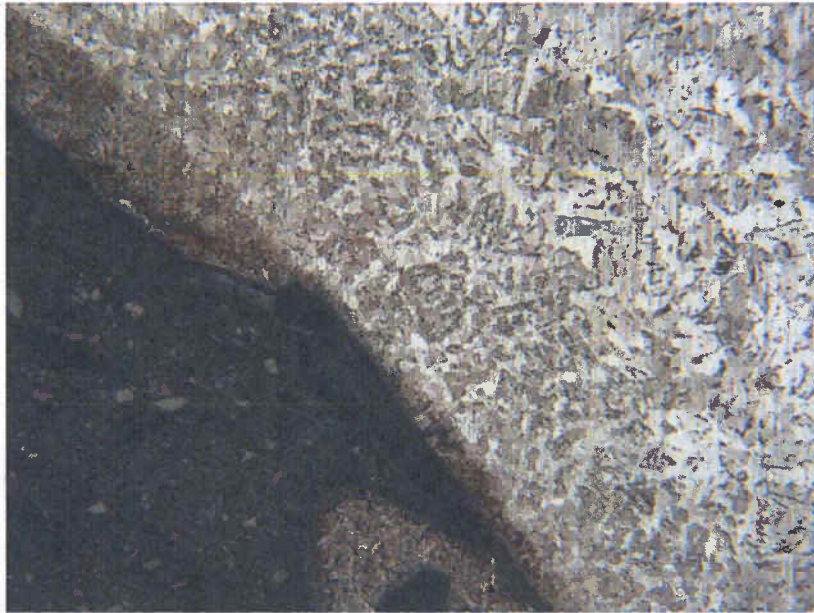
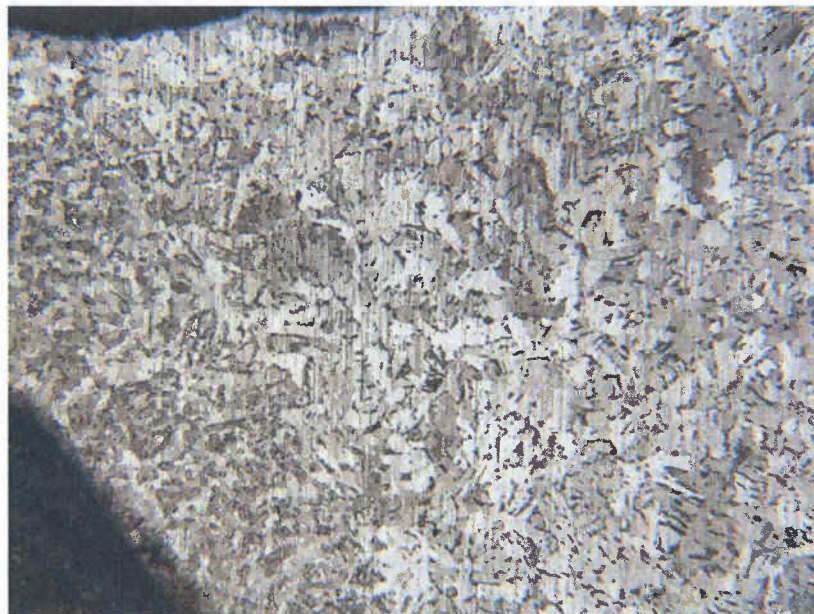
A metallographic mount was made with the entire hole in cross section. The mount was ground, polished and etched using standard metallographic procedures. The etched mount was examined using an optical microscope and the micrographs are presented in Figures 38-41. The hole was clearly created from OD toward the ID, as seen by the missing material; Figure 38. The surface of the hole from ID to OD revealed an altered microstructure due to melting and re-solidification of the surface. The general microstructure of the steel indicates a medium carbon steel; Figure 41.

Figure 40. Detailed optical micrographs showing the metallurgical microstructure of steel section removed from the gas line from 12312 5th Avenue NE. (a) At the hole surface, Etched, 50X; (b) At the hole surface, Etched, 50X.

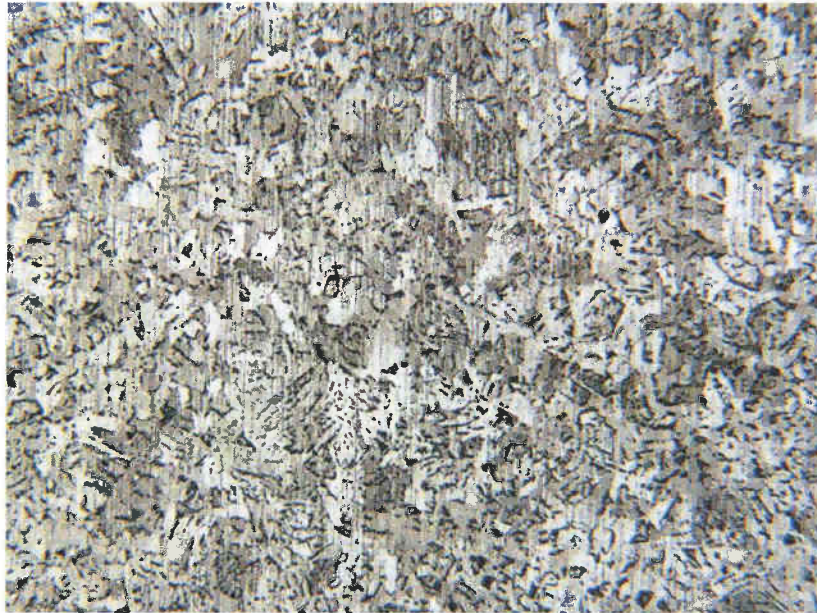
Figure 41. A detailed optical micrograph showing the metallurgical microstructure of steel section removed from the gas line from 12312 5th Avenue NE. Etched, 50X.

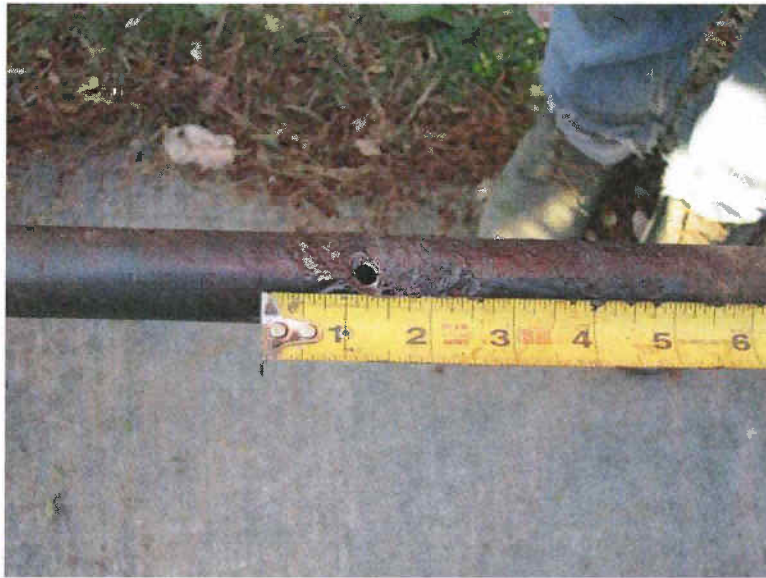
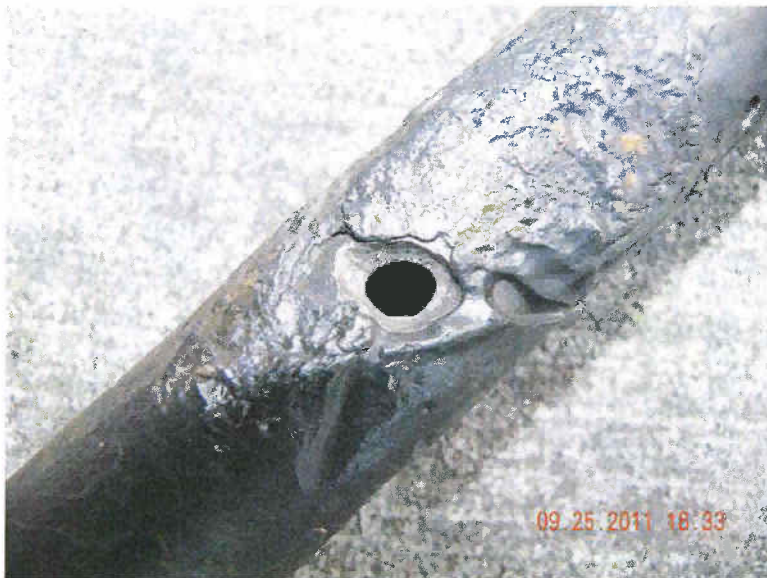
Figure 1. Color photographs showing the “hole” in the gas pipe line from 12040 Ave NE.

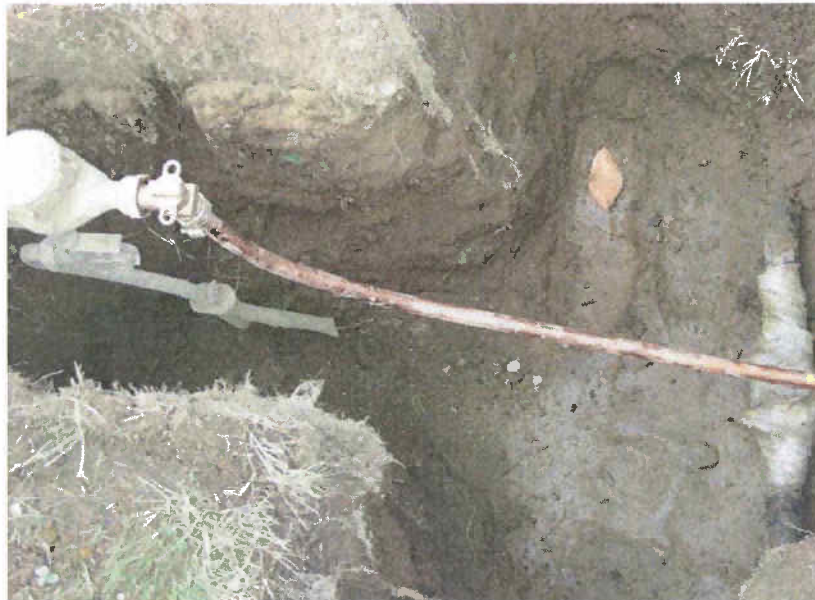
Figure 2. A color photograph showing the wrapped gas pipe line (right) from 913 NE Street containing a "hole".

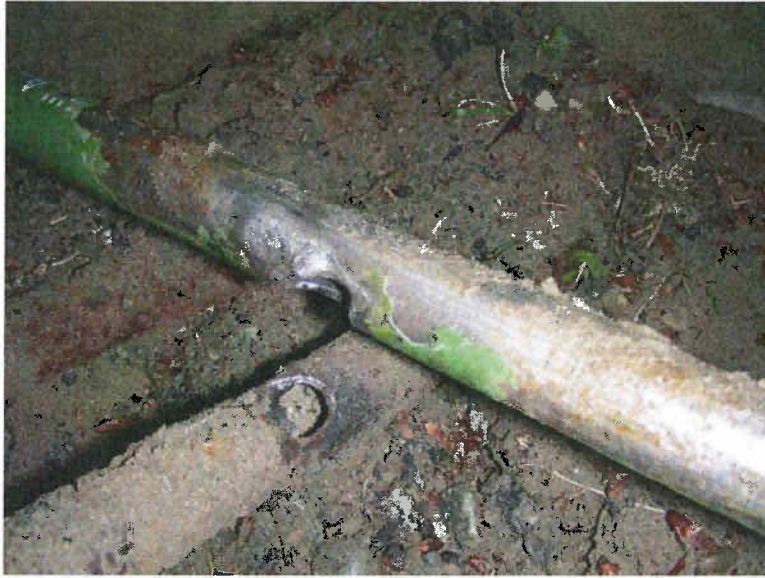
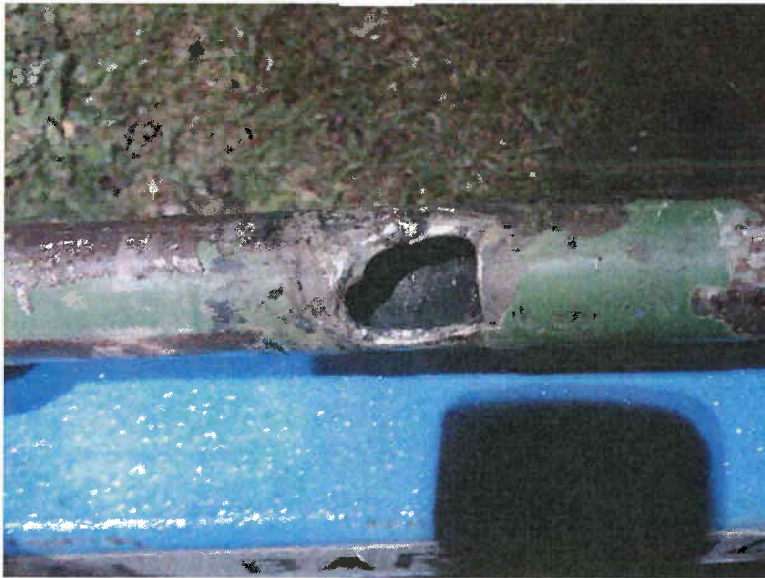
Figure 3. Color photographs showing the “hole” in the gas pipe line from 1020 NE Street.

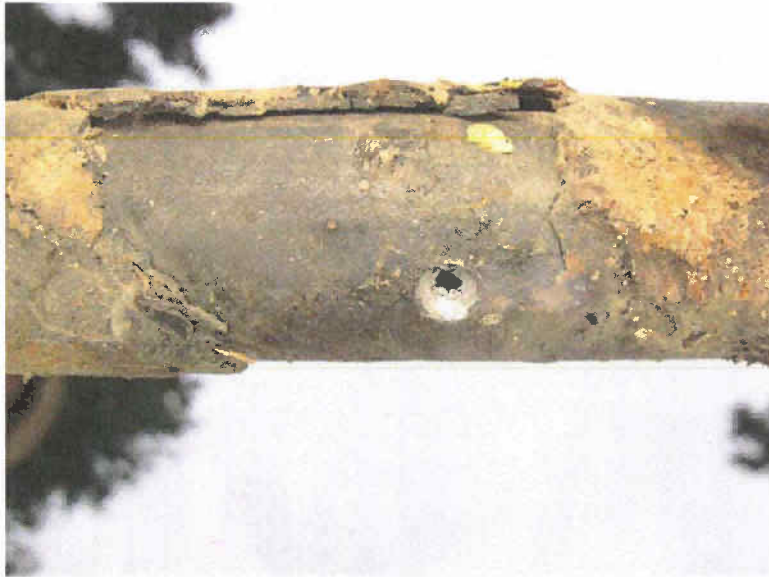
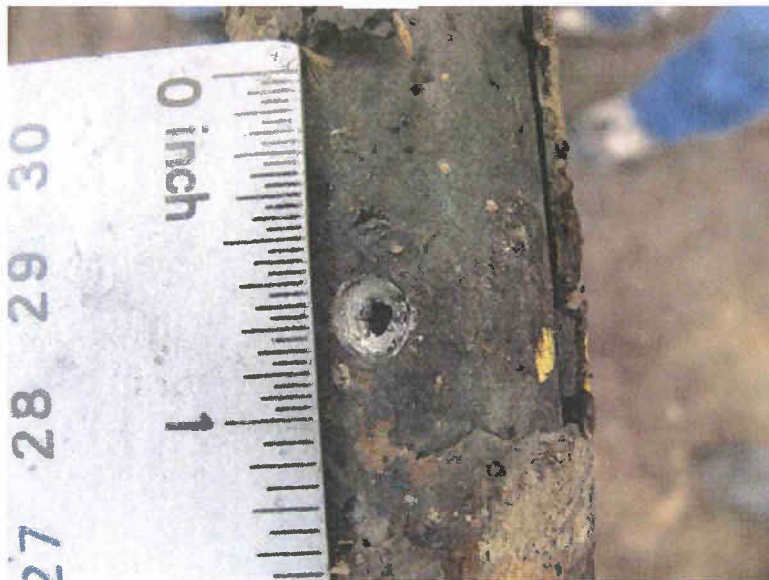
Figure 4. Color photographs showing the “hole” in the gas pipe line from 12312 Ave NE.
