Amtrak Passenger Train 501 Derailment  
DuPont, Washington  
December 18, 2017

NTSB/RAR-19/01  
PB2019-100807

# Railroad Accident Report

Amtrak Passenger Train 501 Derailment

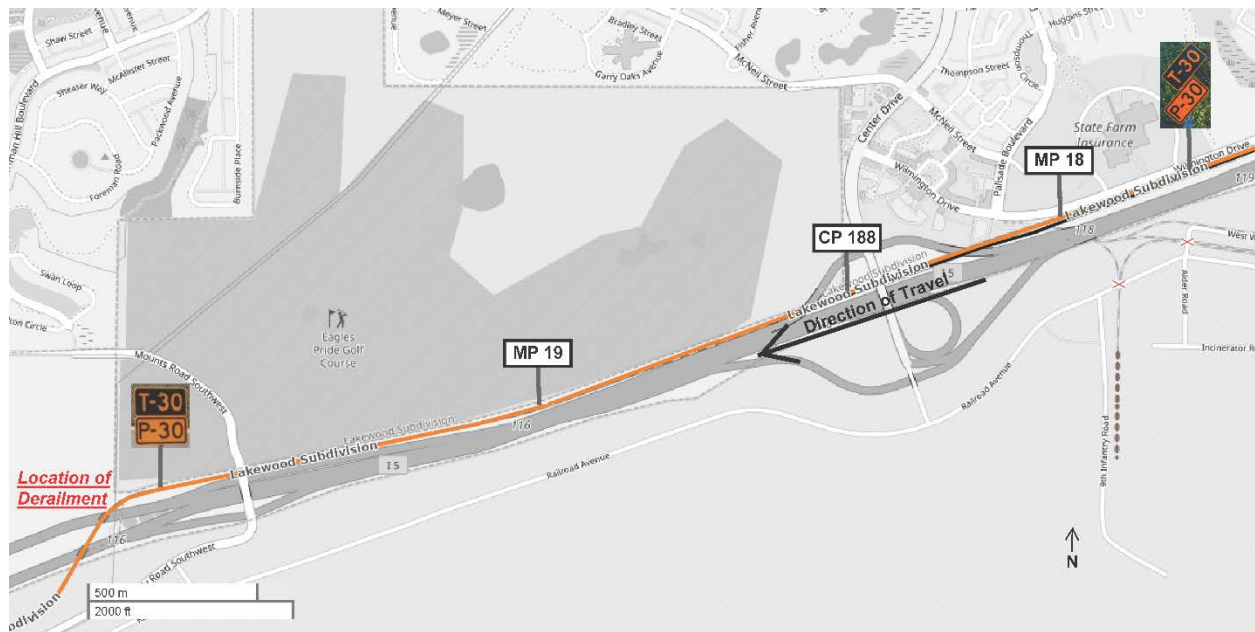
**Figure 4.** Location of signage on the approach to MP 19.8.

NTSB investigators also viewed the locomotive’s outward-facing video to assess the conspicuity of the wayside signs at MP 18 and CP 188. Investigators noted that the sign at MP 18 became conspicuous after the train had passed a grade crossing at MP 17.34. After the crossing, the MP 18 sign was visible for up to 10 seconds, although the numbers on the sign could not be read until the train was about 4 seconds away. NTSB investigators noted that when the train approached the sign, headlights from automobiles heading north on a street that ran parallel to the tracks could be seen from the operating compartment. However, the automobile headlights did not appear to ‘wash out’ the sign.

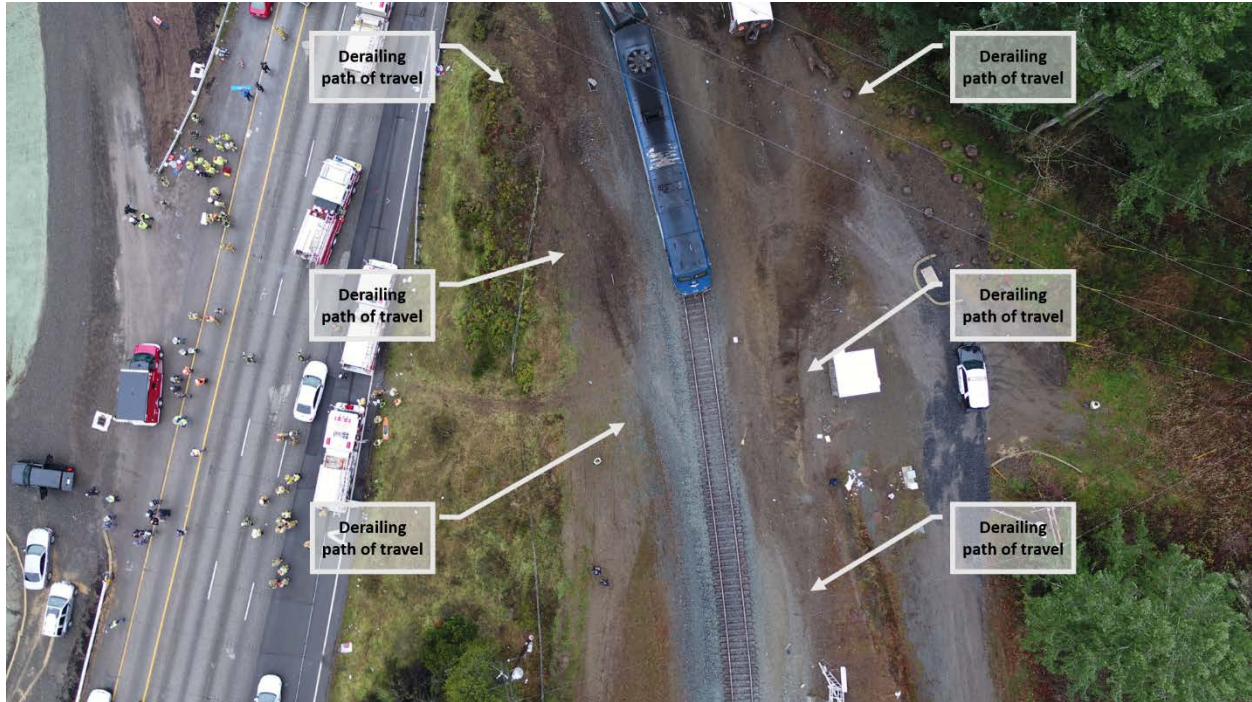
As the lead locomotive and the first six passenger railcars of the train derailed to the right of the main track and down the embankment, the articulated connection between AMTK 7504 (7) and AMTK 7424 (8) fractured. AMTK 7504's (7) articulated coupler connection with AMTK 7303 (6), was also fractured.

The railcars trailing behind AMTK 7422 (10) then traveled to the left of the main track. In the aerial photograph visible marks in the ballast and soil show the path of travel of the separated train. (See figure 14.)

**Figure 14.** Derailing path of travel of Amtrak 501. (Photo provided by WSP.)

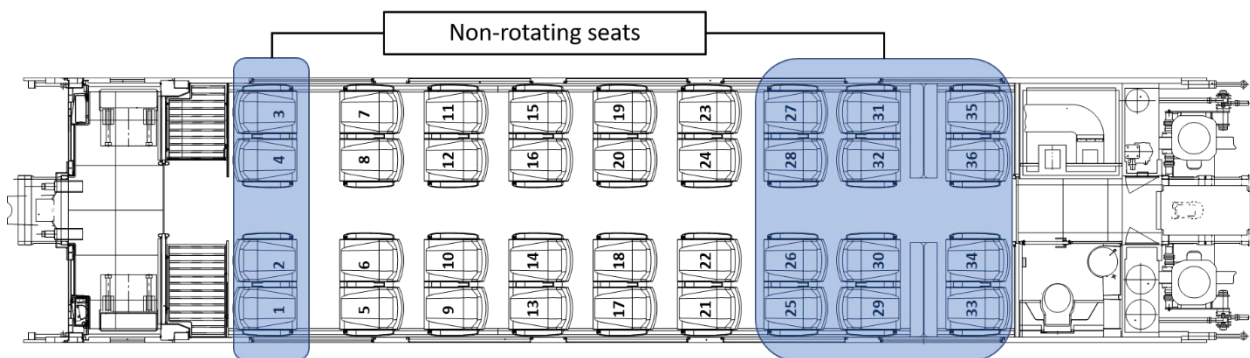
Some of the seats in the Talgo Series VI train are designed to rotate which can decrease the effectiveness of compartmentalization when the seats rotate during an accident. (See figure 30.) In this derailment, investigators observed several seats that had rotated with passengers causing injury. To understand the nature of the injuries and why the seat rotation occurred, NTSB investigators examined the design.

**Figure 30.** Coach class seating layout showing rotating and nonrotating seats.

Postaccident interviews revealed that several passengers in AMTK 7423 (9) were injured when three rows of seats started to rotate. One passenger was struck in the head with enough force to shatter the window. The seat corner of seat 2, which is not designed to rotate, contacted the rear bulkhead of the railcar, shattering the glass partition, directly behind the seat. A postaccident

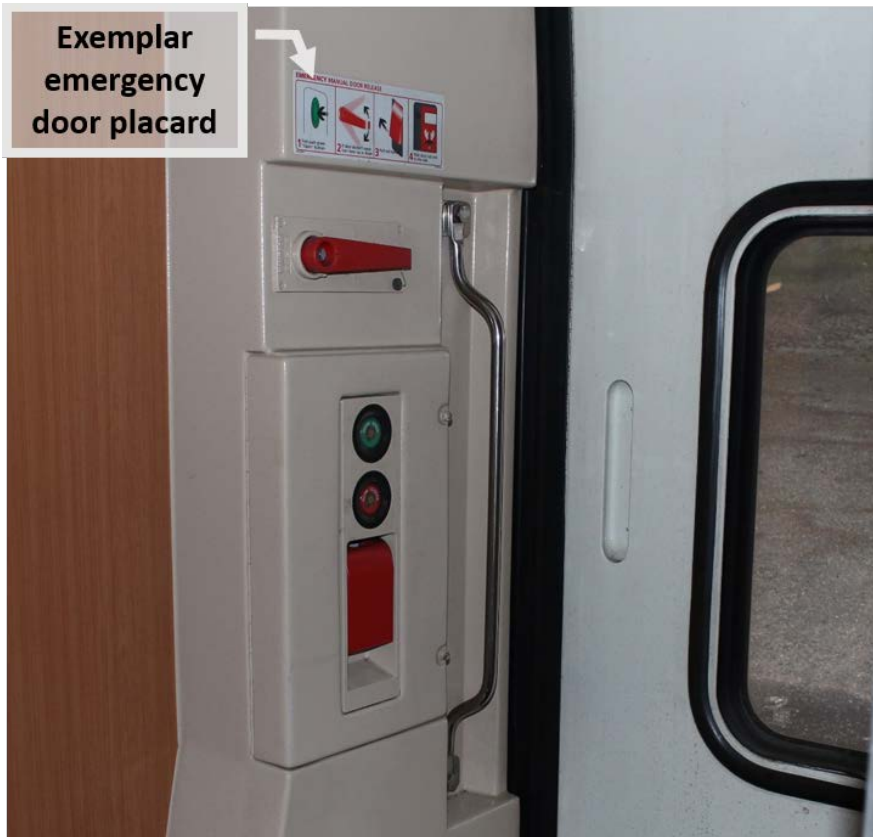
In AMTK 7423 (9), two passengers reported that they had attempted to exit the train after the derailment but could not get either of the exterior doors to open. An examination of the railcar revealed that evidence was present to indicate that someone had attempted to open the door, it was clear that not all the proper steps to open the door were performed. The instructional placard was

present but did not possess the required photoluminescence by regulation. The derailment occurred prior to sunrise. (See figure 37.)

**Figure 37.** Exemplar emergency door showing instruction placard.

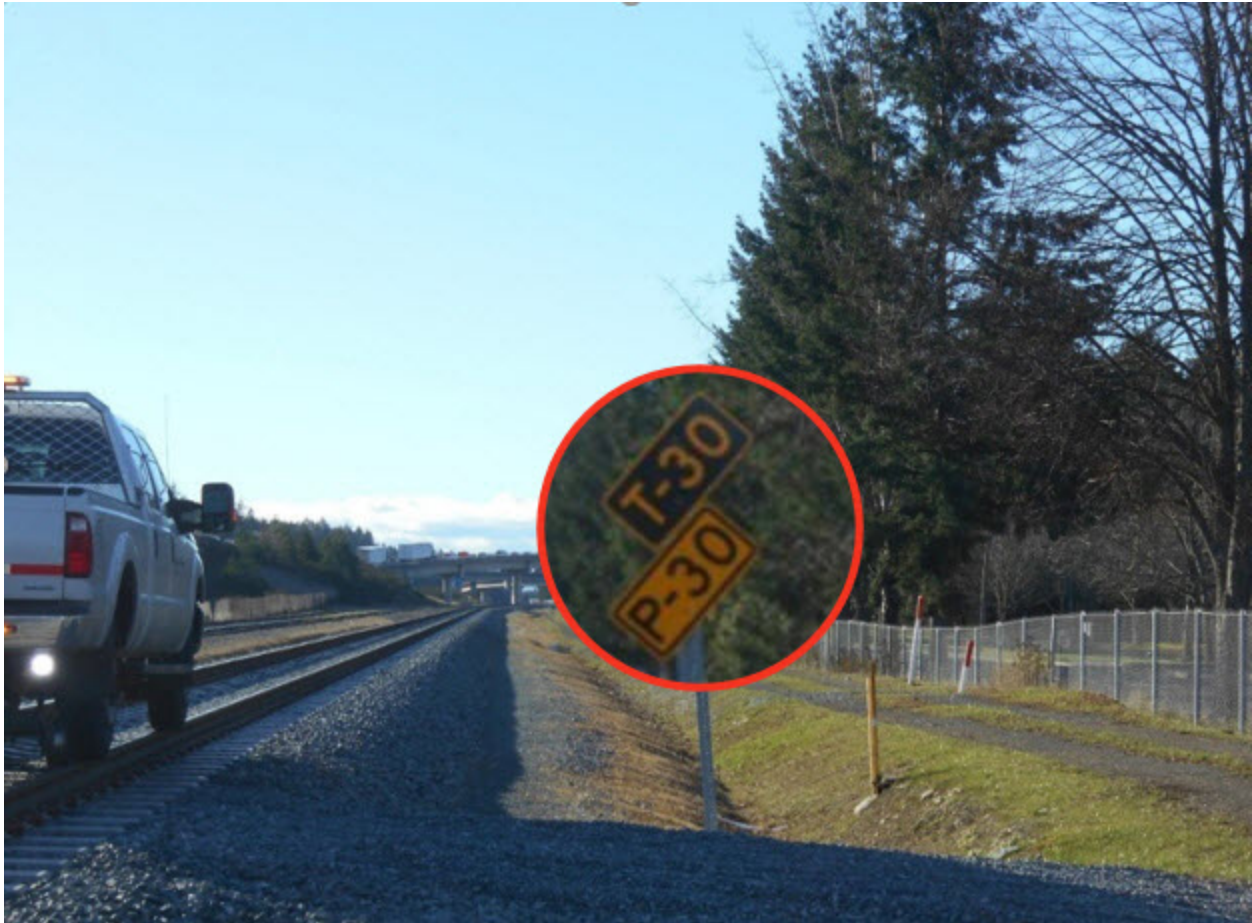
The maximum authorized speed for passenger trains on the Lakewood Subdivision was 79 mph. At MP 19.8, there was a 30-mph speed restriction for the sharp curve.<sup>40</sup> There was a sign at MP 19.8 to indicate the speed restriction. Two miles before reaching the curve, at MP 17.8, there were advance warning speed signs of the upcoming speed restriction. The signs “T-30” and “P-30” alerted Talgo (T) and passenger (P) operating crews that a 30-mph speed restriction entering the curve was 2 miles ahead. The advance warning signs have yellow backgrounds and black letters and/or numbers, except signs for Talgo operations have black backgrounds and yellow letters and numbers. (See figures 40 and 41.)

**Figure 40.** Two-mile advance warning speed sign at MP 17.8- 30 mph.
