## Complaint Form Request

## Case 19-077

**Supporting Documentation**  
**Avista vs Neighborhood Fence Complaint**  
**August 21, 2019**

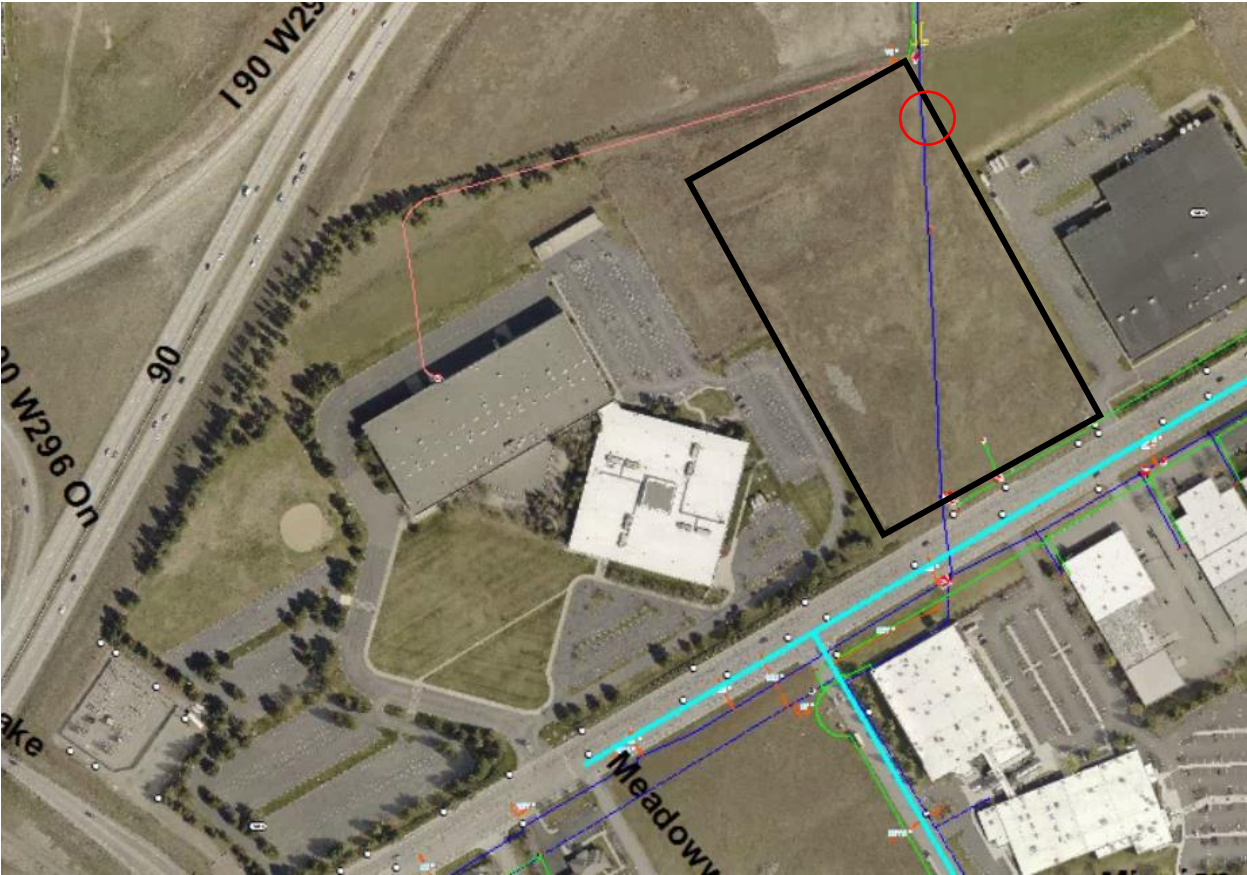
**Attachment #1** – Vicinity map of location of alleged violation, red circle indicates area of conflict with fence and pipeline
