Opening – Avista/ELM responded to the locate request and performed to best of their abilities and knowledge. The issue was the result of a utility mapping error that was immediately corrected upon discovery.

Case 22-020 M&L Construction, Inc vs. Avista Corporation

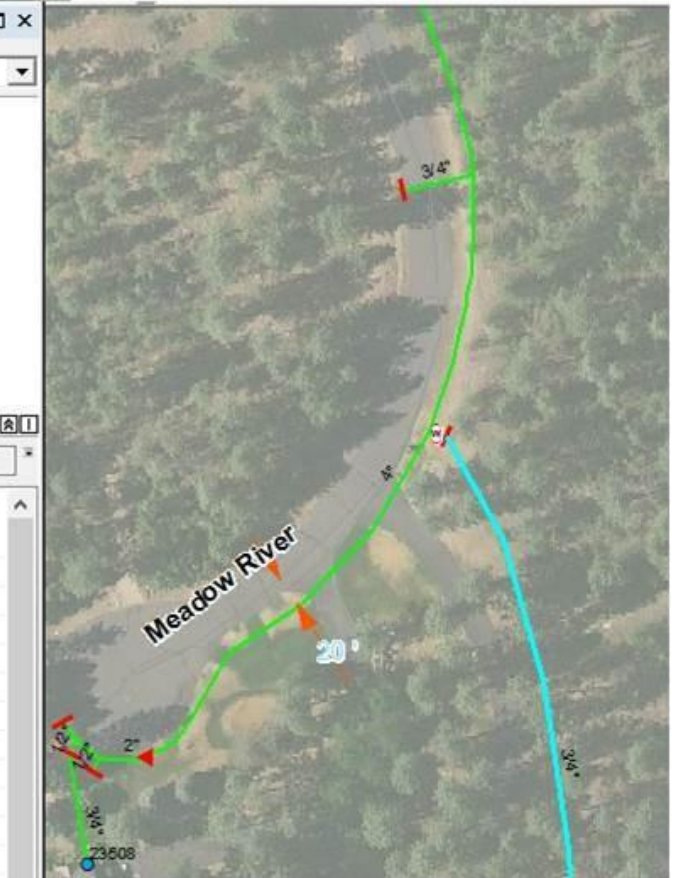
Exhibit J – Avista GIS mapping showing a correction was made.

5/24/2022 – M&L was digging on the south end of the locate request, where the triangle with a “?” in it was placed. While digging M&L struck the gas line just east of the triangle. (See Exhibit H to show damage and proximity to unlocatable gas triangle.) Avista was notified of the gas damage at 8:07am. The responding Avista gas serviceman capped what they thought to be a stub, as it was mapped as a stub, and told M&L that there was only a little remaining gas pipe going into the property. M&L continued digging after the Avista gas serviceman left and found additional gas line. Avista was called back on site and discovered that the line damaged by M&L was actually the service line to the shop at the rear of the property at 23508 N Meadow River Ln., nearly 700 feet away from the damage location. (See Exhibit I.) The Avista gas serviceman reported the incorrect gas mapping to the Avista GIS department, and it was updated at 3:24pm the same day. (See Exhibit J.)
