UTC Incident Investigation Form

Notification ID:	3199	Investigation ID:	7508
-------------------------	------	--------------------------	------

Operator:	McChord Pipeline Company, OPID 31049
District/Unit:	McChord Pipeline Company 3001 Marshall Ave, Tacoma, WA 98421
Locations:	100 th St at A St Tacoma, WA
Incident Dates:	August 2, 2017

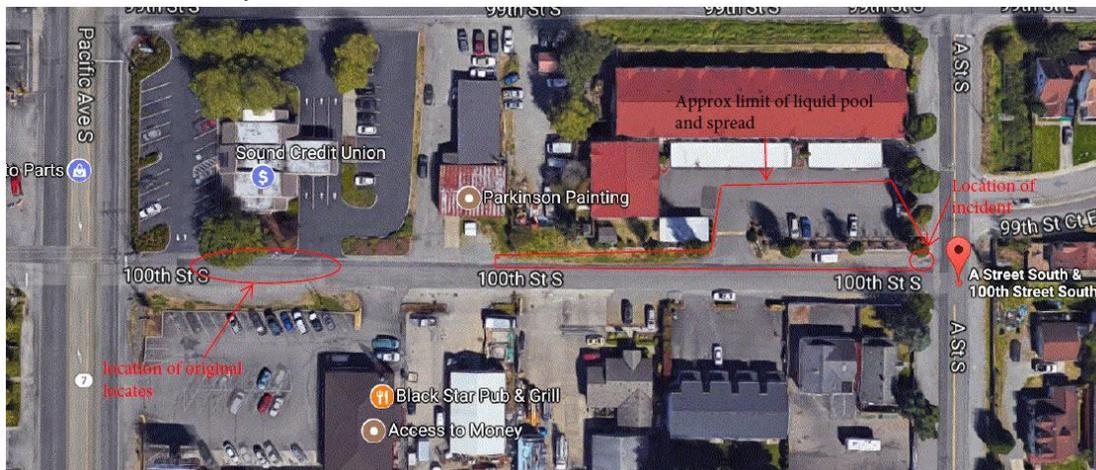
A third party contractor using a directional drill, hit and punctured the six-inch McChord Pipeline causing a leak (**Photo 1-6**). The location was just outside the city limits of Tacoma in unincorporated Pierce County (known locally as Parkland) at the intersection of 100th St and A St. This was MP 8.888 on McChord's pipeline. The initial report to NRC indicated 50-100 gallons of JP8 jet fuel was released. The Accident Report submitted to PHMSA on August 30, 2017, indicated 180 barrels (bbls) (7560 gallons) leaked and 155 bbls (6510 gal) were recovered, leaving 25 bbls (1050 gal) unaccounted for. It appears this accident was preventable with the root cause being the third-party contractor failing to properly define the locate boundary.

Photo 1--Google Satellite view of Parkland area near Tacoma where accident occurred (North is top of photo).

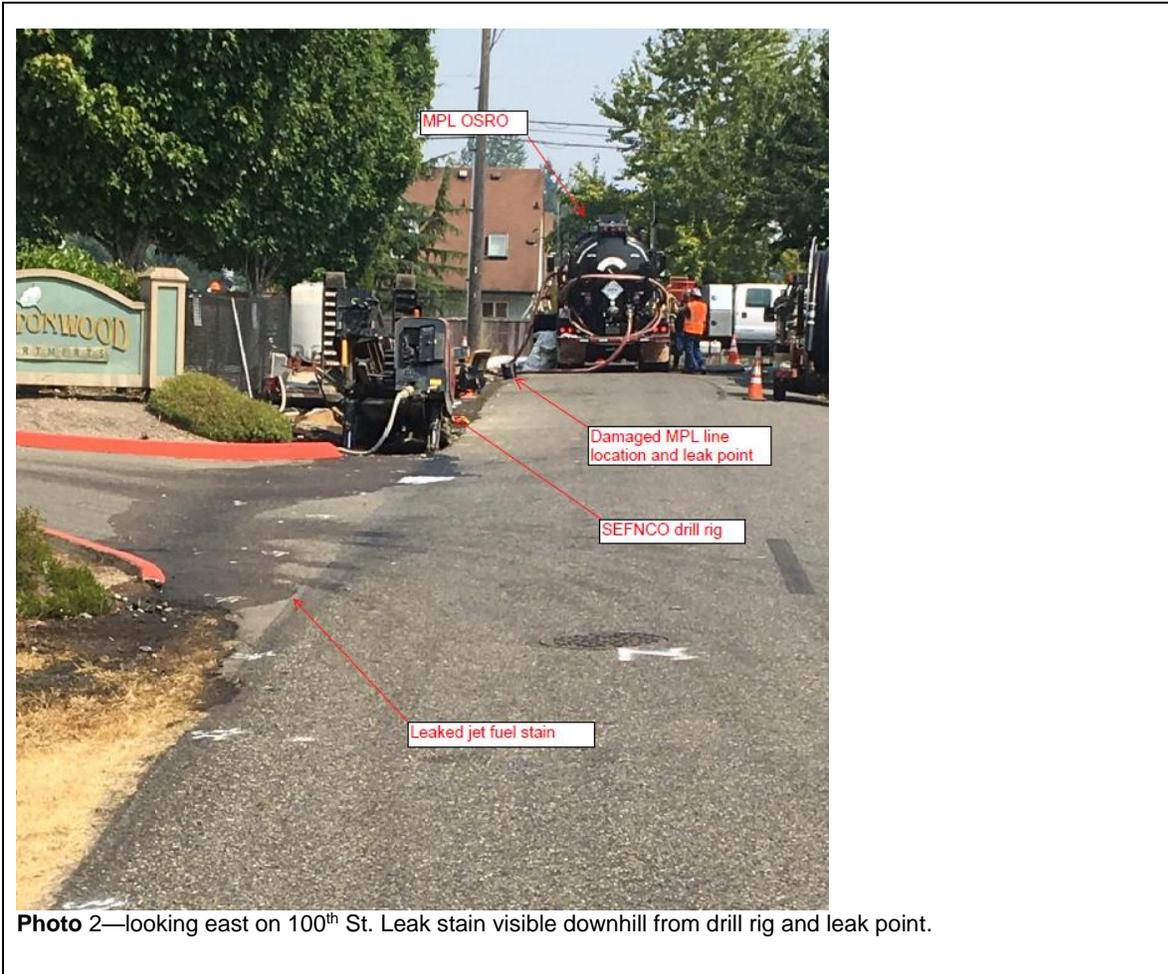
The emergency response to the leak was prompt and effective. USOR emergency response personnel and OSROs were on scene within an hour. OSROs were stationed at appropriate locations downhill from the leak (ditches and catch basins) for product recovery (**Photo 2-6**). An apartment complex adjacent to the leak was first priority for clean-up efforts **Photo 1 and 2**.

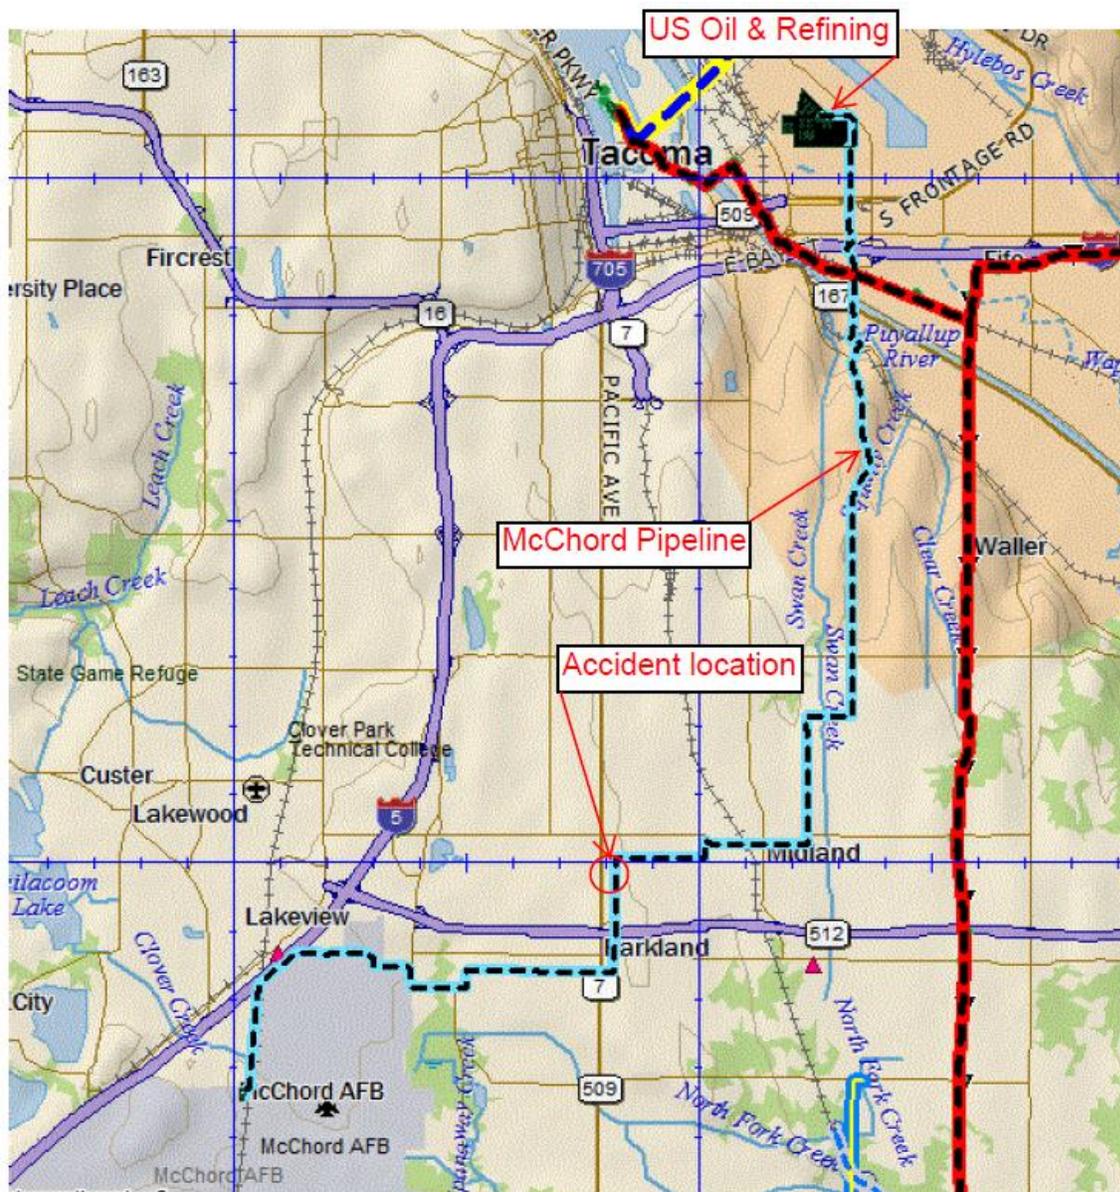
The McChord Pipeline (MPL) is an intrastate, hazardous liquid pipeline 14.25 miles in length. The pipeline transports jet fuel (JP-8) from US Oil Refinery (USOR) located in Tacoma's industrial area in the tide flats to McChord Field, a US Air Force facility on Joint Base Lewis McChord (JBLM). (**Figure 1**). MPL was constructed in 1966 of 6-inch nominal diameter, grade B steel pipeline with wall thickness ranging from 0.188 inch to 0.432 inch. The pipeline has a 720 psig MOP (36% SMYS) with a normal operating pressure at 450 psig (21% SMYS). The pipeline is divided into four sections with isolation valves between each section (**Figure 2**).

Figure 1—McChord Pipeline (blue dashed line)

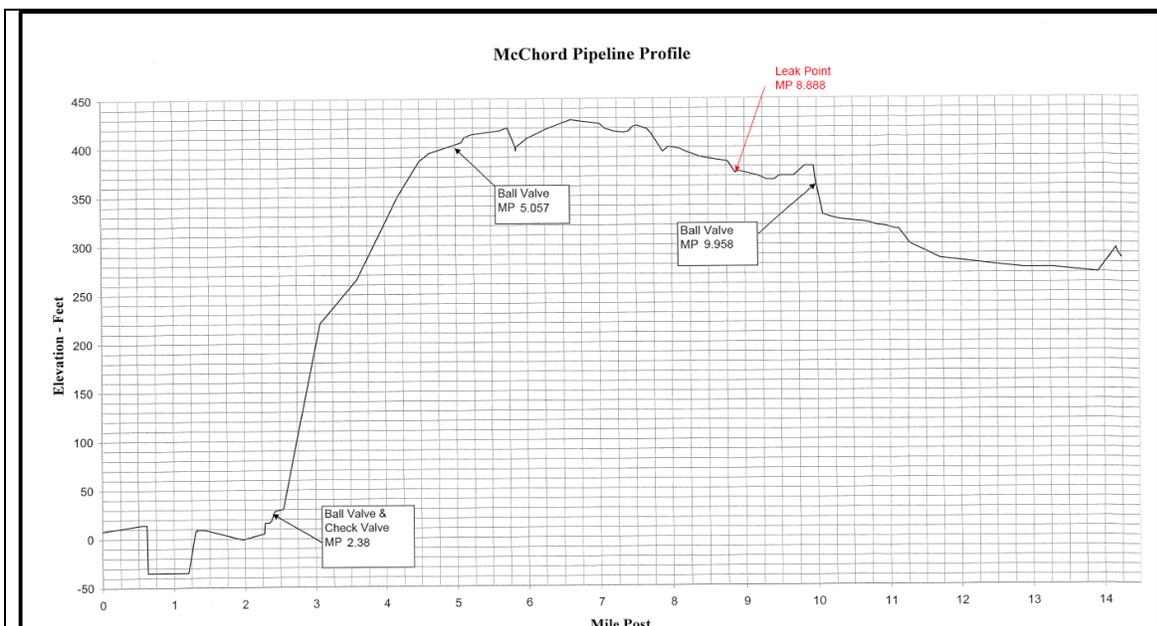
Figure 2 McChord Pipeline Elevation Profile

At 12:45 USOR closes the downstream valve (MP 9.958) from the leak location, followed by the upstream valve (MP 5.057) at 12:54 (**Figure 2**). USOR activated their emergency response plan getting personnel and oil spill removal organizations (OSROs) organized and in route. USOR stages their clean-up crews on site and begins product recovery and assessing steps to access the line for repair (**Photo 1-6**).

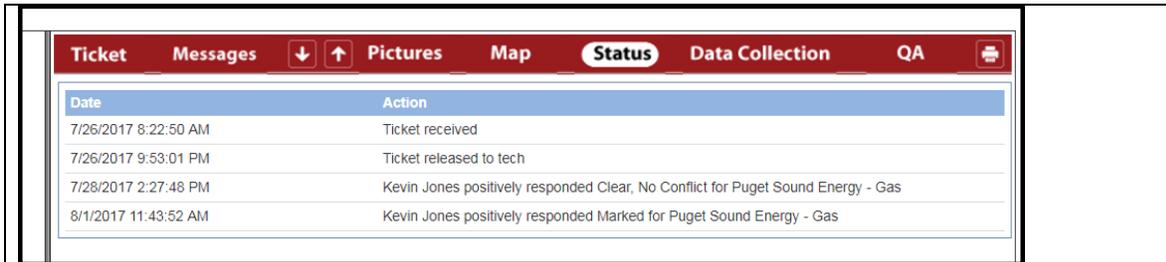
McChord Pipeline and the City of Tacoma Water Department responded the day they received the ticket--July 26, 2017 (**Photo 7,8**). PSE's locate contractor, ELM, responded on July 27, 2017 (**Figure 3**), Parkland Water and Light Company (Parkland Water) responded on August 1, 2017 stating they didn't receive the original ticket. No other locates were visible along 100th St., even though the locate ticket description indicates work to be done all the way to A St. The only visible white paint delineating locate boundaries appears on 100th St. adjacent to 9931 Pacific Ave (**Photo 7,8**).

Figure 3—ELM (locator for PSE) log showing responding to/clearing locate ticket 17284954 on 7/28/17

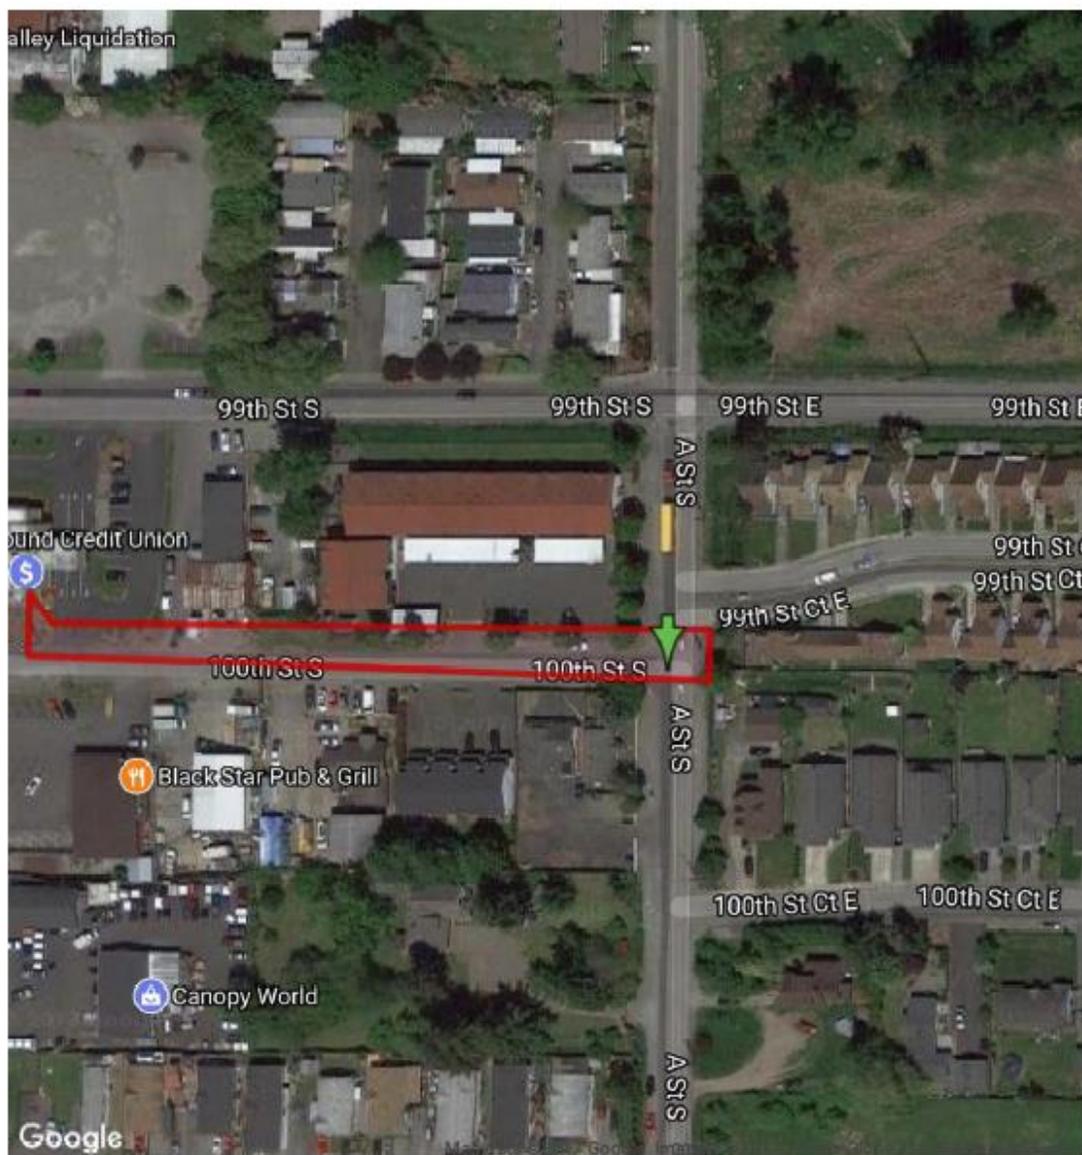
SEFNCO Communications, Inc. (SEFNCO) is a contractor for Comcast. They were drilling to install a cable line to the credit union at 9911 Pacific Ave (Sound Credit Union). Locates were called in at 0645 on July 26, 2017 by SEFNCO, Ticket No. 17284954 (**Figure 6**). The narrative description on the locate ticket was as follows:

Figure 6 continued-WA One Call locate ticket called in by SEFNCO July 26, 2017
