RAILROAD ACCIDENT REPORT

COLLISION OF NATIONAL RAILROAD PASSENGER CORPORATION (AMTRAK)
TRAIN 59 WITH A LOADED TRUCK-SEMITRAILER COMBINATION AT A
HIGHWAY/RAIL GRADE CROSSING IN
BOURBONNAIS, ILLINOIS, MARCH 15, 1999

**RAILROAD ACCIDENT REPORT
NTSB/RAR-02/01 (PB2002-916301)**

**NTSB/RAR-02/01
PB2002-916301
Notation 7168A
Adopted February 5, 2002**

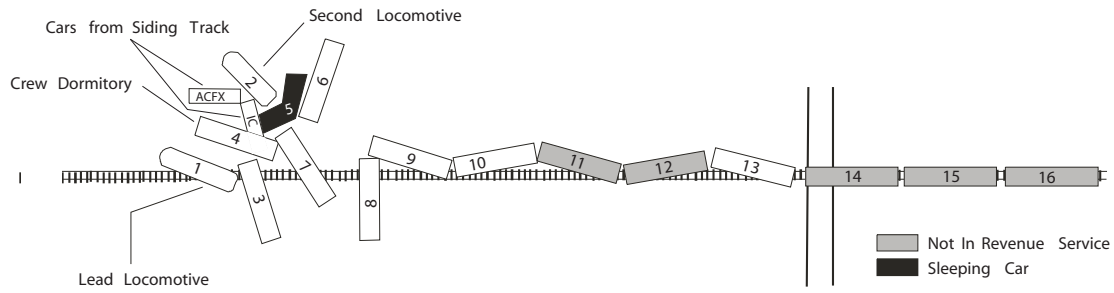
Train. The impact caused both locomotives and 11 of the 14 cars in the consist to derail. The lead locomotive came to rest at a point about 560 feet south of the grade crossing. Adjacent to this was the second locomotive, the baggage car, a transition sleeper car, a sleeping car #32035, diner car #38020, and coach car #34089, which came to rest on its side, all of which were involved in a general pileup of wreckage. (See figure 9.) The remaining cars in the consist either derailed and remained upright or did not derail at all. None was involved in the general pileup of wreckage. These cars did not display any evidence of serious carbody breach, and damage was mostly limited to the carbody end-structures.
