# Investigation Report

## CenturyTel of Inter Island d/b/a CenturyLink

UT-132234

Staff Investigation  
Consumer Protection  
Regulatory Services

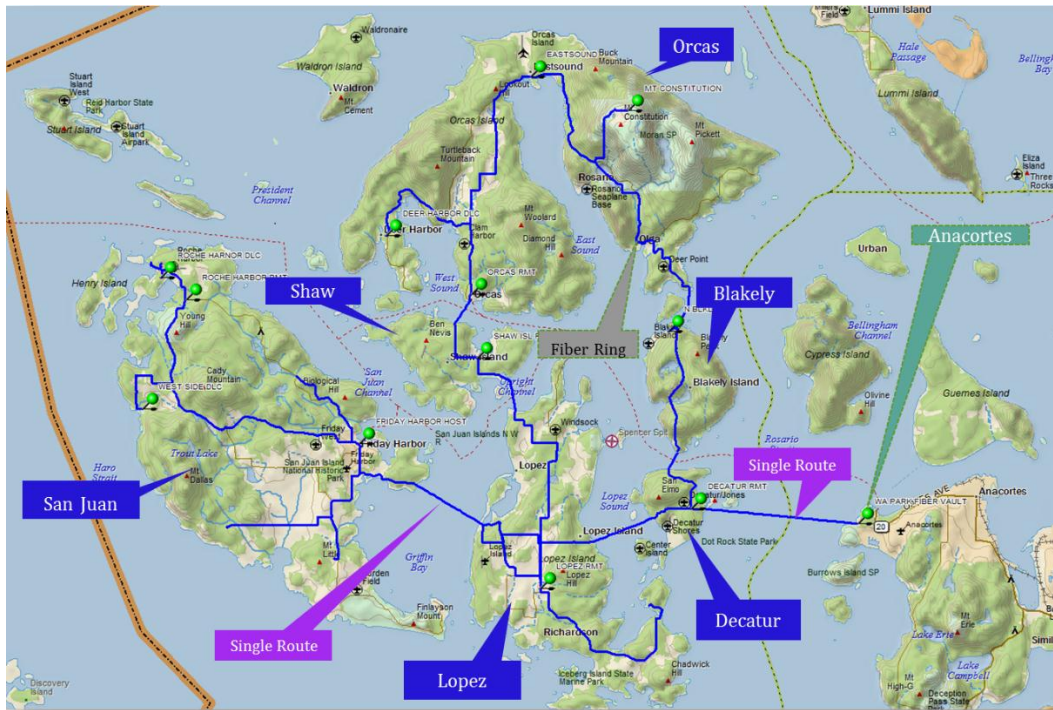
Long distance calling and E911 services require a connection between the central office host switch in Friday Harbor (located on San Juan Island) and the remote line switches located on the other islands. The two fuchsia flags identified as “single route” on the chart above represent the two connections that, if severed, would isolate the central office host switch in Friday Harbor.

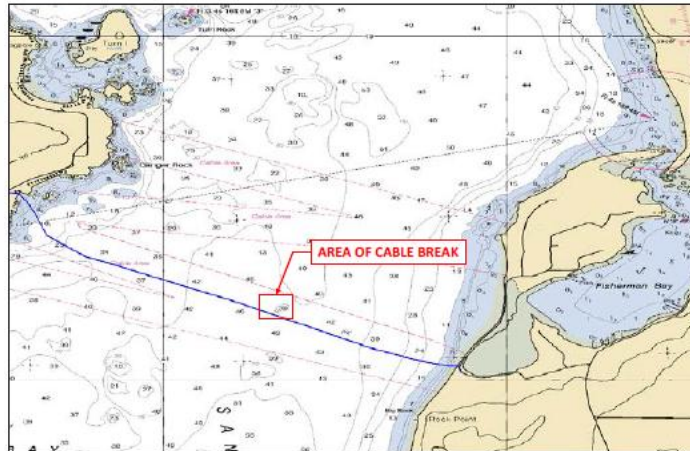
Figure 1 - Area of Cable Break

The following is my expert report, including assessments and recommendations, related to the Century Link cable break between Lopez Island and San Juan Island. The cable break was observed to have occurred sometime between the hours of 3:00 am and 4:00 am on November 5, 2015 midway in the San Juan Channel in about 230 feet of water. The Century Link submarine cable was installed in 1999 and was laid within a designated Cable Corridor. The cause of the break is still unknown.

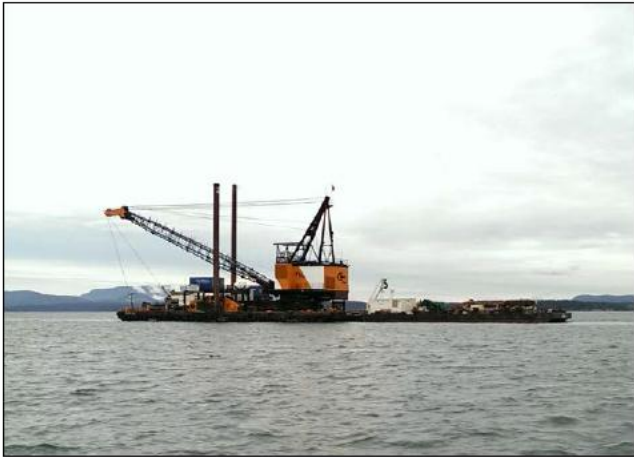
Figure 7 - Cable Repair Barge

Cable repair operations commenced with the recovery of the parted western end of cable. Once sufficient cable had been recovered beyond any damaged cable and water ingress, the western end of cable was cut and prepared for splicing. The western end of cable was spliced to a section of spare cable, and once the splice was completed, the repair barge began laying spare cable eastward towards the Fishermen Bay landing. The cable repair was completed with a new shore end landing at Fishermen Bay.

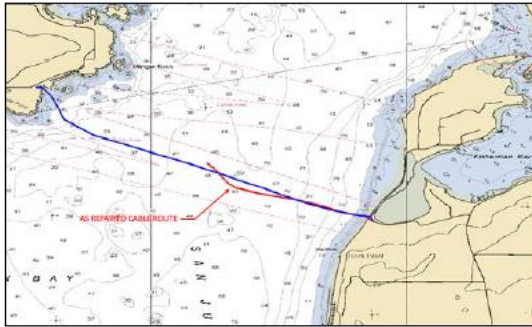
Figure 8 - As Repaired Cable Route

The *As Repaired Cable Route* for the Century Link cable is shown as a red line in the figure below.

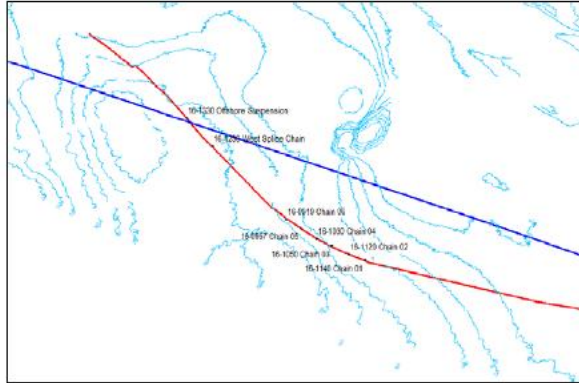
Figure 11 - Anchor Chain Locations

Upon completion of the repair's cable lay and cable landing, ten (10) foot long lengths of 1 3/4 inch chain were laid transversely over the cable at 7 locations, including one at the splice box as a means of stabilizing the cable on the seabed.

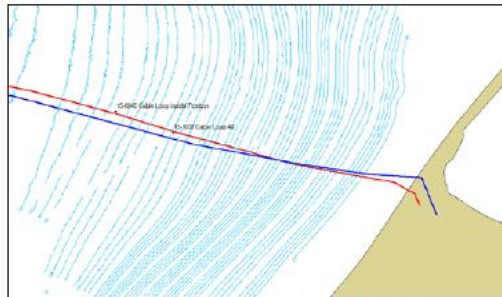
Figure 15 - Cable Loop Locations

The ROV also conducted video inspection of the Century Link cable starting west of the cable repair splice and then to the east, towards the Fishermen Bay landing. Areas of slight suspensions were found to the west of the cable repair splice.

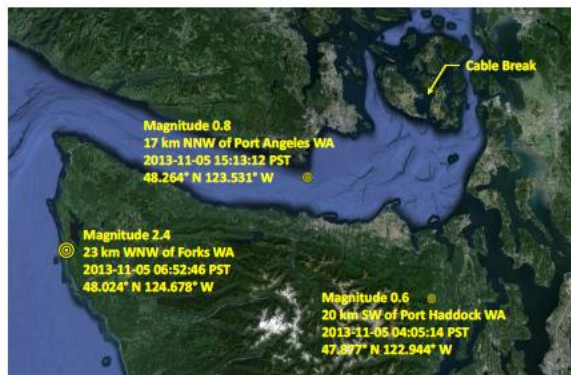
Figure 24 - USGS Historical Data November 5, 2013

According to the U.S. Geological Survey (USGS) historical database, there were three earthquakes in the region on the day of the cable break on November 5, 2013.

Given the magnitude of the earthquakes, the 2013 OPALCO route survey and video observations of the rock features in the vicinity of the break, it seems very unlikely that any of these earthquakes were responsible for the cable break. The OPALCO survey and the ROV video inspection show no indication of instability of the rocky area. There are no signs of slumping or rock slides in the area of the break.

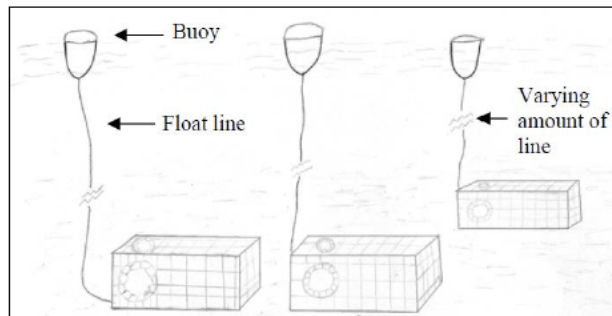
Figure 26- Crab Pots with One Pot per Buoy Line

Crab pot fishing depths in the area are usually shallower than 100’, although 200’ is not unheard of. The breaking strength of a crab pot buoy line is much lower than that of an armored fiber optic cable of this diameter. Buoys are usually attached with synthetic line about ½” diameter, with a maximum breaking strength on the order of 3,700 – 7,000 lb. Even if doubled it may not reach the breaking load of an armored cable such as this. That said, it is possible for multiple strands to tangle a cable. If a tangled pot and line were dragged across the seabed by a snagged piece of towed gear, it could cause significant damage.

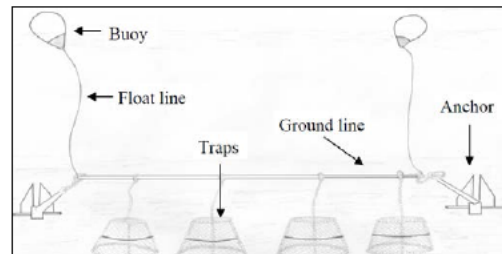
Figure 27 -- Shrimp Pots on a Common Ground Line

Shrimp pots are fished by fewer than 20 State licensed vessels in Puget Sound, as well as an undetermined number of Treaty fishermen. The pots are similar in size to crab pots but they may be fished on “ground lines”, with many pots tied along a line on the seabed, and a buoy at each end of the line. This means that if the buoys are lost, fishermen are more likely to try to recover them with grapnels. In other regions this has caused cable faults. Fishing depths are typically 200’ to 400’, encompassing the fault range. However, the pots shown in the ROV video are clearly crab pots, not shrimp pots. Moreover, shrimp pot fishing at night is prohibited.

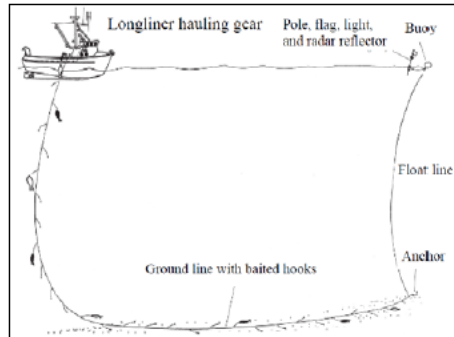
Figure 28 - Bottom Longline

Bottom longlines are used for halibut in Puget Sound. A long ground line or main line has a series of branch lines attached, with a baited hook on the end of each branch line. Their breaking strength is generally well below that of a FO cable. However in rare cases they have caused cable faults in other regions, either by tangles, grapnel recovery, or hook point penetration of cable insulation.

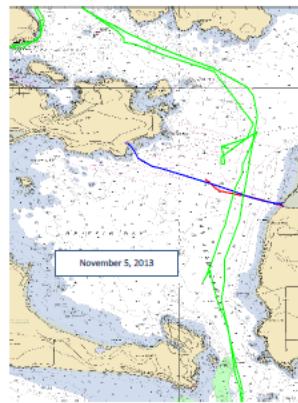
Figure 29 - RV Centennial Nov 5 2013

AIS data initially pointed to activity of a research vessel. The RV Centennial is capable of such a complete cable break, with 58' length, 425 HP engine, winches, trawl and dredge equipment for scientific sampling. However AIS records indicated that the RV Centennial was at the dock in Friday Harbor when the fault was reported. It did not arrive in the break area until approximately 10:14 PM PST on transit to an area well south of the break. It returned to the break area and conducted more complex maneuvers at slow speed at approximately 1:30 PM PST, almost ten hours after the reported alarm.

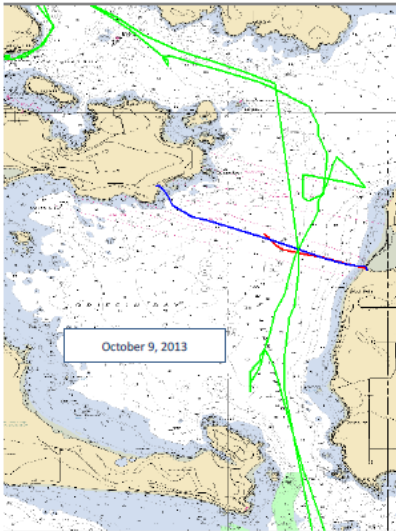
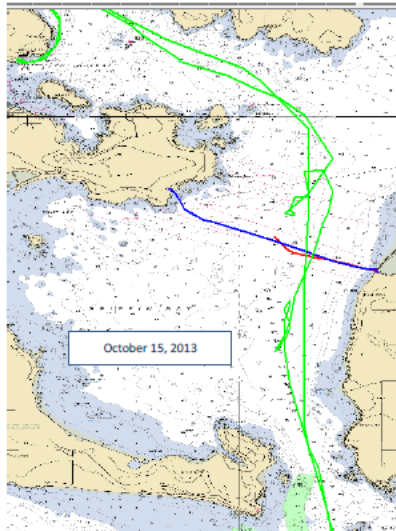
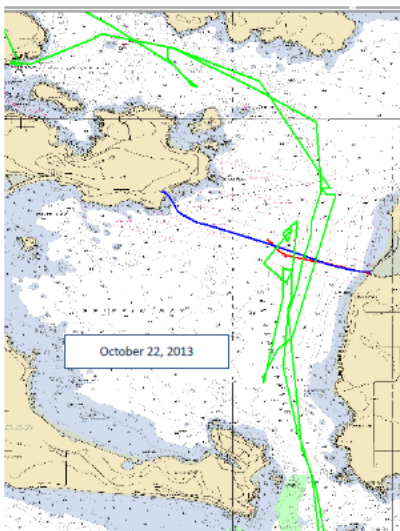
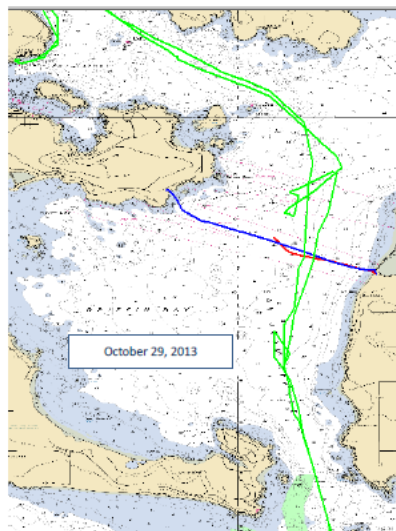
The RV Centennial calendar (available in the Friday Harbor Laboratory's website) indicated that the RV Centennial made similar cruises on October 9, October 15, October 22 and October 29 of 2013. Historical vessel tracks to the RV Centennial for those dates all show changes in speed and heading in the vicinity of the cable areas.

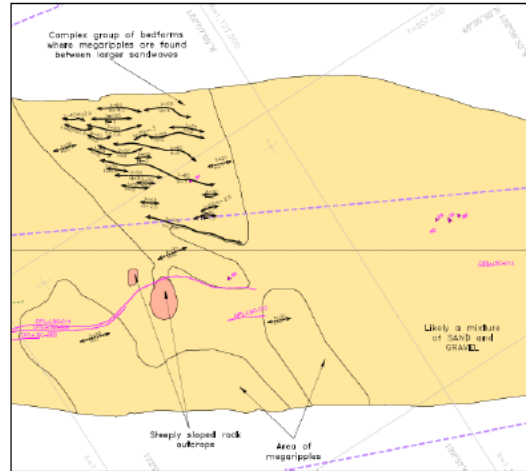
Figure 34 - 2013 OPALCO Survey Geophysical Interpretation

Post lay burial may be performed on sections of the Century Link cable in the middle of the channel. Geophysical data interpretations from the 2013 OPALCO survey indicate that most of the seabed along the cable is comprised of a mixture of sand and gravel.

An ROV with high pressure jetting swords could be used to retro bury the Century Link cable to a target depth of 1 meter below the seabed.

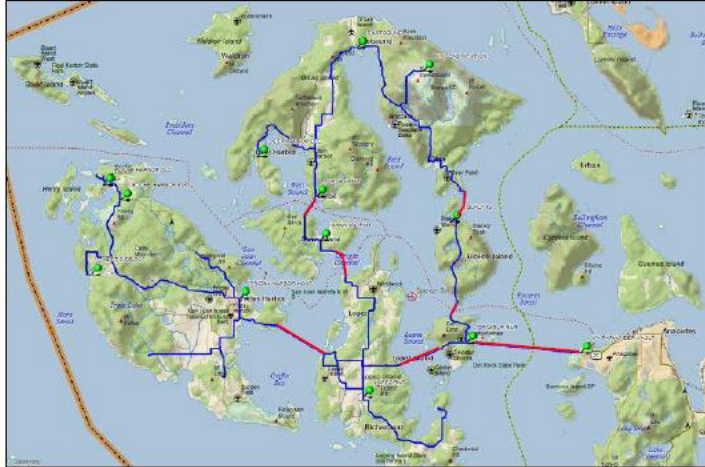
Figure 37 - Century Link Submarine Cables in the San Juan Islands

NOAA nautical charts clearly show the cable areas associated with all of the Century Link cables in the San Juan Islands. Most of the cable crossings are in relatively shallow water and the threats from anchors and bottom fishing are low. The cable from Anacortes to Decatur Island crosses the Rosario Strait, which is a major shipping channel. More than 500 oil tankers pass through the strait each year, to and from the Cherry Point Refinery and refineries near Anacortes. The strait is in constant use by vessels bound for Cherry Point, Bellingham, Anacortes, and the San Juan Islands. There is a low risk of a large vessel dropping anchor, unintentionally or in an emergency situation. Should an anchor ever cause a break in the cable, a repair operation would be extremely difficult as the repair vessel would have to work in the middle of the shipping lanes. The company should contact Port Authorities to inquire about restrictions to performing repair operations in the Rosario Strait. Any such restriction would require special repair operations, possibly abandoning the cable in the shipping lanes and installing a new section of cable.

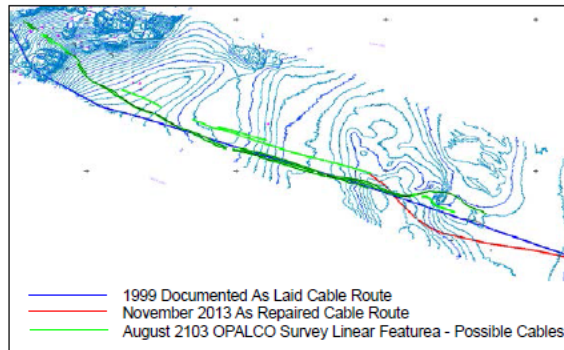
Figure 38 - Other Cables in the San Juan Channel

From conversations with UTC and Century Link, there are several live cables and several out of service cables laid in the same vicinity as the Century Link cable. From the ROV video inspection and the 2013 OPALCO survey, it is clear that these cables cross each other.

Great care will need to be taken on future cable repairs so as not to damage another live cable. As additional cable are planned for the future, Century Link and other cable owners should interface with each other to establish new non-conflicting cable routes. Removal of out of service cables is now required t many landing sites around the world. Consideration for cable removal at landing sites may also be required at some into to make room for new cables.
