SOUTH KING COMPLEX
PUGET SOUND ENERGY
FACILITY CONDITION ASSESSMENT
FINAL REPORT
AUGUST 18, 2016

**PUGET SOUND ENERGY
SOUTH KING COMPLEX
KENT, WASHINGTON**

**June 2, 2016
16-424**

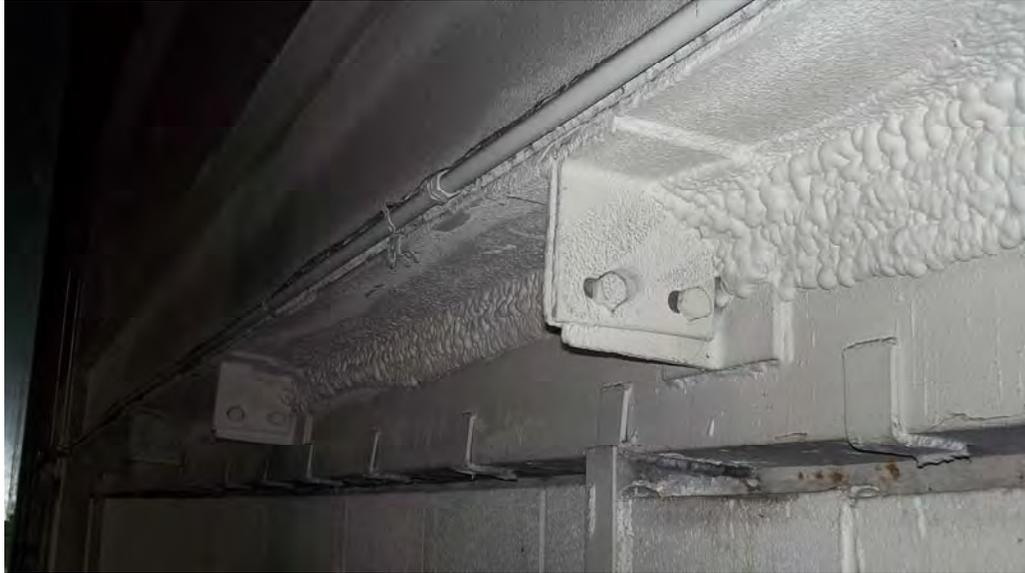
Photo 5: Concrete Spandrel to CMU Wall Interface

3	<p>The exterior east wall of the high-bay warehouse consists of steel post-and-beams supporting a concrete spandrel panel. Several of the bays are infilled with minimally reinforced 6" CWU that does not appear to be anchored to the spandrel panels. The concern is that there is insufficient lateral capacity at these locations to support the roof structure in a seismic event. (See Photos 4, 5, and 6)</p>	<p>Remove the masonry walls and provide cast-in-place concrete shear walls that connect to the spandrel panels as well as the roof deck above.</p>	\$640,000

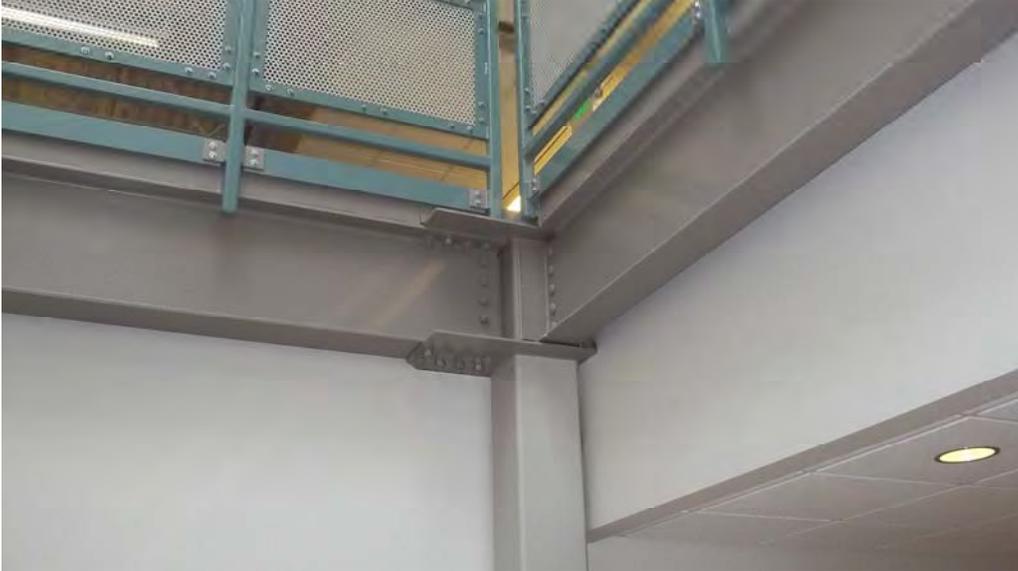
Photo 9: Typical Mezzanine Frame

9	Cross ties do not appear to be adequate. The concern is that the deck may pull apart as the exterior wall systems try to pull away from the structure.	Add cross straps on top, or beneath, the deck.	\$170,000
10	The 1997 Mezzanine addition utilizes moment frames to resist lateral forces. While the loads to the frames appear relatively small, the details are unconventional and do not meet many of the baseline ASCE41 checklist standards. The concern is that excess movement or damage may occur, and the mezzanine would not be fully accessible after a seismic event. (See Photo 9)	Perform further analysis of the frames, using the ASCE 41 Tier 3 approach. This approach may show that the frames are acceptable "as is". If not, improve the strength of the connections and frames.	\$110,000

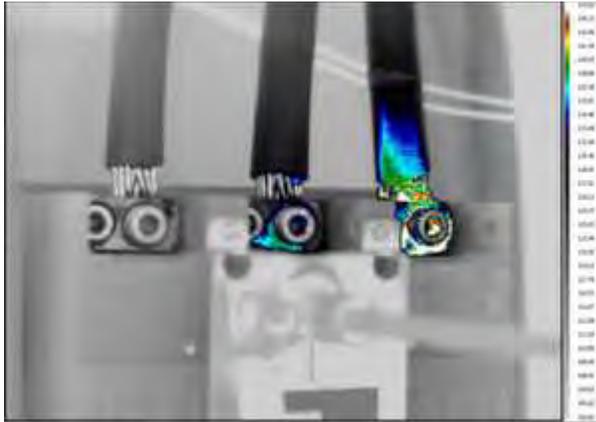
Before

This inspection of your facility found no anomalies. Below are examples of the before and after conditions of thermal anomalies that may be documented.

Simple repairs, such as cleaning and tightening connections, reduce the risk of equipment failure.
