EXHIBIT F
SEAL Laboratories – Final Report (February 16, 2012)

RE: Puget Sound Energy- Ingham Fire
SEAL Job No. 21151.

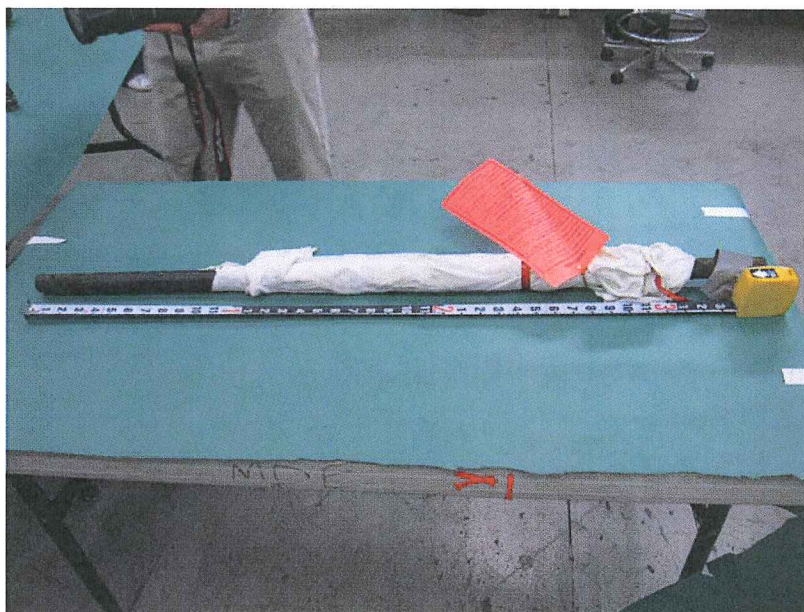
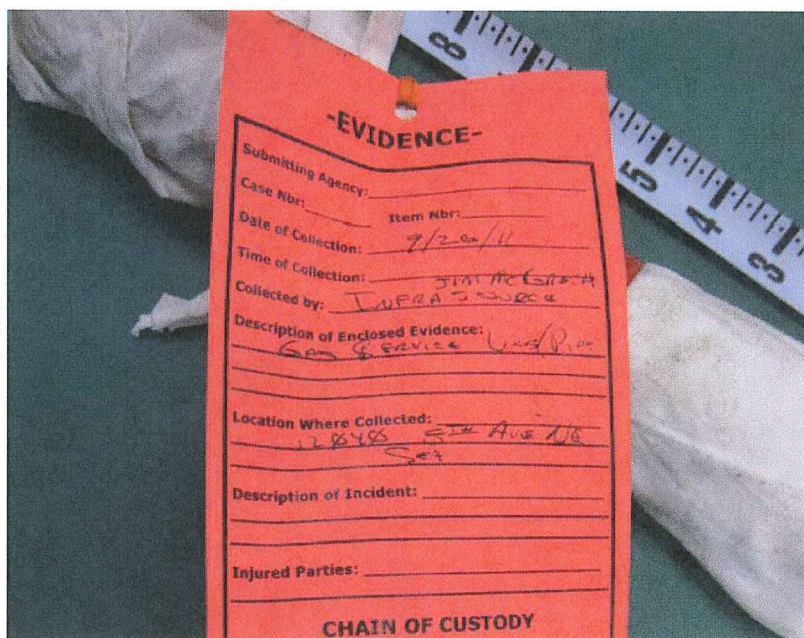
This pipe section was collected by Infrasource on 9-26-11, as evidenced by the tag attached to the rapped pipe section; Figure 1. The gas service line pipe was made from steel, was 42 inches long with 1.2 inch outer diameter and wall thickness of 0.11 inch. The pipe contained a slightly oval hole with major and minor diameters as 0.3 inch and 0.22 inch; Figures 2 and 3. The surface coating on the pipe had melted. A section of the pipe was cut containing ¼ of the hole wall, as shown in Figure 4. The removed section contained the ¼ hole in a corner and is shown from the inner diameter (ID) and outer diameter (OD) side in Figure 5. The hole was clearly created from OD toward the ID, as seen by the missing material at the hole wall. The hole surface appeared smooth with no fracture features; Figure 6.

Figure 1. Color photographs showing the gas line from 12040 8th Avenue NE and the attached tag.

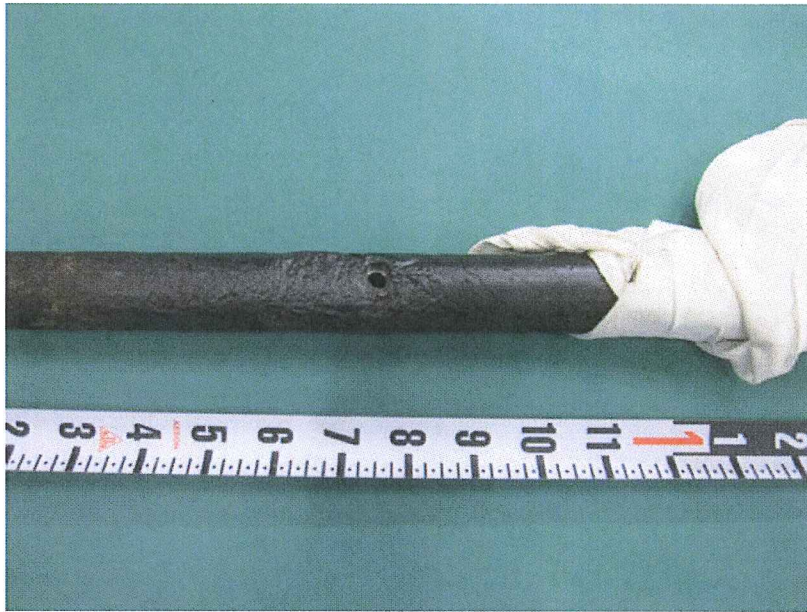
Figure 2. Detailed color photographs showing a hole in the gas line from 12040 8th Avenue NE.

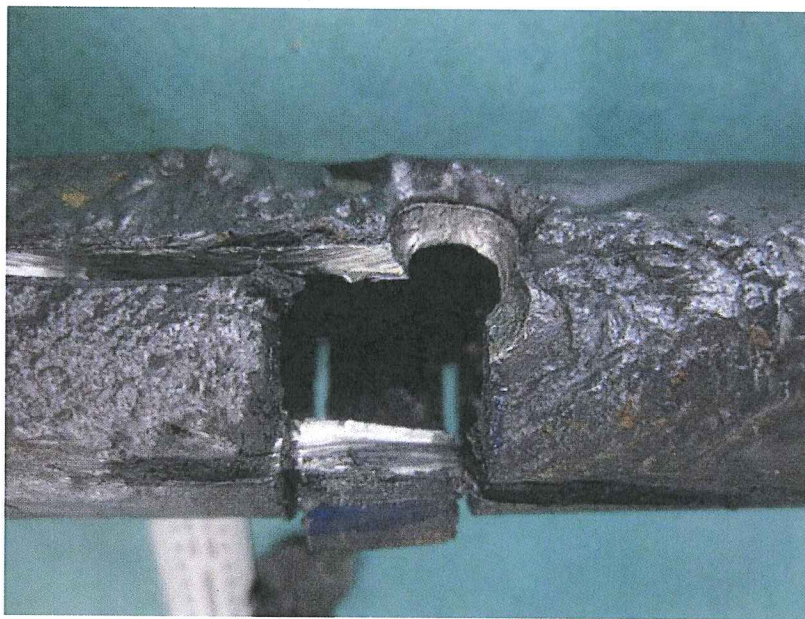
Figure 4. Detailed color photographs showing the marking at the hole and after cutting a portion of the hole from the gas line from 12040 8th Avenue NE.

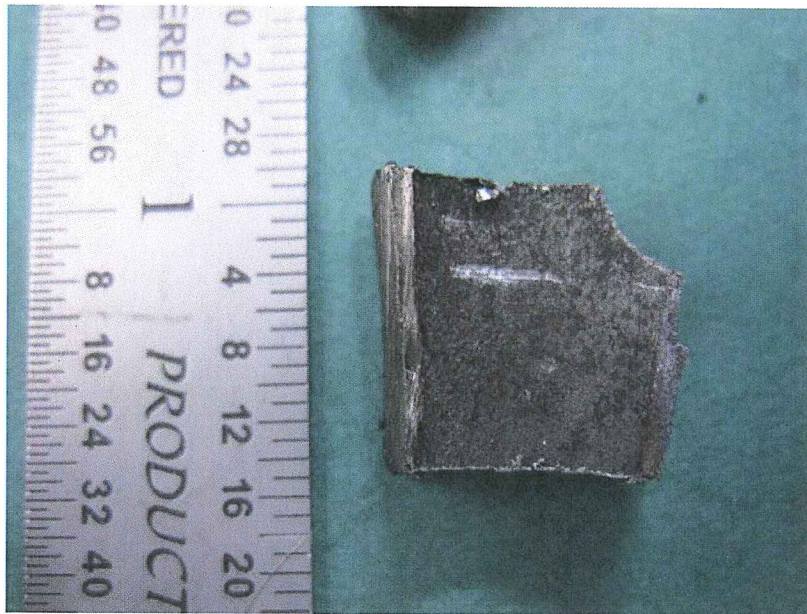
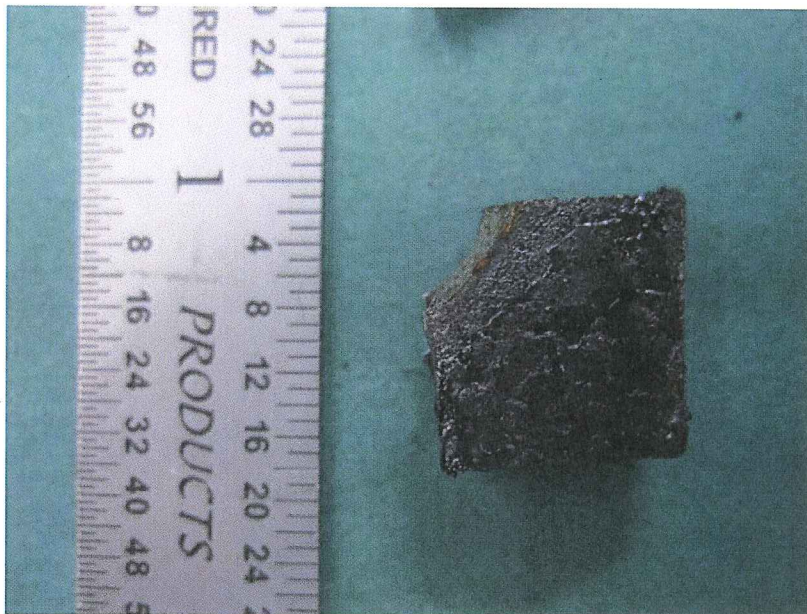
.Figure 5. Detailed color photographs showing a section of the hole removed from the gas line from 12040 8th Avenue NE. (a) ID surface; (b) OD surface.

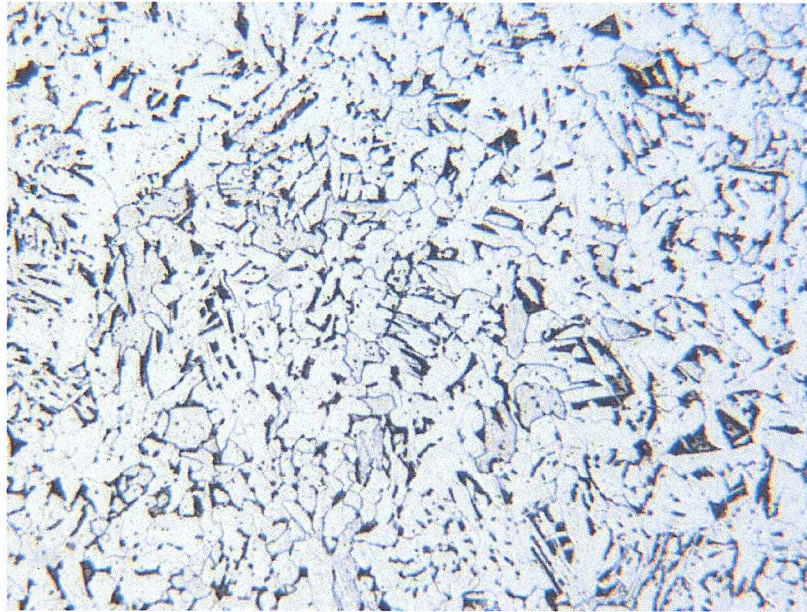
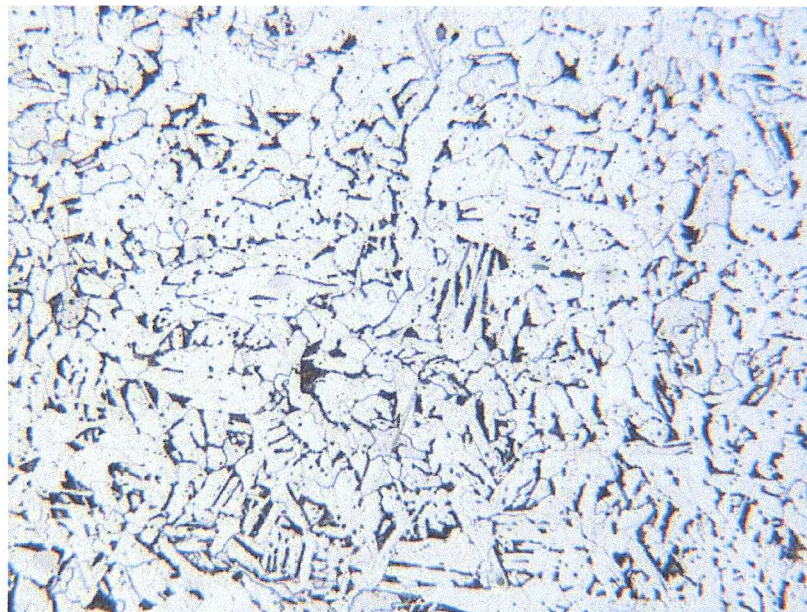
A metallographic mount was made with the hole wall in cross section. The mount was ground, polished and etched using standard metallographic procedures. The etched mount was examined using an optical microscope and the micrographs are presented in Figures 8-11. The surface of the hole from ID to OD revealed an altered microstructure due to melting and re-solidification of the surface; Figures 8-10. The hole surface also revealed a small void; Figure 10(a). The general microstructure of the steel indicates a low to medium carbon steel; Figure 11.

Figure 11. Detailed optical micrographs showing the metallurgical microstructure of steel section removed from the gas line from 12040 8th Avenue NE. (a) Etched, 100X; (b) Etched, 100X.

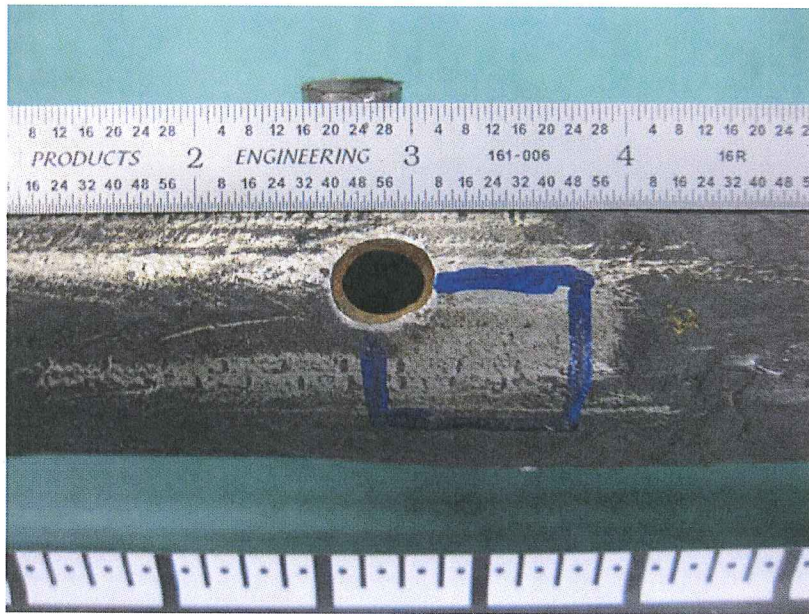
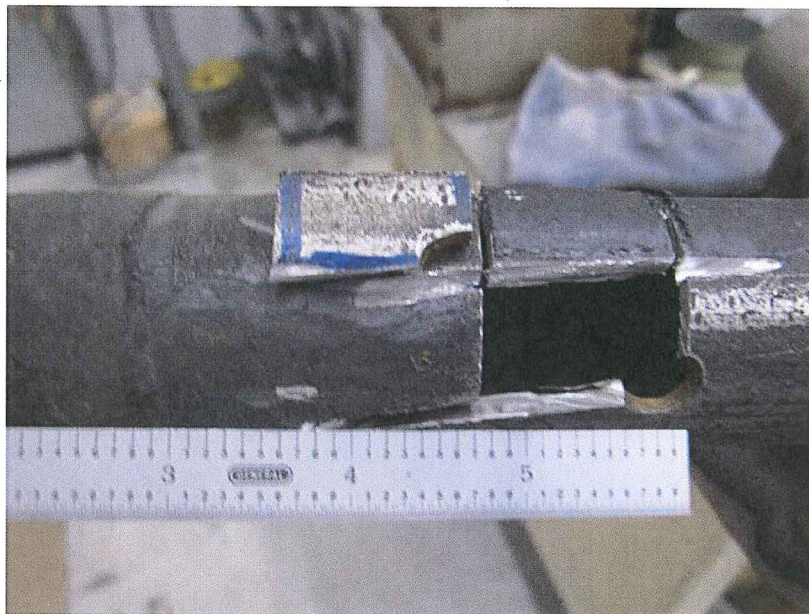
Figure 14. Detailed color photographs showing the marking at the hole and after cutting a portion of the hole from the gas line from 913 NE 122nd Street.

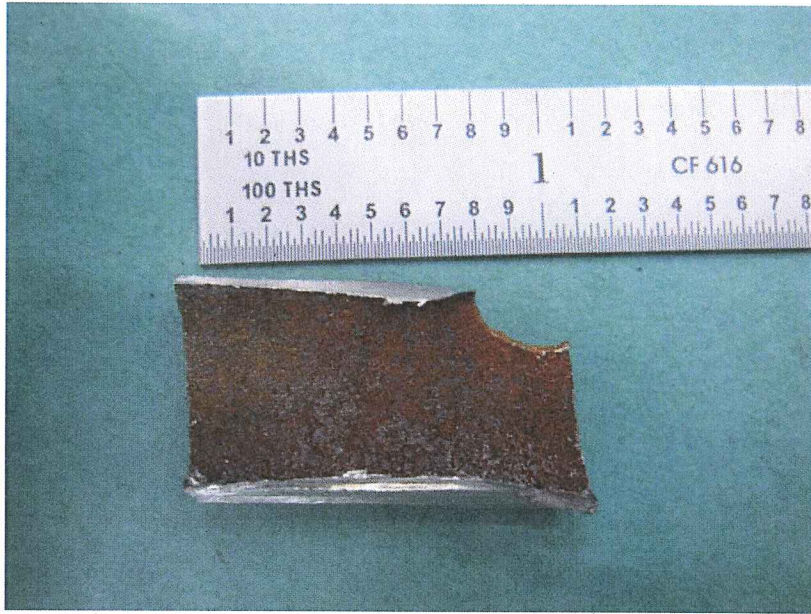
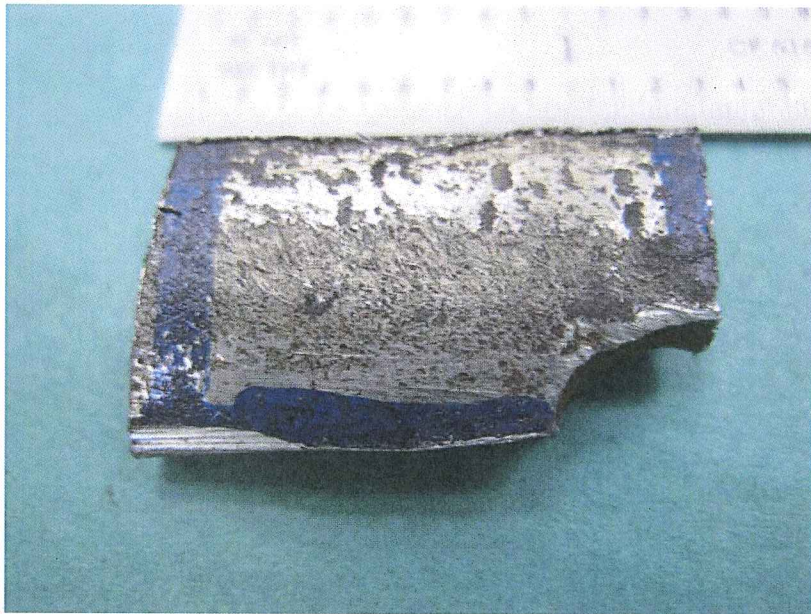
Figure 15. Detailed color photographs showing a section of the hole removed from the gas line from 913 NE 122nd Street. (a) ID surface; (b) OD surface.

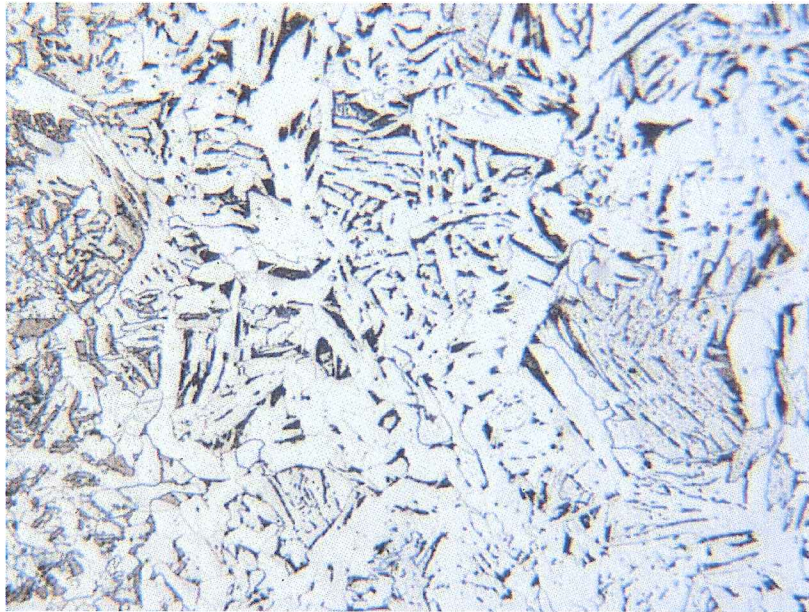
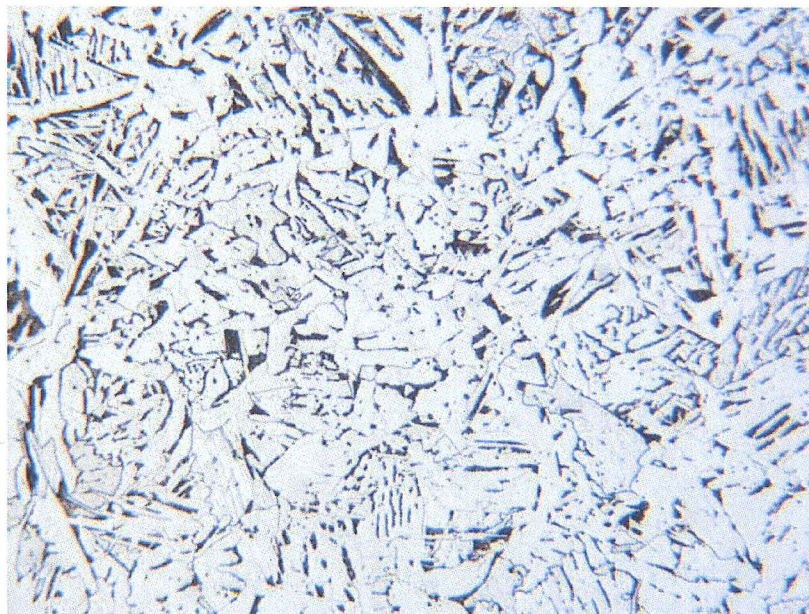
A metallographic mount was made with the hole wall in cross section. The mount was ground, polished and etched using standard metallographic procedures. The etched mount was examined using an optical microscope and the micrographs are presented in Figures 17-20. The surface of the hole from ID to OD revealed an altered microstructure due to melting and re-solidification of the surface; Figures 17-19. The general microstructure of the steel indicates a medium carbon steel; Figure 20.

Figure 20. Detailed optical micrographs showing the metallurgical microstructure of steel section removed from the gas line from 913 NE 122nd Street E. (a) Etched, 100X; (b) Etched, 100X.

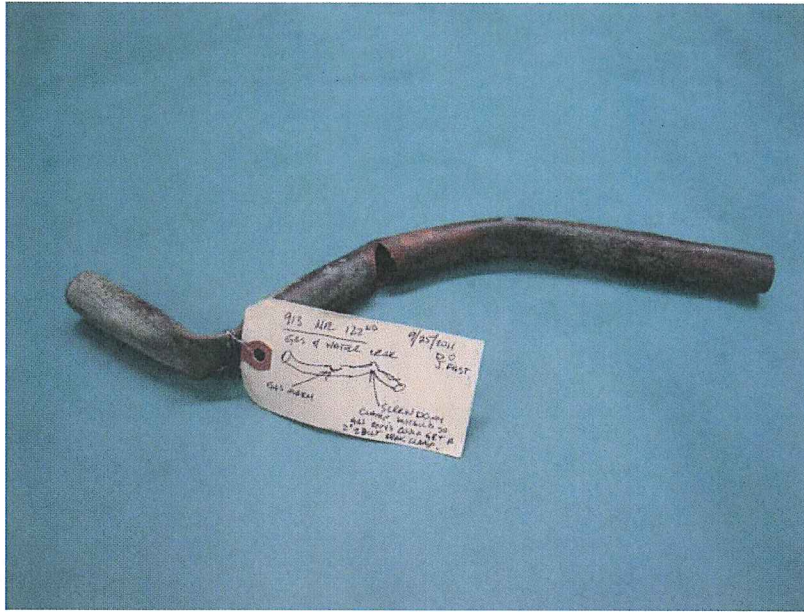
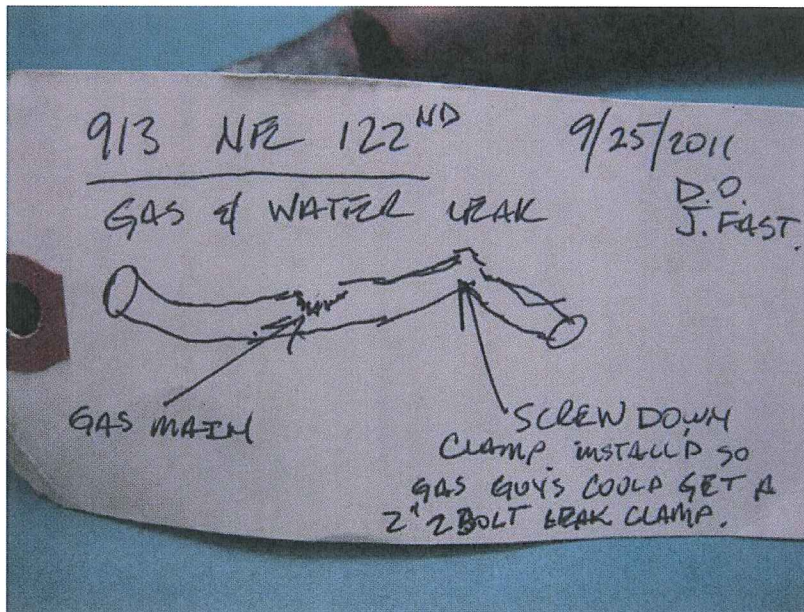
The copper water line that was allegedly in contact with the gas line is shown in Figure 21(a). The attached tag to the water line is shown in Figure 21(b). The periphery of the hole in the copper line shows melted copper balls, indicating it is caused by arcing; Figures 22 and 23. The line was clamped and pinched at a location adjacent to the hole; Figure 24.

Figure 21. Color photographs showing the copper water line from 913 NE 122nd Street and the attached tag.

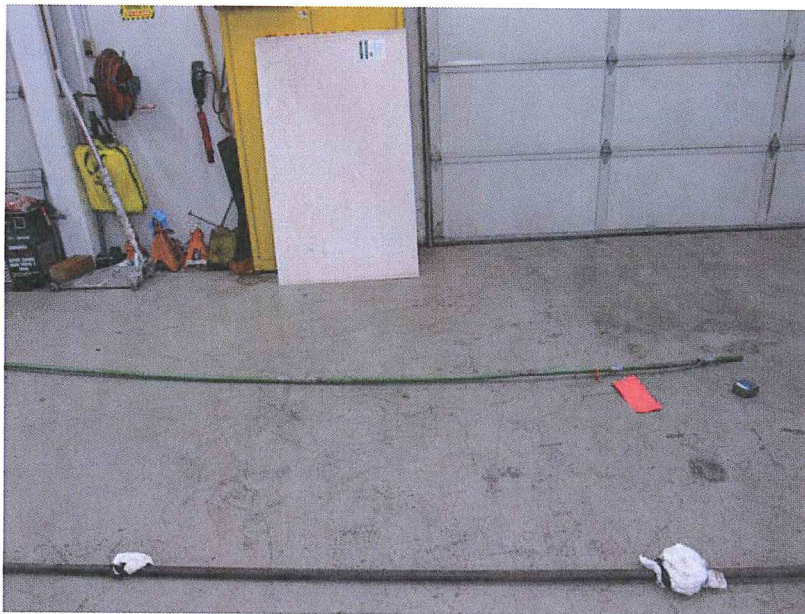
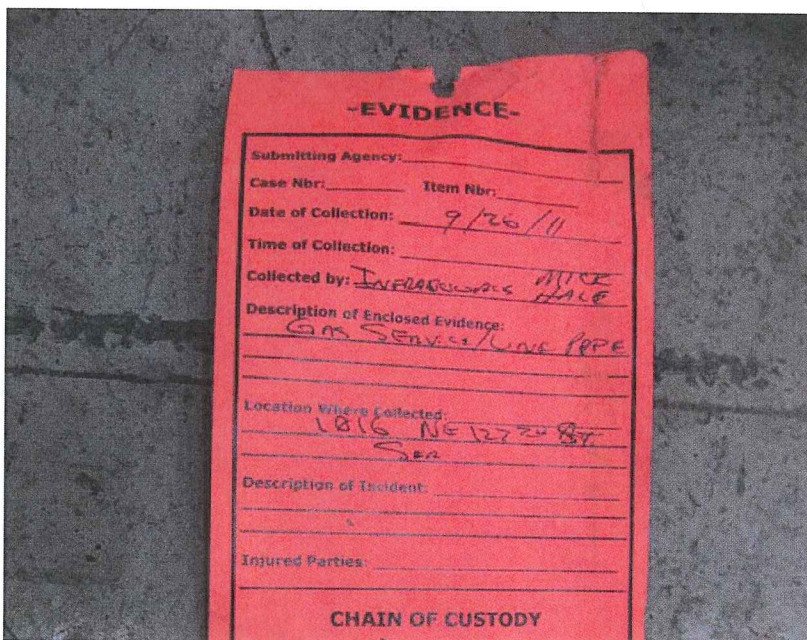
This pipe section was collected by Infrasource on 9-26-11, as evidenced by the tag attached to the pipe section; Figure 25. The gas service line pipe was made from steel, coated with green epoxy Scotchkote 101, was 158 inches long with 1.15 inch outer diameter and wall thickness of 0.11 inch. The pipe contained an irregular shaped oval hole with major diameter as 1.0 inch and minor diameter as 0.6 inch; Figure 26. The green coating had melted and evaporated or flaked off around the hole. A section of the pipe was cut containing $\frac{1}{4}$ of the hole wall, as shown in Figure 27. The removed section contained the $\frac{1}{4}$ hole in a corner and is shown from the ID and OD side in Figures 28-30. The hole was clearly created from OD toward the ID, as seen by the missing material at the hole wall. The hole surface appeared smooth with no fracture features and re-solidified surface; Figure 30.

Figure 25. Color photographs showing the gas line from 1016 NE 127th Street and the attached tag.

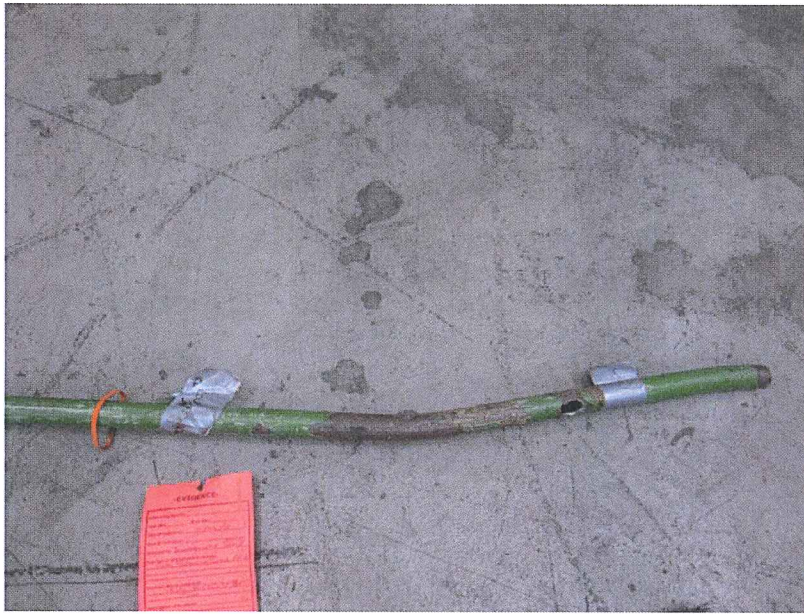
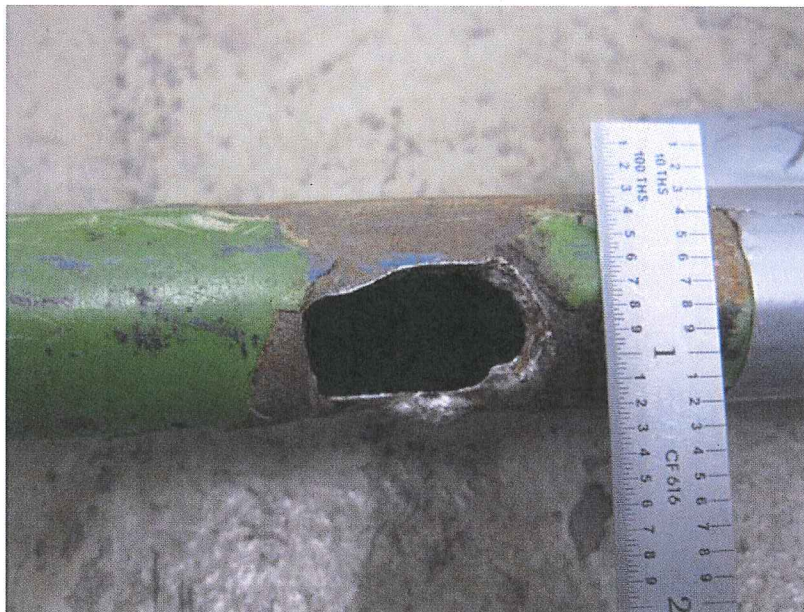
Figure 26. Detailed color photographs showing a hole in the gas line from 1016 NE 127th Street.

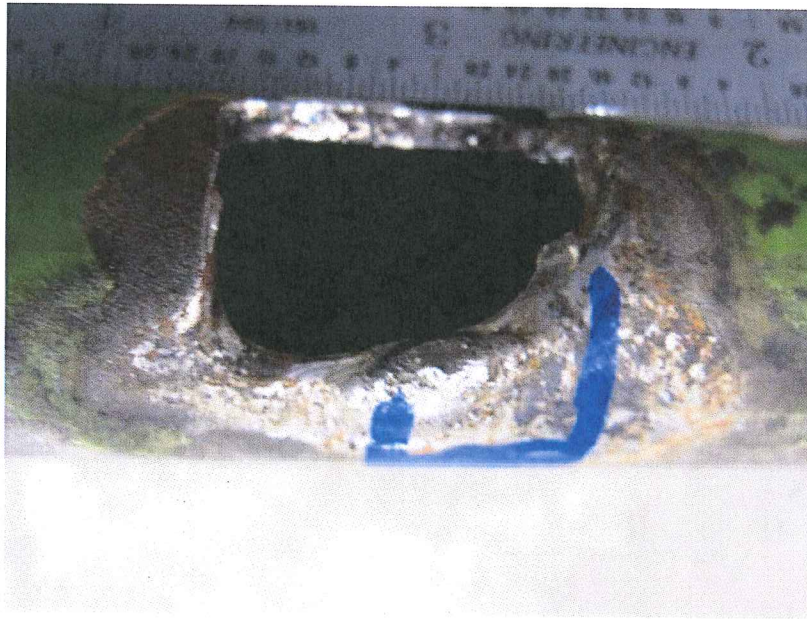
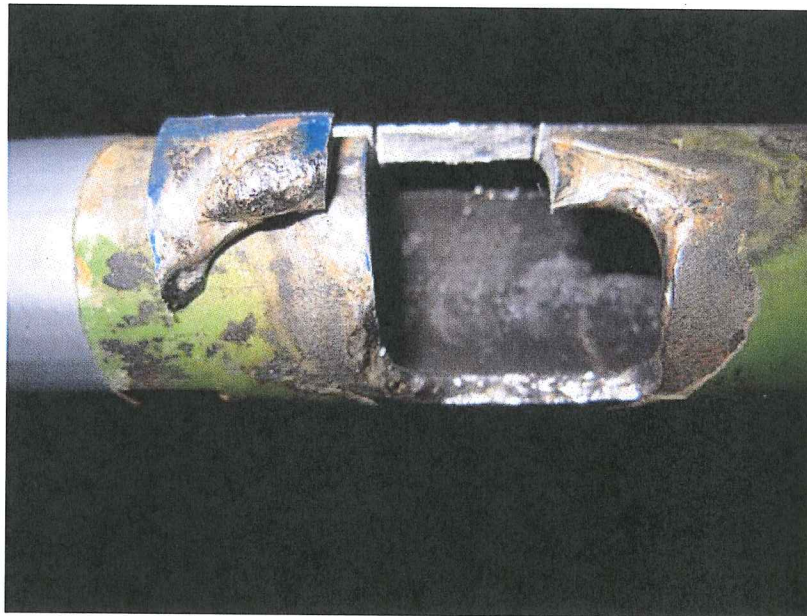
Figure 27. Detailed color photographs showing the marking at the hole and after cutting a portion of the hole from the gas line from 1016 NE 127th Street.

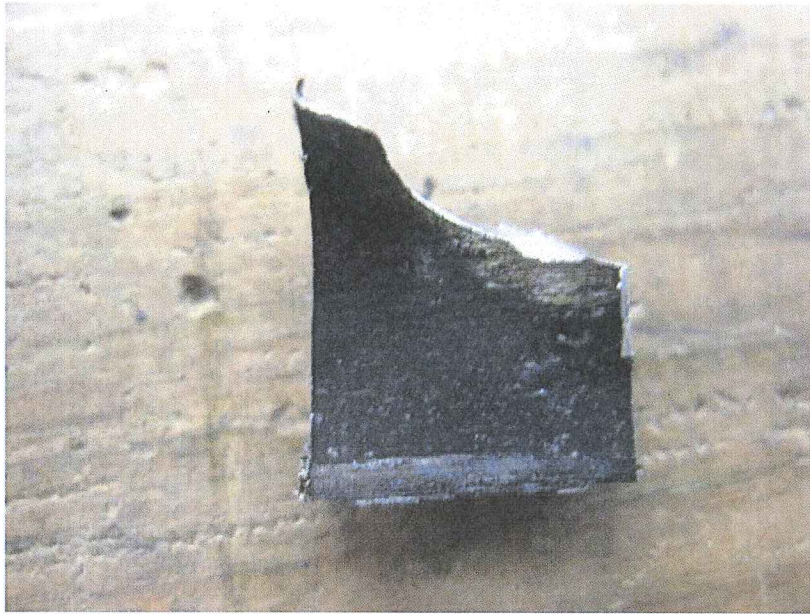
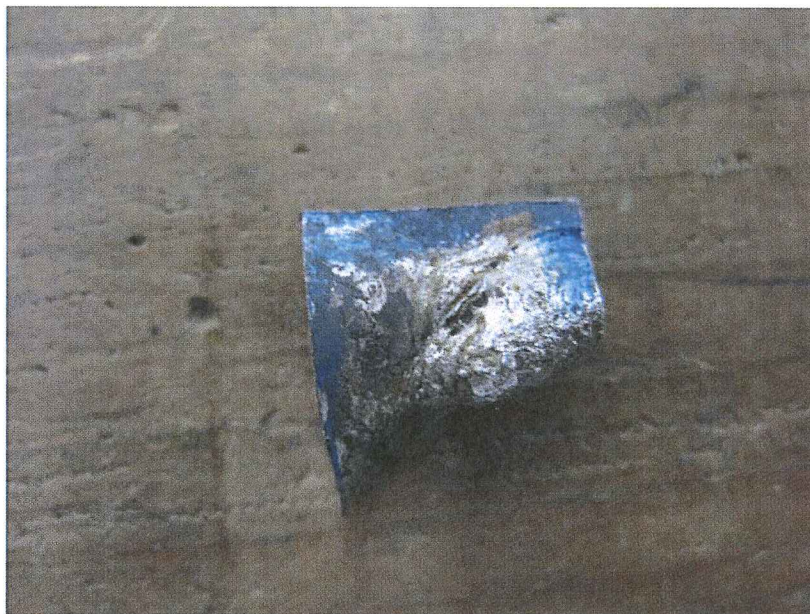
Figure 28. Detailed color photographs showing a section of the hole removed from the gas line from 1016 NE 127th Street. (a) ID surface; (b) OD surface.

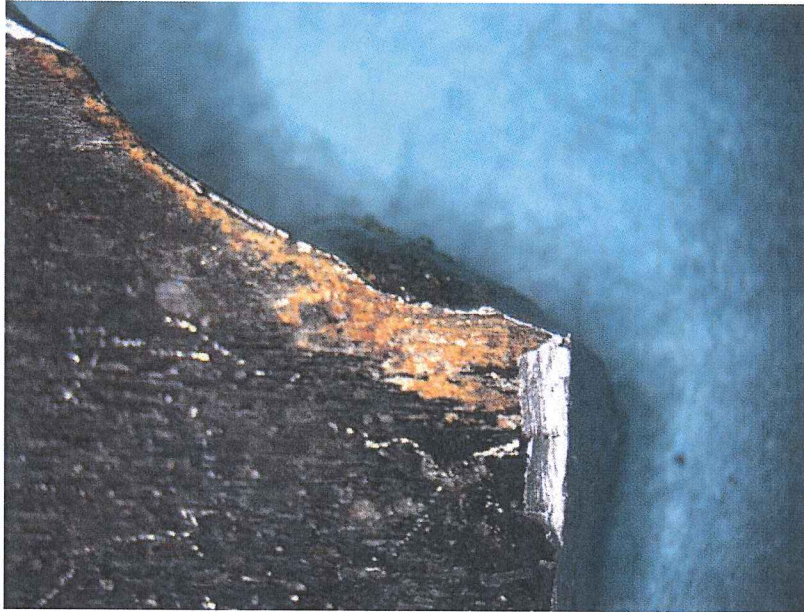
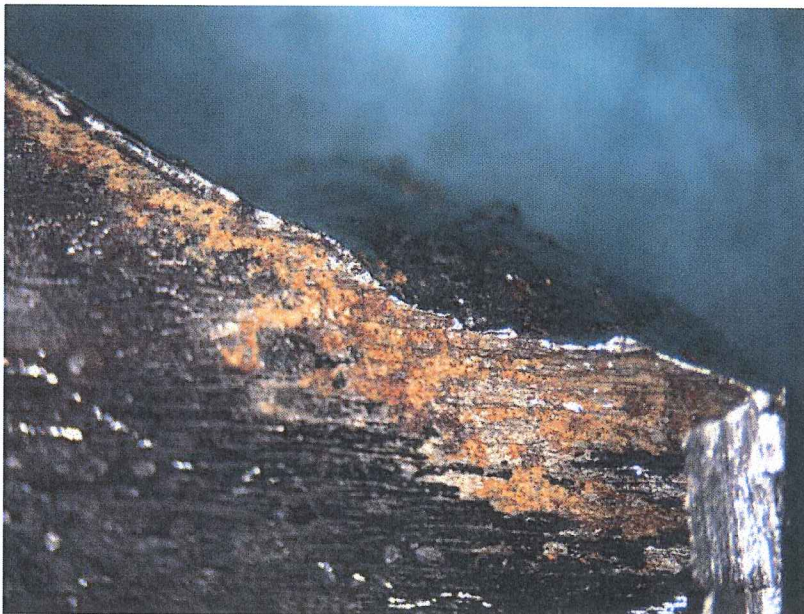
Figure 29. Detailed color photographs showing the ID surface near the hole of the section removed from the gas line from 1016 NE 127th Street. (a) ID surface, 10X; (b) ID Surface, 20X.

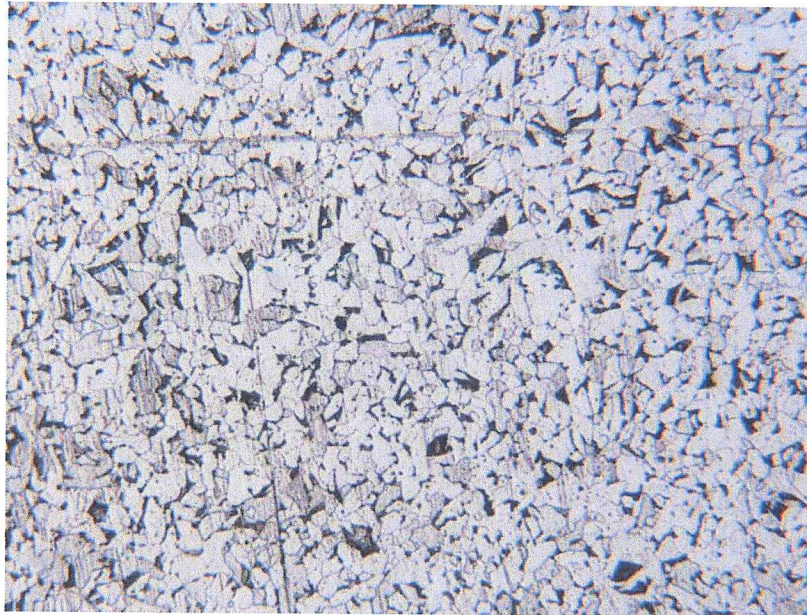
A metallographic mount was made with the hole wall in cross section. The mount was ground, polished and etched using standard metallographic procedures. The etched mount was examined using an optical microscope and the micrographs are presented in Figures 31-33. A large void (gas bubble) was present near the hole surface that was created during the arcing, melting and re-solidification process; Figure 31. The surface of the hole from ID to OD revealed an altered microstructure due to melting and re-solidification of the surface; Figure 32. The general microstructure of the steel indicates a medium carbon steel; Figure 33.

Figure 33. A detailed optical micrograph showing the metallurgical microstructure of steel section removed from the gas line from 1016 NE 127th Street. Etched, 100X.

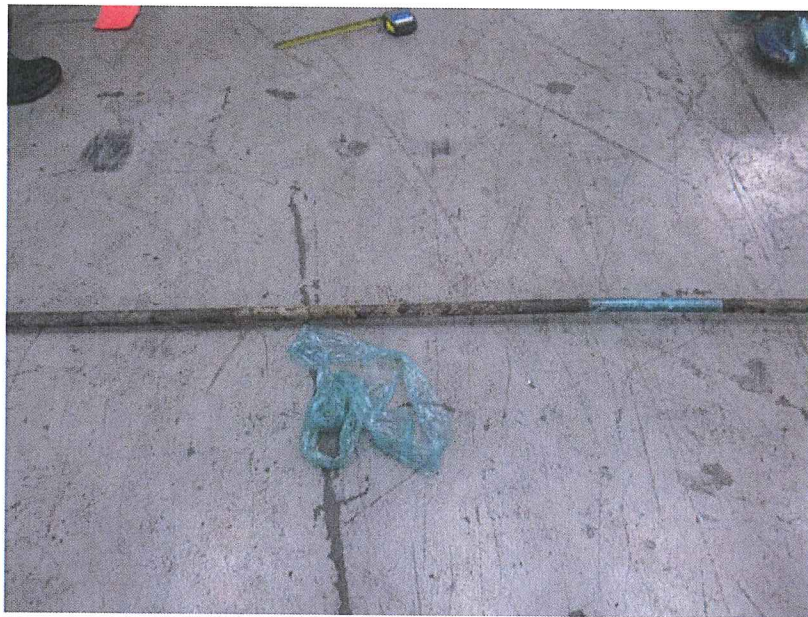
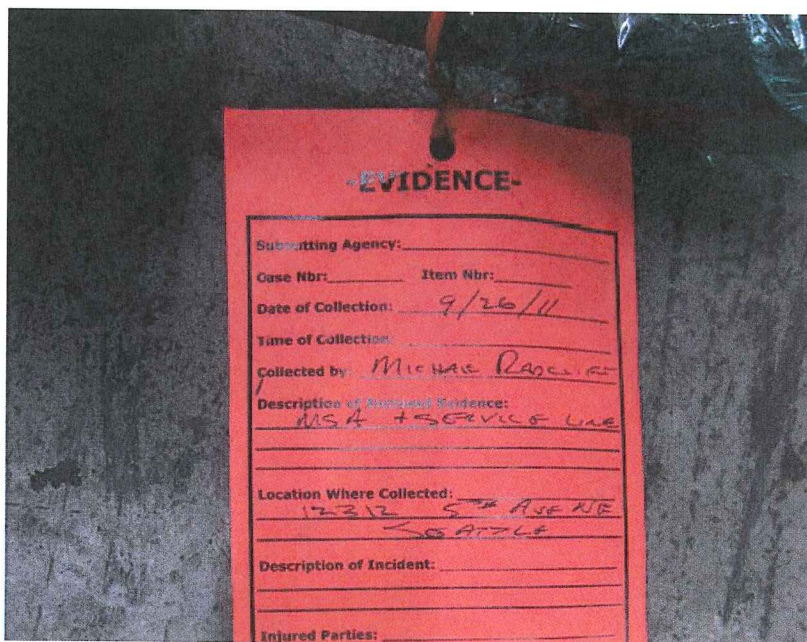
This pipe section was collected by Michael Radcliff on 9-26-11, as evidenced by the tag attached to the pipe section; Figure 34. The gas service line pipe was made from steel, surface coated, was 225 inches long with gas meter attached to one end of the pipe. The pipe has 1.08 inch outer diameter and wall thickness of 0.11 inch. The pipe contained a round hole on the bottom of the pipe with an average diameter of 0.25 inch on the OD surface. A small section of the pipe containing the hole was sectioned; Figure 35. Another section of the pipe containing the hole was marked and cut as shown in Figure 36. The removed section was further cut to expose the hole on the ID surface as shown from the ID and OD side in Figures 37. The hole surface on the OD appeared smooth with no fracture features and re-solidified surface.

Figure 34. Color photographs showing the gas line from 12312 5th Avenue NE and the attached tag.

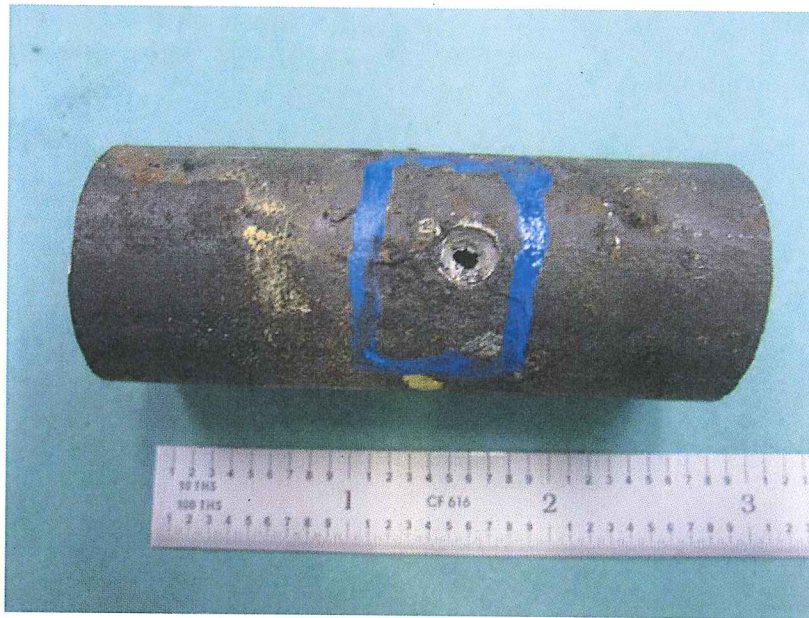
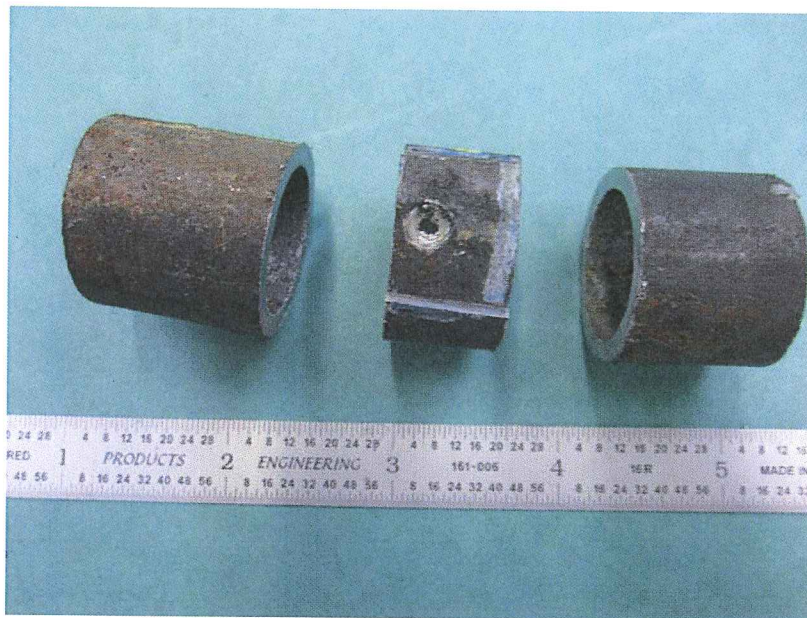
Figure 36. Detailed color photographs showing the marking around the hole and after cutting a portion of the pipe with the hole from the gas line from 12312 5th Avenue NE.

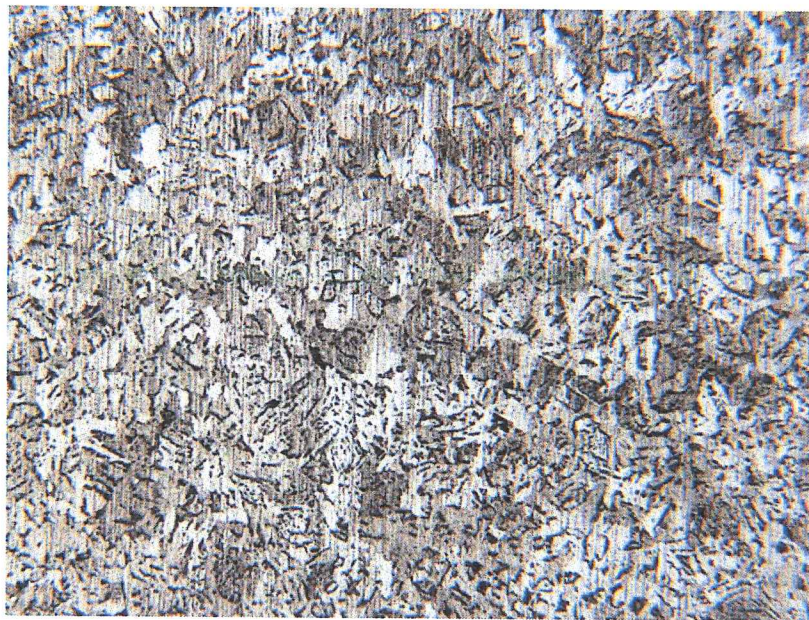
A metallographic mount was made with the entire hole in cross section. The mount was ground, polished and etched using standard metallographic procedures. The etched mount was examined using an optical microscope and the micrographs are presented in Figures 38-41. The hole was clearly created from OD toward the ID, as seen by the missing material; Figure 38. The surface of the hole from ID to OD revealed an altered microstructure due to melting and re-solidification of the surface. The general microstructure of the steel indicates a medium carbon steel; Figure 41.

Figure 41. A detailed optical micrograph showing the metallurgical microstructure of steel section removed from the gas line from 12312 5th Avenue NE. Etched, 50X.
