Seattle Fire Department Fire Investigator's Scene Report

DATE: 9/26/11
TIME: 06:04 HRS

SFD INC#: 11-089814
SPD INC#:

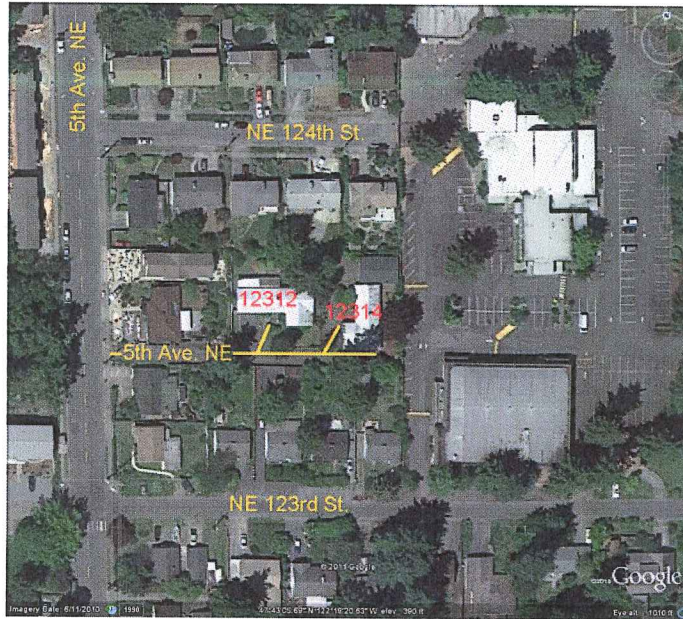
Premise Description This fire occurred as a result of a natural gas explosion. The address of the event is 12312 5th Ave. NE. The house is situated on a unique street lay-out. Even though 5th Ave. runs in a north/south direction, there is a 300 ft. section of the avenue that extends east, perpendicular to the 5th Ave. There are two houses located on the north side of this extension, addressed as 12312 (the explosion site) and 12314 5th Ave. NE. See photo.

aerial satellite photo – dated 6-11-2010
