THE WASHINGTON STATE UTILITIES AND TRANSPORTATION COMMISSION

DOCKET PG-082253

Commission Staff Investigation Report on Explosion and Fire

206 North Birch Street; Odessa, Lincoln County

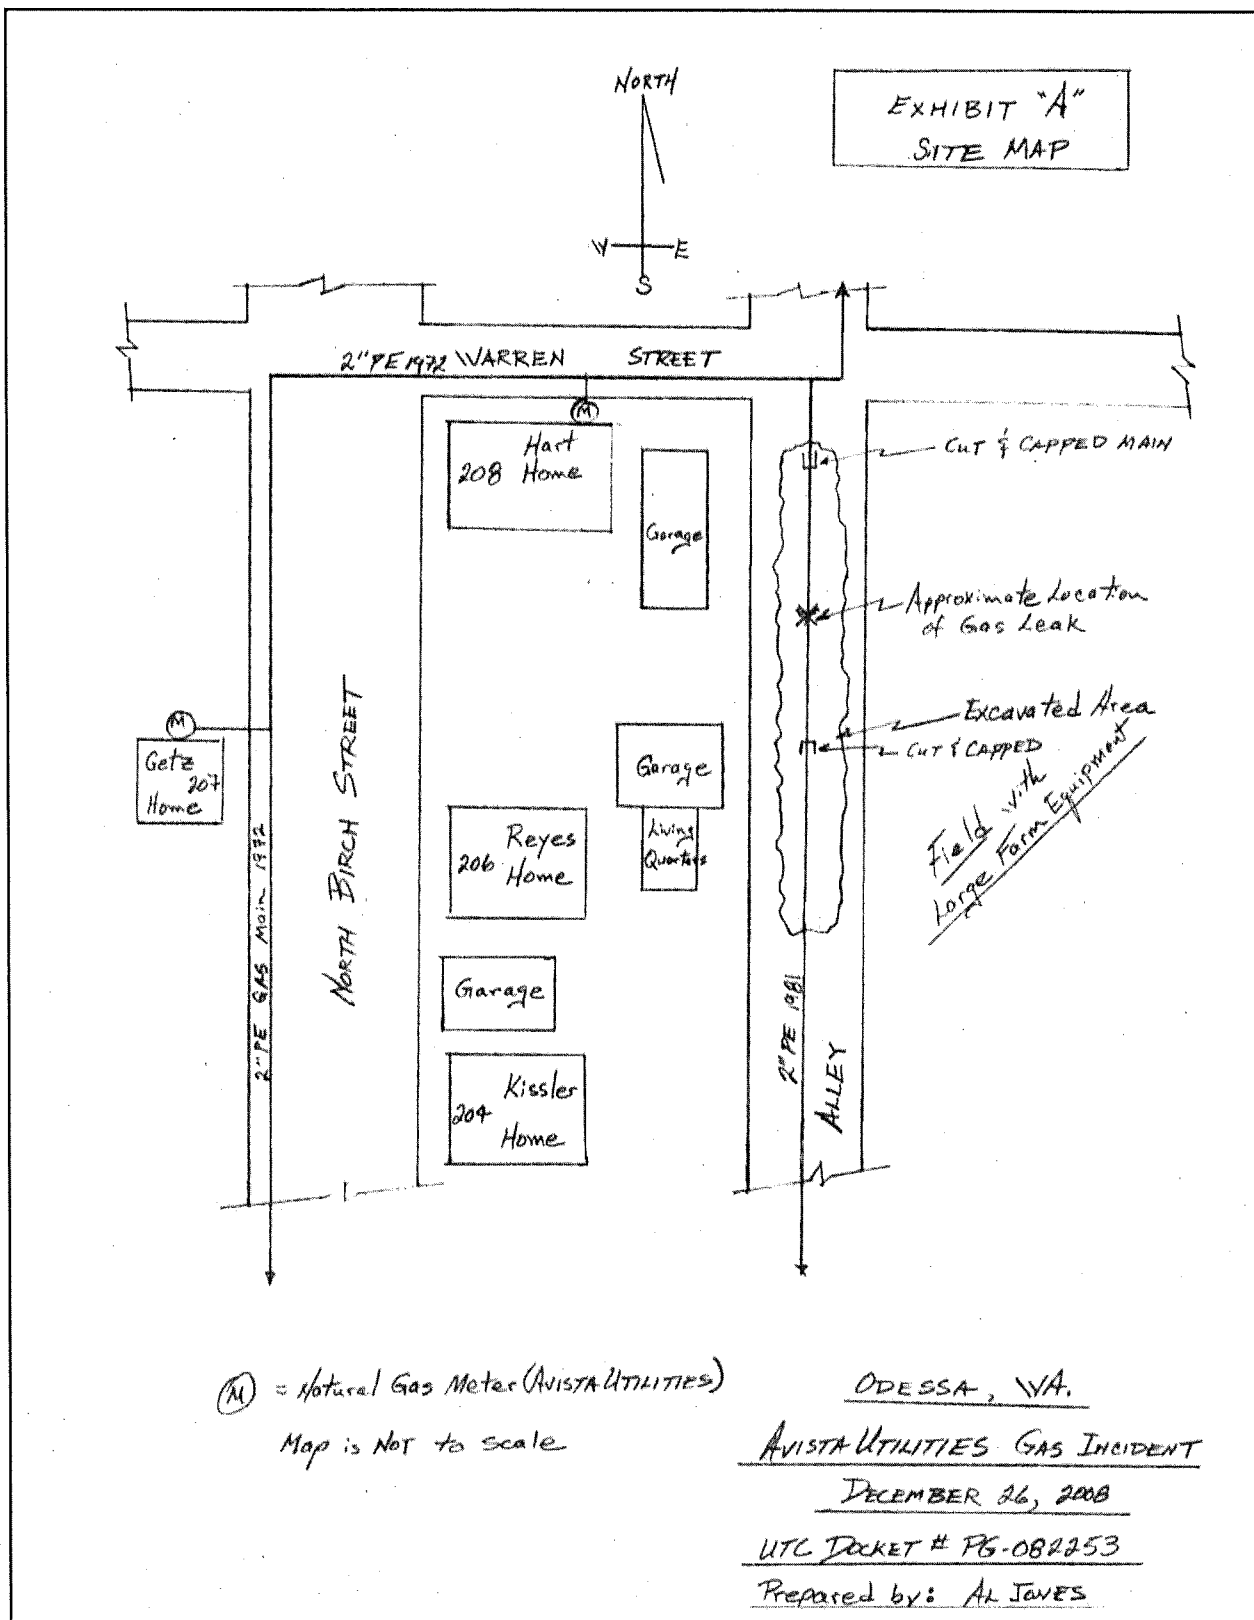
Exhibit A

(M) = Natural Gas Meter (AVISTA UTILITIES)
