Capsizing of Roll-on/Roll-off
Vehicle Carrier *Golden Ray*
St. Simons Sound, Brunswick River,
near Brunswick, Georgia
September 8, 2019

Marine Accident Report

NTSB/MAR-21/03
PB2021-100930

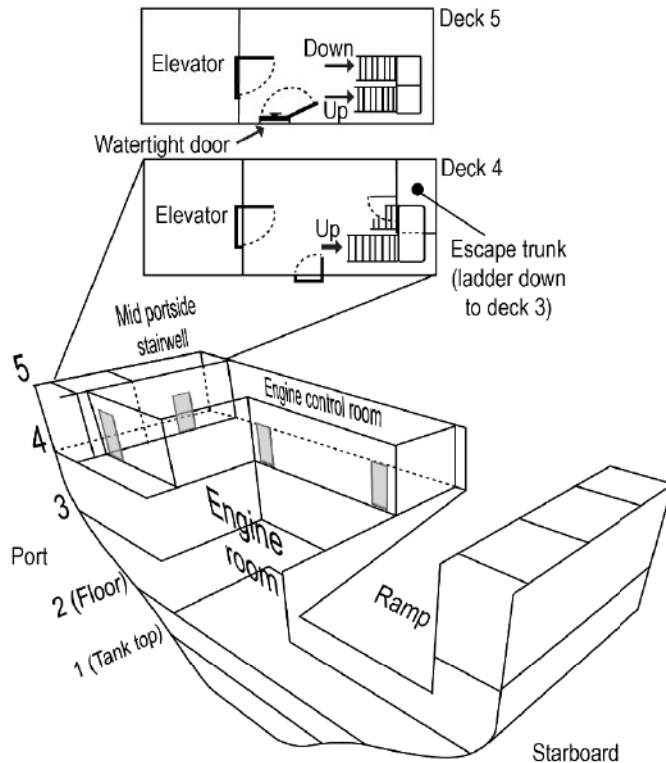
Figure 6. Simplified diagram showing a portion of the engine room and engine control room exits. Doors shaded gray.

the mid-portside stairwell—the primary stairwell serving the engine control room and engine room—but were blocked by incoming water, which was entering the stairwell from an open watertight door on deck 5. The engine control room also had three other doors facing aft that accessed the engine room directly (see figure 6).

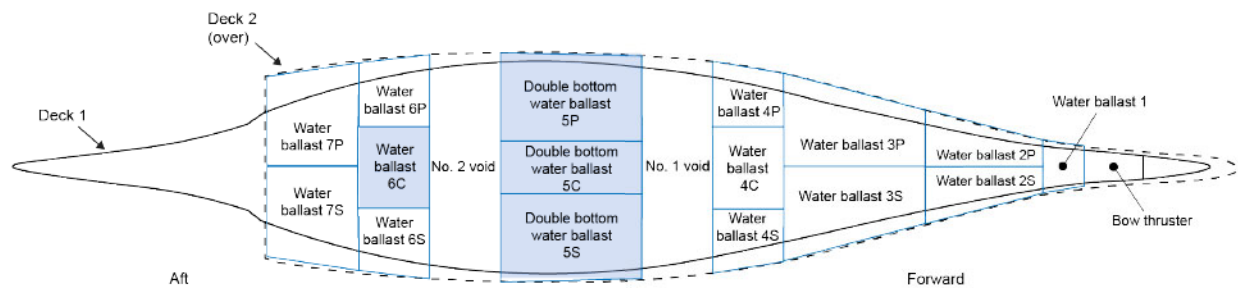
The vessel had 22 ballast tanks, comprised of 18 water ballast tanks, a fore peak tank, and 3 aft peak tanks (see figure 9). The total volume of the tanks was 9,842 cubic meters, and, when the tanks were completely full of salt water, the total capacity was 10,088 MT. Three water ballast tanks did not extend above the lowest cargo deck (deck 1) and were designated double bottom tanks (no. 5 starboard, centerline, and port water ballast tanks). (See [Appendix D](#) for water ballast tank levels at the time of the accident.)

Figure 9. Simplified plan of water ballast tanks on *Golden Ray*. Blue lines show water ballast tanks, and blue highlights show water ballast tanks used to transfer ballast prior to the accident voyage. Note: the solid line is deck 1, and the dashed line shows deck 2 above. Fore and aft peak tanks are not indicated for clarity.

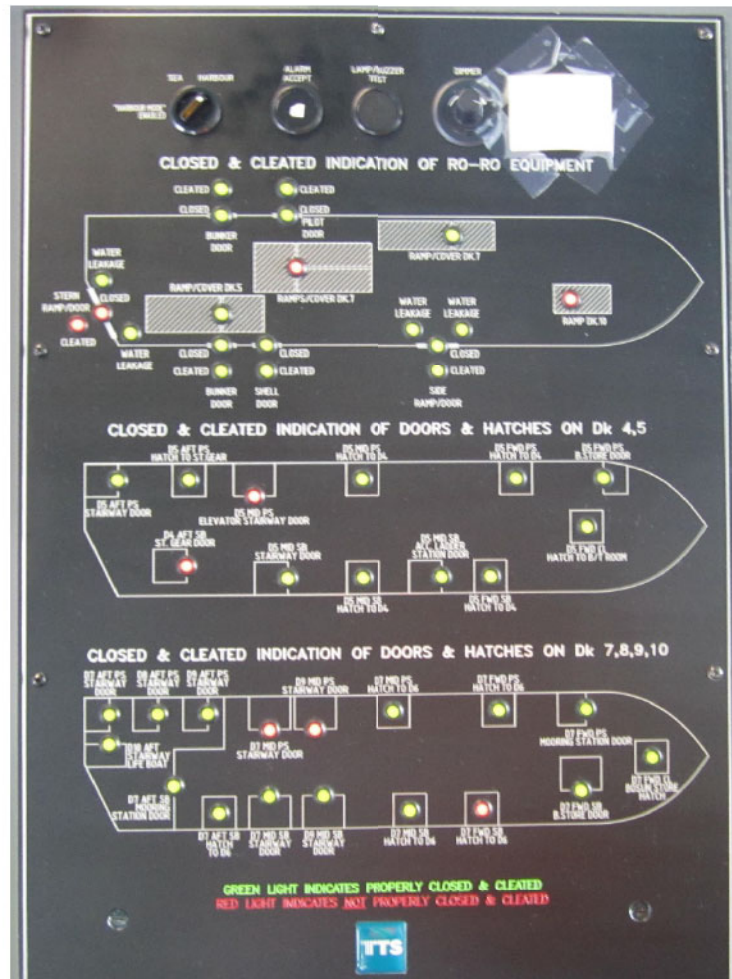
Figure 10. Watertight door indicator panel located on the bridge of the *Silver Ray*, a vessel of the same class as the *Golden Ray*.

The IMACS data showed that in addition to the portside pilot door, the watertight doors to both the aft and mid portside deck 5 stairwells were open at the time of the accident and had been open since 2341 on September 7 before the vessel departed the Colonel’s Island Terminal. The mid portside stairwell, about 75 feet (22.9 feet) aft of the pilot door, served as the primary access to the engine room and the engine control room on deck 4; the escape trunk stairwell serving the lower engine room exited to this stairwell at deck 4 (see figure 11).

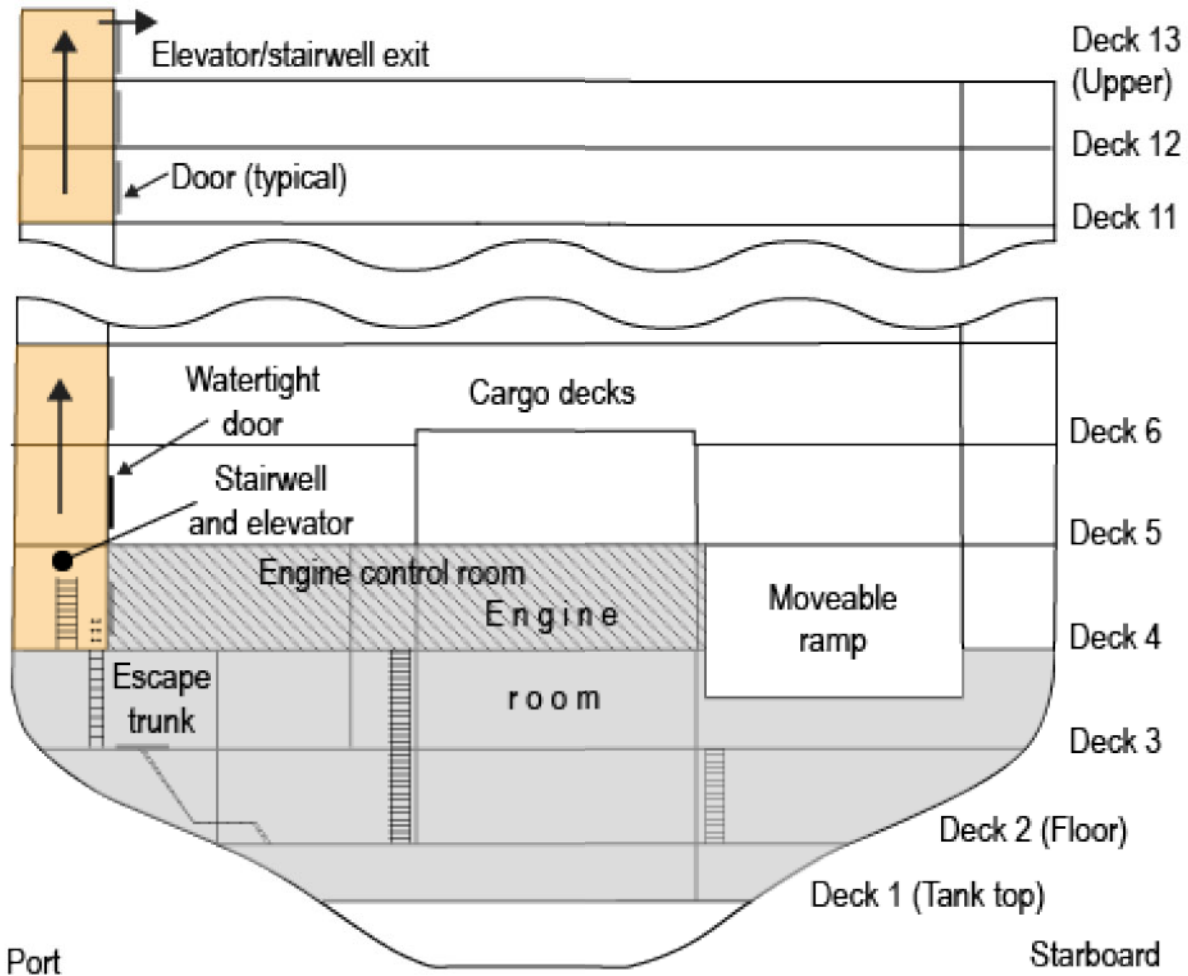
Figure 12. Simplified section view of the escape trunk and mid portside stairwell exit from the engine room and engine control room.

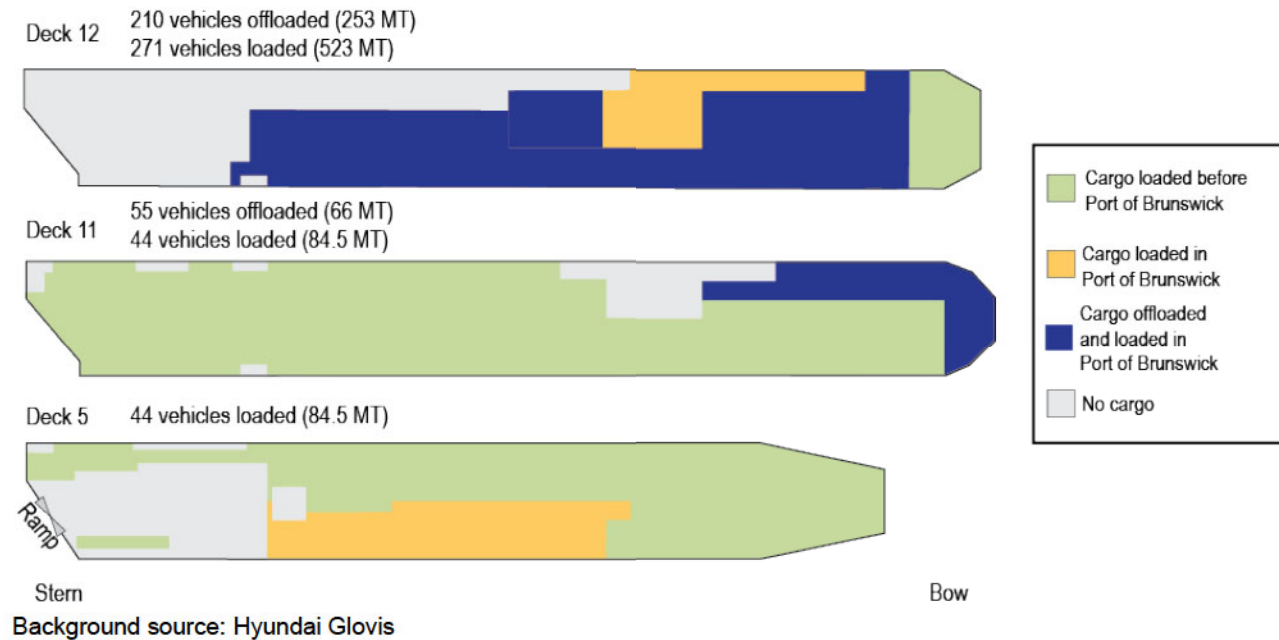
Figure 13. Preload plan (top view of decks 5, 12, and 13) for the *Golden Ray* at the Colonel's Island Terminal.

The chief officer stated that the preload plan that he received only contained the number and type of vehicles but did not contain the weight of each type of vehicle. (A postaccident review of the plan confirmed that the plan contained the number of vehicles and the total weight to be loaded in each loading location). Based on his experience, he estimated that each small vehicle being offloaded weighed 1.3 MT and each mid-sized vehicle being loaded weighed 2 MT, and he determined the total weight of the vehicles “based on the average weight of the given number of cars.” Using the stowage locations of the cargo provided in the preload plan and the estimated weight based on his calculations, the chief officer used the LOADCOM stability calculation program to determine the effect the cargo change would have on the vessel's stability. He concluded that the vessel would be able to accommodate the vehicles and meet stability requirements. He emailed the ship's agent to accept the preload plan before the vessel's arrival at the Port of Brunswick.

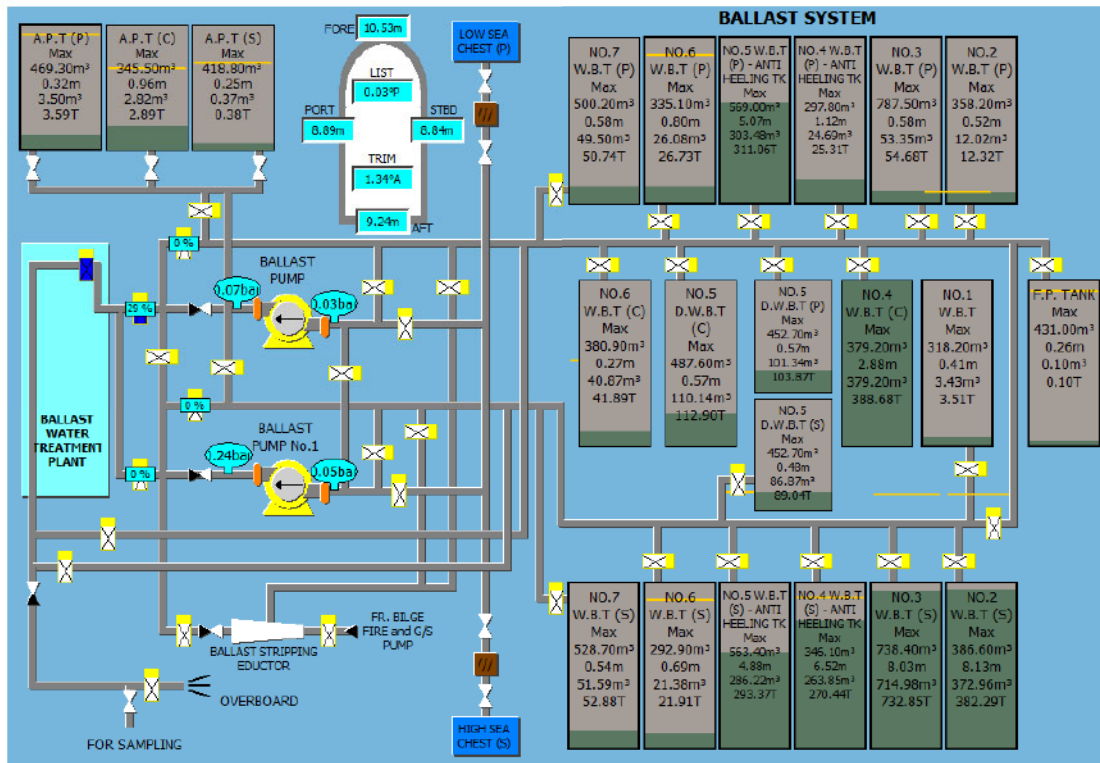
Figure D-1. IMACS water ballast system data before the *Golden Ray's* departure from the Colonel's Island Terminal.
