GEOTECHNICAL REPORT FOUNDATION FAILURE MODES REPORT Upper Baker Dam CONCRETE, WASHINGTON

December 22, 2022 Shannon & Wilson No: 105102-033 **SHANNON & WILSON**

Upper Baker Dam Geotechnical Report Foundation Failure Modes Report

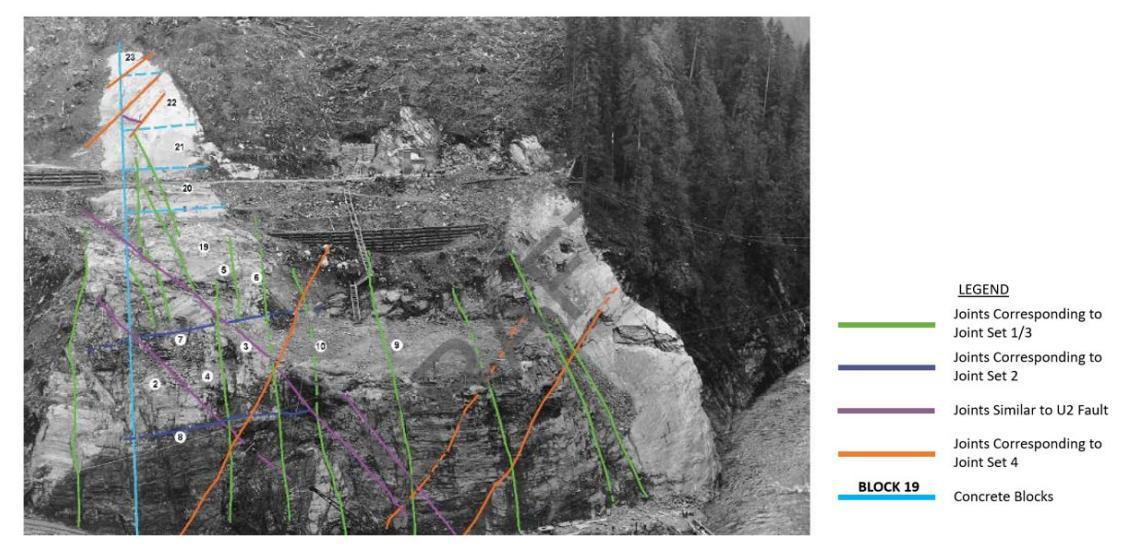
Exhibit 7-2: Photograph of the Left Abutment during Construction Showing Selected Joint Sets

data due to borehole direction bias. Stone & Webster (1960b) identified several discontinuities in Joint Sets 1 and 3 that contained soft, clay-like material and had an open aperture. Joint persistence is often greater than 100 feet as seen in construction-era photographs (Exhibit 7-2).

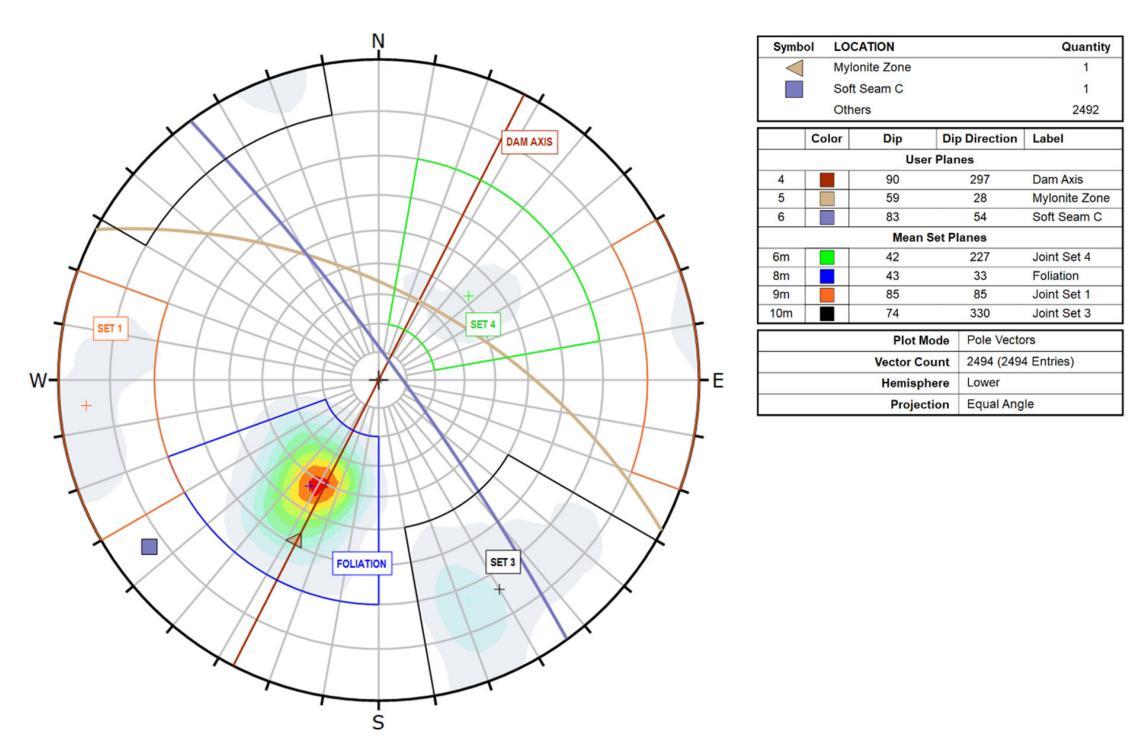
Exhibit 10-3: Lower Hemisphere Equal-Angle Polar Projection Showing Concentration of Minor Structure, and Great Circles and Poles to the Plane for Soft Seam C and the Mylonitic Zone

As presented in Exhibit 10-3, the major structure Soft Seam C and the Phyllite Zone are consistent with the general orientation of the foliation and do not form a kinematically admissible block of rock under the foundation of the dam. The wedge formed by these two (2) major structures has a favorable trend/plunge of 349/52 degrees and does not daylight downstream of the dam. This interpretation that a kinematically admissible wedge does not exist under Monoliths 4 and 5 supports listing PFMs N-UB-2C, F-UB-2C, and S-UB-2C as Category IV.

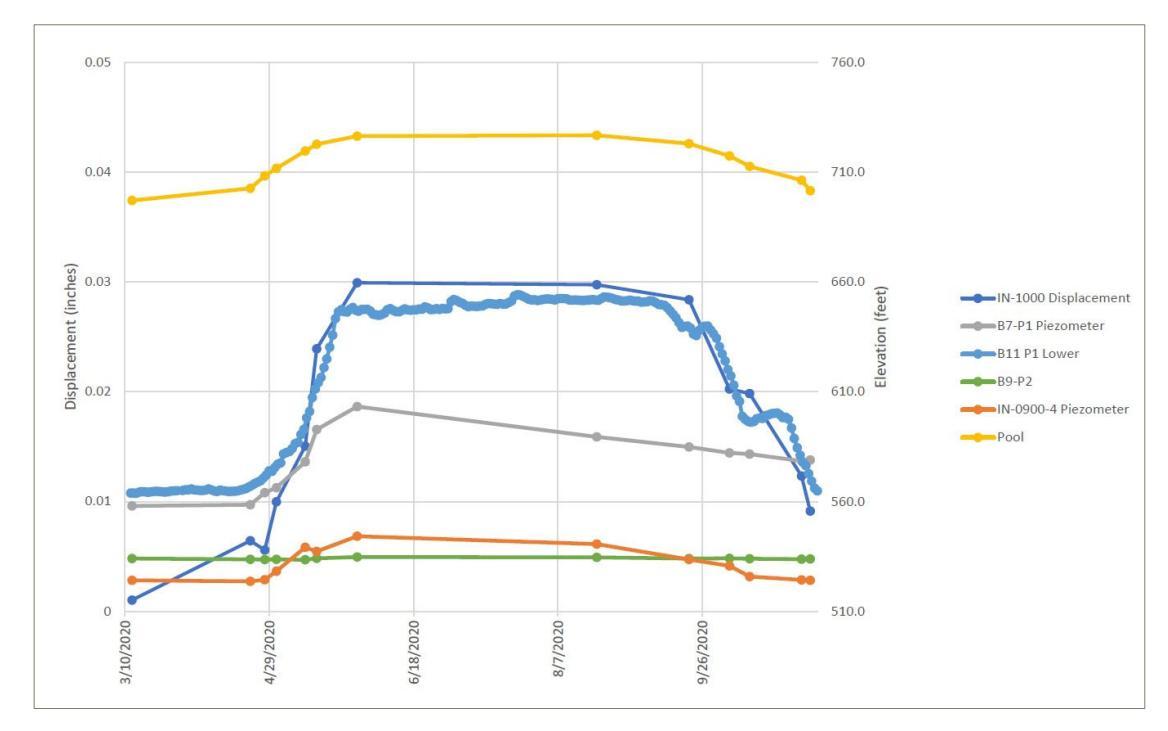
Exhibit 10-7: Elastic Displacement IN-1000 (Elevation 491 Feet) versus Selected Piezometers and Pool Elevation

Review of manual inclinometer data and piezometer data indicates that recent displacements observed in IN-1000 at Elevation 491 feet, in EX-0900 between anchors 3 and 4, and in EX-1000 between anchors 2 and 3 are elastic and directly correlated to groundwater elevation measured in piezometer data (B7-P1, B11-P1 Lower, and IN-0900-4) and to reservoir elevation. The relationship between elastic displacements in IN-1000, and piezometer data and reservoir elevation is shown in Exhibit 10-7.

Previously measured hydrostatic pressures in selected piezometers (B7-P1 Lower, VWP\_IN-0900-4, and B11-P1 Lower) appear to have a direct connection to the reservoir. These piezometers are positioned or have a screened interval that cross, or are in proximity to, the Block 6-10 Discontinuity. In past years, as the Baker Lake pool is raised in the spring, the phreatic surface in B7-P1 Lower approaches Elevation 600 and remains high for a 2- to 3-week period and then drops to approximately Elevation 560 to 570 feet. However, after mid-May 2020 the phreatic surface in B7-P1 remained high, fluctuating between Elevation 595 and 609 feet, possibly indicating a continued connection to the reservoir and an opening of seepage pathway along the Block 6-10 Discontinuity. Exhibit 10-8 presents a section in Monolith 8 drawn perpendicular to the axis of the dam, which shows that Block 6-10 Discontinuity projects into the reservoir.

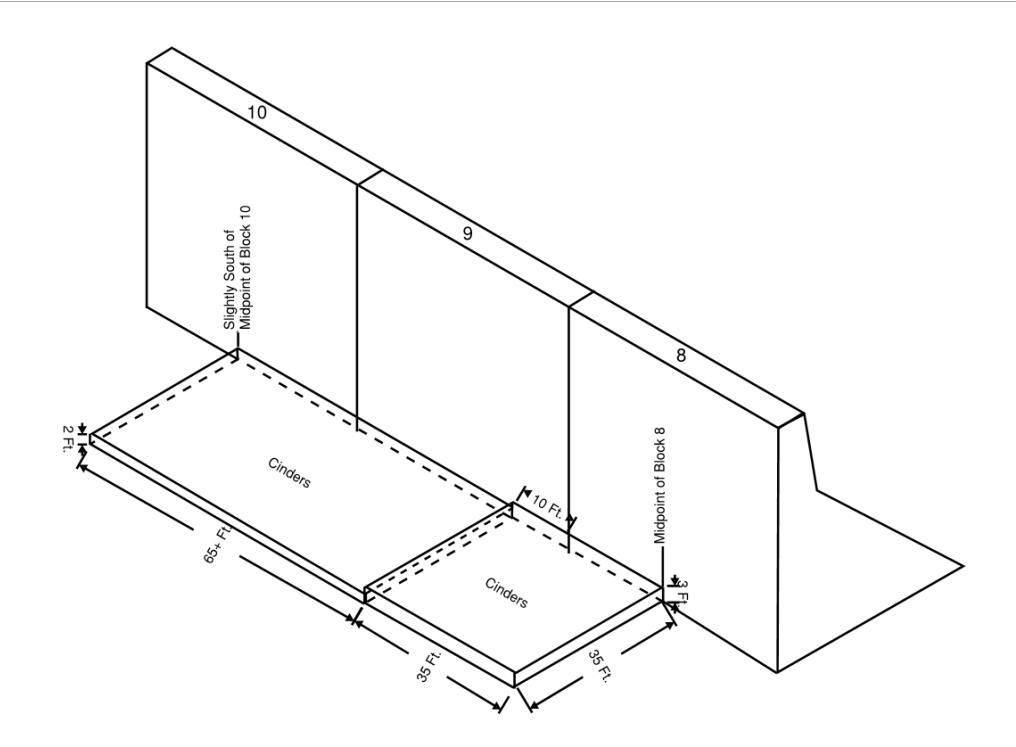
Exhibit 10-9: Illustration Showing the Coverage of the Cinder Blanket Installed Upstream of the Dam in 1963

In early 1963, it was recognized that a discontinuity projected into the reservoir and, in addition to adding more drain holes, a cinder blanket was constructed upstream of the dam that extended from the midpoint of Monolith 8 to the midpoint of Monolith 10. An illustration showing the cinder blanket relative to the monoliths is shown in Exhibit 10-9. Note that the cinder blanket does not extend into Monoliths 6 and 7, and does not cover the full projection of the Block 6-10 Discontinuity into the reservoir.

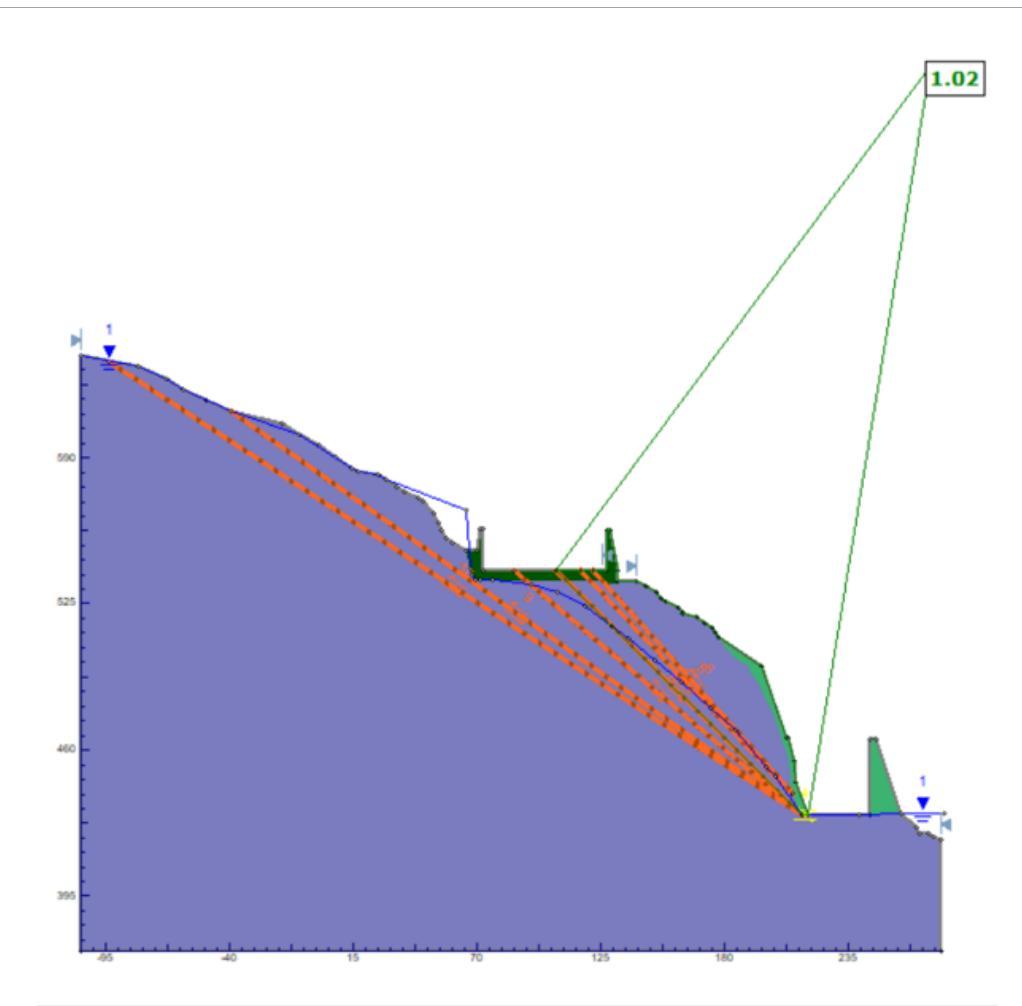
As illustrated in Exhibit 10-18, a static FS against sliding failure equal to approximately 1.0 (1.02) was achieved for Section 1 with a foliation shear strength of 0 cohesion and a joint friction angle of 48 degrees. As illustrated in Exhibit 10-19, a static FS against sliding failure equal to approximately 1.1 (1.11) was achieved for Section 2 with the same material properties. Existing condition model results and stability analysis reports from Slide (v. 9.023) by Rocscience are presented in Appendix N.

Exhibit 10-18: Existing Conditions Analysis for Section 1. Artesian groundwater pressures have been measured in the VWP upslope of the spillway (boring BH-17-1). In Slide, artesian groundwater conditions are modeled using a piezometric head line, shown as the blue boundary, which accounts for the artesian pore pressures without contributions from the additional weight of the water (i.e., pooled water).

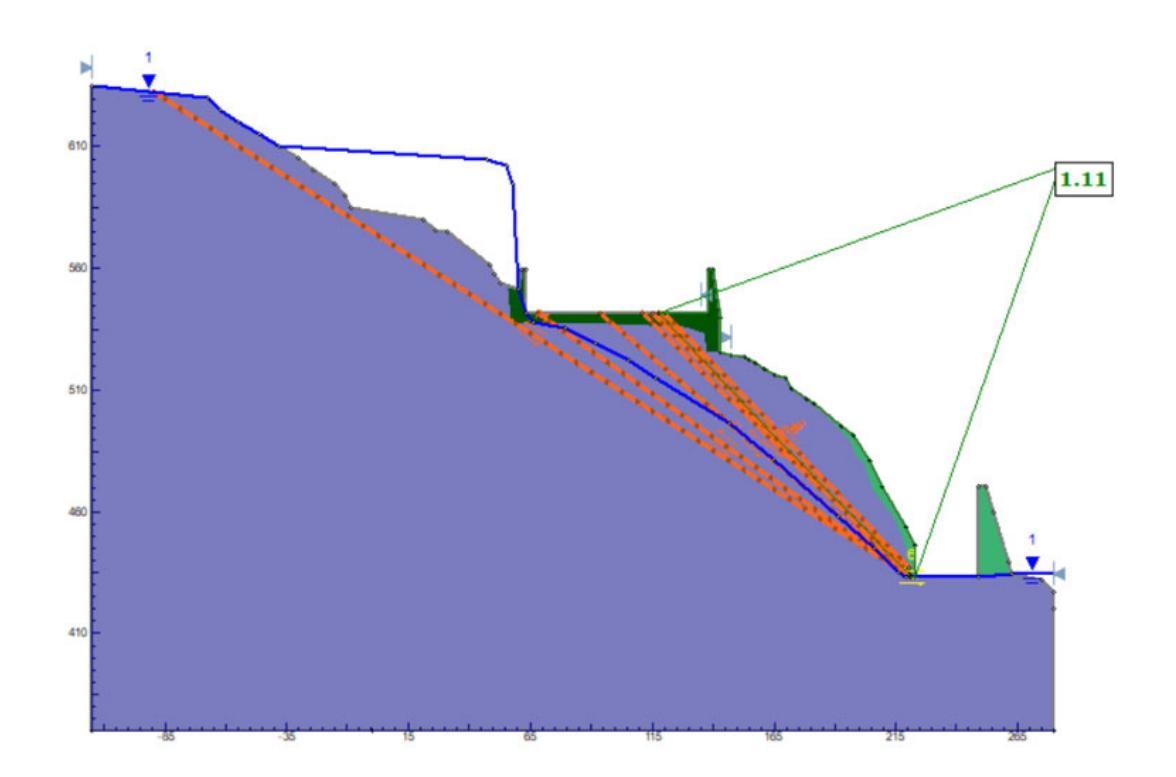
Exhibit 10-19: Existing Conditions Analysis for Section 2. Artesian groundwater pressures have been measured in the VWP upslope of the spillway (boring BH-17-2). In Slide, artesian groundwater conditions are modeled using a piezometric head line, shown as the blue boundary, which accounts for the artesian pore pressures without contributions from the additional weight of the water (i.e., pooled water).

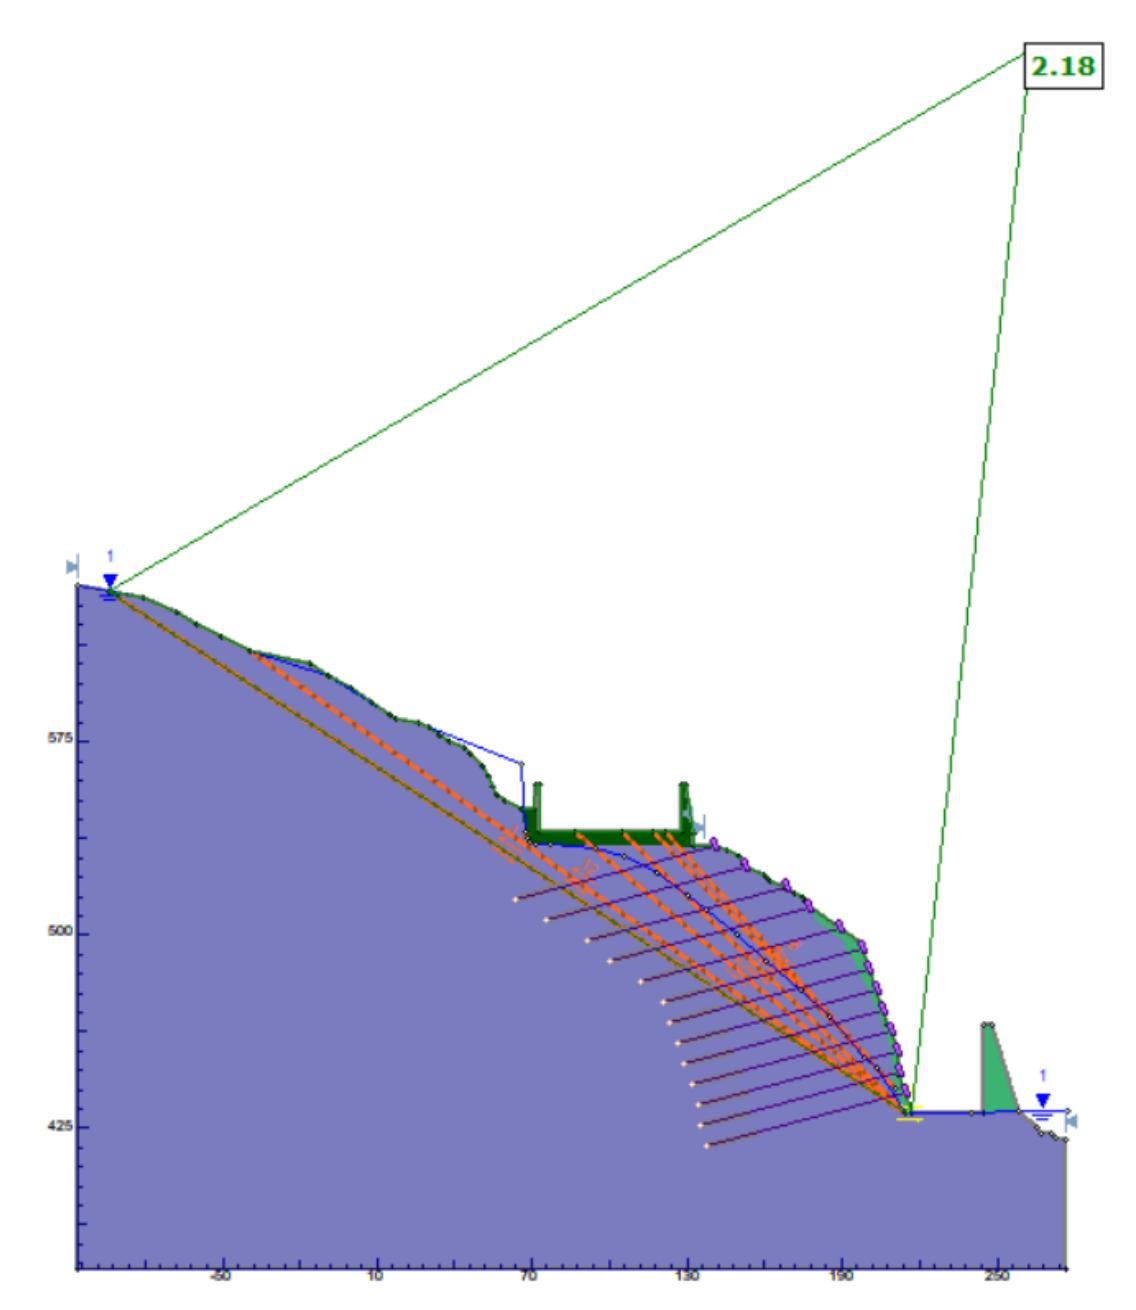
The Slide results for a 1 <sup>3</sup>/<sub>4</sub>-inch, Grade 150 anchor-supported slope are presented in Exhibit 10-20 and Exhibit 10-21, respectively. The proposed rock anchor support pattern exceeds the required FS of 1.5 under usual loading conditions established by GD-1, Rev. 1 (Shannon & Wilson, 2022) for both Section 1 and Section 2.

Exhibit 10-20: Limit Equilibrium Results for the Static Analysis of the 1 <sup>3</sup>/<sub>4</sub>-inch, Grade 150 Anchor-Supported Slope under Usual Loading Conditions for Section 1. Artesian groundwater pressures have been measured in the VWP upslope of the spillway (boring BH-17-1). In Slide, artesian groundwater conditions are modeled using a piezometric head line, shown as the blue boundary, which accounts for the artesian pore pressures without contributions from the additional weight of the water (i.e., pooled water).

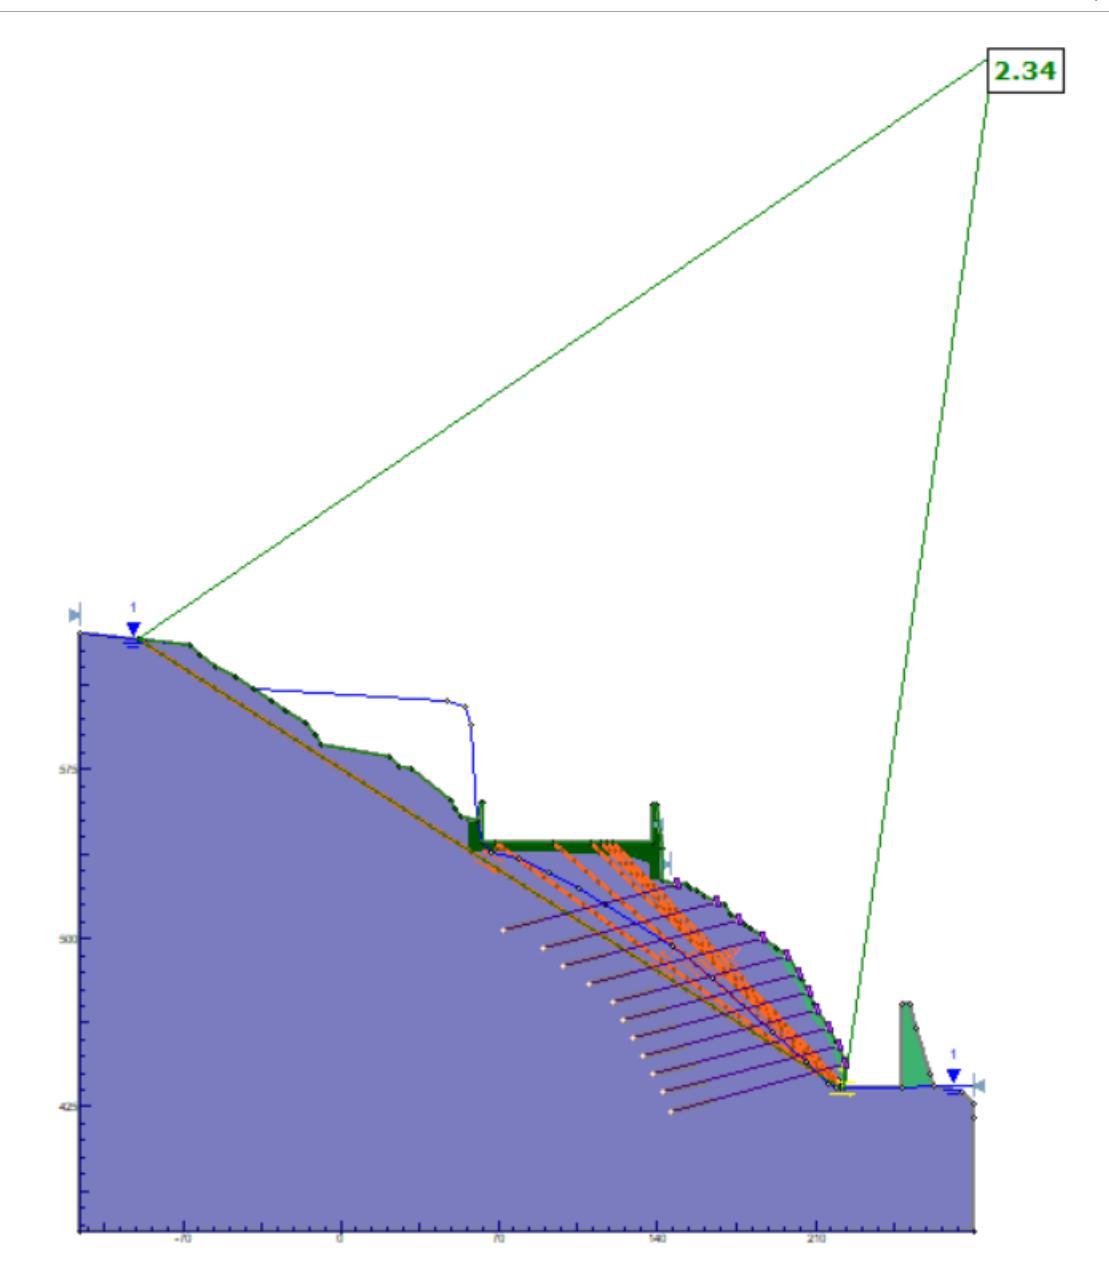
Exhibit 10-21: Limit Equilibrium Results for the Static Analysis of the 1 <sup>3</sup>/<sub>4</sub>-inch, Grade 150 Anchor-Supported Slope under Usual Loading Conditions for Section 2. Artesian groundwater pressures have been measured in the VWP upslope of the spillway (boring BH-17-2). In Slide, artesian groundwater conditions are modeled using a piezometric head line, shown as the blue boundary, which accounts for the artesian pore pressures without contributions from the additional weight of the water (i.e., pooled water).

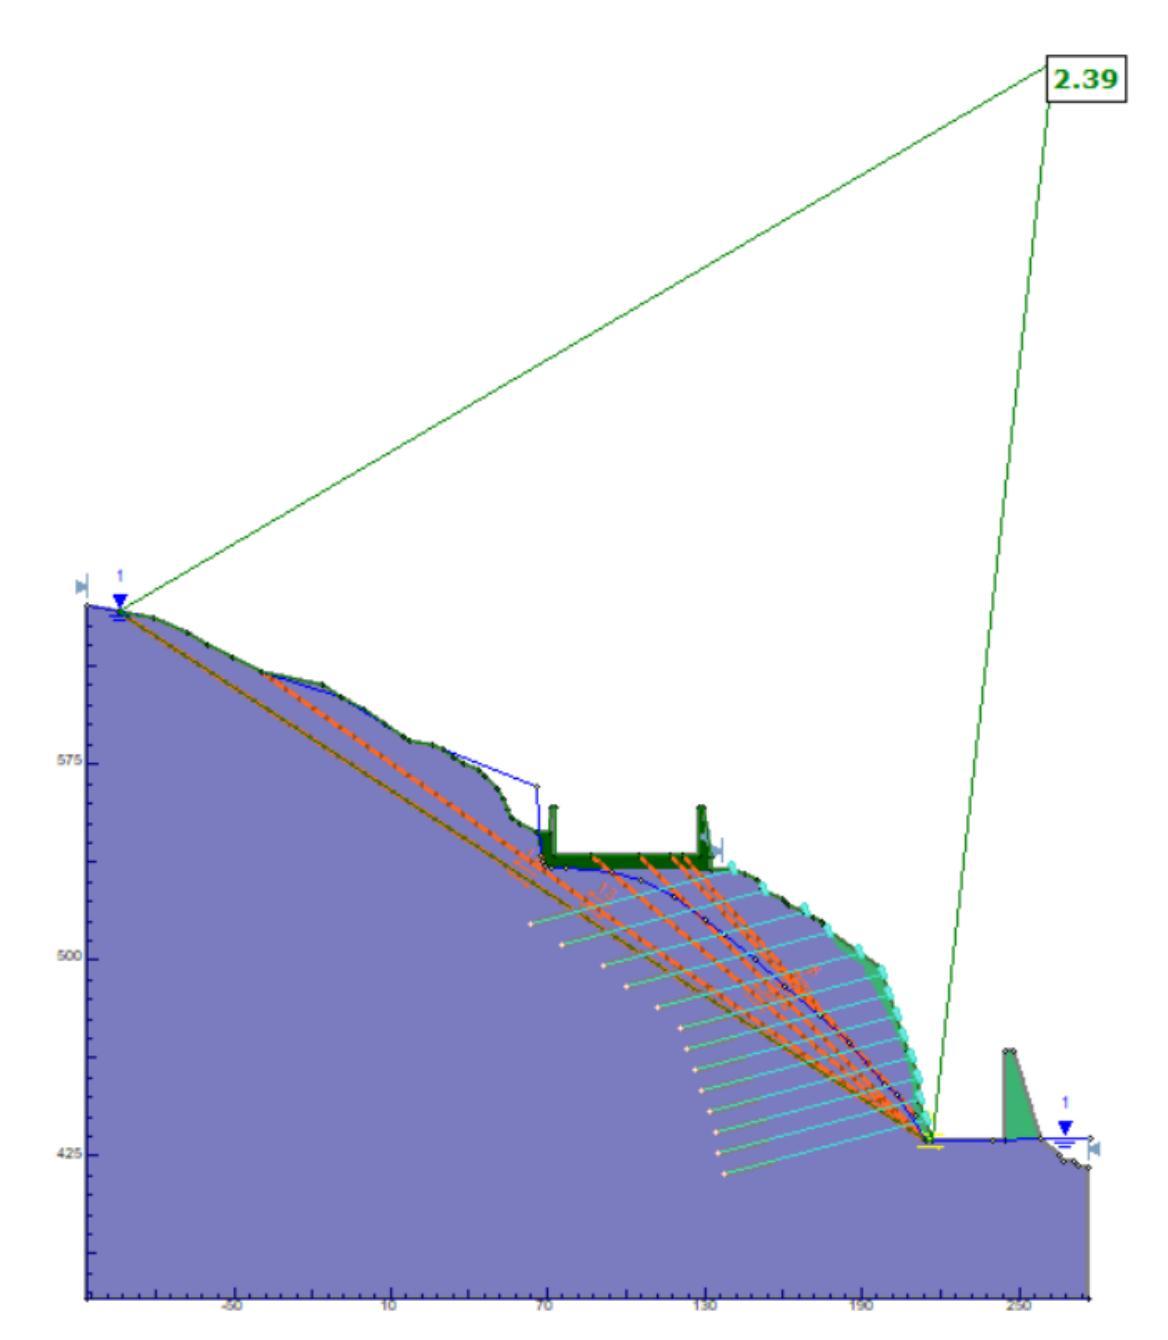
The Slide results for an 8 Strand anchor-supported slope are presented in Exhibit 10-22 and Exhibit 10-23, respectively. The proposed rock anchor support pattern exceeds the required FS of 1.5 under usual loading conditions established by GD-1, Rev. 1 (Shannon & Wilson, 2022) for both Section 1 and Section 2.

Exhibit 10-22: Limit Equilibrium Results for the Static Analysis of the 8 Strand Anchor-Supported Slope under Usual Loading Conditions for Section 1. Artesian groundwater pressures have been measured in the VWP upslope of the spillway (boring BH-17-1). In Slide, artesian groundwater conditions are modeled using a piezometric head line, shown as the blue boundary, which accounts for the artesian pore pressures without contributions from the additional weight of the water (i.e., pooled water).

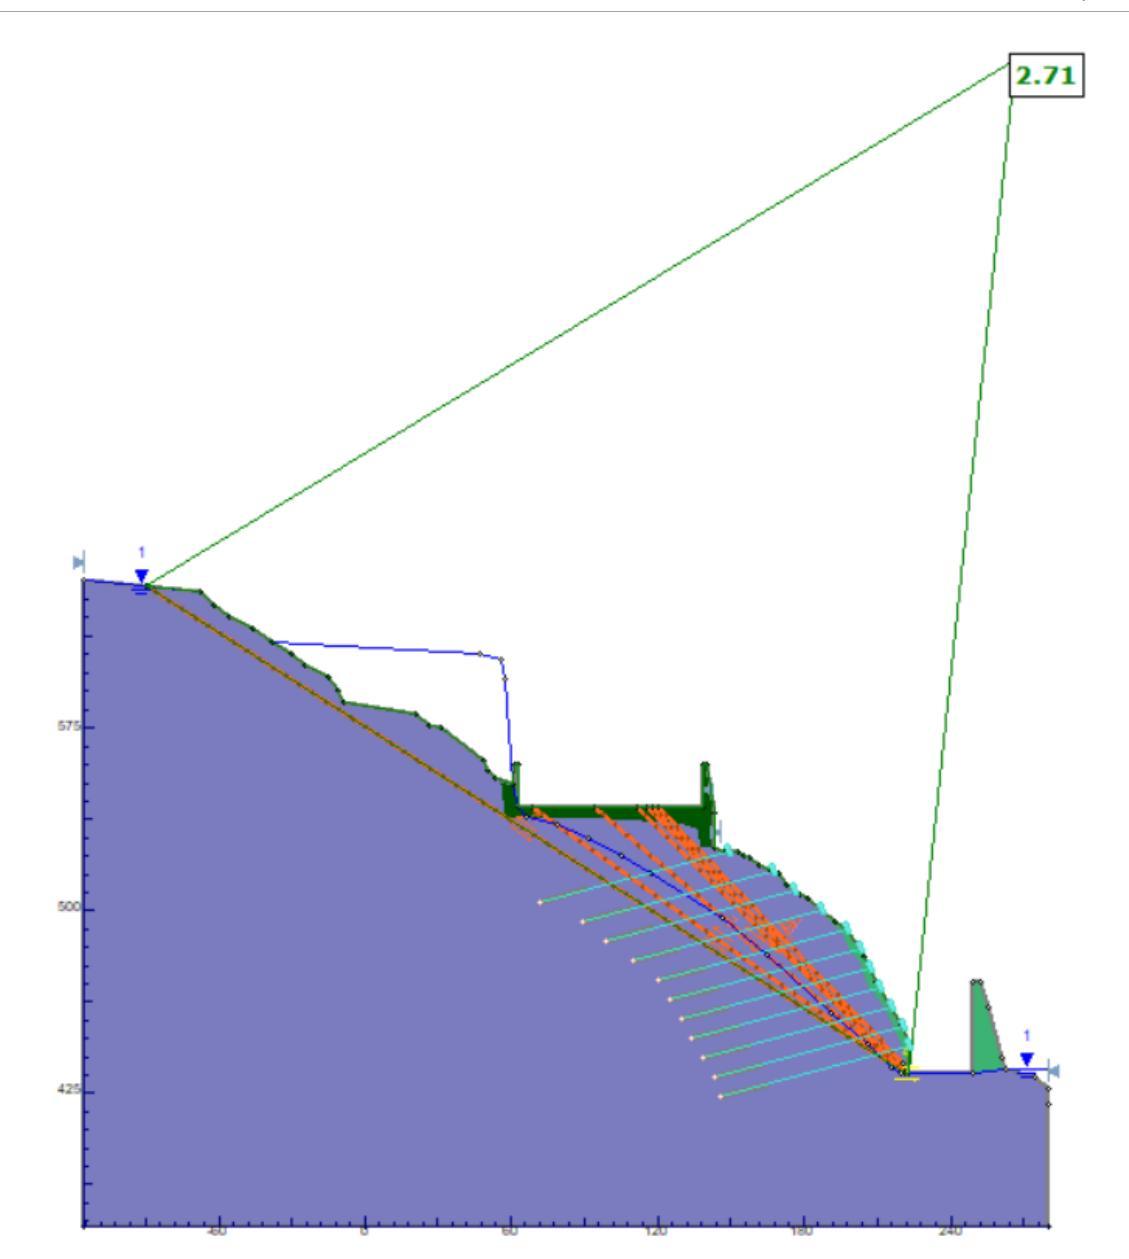
Exhibit 10-23: Limit Equilibrium Results for the Static Analysis of the 8 Strand Anchor-Supported Slope under Usual Loading Conditions for Section 2. Artesian groundwater pressures have been measured in the VWP upslope of the spillway (boring BH-17-2). In Slide, artesian groundwater conditions are modeled using a piezometric head line, shown as the blue boundary, which accounts for the artesian pore pressures without contributions from the additional weight of the water (i.e., pooled water).

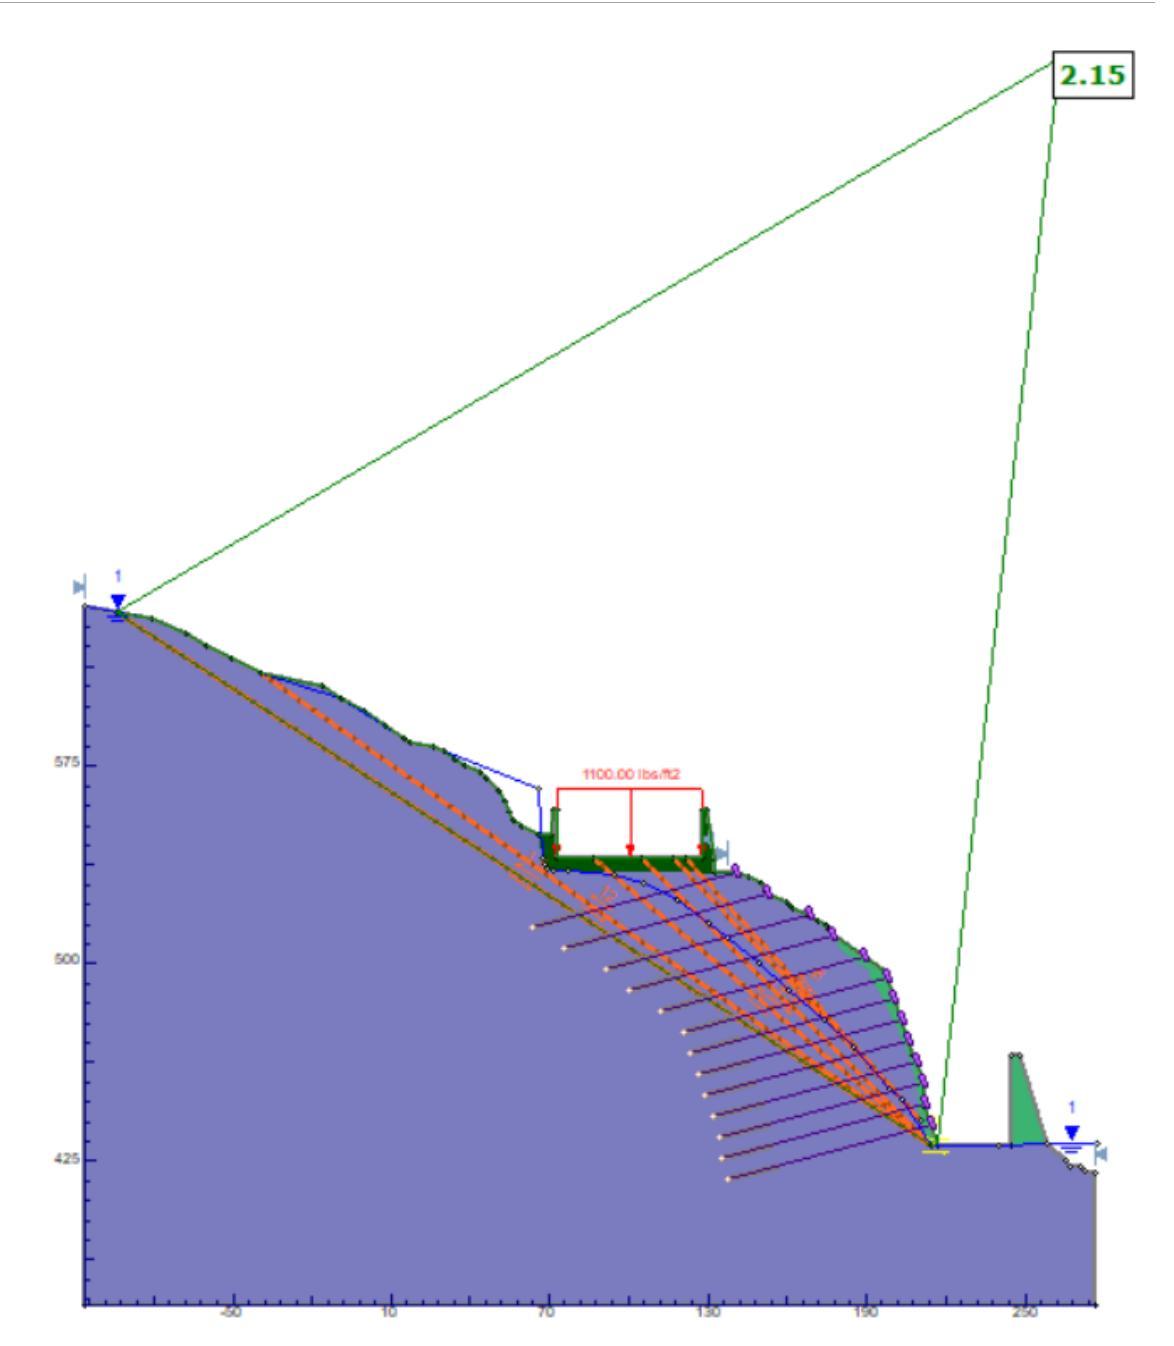
The Slide results for a 1 <sup>3</sup>/<sub>4</sub>-inch, Grade 150 anchor-supported slope are presented in Exhibit 10-24 and Exhibit 10-25, respectively. The proposed rock anchor support pattern exceeds the required FS of 1.3 under unusual loading conditions established by GD-1, Rev. 1 (Shannon & Wilson, 2022) for both Section 1 and Section 2.

Exhibit 10-24: Limit Equilibrium Results for the Static Analysis of the 1 <sup>3</sup>/<sub>4</sub>-inch, Grade 150 Anchor-Supported Slope under Unusual Loading Conditions for Section 1. Artesian groundwater pressures have been measured in the VWP upslope of the spillway (boring BH-17-1). In Slide, artesian groundwater conditions are modeled using a piezometric head line, shown as the blue boundary, which accounts for the artesian pore pressures without contributions from the additional weight of the water (i.e., pooled water).

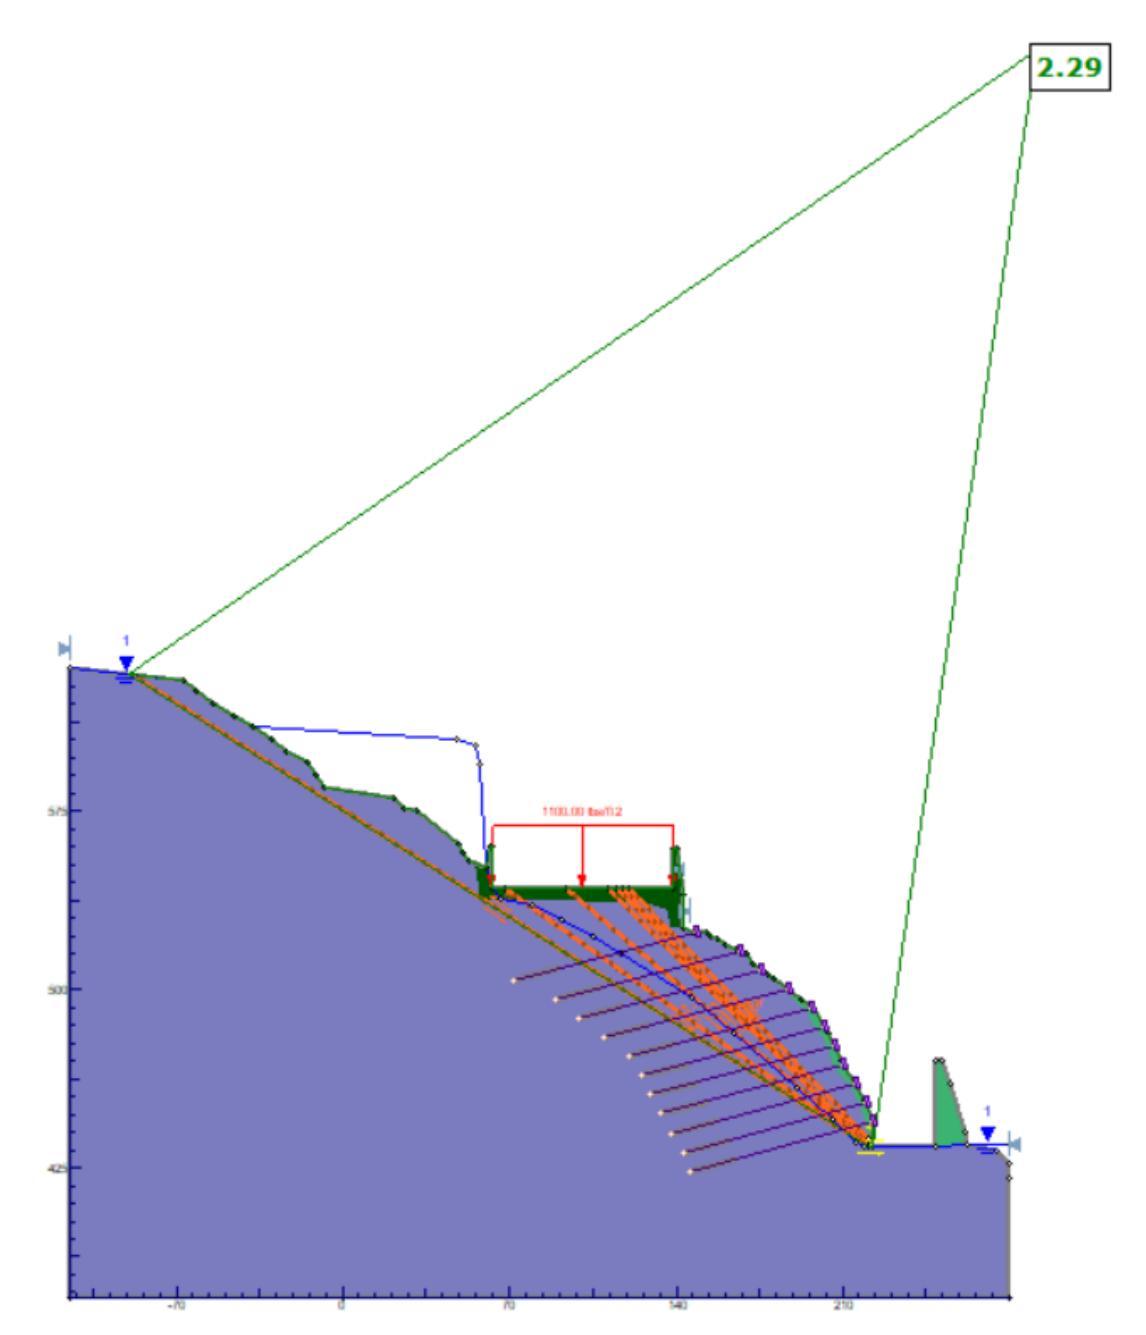
Exhibit 10-25: Limit Equilibrium Results for the Static Analysis of the 1 <sup>3</sup>/<sub>4</sub>-inch, Grade 150 Anchor-Supported Slope under Unusual Loading Conditions for Section 2. Artesian groundwater pressures have been measured in the VWP upslope of the spillway (boring BH-17-2). In Slide, artesian groundwater conditions are modeled using a piezometric head line, shown as the blue boundary, which accounts for the artesian pore pressures without contributions from the additional weight of the water (i.e., pooled water).

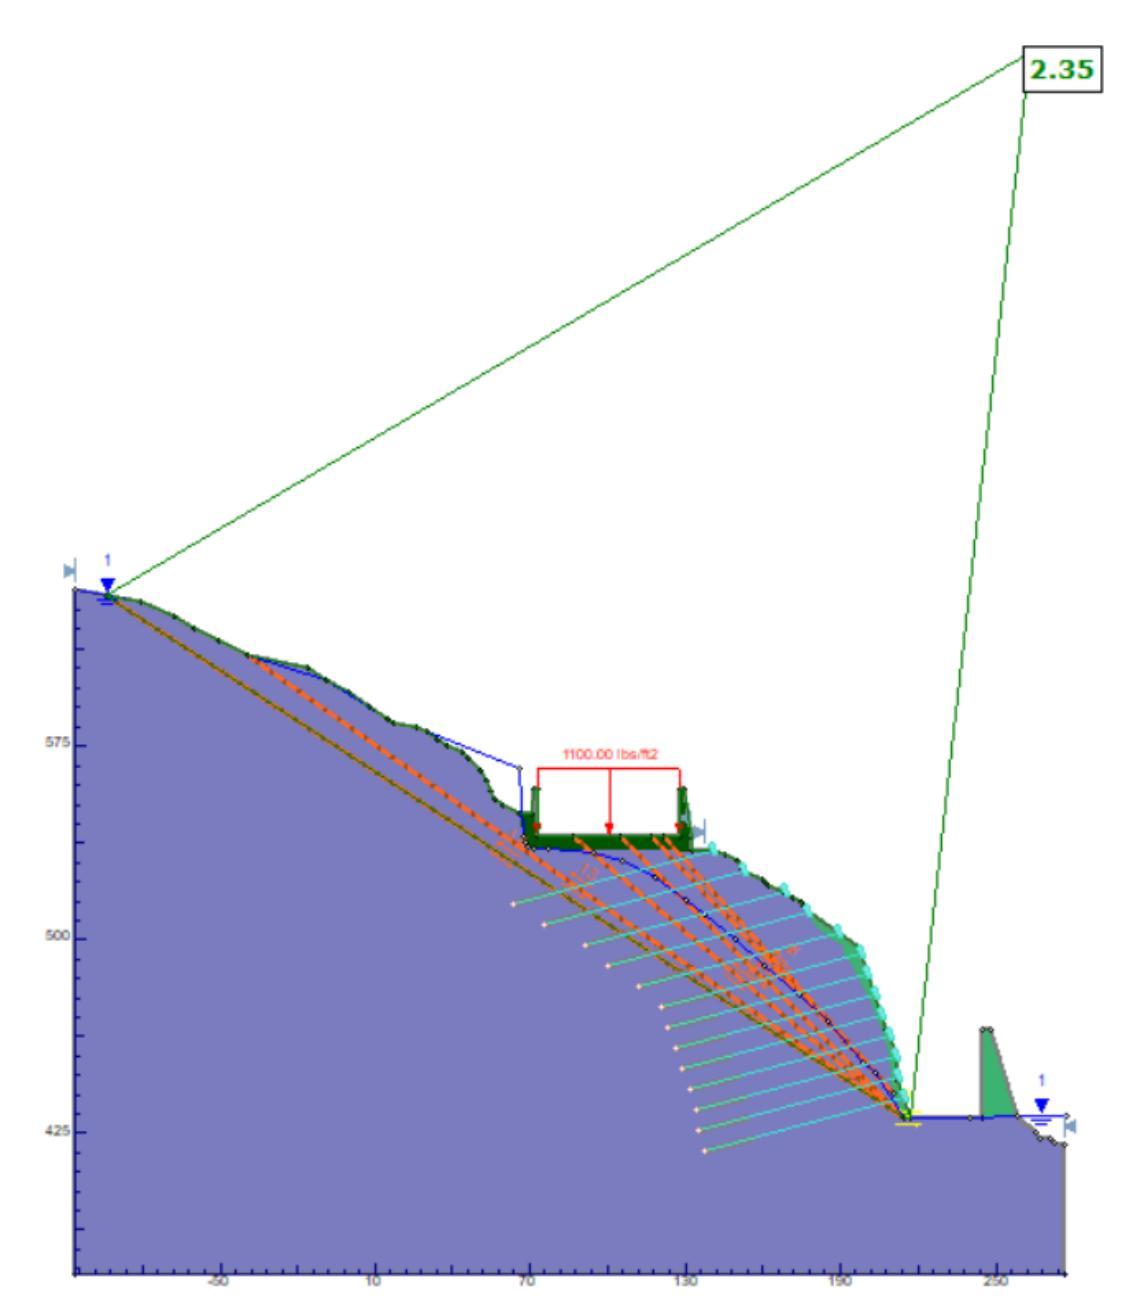
The Slide results for an 8 Strand anchor-supported slope are presented in Exhibit 10-26 and Exhibit 10-27, respectively. The proposed rock anchor support pattern exceeds the required FS of 1.3 under unusual loading conditions established by GD-1, Rev. 1 (Shannon & Wilson, 2022) for both Section 1 and Section 2.

Exhibit 10-26: Limit Equilibrium Results for the Static Analysis of the 8 Strand Anchor-Supported Slope under Unusual Loading Conditions for Section 1. Artesian groundwater pressures have been measured in the VWP upslope of the spillway (boring BH-17-1). In Slide, artesian groundwater conditions are modeled using a piezometric head line, shown as the blue boundary, which accounts for the artesian pore pressures without contributions from the additional weight of the water (i.e., pooled water).

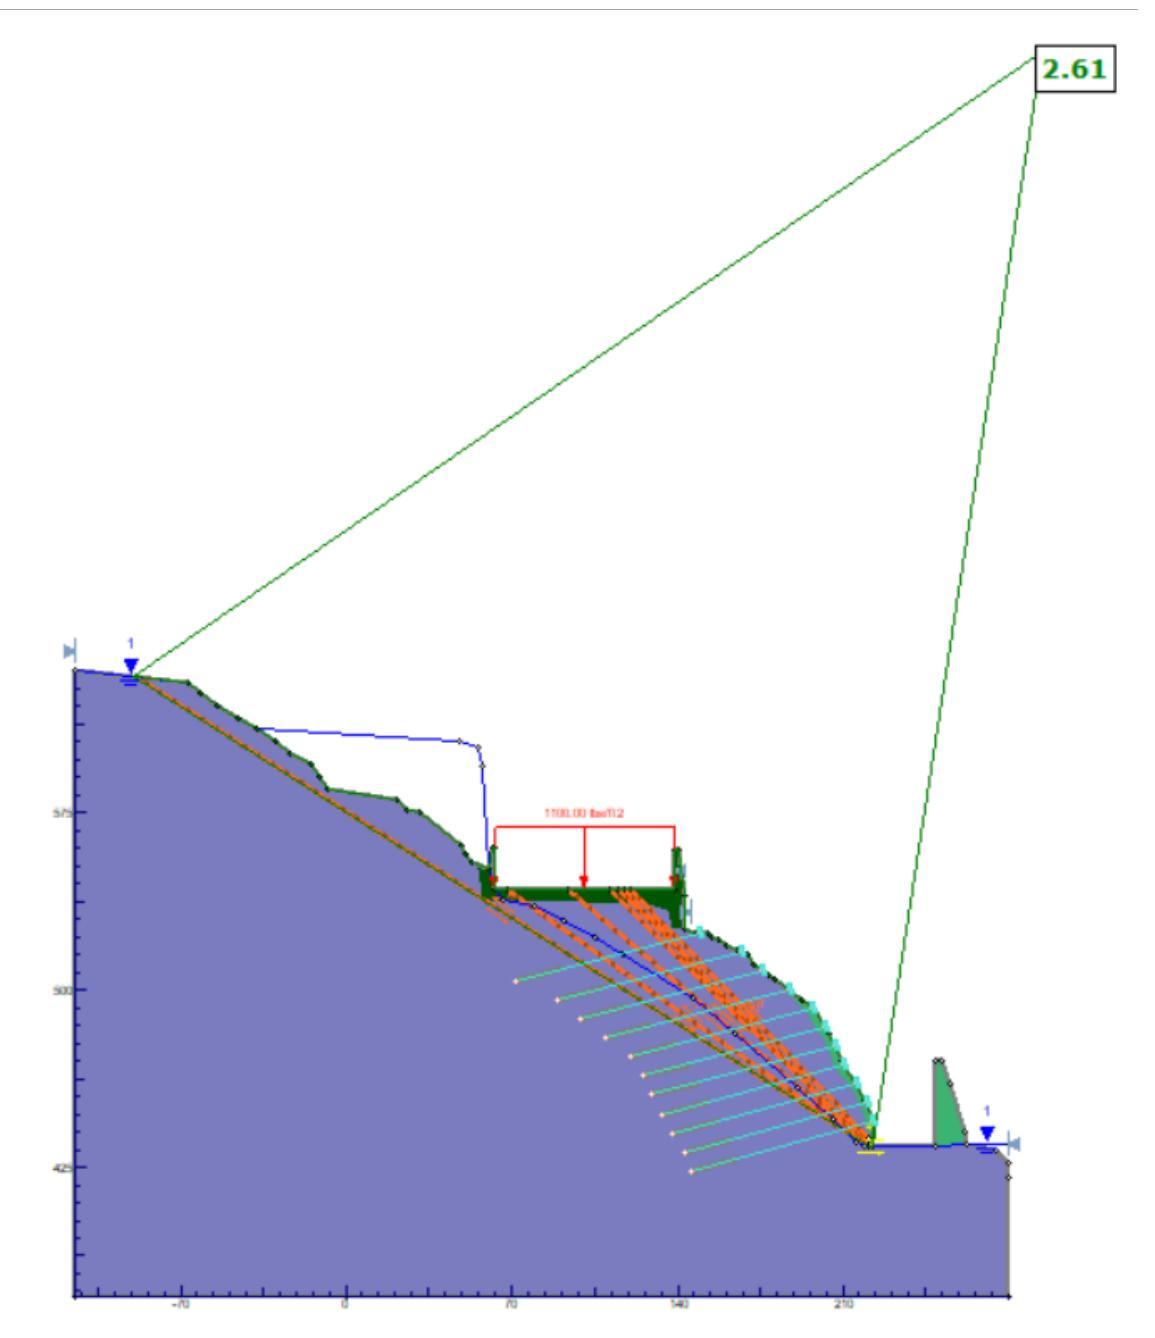
Exhibit 10-27: Limit Equilibrium Results for the Static Analysis of the 8 Strand Anchor-Supported Slope under Unusual Loading Conditions for Section 2. Artesian groundwater pressures have been measured in the VWP upslope of the spillway (boring BH-17-2). In Slide, artesian groundwater conditions are modeled using a piezometric head line, shown as the blue boundary, which accounts for the artesian pore pressures without contributions from the additional weight of the water (i.e., pooled water).

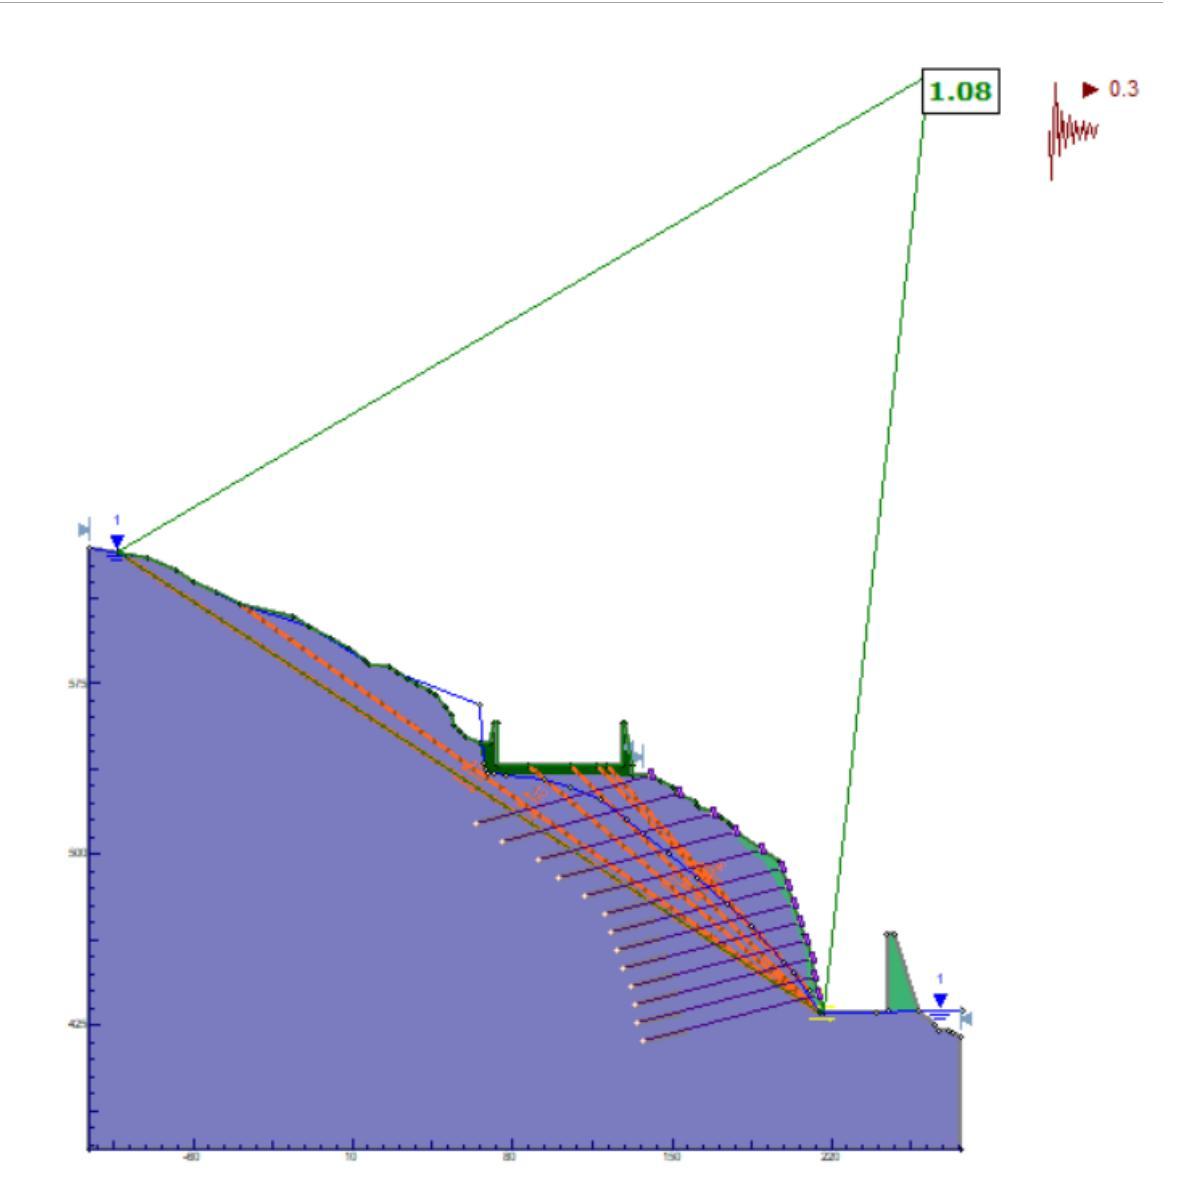
The Slide results for a 1 <sup>3</sup>/<sub>4</sub>-inch, Grade 150 anchor-supported slope are presented in Exhibit 10-28 and Exhibit 10-29, respectively. The proposed rock anchor support pattern meets the required FS of 1.1 under extreme pseudo-static loading conditions established by GD-1, Rev. 1 (Shannon & Wilson, 2022) for Section 1 and exceeds the required FS of 1.1 for Section 2.

Exhibit 10-28: Limit Equilibrium Results for the Pseudo-Static Analysis of the 1 <sup>3</sup>/<sub>4</sub>-inch, Grade 150 Anchor-Supported Slope under Extreme Loading Conditions for Section 1. Artesian groundwater pressures have been measured in the VWP upslope of the spillway (boring BH-17-1). In Slide, artesian groundwater conditions are modeled using a piezometric head line, shown as the blue boundary, which accounts for the artesian pore pressures without contributions from the additional weight of the water (i.e., pooled water).
