GEOTECHNICAL REPORT FOUNDATION FAILURE MODES REPORT Upper Baker Dam CONCRETE, WASHINGTON

December 22, 2022 Shannon & Wilson No: 105102-033 **SHANNON & WILSON**

Upper Baker Dam Geotechnical Report Foundation Failure Modes Report

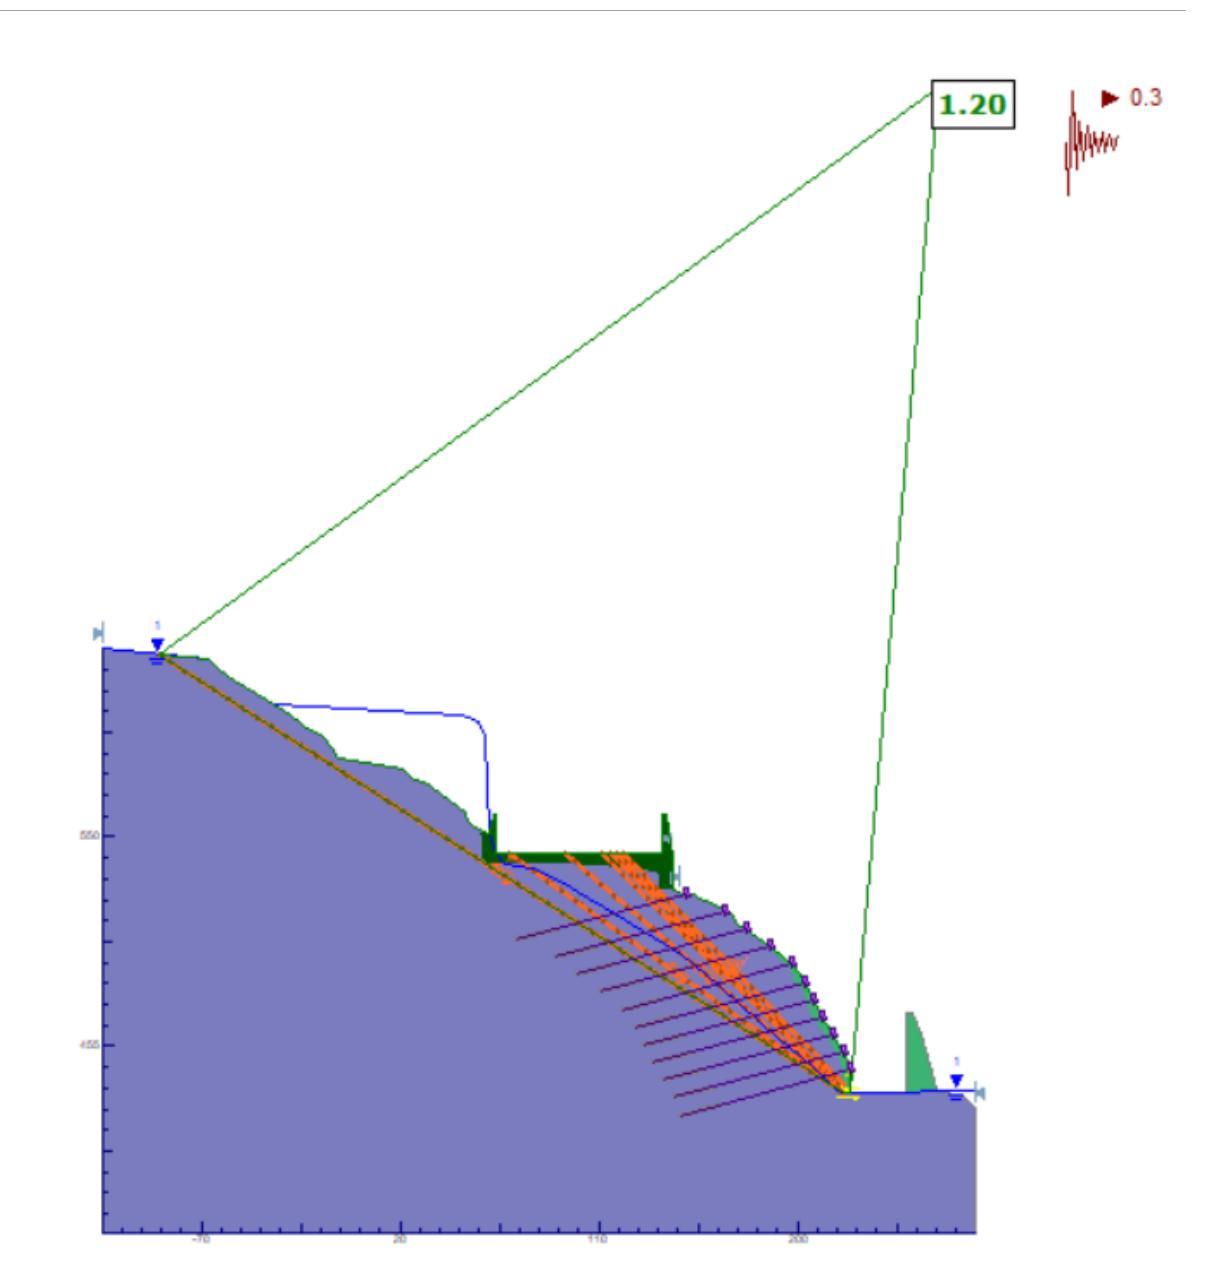
The Slide results for a 1 <sup>3</sup>/<sub>4</sub>-inch, Grade 150 anchor-supported slope are presented in Exhibit 10-28 and Exhibit 10-29, respectively. The proposed rock anchor support pattern meets the required FS of 1.1 under extreme pseudo-static loading conditions established by GD-1, Rev. 1 (Shannon & Wilson, 2022) for Section 1 and exceeds the required FS of 1.1 for Section 2.

Exhibit 10-29: Limit Equilibrium Results for the Pseudo-Static Analysis of the 1 <sup>3</sup>/<sub>4</sub>-inch, Grade 150 Anchor-Supported Slope under Extreme Loading Conditions for Section 2. Artesian groundwater pressures have been measured in the VWP upslope of the spillway (boring BH-17-2). In Slide, artesian groundwater conditions are modeled using a piezometric head line, shown as the blue boundary, which accounts for the artesian pore pressures without contributions from the additional weight of the water (i.e., pooled water).

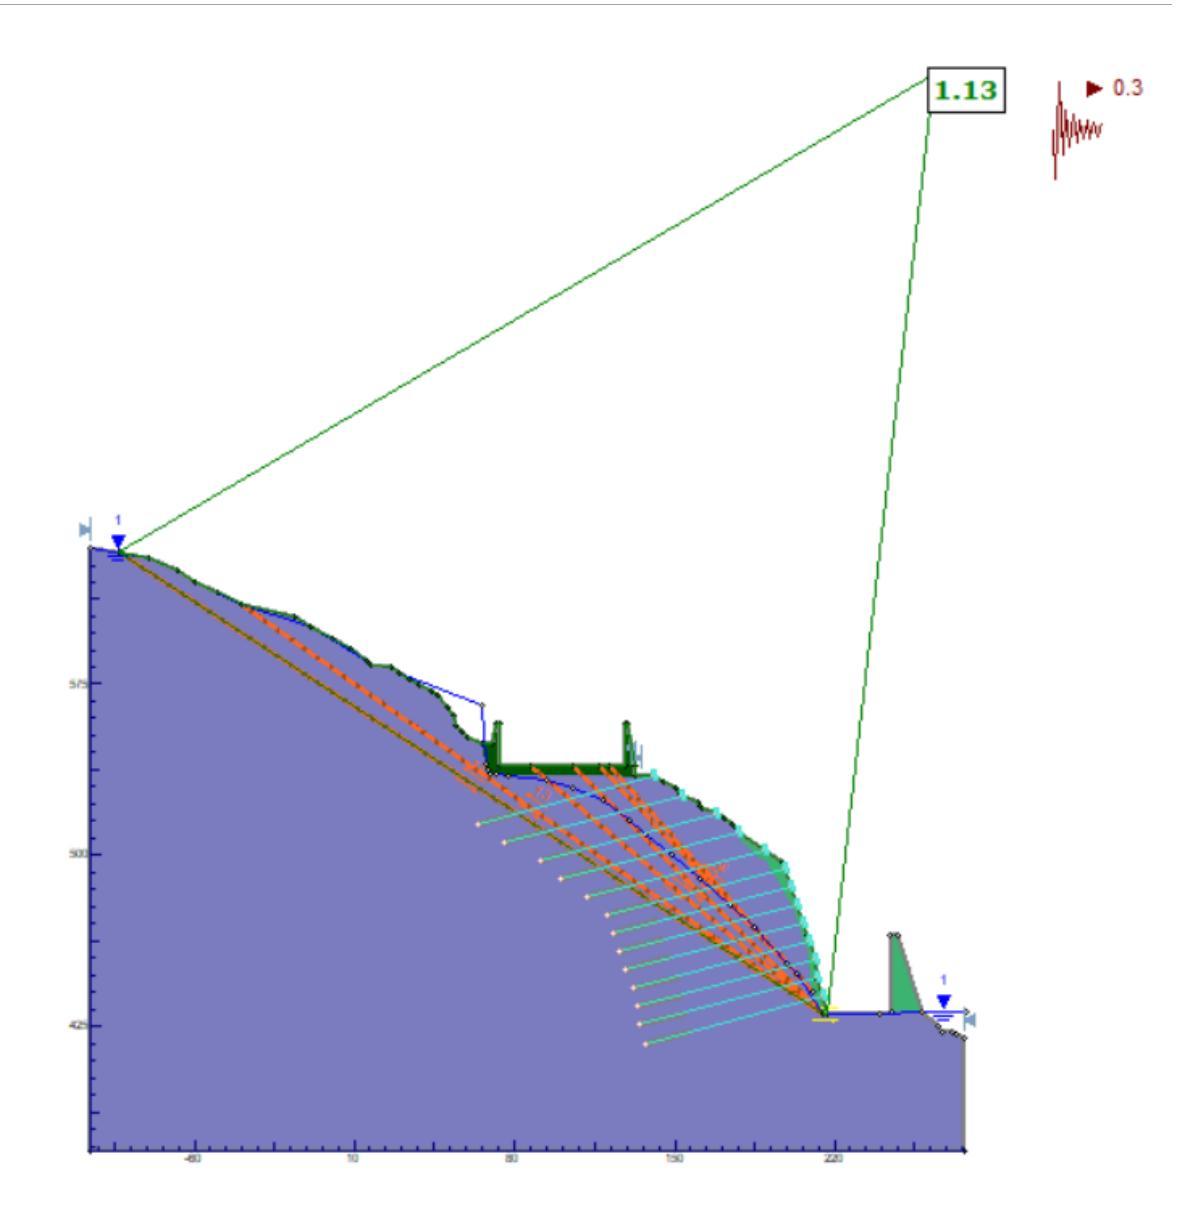
The Slide results for an 8 Strand anchor-supported slope are presented in Exhibit 10-30 and Exhibit 10-31, respectively. The proposed rock anchor support pattern meets the required FS of 1.1 under extreme pseudo-static loading conditions established by GD-1, Rev. 1 (Shannon & Wilson, 2022) for Section 1 and exceeds the required FS of 1.1 for Section 2.

Exhibit 10-30: Limit Equilibrium Results for the Pseudo-Static Analysis of the 8 Strand Anchor-Supported Slope under Extreme Loading Conditions for Section 1. Artesian groundwater pressures have been measured in the VWP upslope of the spillway (boring BH-17-1). In Slide, artesian groundwater conditions are modeled using a piezometric head line, shown as the blue boundary, which accounts for the artesian pore pressures without contributions from the additional weight of the water (i.e., pooled water).

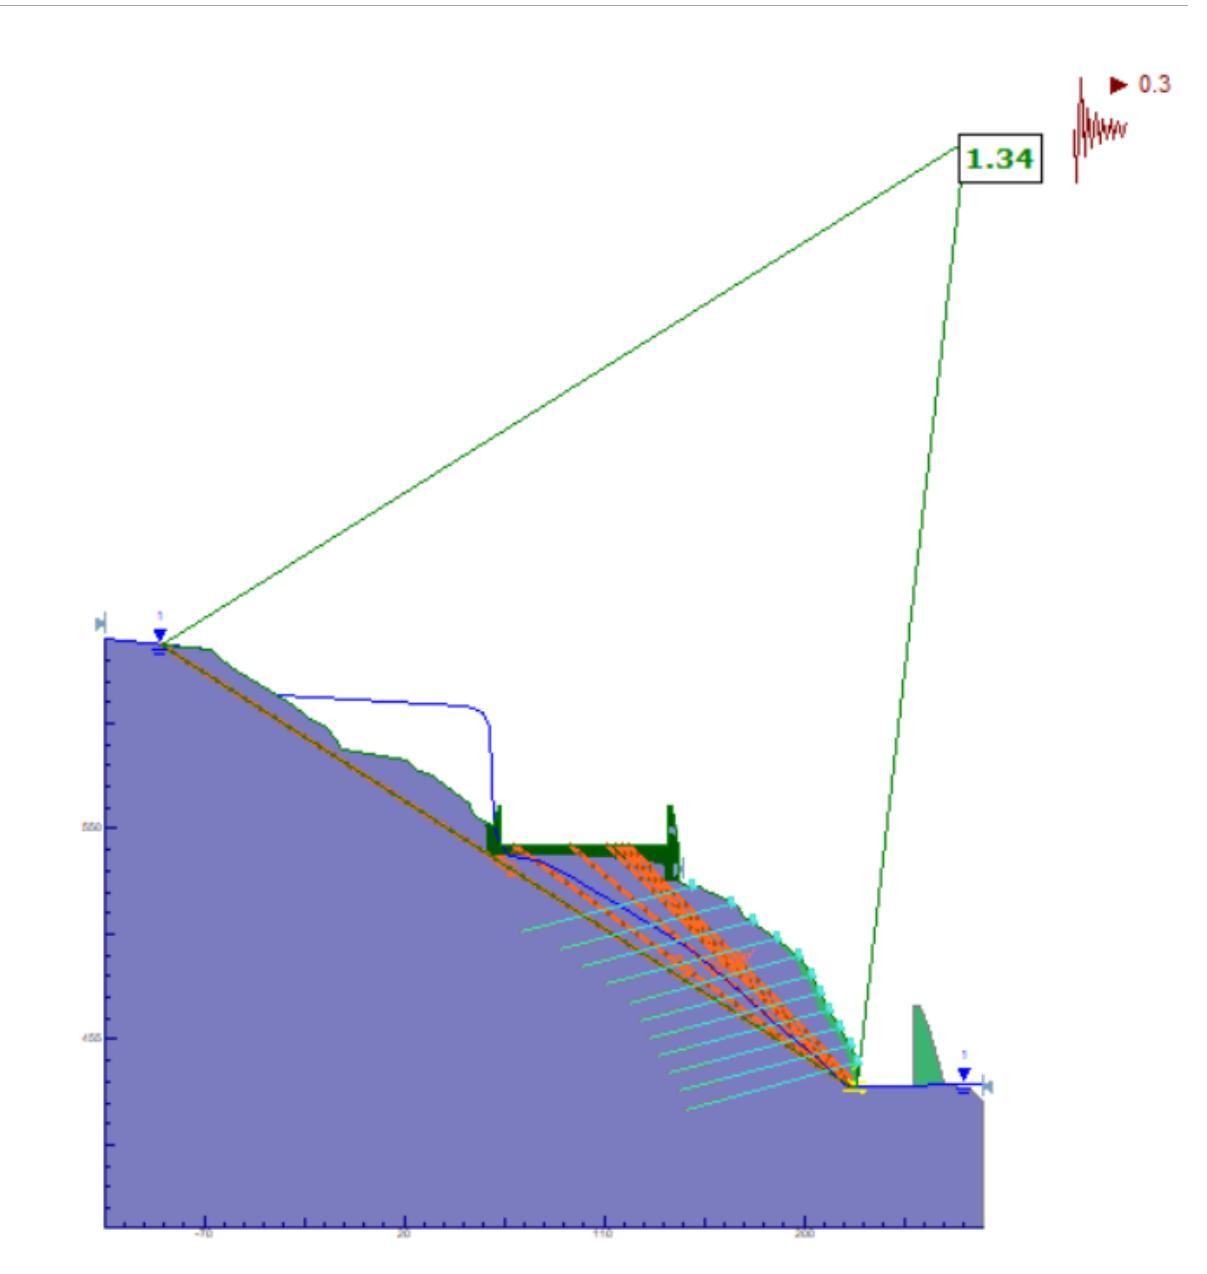
Exhibit 10-31: Limit Equilibrium Results for the Pseudo-Static Analysis of the 8 Strand Anchor-Supported Slope under Extreme Loading Conditions for Section 2. Artesian groundwater pressures have been measured in the VWP upslope of the spillway (boring BH-17-2). In Slide, artesian groundwater conditions are modeled using a piezometric head line, shown as the blue boundary, which accounts for the artesian pore pressures without contributions from the additional weight of the water (i.e., pooled water).

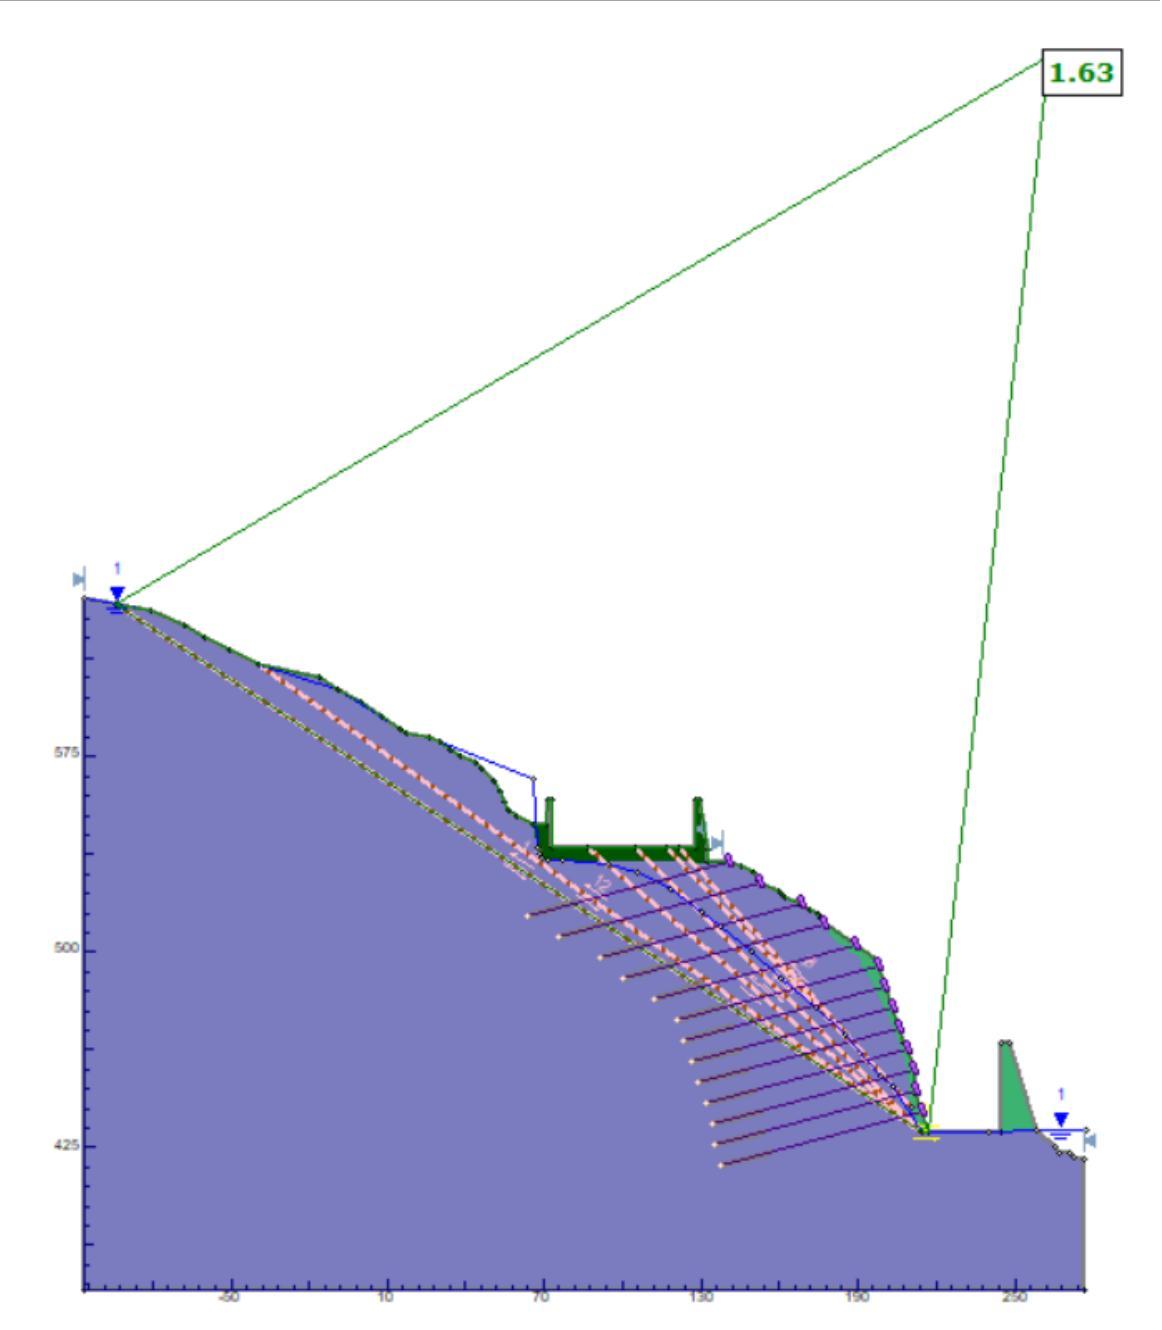
The Slide results for a 1 <sup>3</sup>/<sub>4</sub>-inch, Grade 150 anchor-supported slope are presented in Exhibit 10-32 and Exhibit 10-33, respectively. The proposed rock anchor support pattern exceeds the required FS of 1.3 under usual loading conditions with post-earthquake material established by GD-1, Rev. 1 (Shannon & Wilson, 2022) for both Section 1 and Section 2.

Exhibit 10-32: Limit Equilibrium Results for the Static Analysis of the 1 <sup>3</sup>/<sub>4</sub>-inch, Grade 150 Anchor-Supported Slope under Usual Loading Conditions with Post-Earthquake Material Properties for Section 1. Artesian groundwater pressures have been measured in the VWP upslope of the spillway (boring BH-17-1). In Slide, artesian groundwater conditions are modeled using a piezometric head line, shown as the blue boundary, which accounts for the artesian pore pressures without contributions from the additional weight of the water (i.e., pooled water).

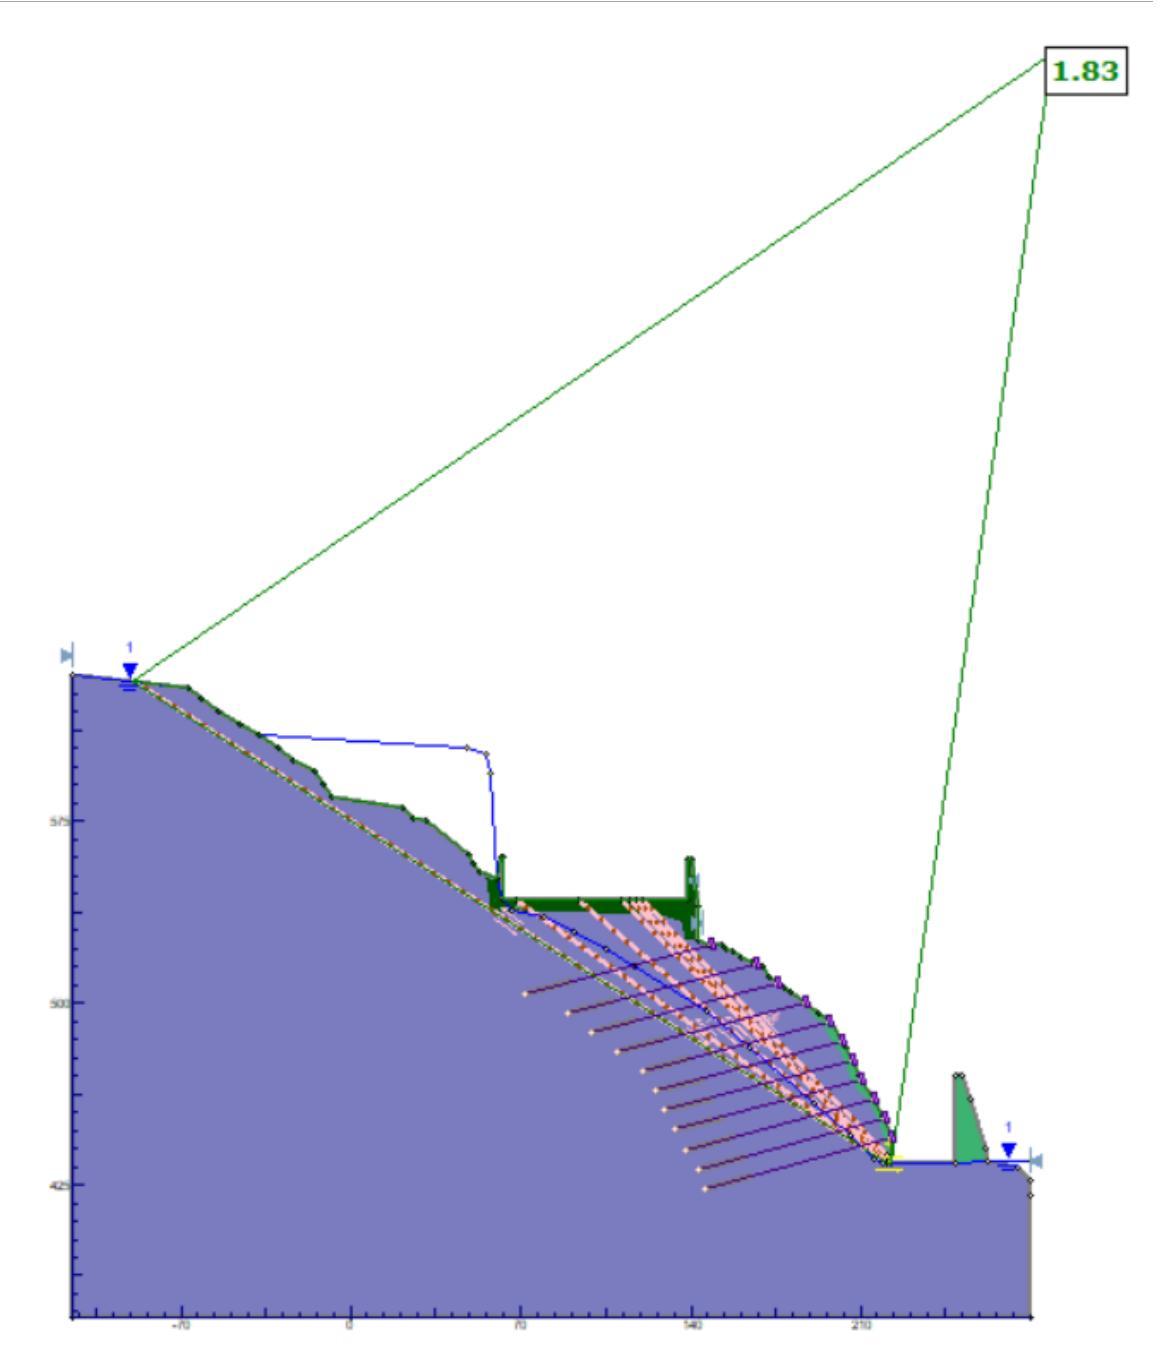
Exhibit 10-33: Limit Equilibrium Results for the Static Analysis of the 1 <sup>3</sup>/<sub>4</sub>-inch, Grade 150 Anchor-Supported Slope under Usual Loading Conditions with Post-Earthquake Material Properties for Section 2. Artesian groundwater pressures have been measured in the VWP upslope of the spillway (boring BH-17-2). In Slide, artesian groundwater conditions are modeled using a piezometric head line, shown as the blue boundary, which accounts for the artesian pore pressures without contributions from the additional weight of the water (i.e., pooled water).

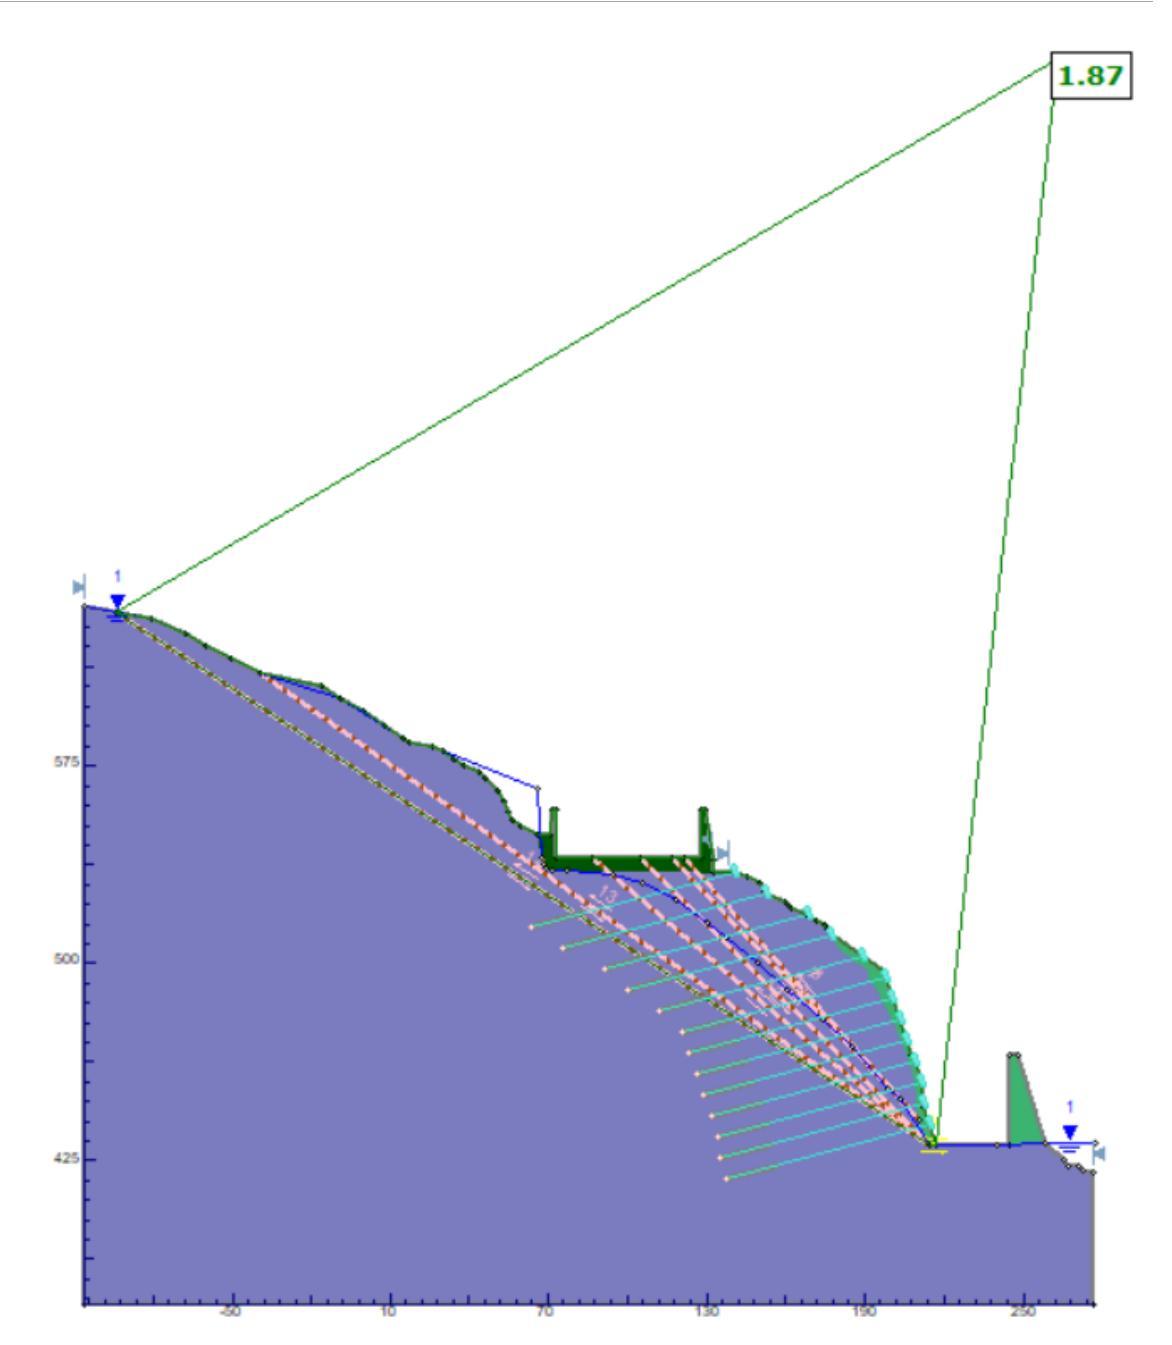
The Slide results for an 8 Strand anchor-supported slope are presented in Exhibit 10-34 and Exhibit 10-35, respectively. The proposed rock anchor support pattern exceeds the required FS of 1.3 under usual loading conditions with post-earthquake material established by GD-1, Rev. 1 (Shannon & Wilson, 2022) for both Section 1 and Section 2.

Exhibit 10-34: Limit Equilibrium Results for the Static Analysis of the 8 Strand Anchor-Supported Slope under Usual Loading Conditions with Post-Earthquake Material Properties for Section 1. Artesian groundwater pressures have been measured in the VWP upslope of the spillway (boring BH-17-1). In Slide, artesian groundwater conditions are modeled using a piezometric head line, shown as the blue boundary, which accounts for the artesian pore pressures without contributions from the additional weight of the water (i.e., pooled water).

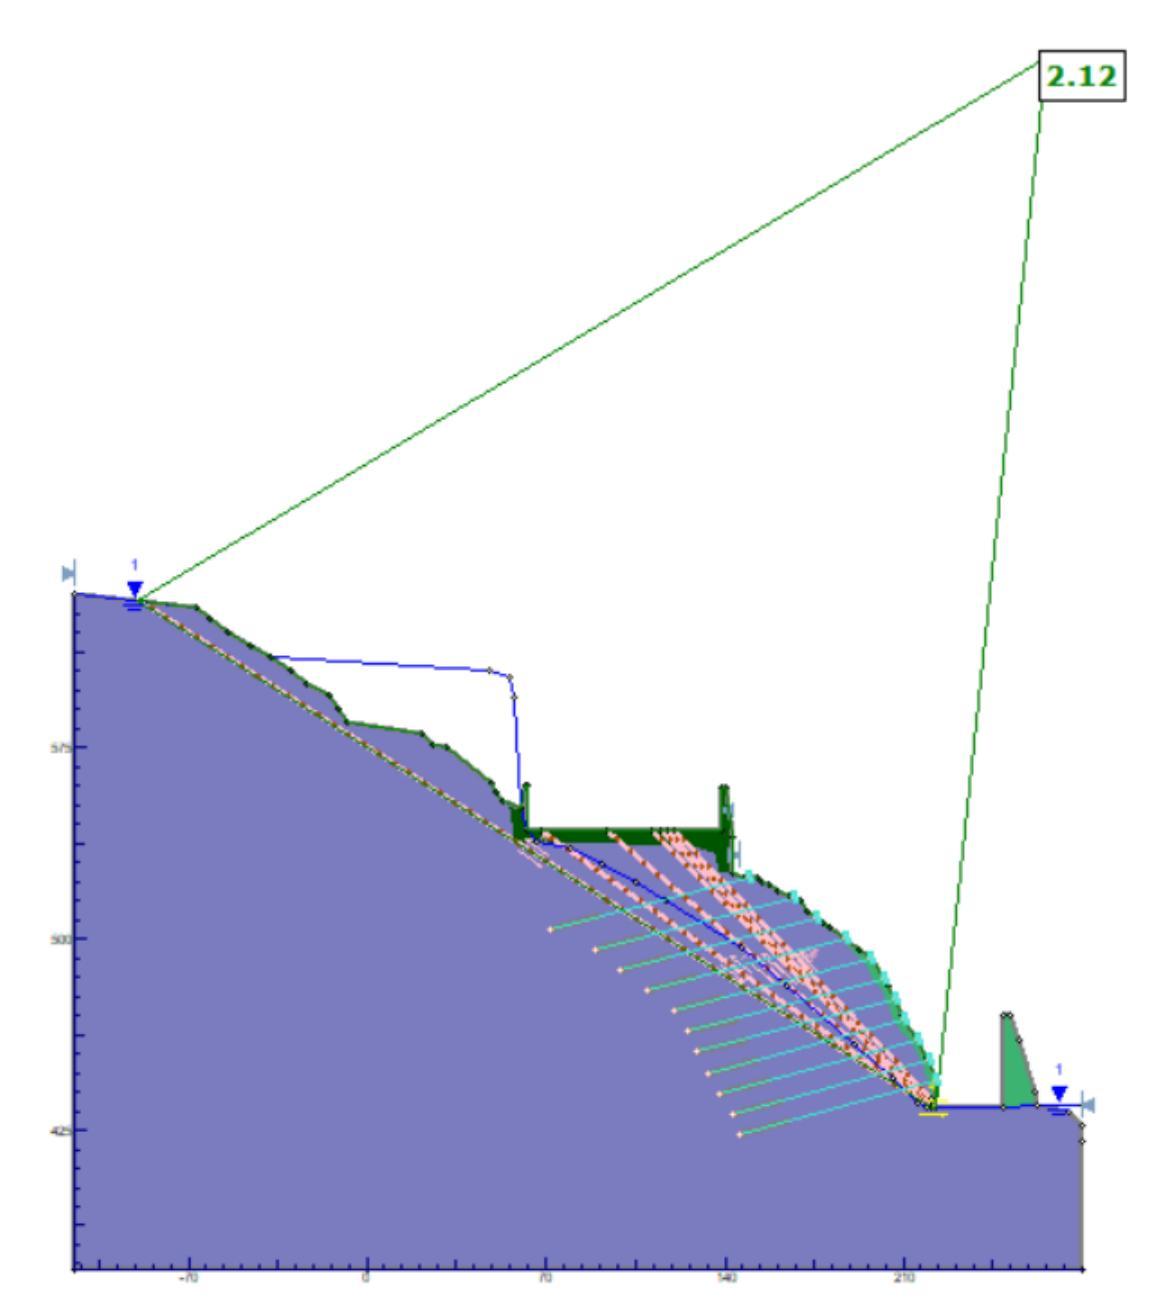
Exhibit 10-35: Limit Equilibrium Results for the Static Analysis of the 8 Strand Anchor-Supported Slope under Usual Loading Conditions with Post-Earthquake Material Properties for Section 2. Artesian groundwater pressures have been measured in the VWP upslope of the spillway (boring BH-17-2). In Slide, artesian groundwater conditions are modeled using a piezometric head line, shown as the blue boundary, which accounts for the artesian pore pressures without contributions from the additional weight of the water (i.e., pooled water).

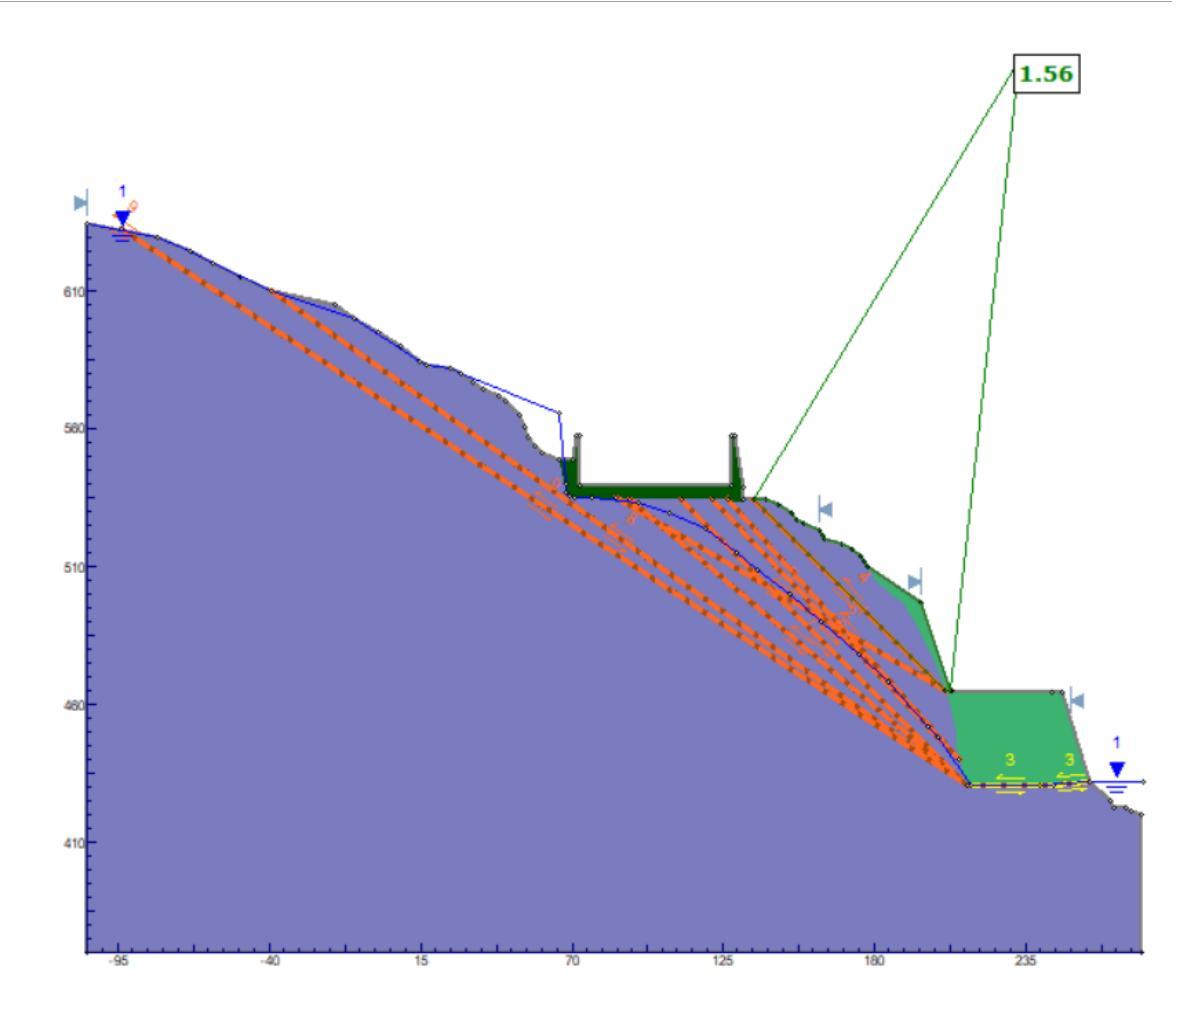
- Against failure through the concrete lining above the grouted rock buttress is 1.6 and
- Against global failure of the dowel-supported grouted rock buttress is 2.0.

The Slide results for failure cases above and through the dowel-supported grouted rock buttress are presented in Exhibit 10-36 and Exhibit 10-37. The proposed dowel-supported grouted rock buttress design exceeds the required FS of 1.5 under usual loading conditions established by GD-1, Rev. 1 (Shannon & Wilson, 2022) for Section 1.

Exhibit 10-36: Limit Equilibrium Results for the Static Analysis of Failure Above the Dowel-Supported Grouted Rock Buttress under Usual Loading Conditions for Section 1. Artesian groundwater pressures have been measured in the VWP upslope of the spillway (boring BH-17-1). In Slide, artesian groundwater conditions are modeled using a piezometric head line, shown as the blue boundary, which accounts for the artesian pore pressures without contributions from the additional weight of the water (i.e., pooled water).

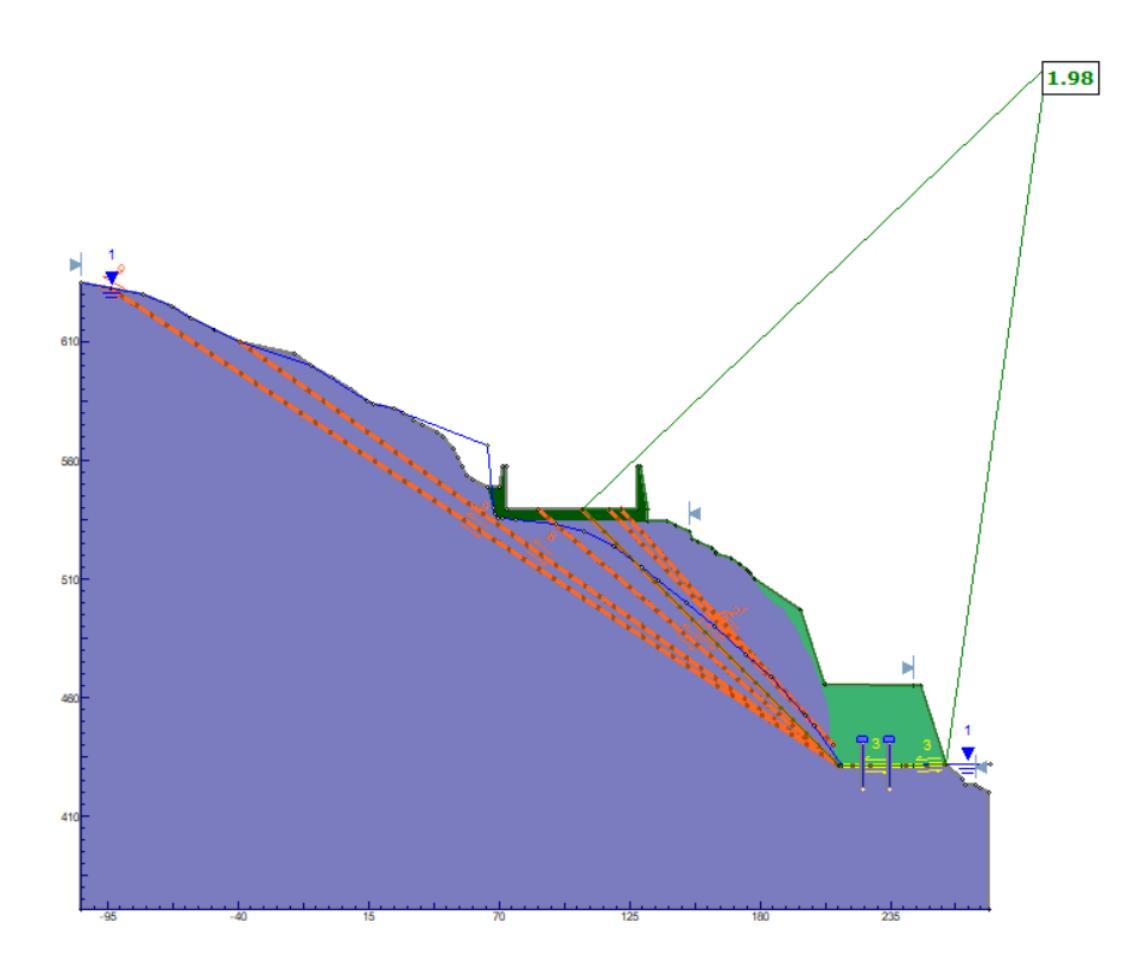
Exhibit 10-37: Limit Equilibrium Results for the Static Analysis of Failure Through the Dowel-Supported Grouted Rock Buttress under Usual Loading Conditions for Section 1. Artesian groundwater pressures have been measured in the VWP upslope of the spillway (boring BH-17-1). In Slide, artesian groundwater conditions are modeled using a piezometric head line, shown as the blue boundary, which accounts for the artesian pore pressures without contributions from the additional weight of the water (i.e., pooled water).

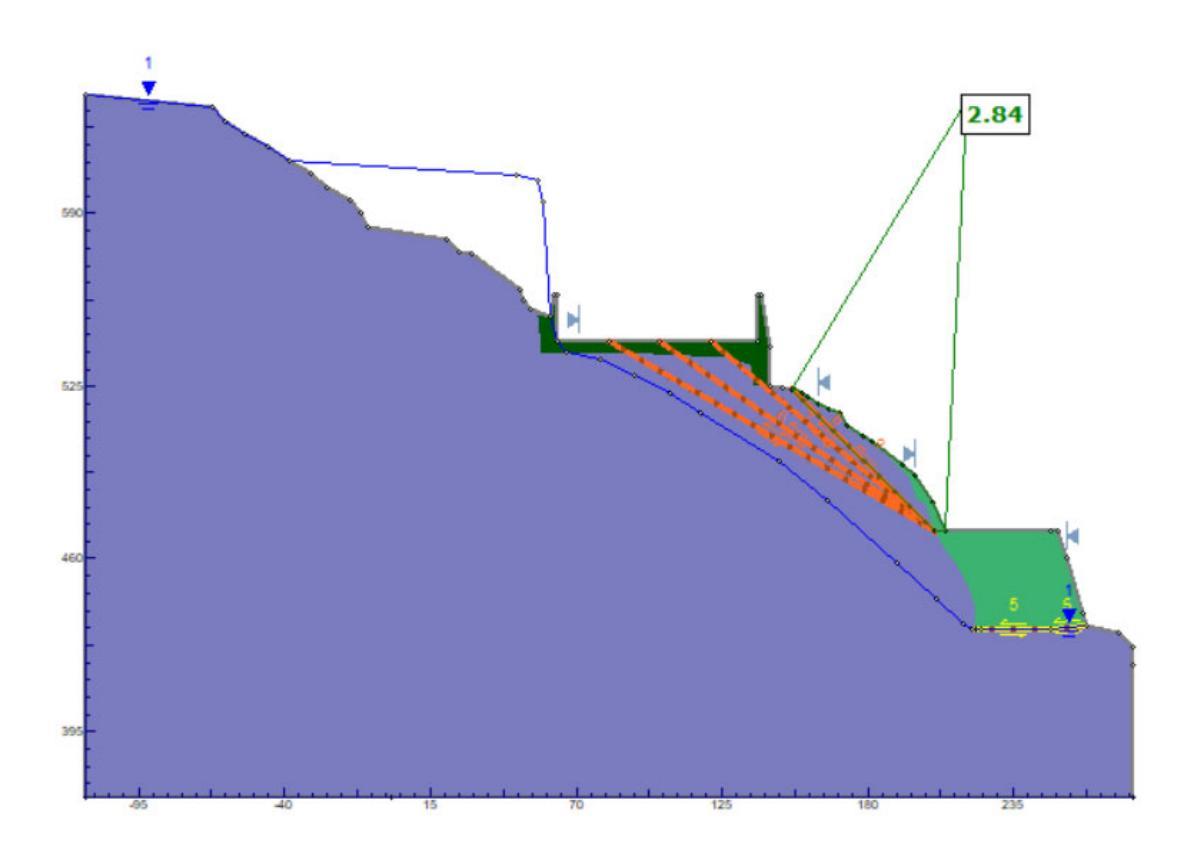
- Against failure through the concrete lining above the grouted rock buttress is 2.8 and
- Against global failure of the dowel-supported grouted rock buttress is 2.3.

The Slide results for failure cases above and through the dowel-supported grouted rock buttress are presented in Exhibit 10-38 and Exhibit 10-39. The proposed dowel-supported grouted rock buttress design exceeds the required FS of 1.5 under usual loading conditions established by GD-1, Rev. 1 (Shannon & Wilson, 2022) for Section 2.

Exhibit 10-38: Limit Equilibrium Results for the Static Analysis of Failure Above the Dowel-Supported Grouted Rock Buttress under Usual Loading Conditions for Section 2. Artesian groundwater pressures have been measured in the VWP upslope of the spillway (boring BH-17-2). In Slide, artesian groundwater conditions are modeled using a piezometric head line, shown as the blue boundary, which accounts for the artesian pore pressures without contributions from the additional weight of the water (i.e., pooled water).

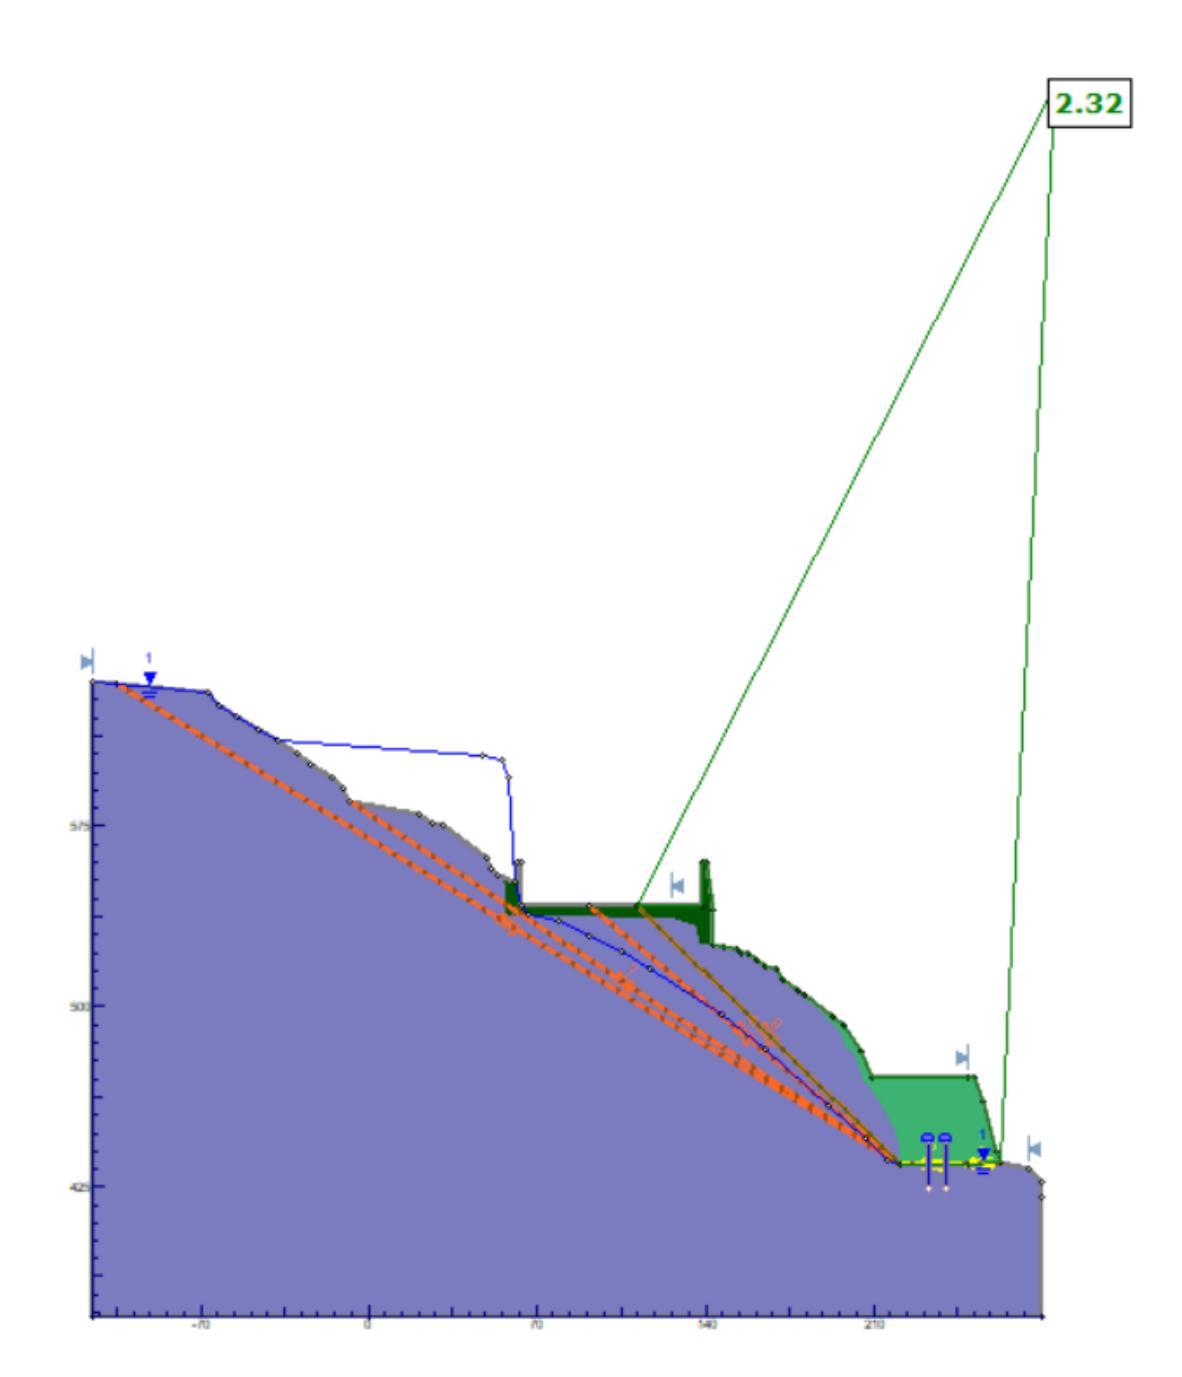
Exhibit 10-39: Limit Equilibrium Results for the Static Analysis of Failure Through the Dowel-Supported Grouted Rock Buttress under Usual Loading Conditions for Section 2. Artesian groundwater pressures have been measured in the VWP upslope of the spillway (boring BH-17-2). In Slide, artesian groundwater conditions are modeled using a piezometric head line, shown as the blue boundary, which accounts for the artesian pore pressures without contributions from the additional weight of the water (i.e., pooled water).

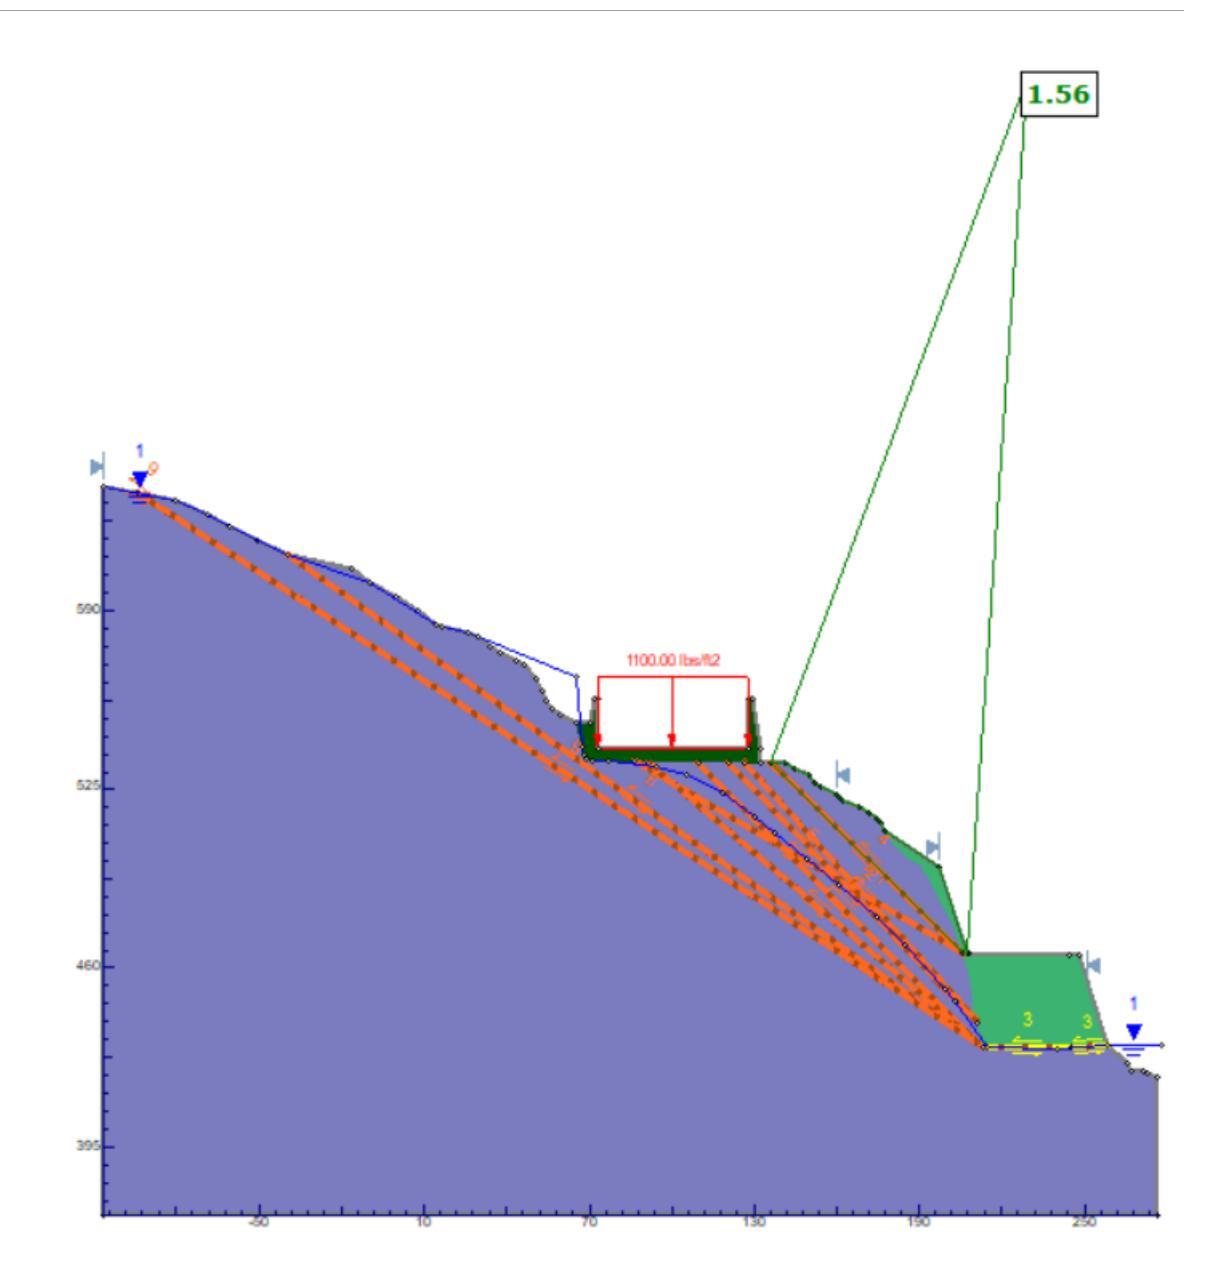
- Against failure through the concrete lining above the grouted rock buttress is 1.6 and
- Against global failure of the dowel-supported grouted rock buttress is 2.0.

The Slide result for failure cases above and through the dowel-supported grouted rock buttress are presented in Exhibit 10-40 and Exhibit 10-41. The proposed dowel-supported grouted rock buttress design exceeds the required FS of 1.3 under unusual, PMF loading conditions established by GD-1, Rev. 1 (Shannon & Wilson, 2022) for Section 1.

Exhibit 10-40: Limit Equilibrium Results for the Static Analysis of Failure Above the Dowel-Supported Grouted Rock Buttress under Unusual Loading Conditions for Section 1. Artesian groundwater pressures have been measured in the VWP upslope of the spillway (boring BH-17-1). In Slide, artesian groundwater conditions are modeled using a piezometric head line, shown as the blue boundary, which accounts for the artesian pore pressures without contributions from the additional weight of the water (i.e., pooled water).

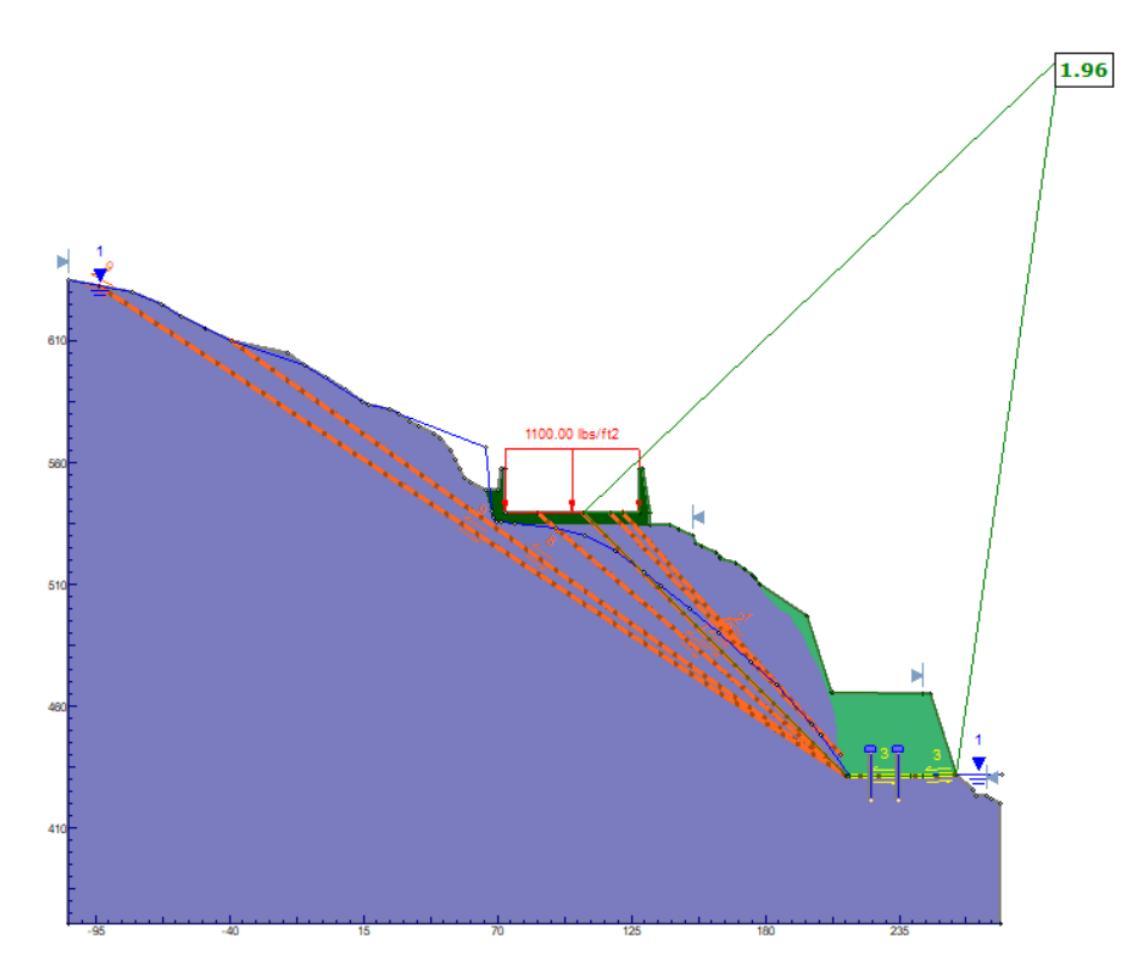
Exhibit 10-41: Limit Equilibrium Results for the Static Analysis of Failure Through the Dowel-Supported Grouted Rock Buttress under Unusual Loading Conditions for Section 1. Artesian groundwater pressures have been measured in the VWP upslope of the spillway (boring BH-17-1). In Slide, artesian groundwater conditions are modeled using a piezometric head line, shown as the blue boundary, which accounts for the artesian pore pressures without contributions from the additional weight of the water (i.e., pooled water).

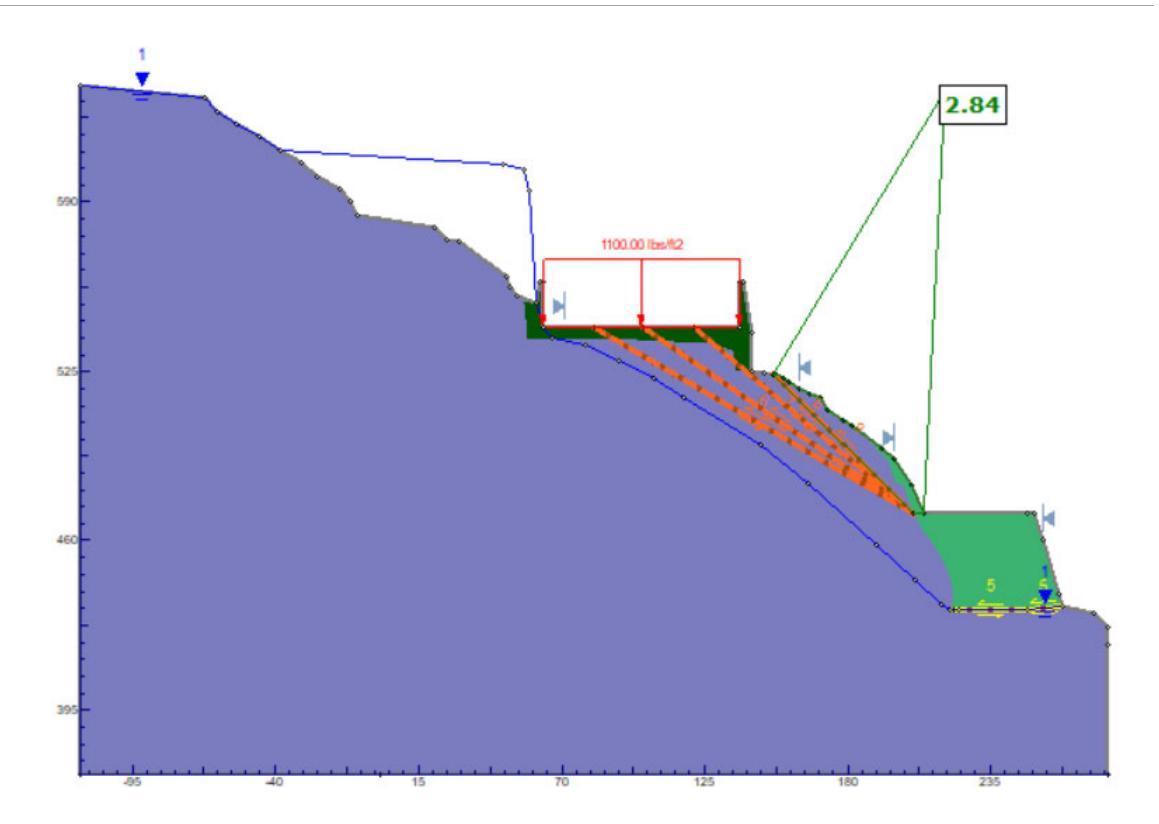
- Against failure through the concrete lining above the grouted rock buttress is 2.8 and
- Against global failure of the dowel-supported grouted rock buttress is 2.3.

The Slide result for failure cases above and through the dowel-supported grouted rock buttress is presented in Exhibit 10-42 and Exhibit 10-43. The proposed dowel-supported grouted rock buttress design exceeds the required FS of 1.3 under unusual, PMF loading conditions established by GD-1, Rev. 1 (Shannon & Wilson, 2022) for Section 2.

Exhibit 10-42: Limit Equilibrium Results for the Static Analysis of Failure Above the Dowel-Supported Grouted Rock Buttress under Unusual Loading Conditions for Section 2. Artesian groundwater pressures have been measured in the VWP upslope of the spillway (boring BH-17-2). In Slide, artesian groundwater conditions are modeled using a piezometric head line, shown as the blue boundary, which accounts for the artesian pore pressures without contributions from the additional weight of the water (i.e., pooled water).
