GEOTECHNICAL REPORT FOUNDATION FAILURE MODES REPORT Upper Baker Dam CONCRETE, WASHINGTON

December 22, 2022 Shannon & Wilson No: 105102-033 **SHANNON & WILSON**

Upper Baker Dam Geotechnical Report Foundation Failure Modes Report

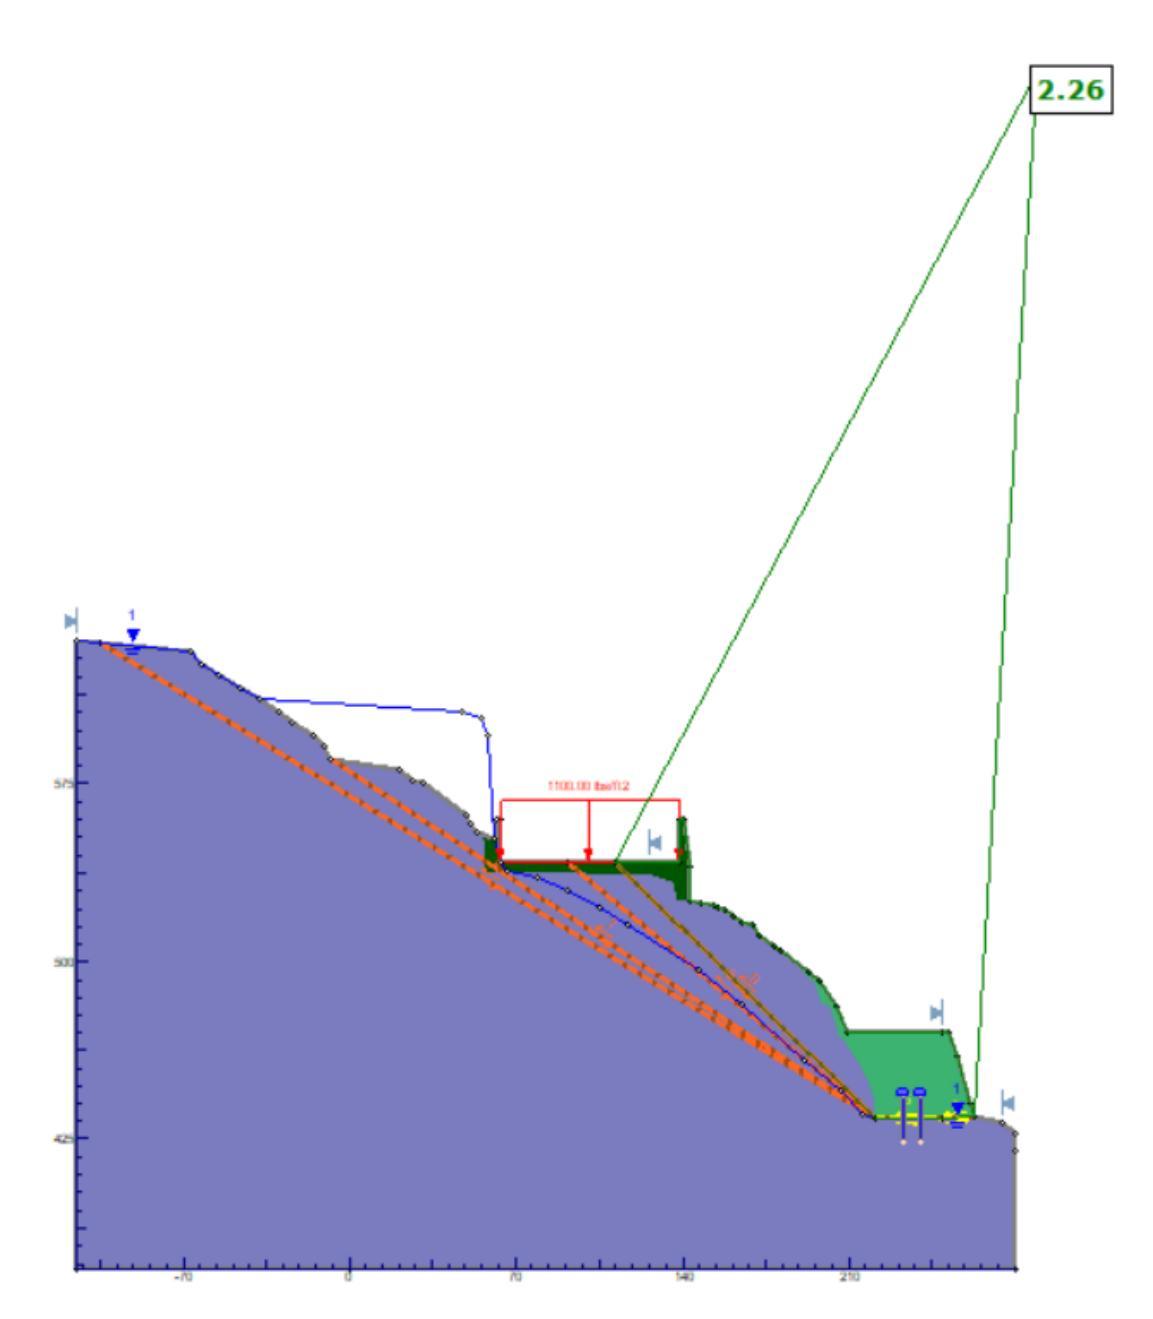
Exhibit 10-43: Limit Equilibrium Results for the Static Analysis of Failure Through the Dowel-Supported Grouted Rock Buttress under Unusual Loading Conditions for Section 2. Artesian groundwater pressures have been measured in the VWP upslope of the spillway (boring BH-17-2). In Slide, artesian groundwater conditions are modeled using a piezometric head line, shown as the blue boundary, which accounts for the artesian pore pressures without contributions from the additional weight of the water (i.e., pooled water).

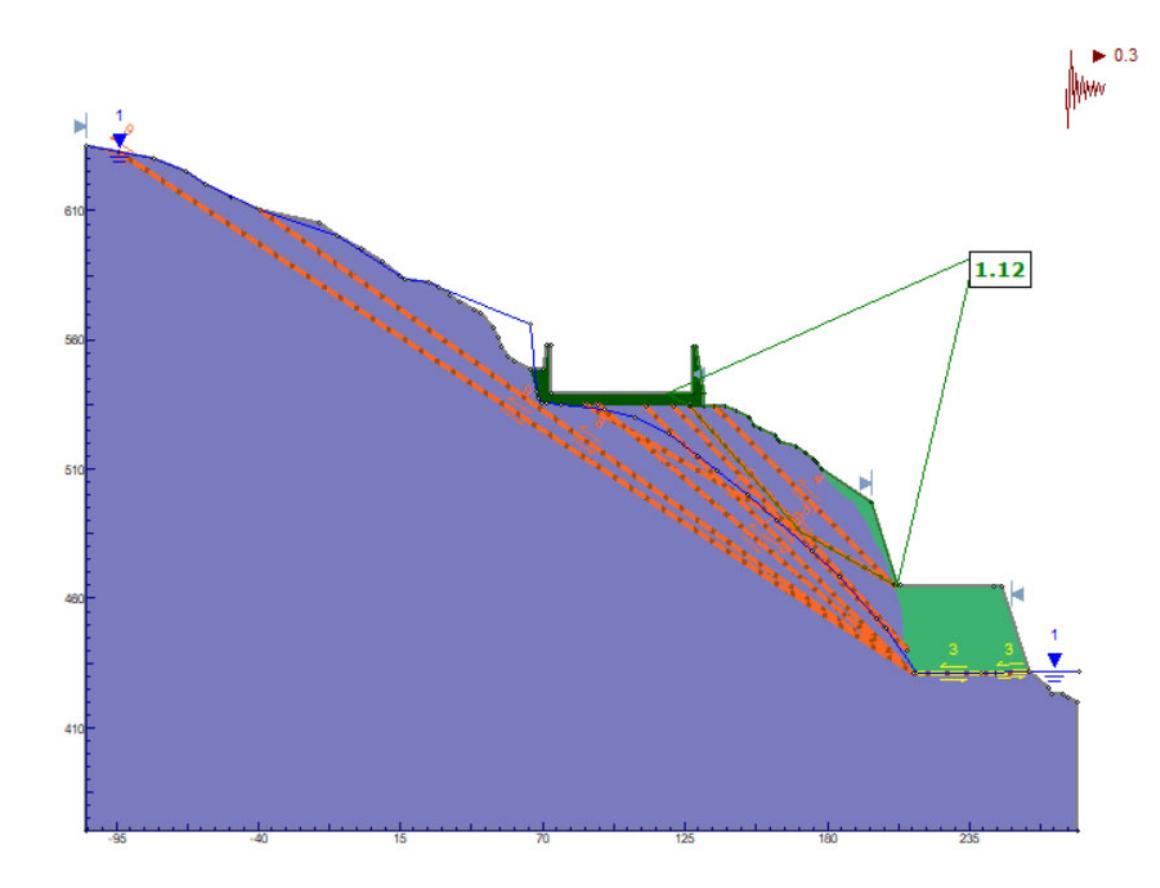
The Slide results for failure cases above and through the dowel-supported grouted rock buttress are presented in Exhibit 10-44 and Exhibit 10-45. The proposed dowel-supported grouted rock buttress design exceeds the required FS of 1.1 under extreme, pseudo-static loading conditions established by GD-1, Rev. 1 (Shannon & Wilson, 2022) for Section 1. Additionally, we evaluated the seismic conditions of the sluiceway slope using conventional Newmark sliding block deformation analysis according to Newmark (1965), described in Section 10.3.4.

Exhibit 10-44: Limit Equilibrium Results for the Static Analysis of Failure Above the Dowel-Supported Grouted Rock Buttress under Extreme Loading Conditions for Section 1. Artesian groundwater pressures have been measured in the VWP upslope of the spillway (boring BH-17-1). In Slide, artesian groundwater conditions are modeled using a piezometric head line, shown as the blue boundary, which accounts for the artesian pore pressures without contributions from the additional weight of the water (i.e., pooled water).

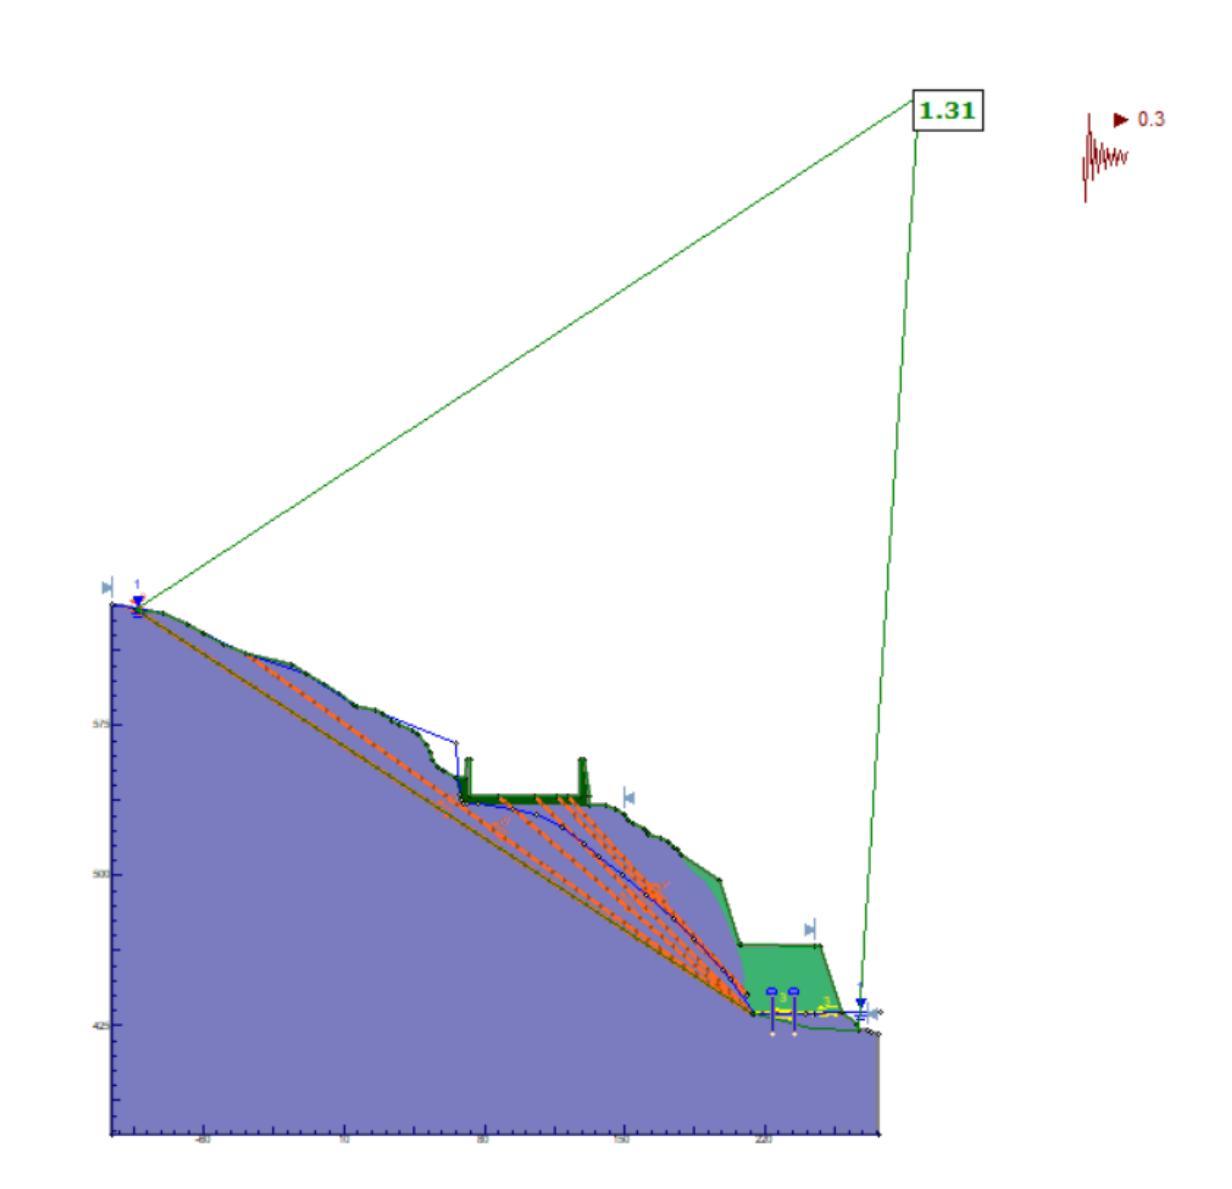
Exhibit 10-45: Limit Equilibrium Results for the Static Analysis of Failure Through the Dowel-Supported Grouted Rock Buttress under Extreme Loading Conditions for Section 1. Artesian groundwater pressures have been measured in the VWP upslope of the spillway (boring BH-17-1). In Slide, artesian groundwater conditions are modeled using a piezometric head line, shown as the blue boundary, which accounts for the artesian pore pressures without contributions from the additional weight of the water (i.e., pooled water).

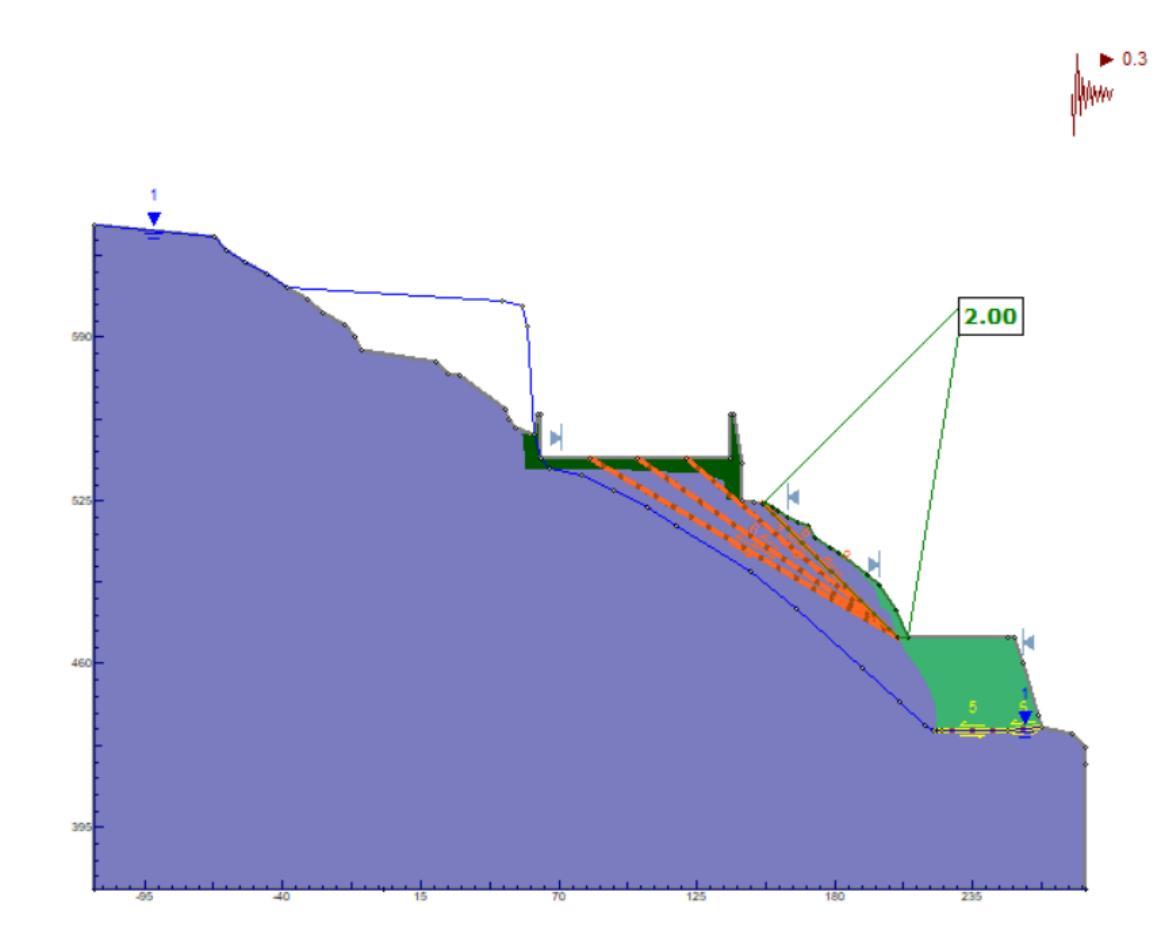
The Slide results for failure cases above and through the dowel-supported grouted rock buttress are presented in Exhibit 10-46 and Exhibit 10-47. The proposed dowel-supported grouted rock buttress design exceeds the required FS of 1.1 under extreme, pseudo-static loading conditions established by GD-1, Rev. 1 (Shannon & Wilson, 2022) for Section 2. Additionally, we evaluated the seismic conditions of the sluiceway slope using conventional Newmark sliding block deformation analysis according to Newmark (1965), described in Section 10.3.8.

Exhibit 10-46: Limit Equilibrium Results for the Static Analysis of Failure Above the Dowel-Supported Grouted Rock Buttress under Extreme Loading Conditions for Section 2. Artesian groundwater pressures have been measured in the VWP upslope of the spillway (boring BH-17-2). In Slide, artesian groundwater conditions are modeled using a piezometric head line, shown as the blue boundary, which accounts for the artesian pore pressures without contributions from the additional weight of the water (i.e., pooled water).

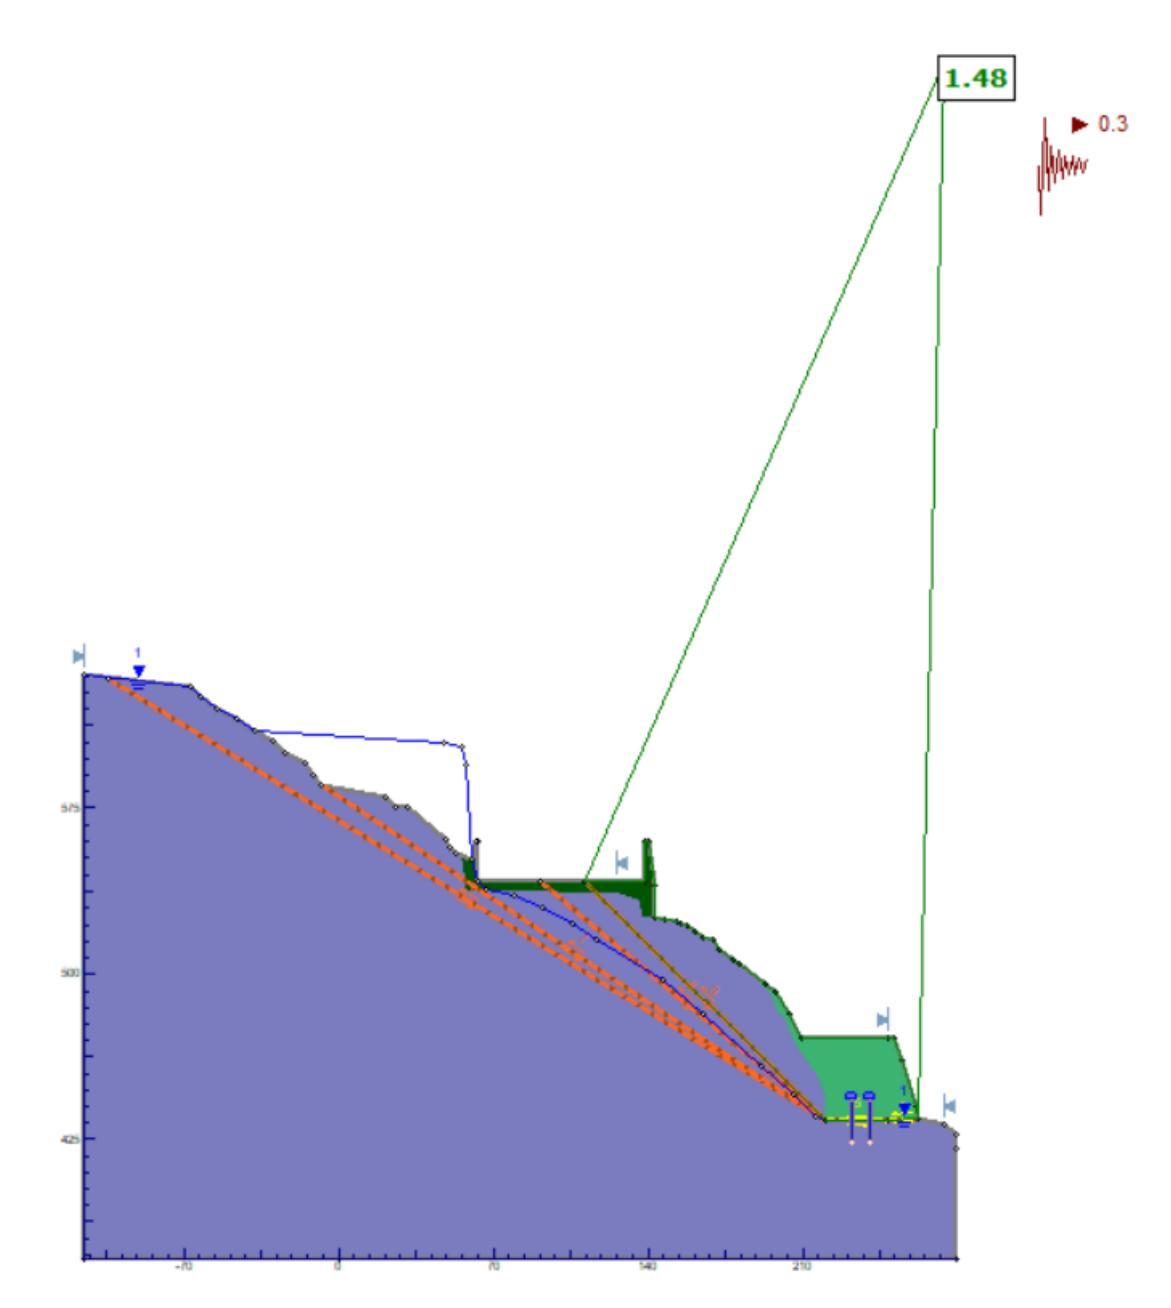
Exhibit 10-47: Limit Equilibrium Results for the Static Analysis of Failure Through the Dowel-Supported Grouted Rock Buttress under Extreme Loading Conditions for Section 2. Artesian groundwater pressures have been measured in the VWP upslope of the spillway (boring BH-17-2). In Slide, artesian groundwater conditions are modeled using a piezometric head line, shown as the blue boundary, which accounts for the artesian pore pressures without contributions from the additional weight of the water (i.e., pooled water).

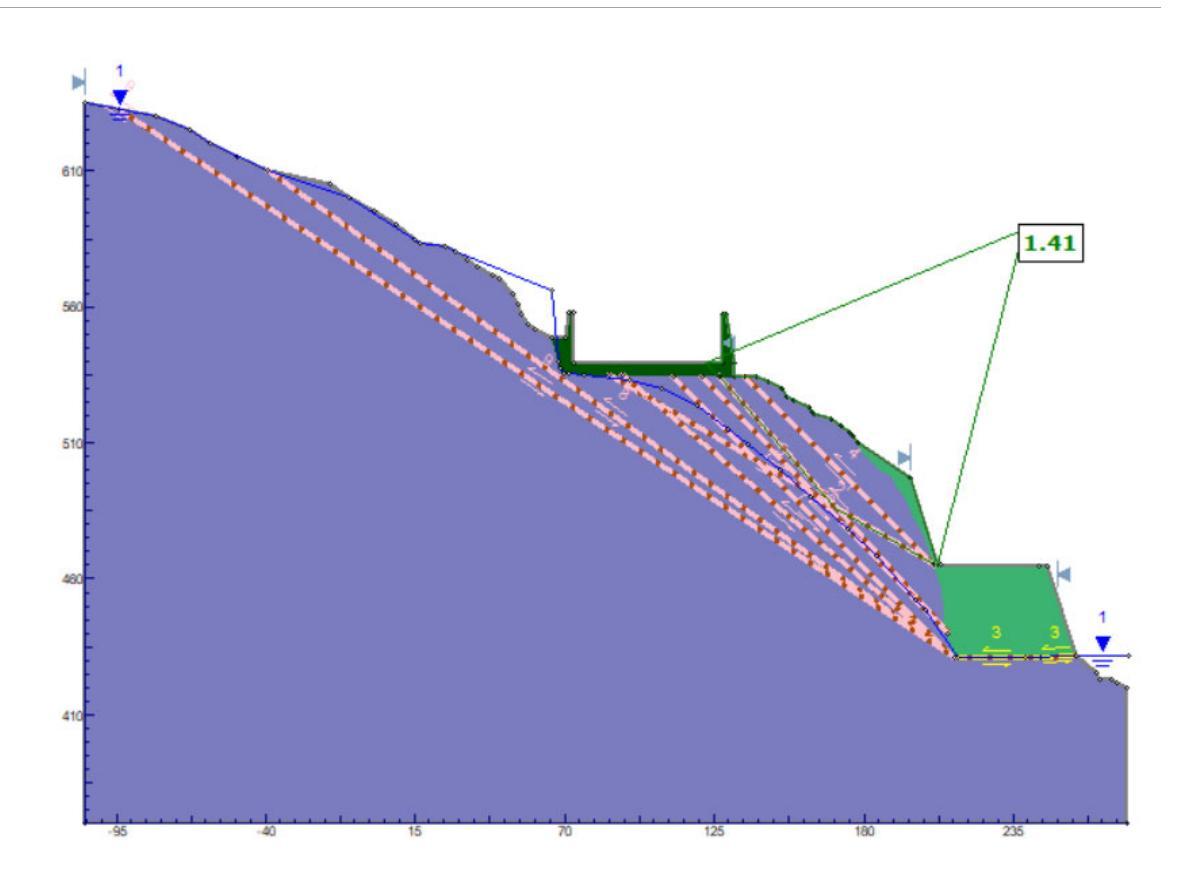
The Slide results for failure cases above and through the dowel-supported grouted rock buttress are presented in Exhibit 10-48 and Exhibit 10-49. The proposed dowel-supported grouted rock buttress design exceeds the required FS of 1.3 under usual loading conditions with post-earthquake material established by GD-1, Rev. 1 (Shannon & Wilson, 2022) for Section 1.

Exhibit 10-48: Limit Equilibrium Results for the Static Analysis of Failure Above the Dowel-Supported Grouted Rock Buttress under Usual Loading Conditions with Post-Earthquake Material Properties for Section 1. Artesian groundwater pressures have been measured in the VWP upslope of the spillway (boring BH-17-1). In Slide, artesian groundwater conditions are modeled using a piezometric head line, shown as the blue boundary, which accounts for the artesian pore pressures without contributions from the additional weight of the water (i.e., pooled water).

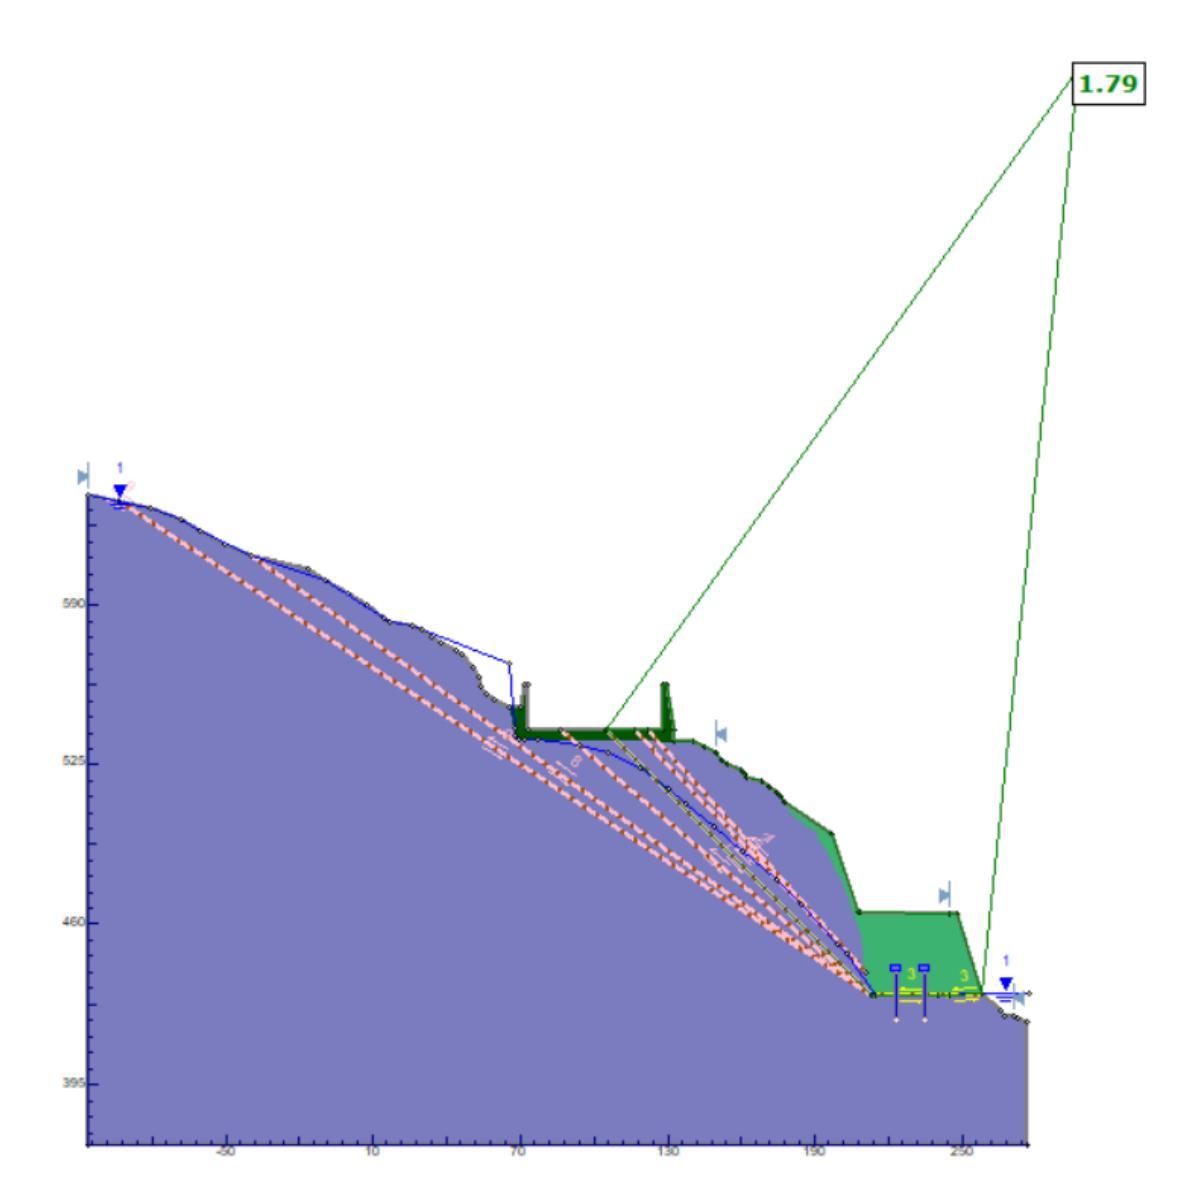
Exhibit 10-49: Limit Equilibrium Results for the Static Analysis of Failure Through the Dowel-Supported Grouted Rock Buttress under Usual Loading Conditions with Post-Earthquake Material Properties for Section 1. Artesian groundwater pressures have been measured in the VWP upslope of the spillway (boring BH-17-1). In Slide, artesian groundwater conditions are modeled using a piezometric head line, shown as the blue boundary, which accounts for the artesian pore pressures without contributions from the additional weight of the water (i.e., pooled water).

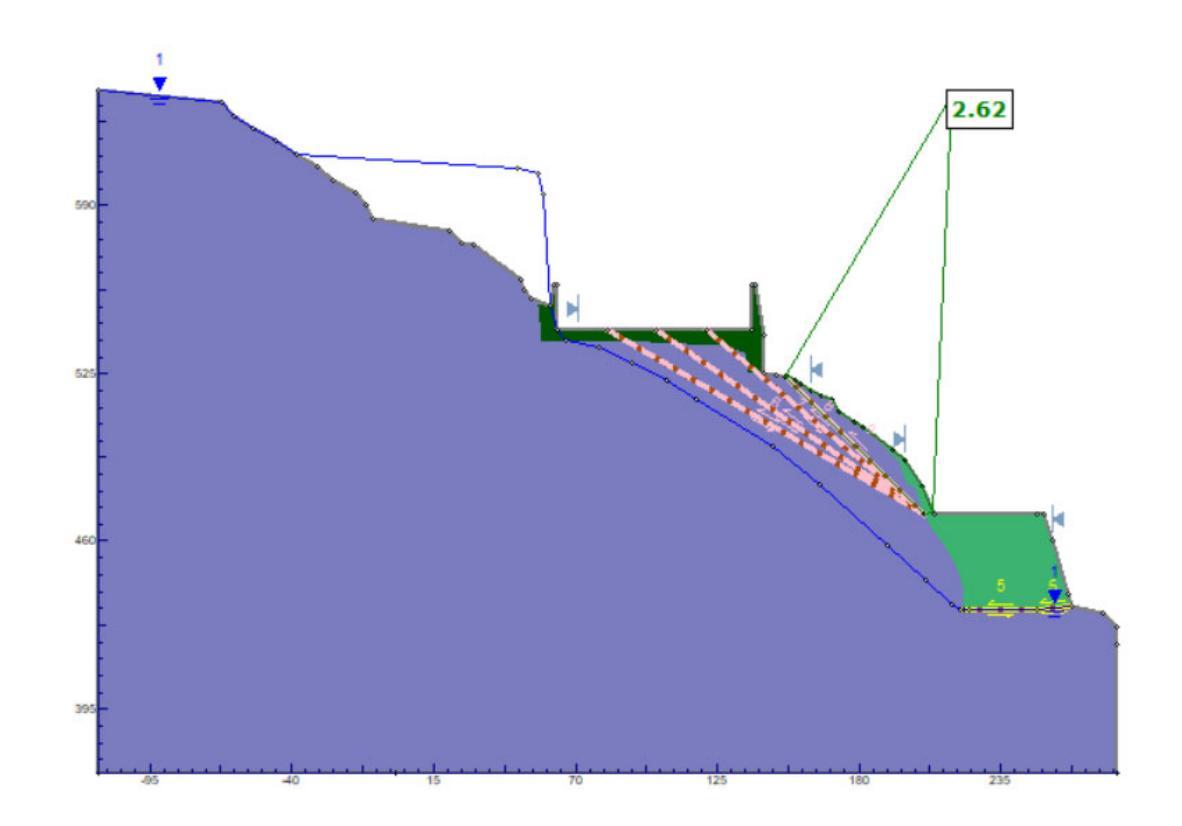
The Slide results for failure cases above and through the dowel-supported grouted rock buttress are presented in Exhibit 10-50 and Exhibit 10-51. The proposed dowel-supported grouted rock buttress design exceeds the required FS of 1.3 under usual loading conditions with post-earthquake material established by GD-1, Rev. 1 (Shannon & Wilson, 2022) for Section 2.

Exhibit 10-50: Limit Equilibrium Results for the Static Analysis of Failure Above the Dowel-Supported Grouted Rock Buttress under Usual Loading Conditions with Post-Earthquake Material Properties for Section 2. Artesian groundwater pressures have been measured in the VWP upslope of the spillway (boring BH-17-2). In Slide, artesian groundwater conditions are modeled using a piezometric head line, shown as the blue boundary, which accounts for the artesian pore pressures without contributions from the additional weight of the water (i.e., pooled water).
Upper Baker Dam Geotechnical Report Foundation Failure Modes Report

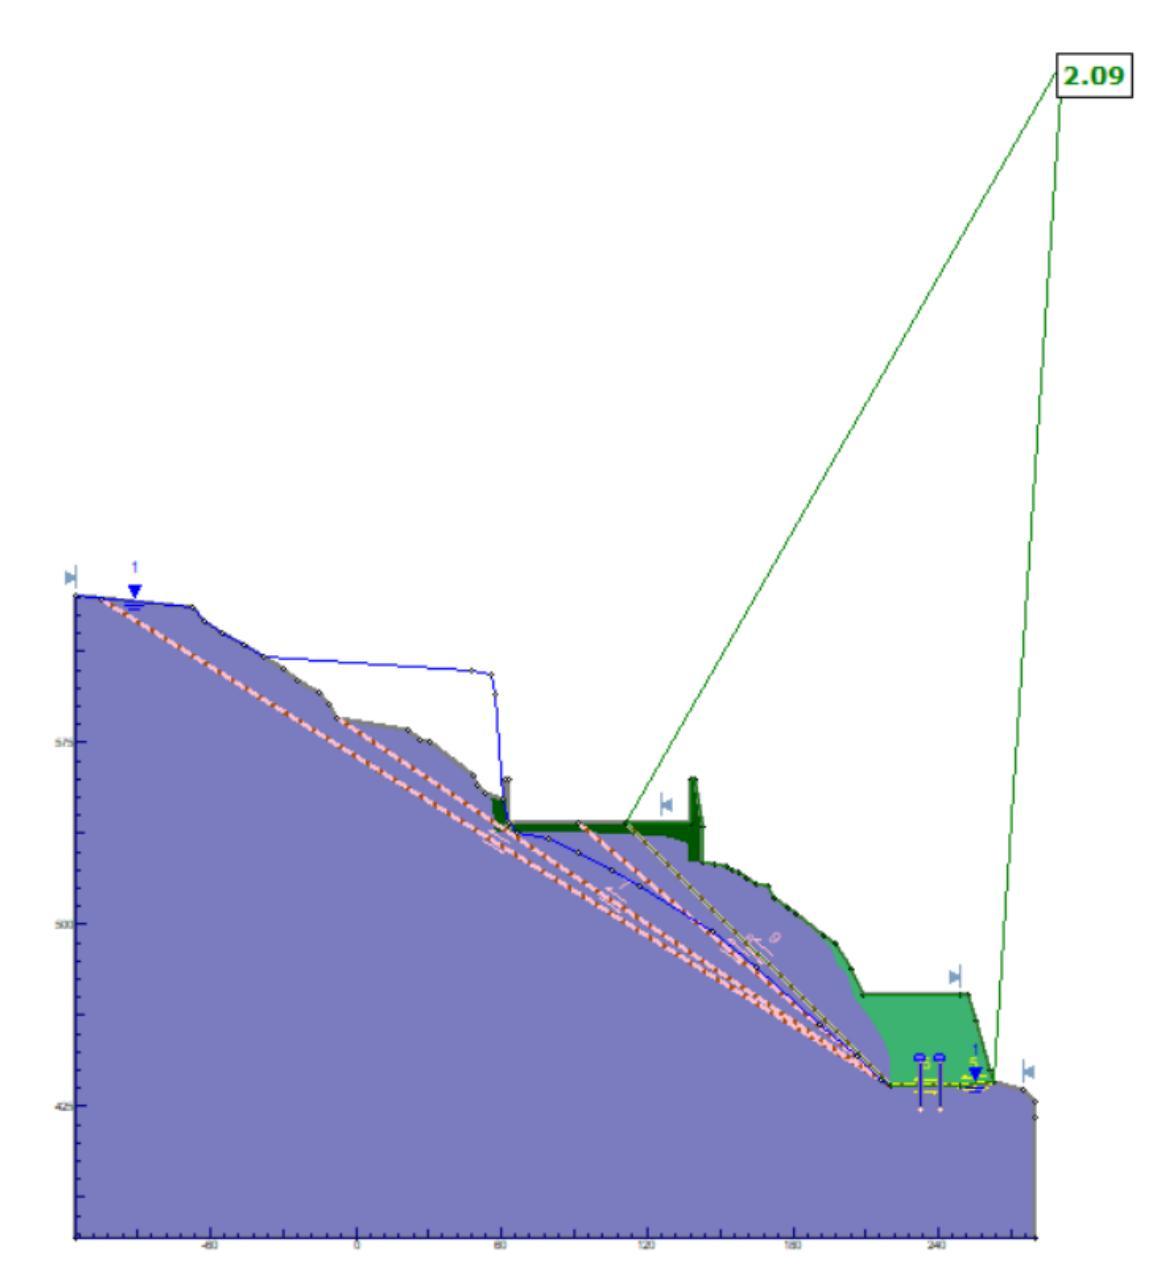
Exhibit 10-51: Limit Equilibrium Results for the Static Analysis of Failure Through the Dowel-Supported Grouted Rock Buttress under Usual Loading Conditions with Post-Earthquake Material Properties for Section 2. Artesian groundwater pressures have been measured in the VWP upslope of the spillway (boring BH-17-2). In Slide, artesian groundwater conditions are modeled using a piezometric head line, shown as the blue boundary, which accounts for the artesian pore pressures without contributions from the additional weight of the water (i.e., pooled water).
