Incident Investigation

M/T Overseas Boston

9/8/14

Incident Type: Pilot Ladder Accident/Injury at Port Angeles Pilot Boarding Area, WA

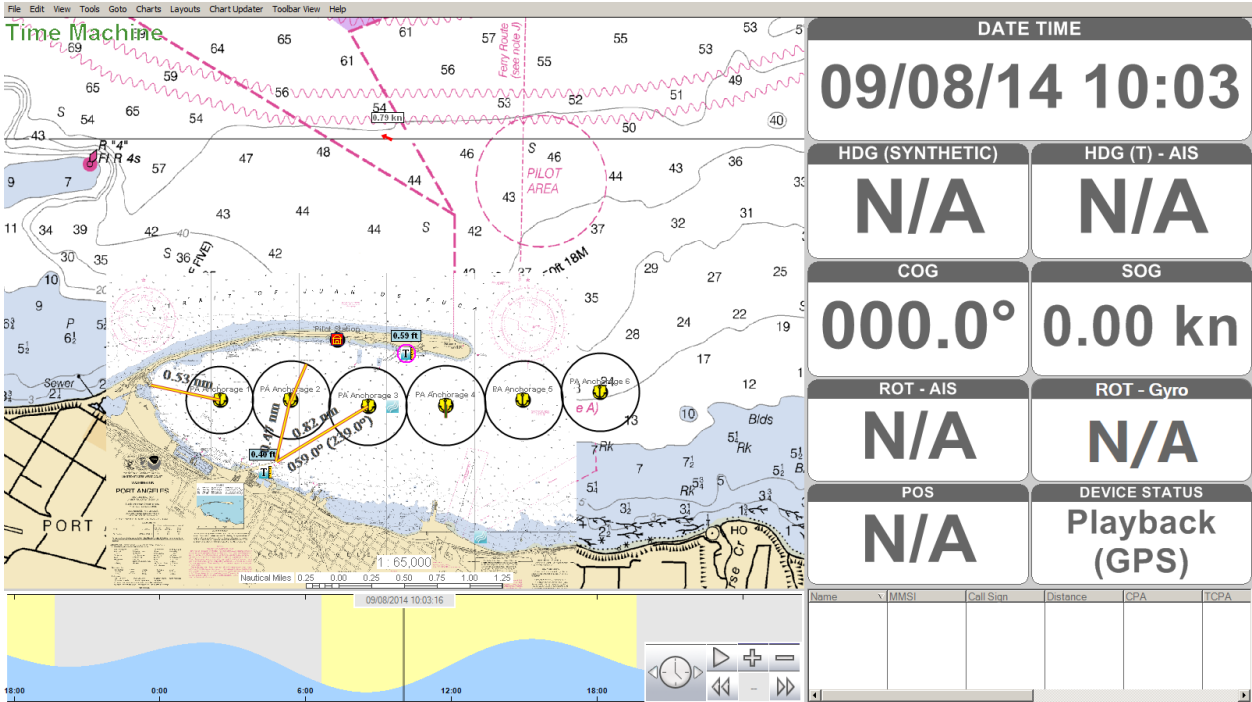
The M/T Overseas Boston arrived at the Port Angeles pilot boarding area north of Ediz Hook the morning of September 8, 2014 intending to embark a pilot, then proceed into Port Angeles Harbor. There she would discharge 31,000 barrels of Decant to a barge.
