BEFORE THE WASHINGTON UTILITIES AND TRANSPORTATION COMMISSION

DOCKET NO. UE-090134

EXHIBIT NO. SJK-6

**AVISTA CORP.  
RESPONSE TO REQUEST FOR INFORMATION**

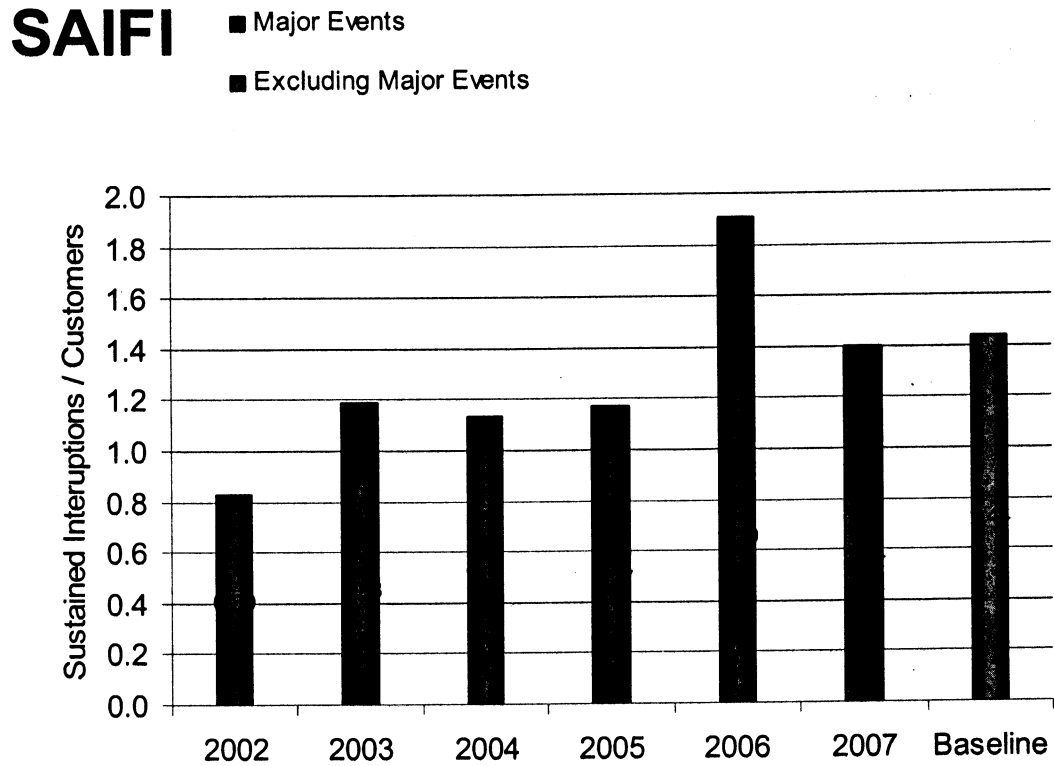
Chart 1.1 – SAIFI - Sustained Interruptions / Customer

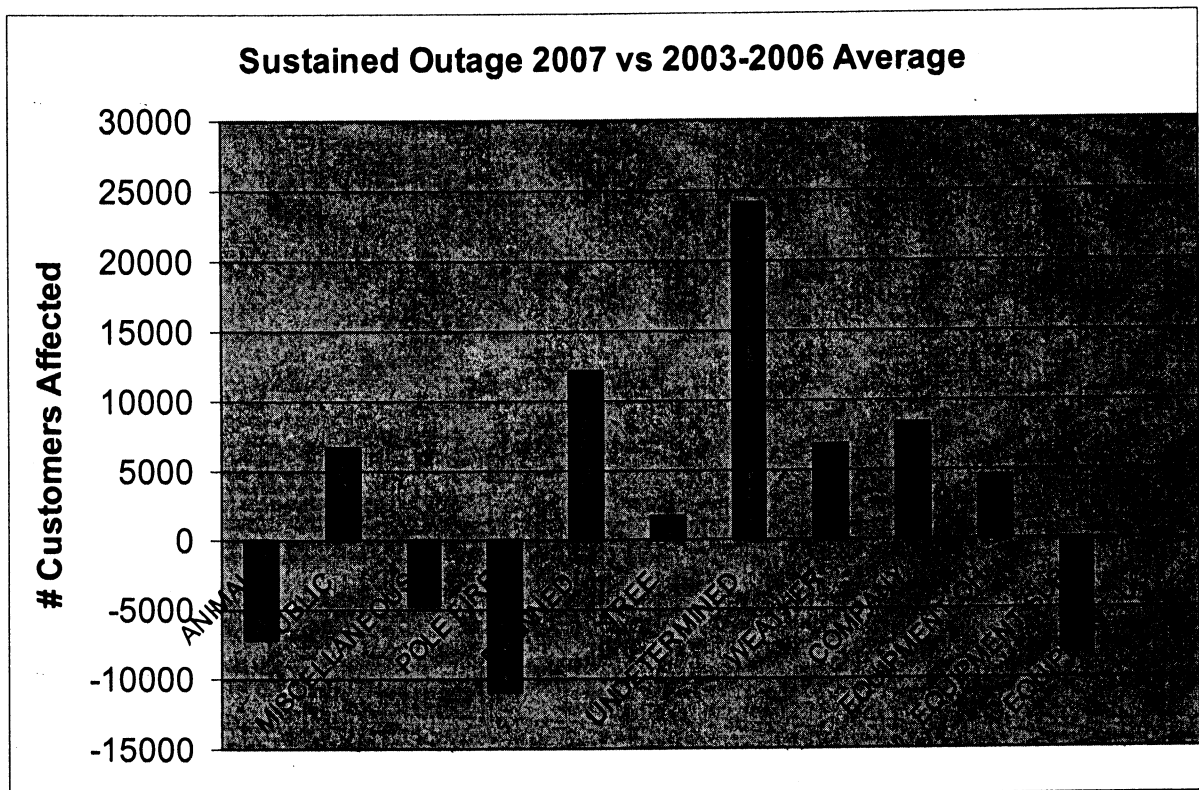
Chart 1.2 – Sustained Interruptions / Customer Historic Comparison

SAIFI for 2007 was within the existing baseline and 12% lower than 2006. Major contributors to this difference were lower weather, tree, public, and overhead equipment outages.

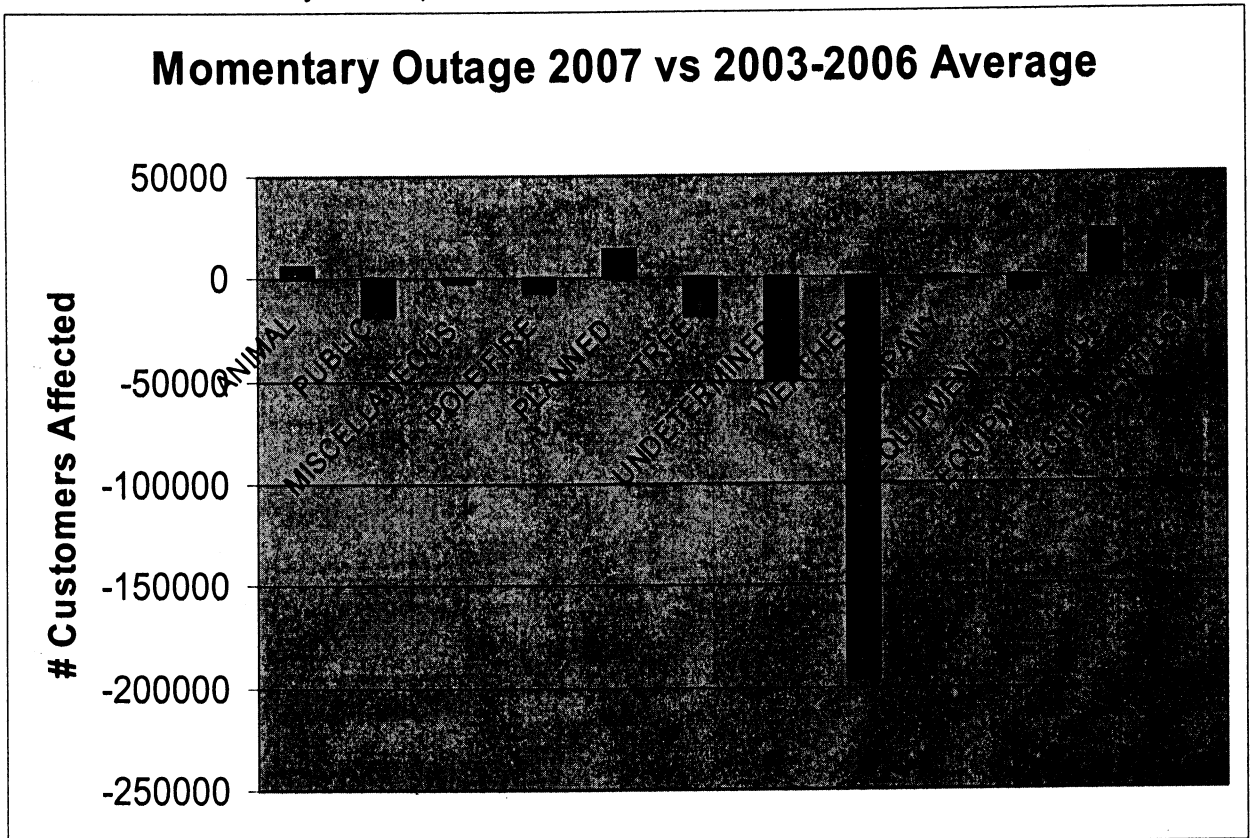
Chart 1.4 – Momentary Interruptions/ Customer Historic Comparison

The 2007 results for MAIFI show a small decrease in the number of incidents compared to the 2003 to 2006 average. There was a significant reduction in weather/undetermined related momentary outages, that were most likely due to the better overall weather conditions. Distribution Dispatch continues to make improvements in correlating the momentary outages with subsequent sustained outages, which reduces the undetermined causes. Wind contributed to 32,157 customers being impacted, Heavy Snow impacted 39,443 customers while Lightning accounted for impacts to 23,566 customers.

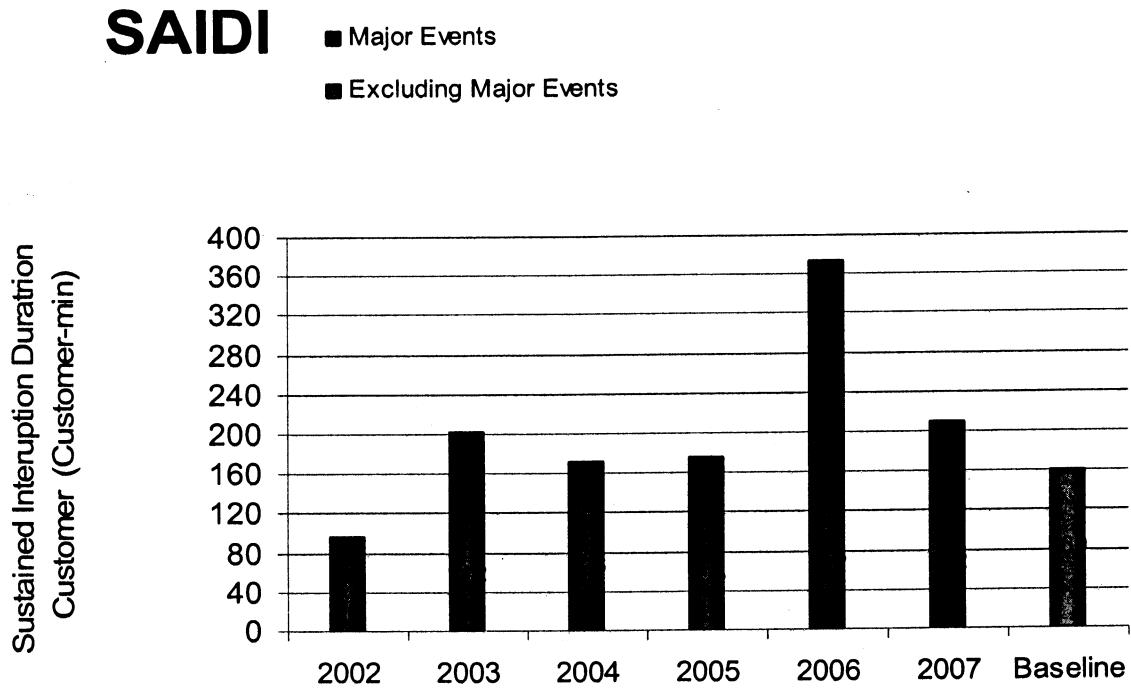
Chart 1.5 - SAIDI – Average Outage Time / Customer
