BEFORE THE WASHINGTON UTILITIES AND TRANSPORTATION COMMISSION

DON F. KOPCZYNSKI

REPRESENTING AVISTA CORPORATION

**Re: Pipeline Replacement Plans of Avista Utilities - Docket No. UG-120715**

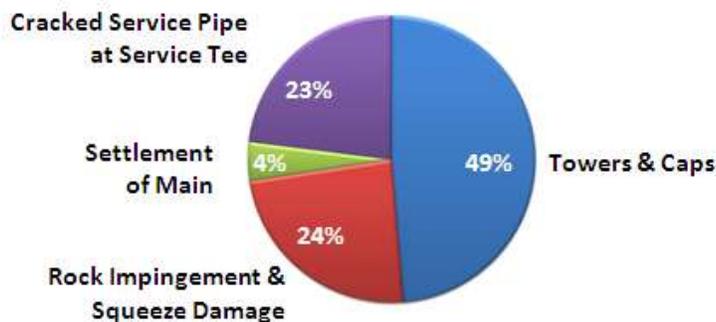
Figure 1. Modes or types of material failures documented in a sample of 113 leaks in Avista's Aldyl A piping in Washington State, December 2005 through March 2011.

**Aldyl A Material Failures**  
113 leak sample size, Washington State, Dec. 2005-Mar. 2011

In tackling the first objective of the assessment of its Aldyl A piping, Avista aggregated the gas leaks resulting from Aldyl A material failures found in its gas system in Washington State from late 2005 through March 2011. The sample included 113 material failures that were evaluated and summarized by component to offer an understanding of the specific failure modes for Aldyl A pipe. The 'modes' or types of material failures categorized are shown below in Figure 1.

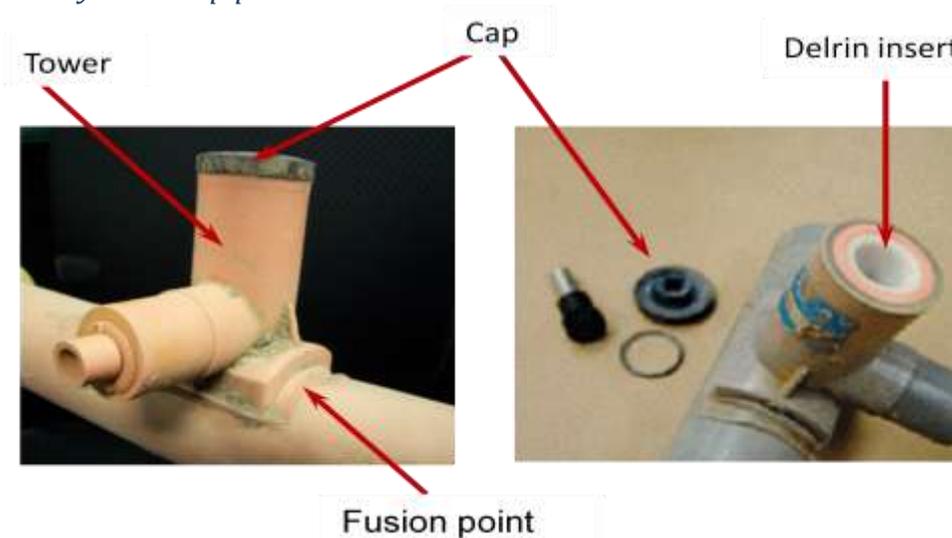
Figure 2. External features and internal components of a typical Aldyl A service tee, as fused to Aldyl A main pipe.

The largest percentage of material failures in the sample occurred in Towers and Caps, referring to failure of the service tapping tee itself, shown below in Figure 2. In these cases, the pressure applied to the tee as the cap was tightened onto the body during initial installation has resulted in slow crack growth and failure of the tower body, the cap, or the Delrin<sup>®</sup> insert many years later. Additionally, the saddle fusion point of the tower to the main pipe is another frequent point of failure in this assembly. The unavoidable stresses created during standard installation (using factory recommended procedures) have led to brittle cracking in these components many years later. This phenomenon clearly demonstrates the susceptibility of certain resins of Aldyl A piping to tend to fail by brittle cracking due to the slow crack growth initiated during installation.

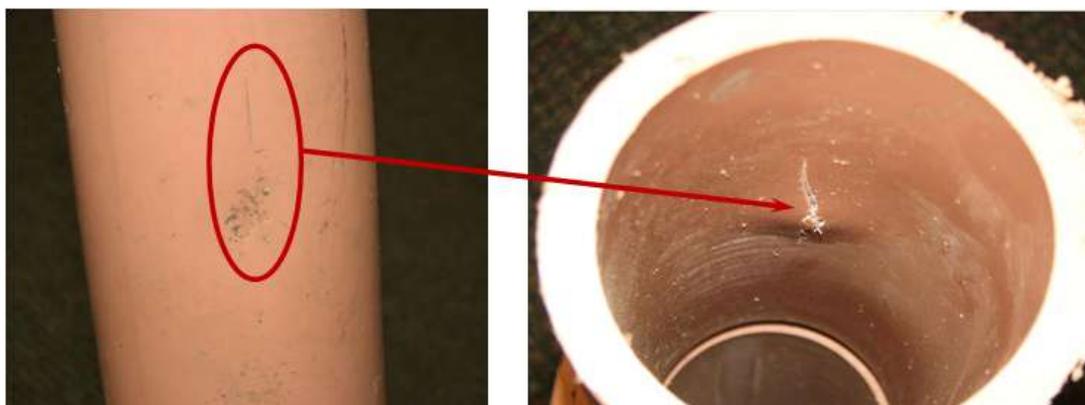
*Figure 3. Typical brittle-like crack through the wall of Aldyl A pipe, resulting from rock contact directly on the pipe.*

The second-most common material failure observed in Avista's Aldyl A pipe was due to localized, brittle cracking in Aldyl A mains that resulted from rock impingement – rock pressure directly on the pipe, or places where ‘squeeze-off’ was applied over the pipe's service life. These failures are very typical for certain resins of Aldyl A main pipe, having been consistently reported by other utilities since before the time of DuPont's 1986 letter. As described earlier, when these external stresses (rock impingement or squeeze-off) cause the pipe to fail, it always begins with crack initiation on the inside surface of the pipe wall, eventually resulting in slow crack growth that propagates toward the outer wall of the pipe, and finally, through-wall failure. These failures generally appear as short, tight cracks in the outer wall of the pipe that run either parallel, or slightly off-parallel with the length of the pipe. A typical failure in Aldyl A main pipe, showing a crack through the pipe wall as it appears on both the inner and outer surfaces, is shown below in Figure 3.

Although the duration of the stress caused by rock contact with the pipe is very different from that associated with squeeze-off, they both result in the same pattern of crack initiation and slow crack growth leading to failure of the pipe. Other sources of external stress that can result in brittle failure of Aldyl A pipe, as mentioned earlier in the report, include bending of the pipe, soil settlement, dents or gouges to the pipe, and improper installation of fittings.

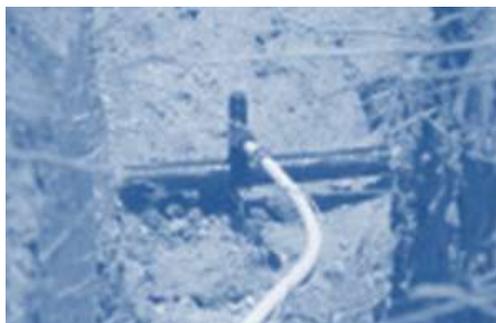
*Figure 4. Typical polyethylene service tapped from a steel main.*

The third most-common failure in Avista's sample occurred where small diameter Aldyl A service pipe is tapped from steel main pipe. In this application, a steel service tee is welded to the steel main pipe and the small-diameter Aldyl A service pipe is then connected to a mechanical transition fitting on the tee, as pictured below in Figure 4.

It is at this transition point, between the rigid steel fitting and the more-flexible Aldyl A service pipe, that brittle-like cracking has been observed. This failure mode in older plastic pipe is well understood, and was one of the three study objectives reported by the National Transportation Safety Board in its 1998 bulletin, summarized earlier in this report.

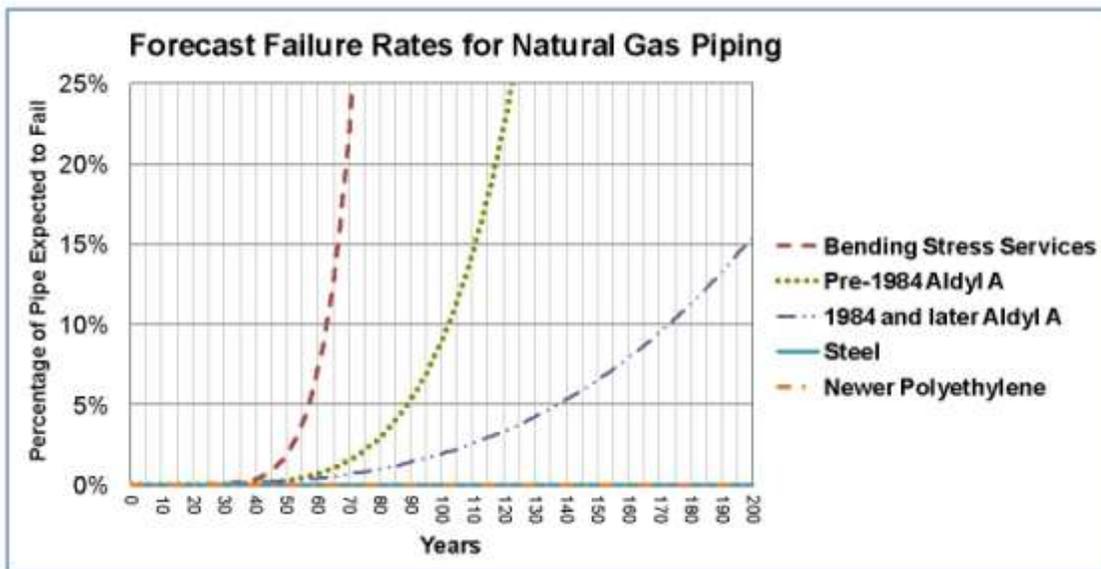
*Figure 5. The expected failure rates for several classes of pipe in Avista’s system, as forecast by Availability Workbench Modeling. The “Steel” curve is obscured by the “Newer Polyethylene” curve, both of which are essentially flat lines.*

Results of the forecast modeling, for the pipe classes evaluated, are represented as ‘curves’ showing the percentage of the amount of each pipe class that is projected to fail in each year of the forecast time period. The resulting reliability curves are shown in the graph below in Figure 5.

The failure curves show dramatic differences in the expected life for the pipe classes evaluated. The difference in expected life between the Aldyl A products as a group, compared with that of steel and newer-generation plastic pipe, is particularly evident. Striking also, are the expected performance differences among the classes of Aldyl A pipe evaluated, providing some clear trends useful in designing remediation strategies.

Although the failure curves for the different classes of pipe differ significantly over the long term, as mentioned, the failure rates also appear to remain below one percent for the first 45 years for Aldyl A services tapped to steel main, and for 65 years for Pre-1984 Aldyl A main pipe. Since the weighted average age for Aldyl A pipe in Avista’s system is 32 years, it would appear that we might have ample time before the failure rate would start to rise substantially for Pre-1984 Aldyl A main pipe. Using the Pre-1984 main pipe in Washington as an example, the failure curve estimates that when this pipe is 65 years old that approximately one percent of it will fail in that single year. Given that Avista has 328 miles of this vintage pipe in Washington, that mileage equals nearly 35,000 discrete elements (50-ft sections) in the forecast model. The one percent failure, then, translates to 346 leaks in that 65<sup>th</sup> year. To put this failure rate into perspective, consider the 113 leaks documented (primarily on Pre-1984 main pipe) over the past five years in Washington state. The 113 leaks equal an average of 22.6 leaks per year, or an annual failure rate of 0.06 percent. Since it is expected that the number of hazardous leaks and incidents would increase proportionally with the increase in total leaks, then it’s easy to imagine just how unacceptable the pipe performance would be at an annual failure rate of one percent.

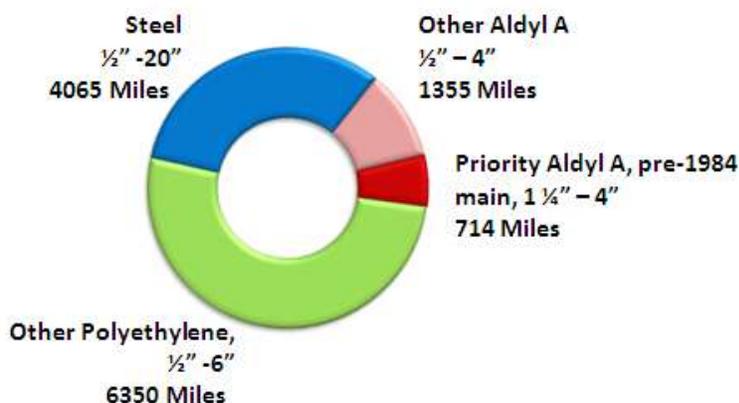
*Figure 6. Avista's priority Aldyl A pipe, shown as a proportion of the different pipe classes in Avista's natural gas system (items 2 and 3 from the list above).*

#### **Miles of Pipe Materials in Avista's Natural Gas System**

**Main Pipe** - Avista has approximately 12,500 miles of natural gas main pipe in its service territories in the States of Washington, Oregon and Idaho. Approximately seventeen percent of this total, or 2,000 miles, is Aldyl A pipe of all classes and sizes. Proportions of various classes of piping in Avista's system, including priority Aldyl A pipe (pre-1973 and pre-1984 mains) is shown below in Figure 6.

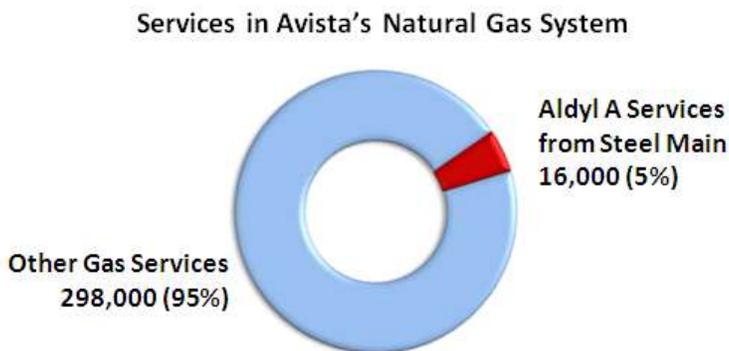
*Figure 7. Avista's priority Aldyl A gas services (tapped from steel mains), shown as a proportion of Avista's total gas services.*

**Gas Services** - Avista has approximately 314,000 natural gas services, of which approximately 16,000, or five percent, are Aldyl service pipe tapped to steel main pipe, shown below in Figure 7 as priority Aldyl A services.

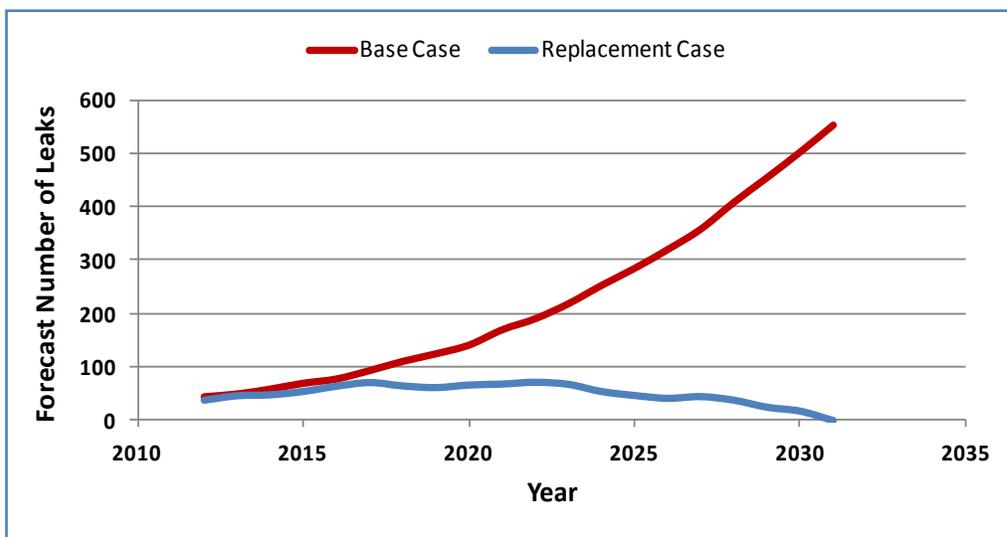
*Figure 8. Expected numbers of material failures in Avista's priority Aldyl A piping in two cases: Replacement Case - piping replaced over a twenty year horizon in the manner proposed by Avista in this report, and Base Case - assumed that priority piping was not remediated under any program.*

failures each year is expected to increase slightly until 2017, at which time the cumulative effect of priority piping replaced since 2012 begins to check the failure count and then drive it toward zero over the remaining course of the program (Figure 8).
