Avista Utilities Asset Management

Protocol for Managing Select Aldyl A Pipe in Avista Utilities' Natural Gas System

May 2013

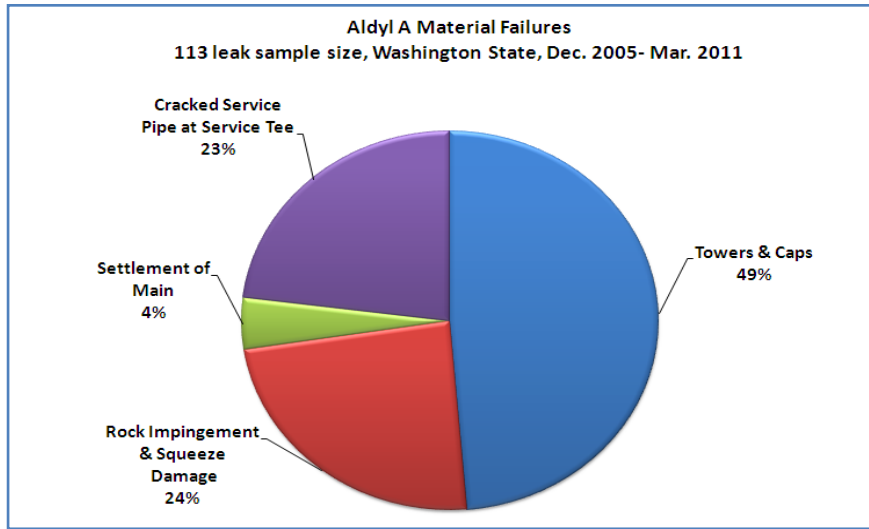
Figure 1. Modes or types of material failures documented in a sample of 113 leaks in Avista's Aldyl A piping in Washington State, December 2005 through March 2011.

In tackling the first objective of the assessment of its Aldyl A piping, Avista aggregated the gas leaks resulting from Aldyl A material failures found in its gas system in Washington State from late 2005 through March 2011. The sample included 113 material failures that were evaluated and summarized by component to offer an understanding of the specific failure modes for Aldyl A pipe. The 'modes' or types of material failures categorized are shown below in Figure 1.

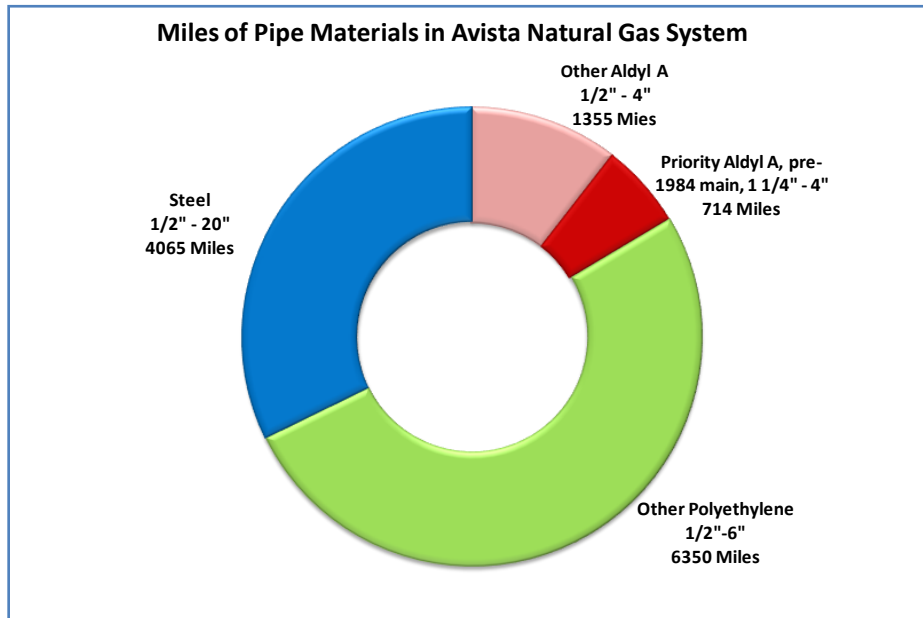
Figure 6. Avista's priority Aldyl A pipe, shown as a proportion of the different pipe classes in Avista's natural gas system (items 2 and 3 from the list above).

Main Pipe - Avista has approximately 12,500 miles of natural gas main pipe in its service territories in the States of Washington, Oregon and Idaho. Approximately seventeen percent of this total, or 2,000 miles, is Aldyl A pipe of all classes and sizes. Proportions of various classes of piping in Avista's system, including priority Aldyl A pipe (pre-1973 and pre-1984 mains) is shown below in Figure 6.

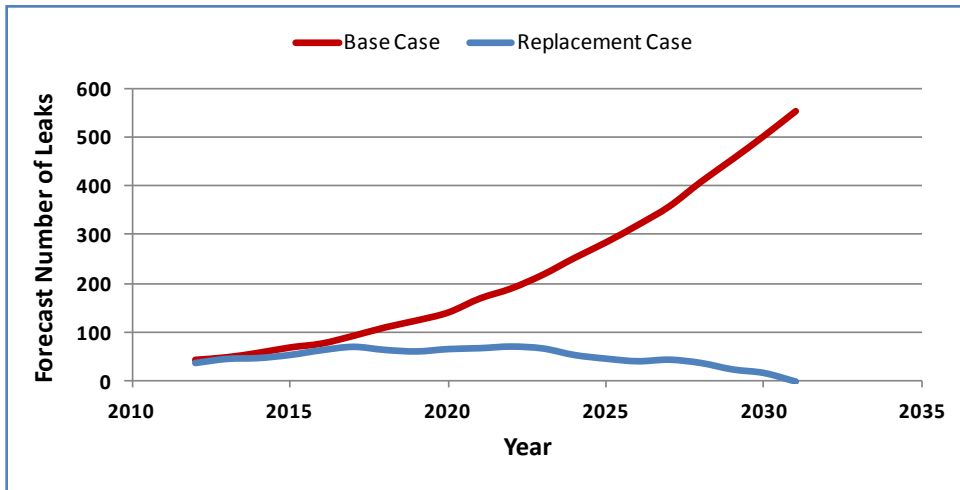
Figure 8. Expected numbers of material failures in Avista’s priority Aldyl A piping in two cases: Replacement Case - piping replaced over a twenty year horizon in the manner proposed by Avista in this report, and Base Case – assumed that priority piping was not remediated under any program.

failures each year is expected to increase slightly until 2017, at which time the cumulative effect of priority piping replaced since 2012 begins to check the failure count and then drive it toward zero over the remaining course of the program (Figure 8).
