BEFORE THE WASHINGTON UTILITIES AND TRANSPORTATION COMMISSION

DIRECT TESTIMONY OF

THOMAS C. DEMPSEY

REPRESENTING AVISTA CORPORATION

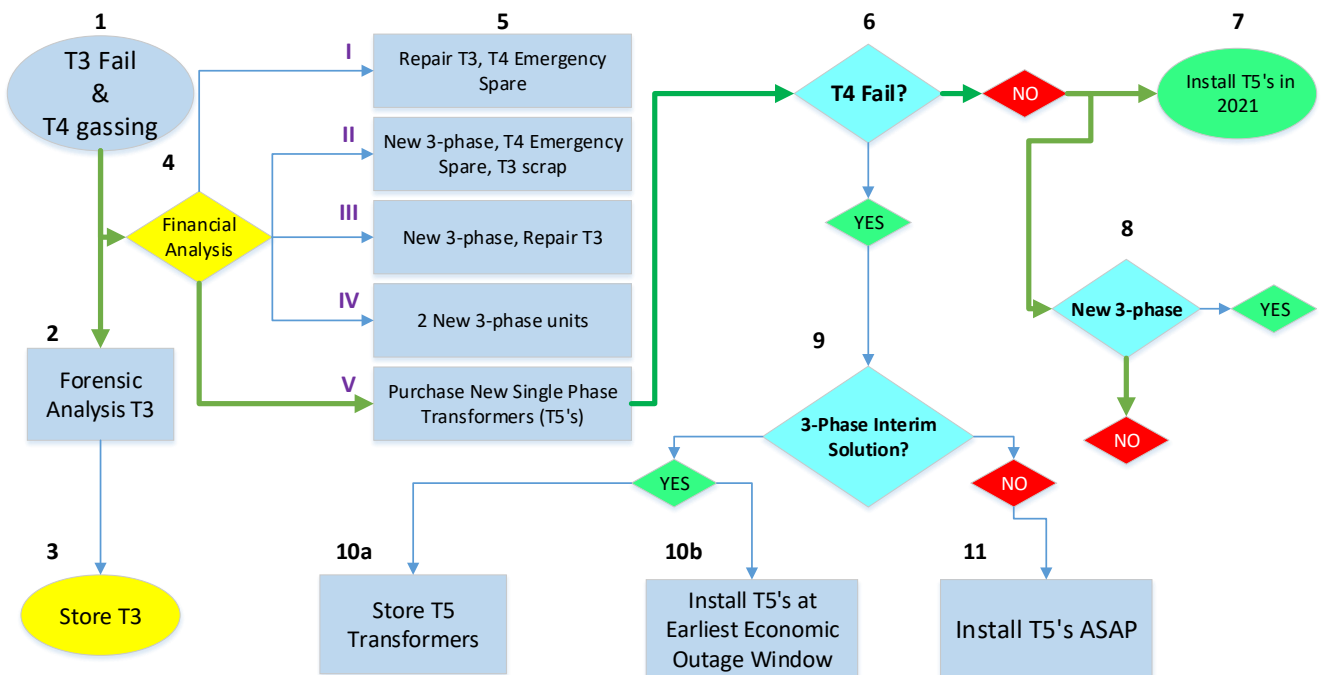
Illustration No. 1: Coyote Springs 2 Transformer Decision Tree

1 various T3/T4 repair combinations, purchasing of two new dual wound three-phase units, and
 2 purchasing new single-phase dual wound units. The financial analysis determined the purchase of
 3 single phase dual wound transformers to be the most cost-effective solution for customers.
 4 Because of the extraordinarily long lead time associated with acquiring transformers of this size,
 5 Avista kept other options open. In the decision tree below, the bolded green lines represent the
 6 chosen path. You may note that Element 6 presented a choice that could have taken us down a
 7 path of repairing T3 or T4 and placing it back into service even though new transformers of a
 8 completely different design had been ordered. The reason for maintaining this optionality is the
 9 long lead time required for these types of transformers to be built and shipped, and the potential
 10 for extremely long outages that expose the Company to market volatility and higher power supply

11 expense. Fortunately, this is not an alternative the Company had to act on as the units have since
 12 been installed successfully.
