Gary M. Saenz Team Leader Chevron Pipe Line
Global Gas
4800 Fournace Place
Bellaire, TX 77401-2324
Tel (713) 432-3332
garysaenz@chevron.com

Chevron Pipe Line Company Notice of Amendment - CPF 5-2010-5023M

Pursuant to the captioned US DOT PHMSA Notice of Amendment CPF 5-2010-5023M, received August 30, 2010, Chevron Pipe Line Company (CPL) respectfully submits the attached revised written procedure to address the inadequacies identified in the Notice of Amendment.

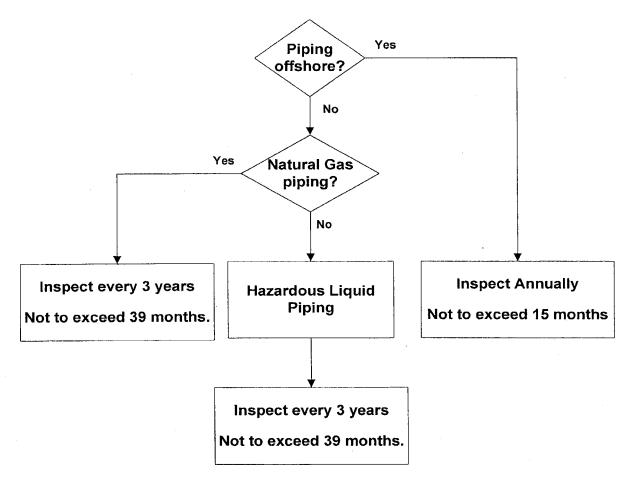
FIGURE 503.2: Atmospheric Coating Inspection Requirements

5.3.1 Schedule atmospheric coating inspections in SAP/PM as indicated in <u>figure 503.2:</u>
Atmospheric Coating Inspection Requirements of this procedure.

**Use <u>HES-114</u> Inspection Form (Appendix A, B or C) to document Atmospheric Coating Inspection.

The Field Team Leader may increase the inspection frequency of above ground piping from every three years to once per year, especially in historically corrosive atmospheres.
