2011 Continuing Surveillance Annual Report

Gas System Integrity Department
May 2012

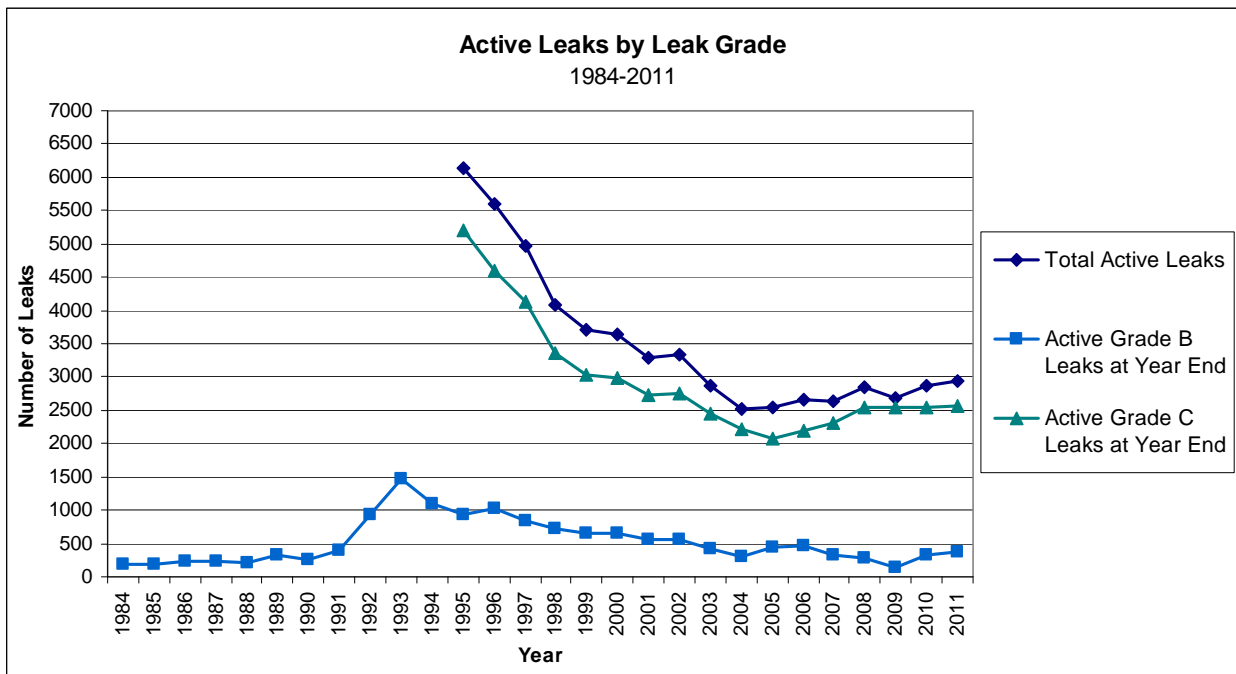
Figure 1. Number of Active Leaks by Leak Grade

Figure 1 shows that even with the recent increase, the total number of active leaks in 2011 is less than 50% of the historical peak in 1995 and grade “B” leaks remain approximately 30% lower than the peak seen in 1993.

Based on the information that is currently available, additional research of historic leak trends was performed. The results of this research are shown in Figure 1.

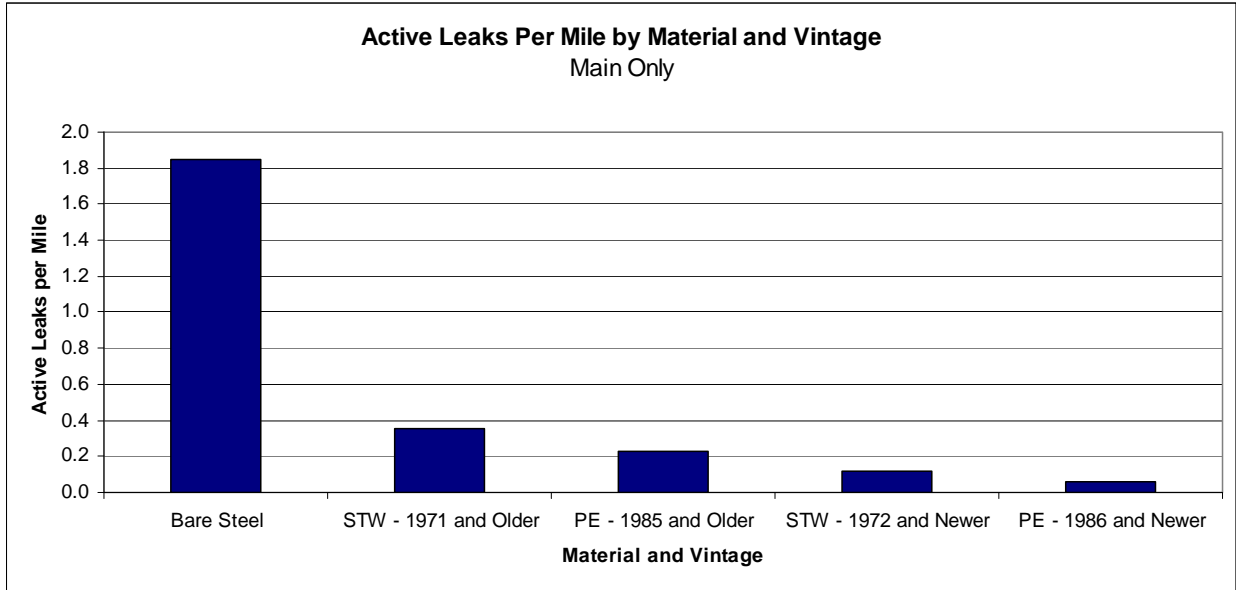
Figure 2. Number of Active Leaks Per Mile by Material and Vintage

This figure shows that in 2008, bare steel had the highest number of active leaks per mile. In addition, bare steel has the highest number of new leaks found per mile. This data supports completing the replacement of bare steel by the end of 2014 as an appropriate risk reduction measure.

In 2008, PSE performed a study in to gain information on the distribution of active leaks by material and age of facility. The results of this study are shown in Figure 2. The 2012 leak initiative will identify the best method of updating this information going forward to provide insight into active leak trends in addition to this one-time snapshot.

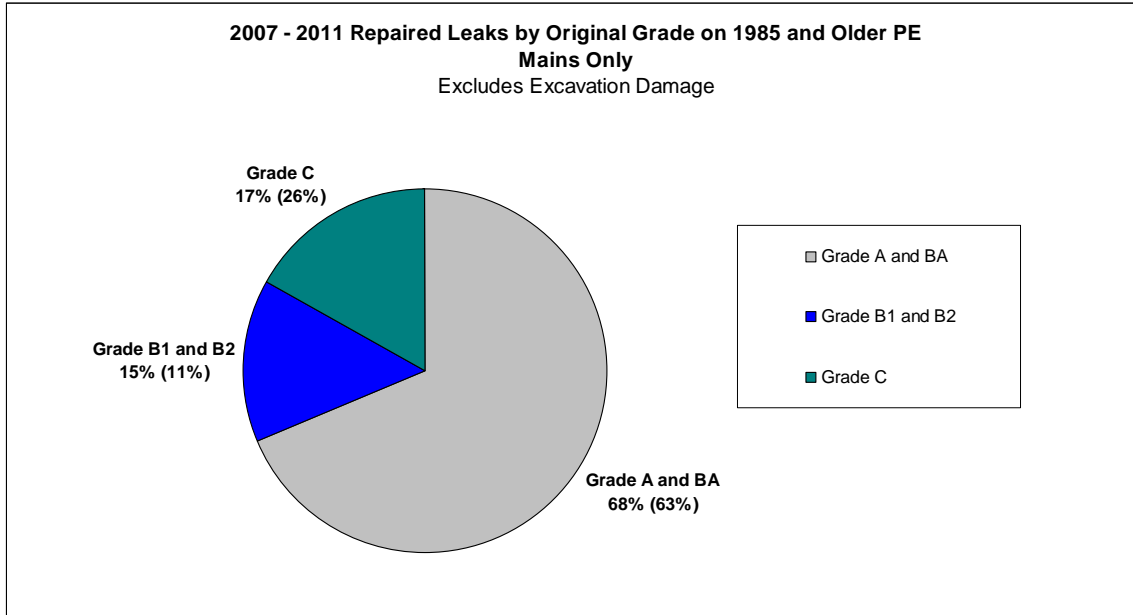
Note: 2011 percentages are provided in the parenthesis for comparison.

Figure 3. Number of Repaired Leaks by Original Grade on 1985 and Older PE Mains

The data on leak repairs by grade and material type show leaks repaired on older vintage PE main are more than twice as likely to be hazardous than leaks repaired on older STW main or bare steel main. As shown in Figure 3, the original grade of repaired leaks on older PE main are hazardous approximately 65% of the time compared to 30% and 20% on older STW main and bare steel main, respectively. This highlights the important role that the Older Vintage PE Pipe Mitigation Program has in reducing the risks associated with these facilities.

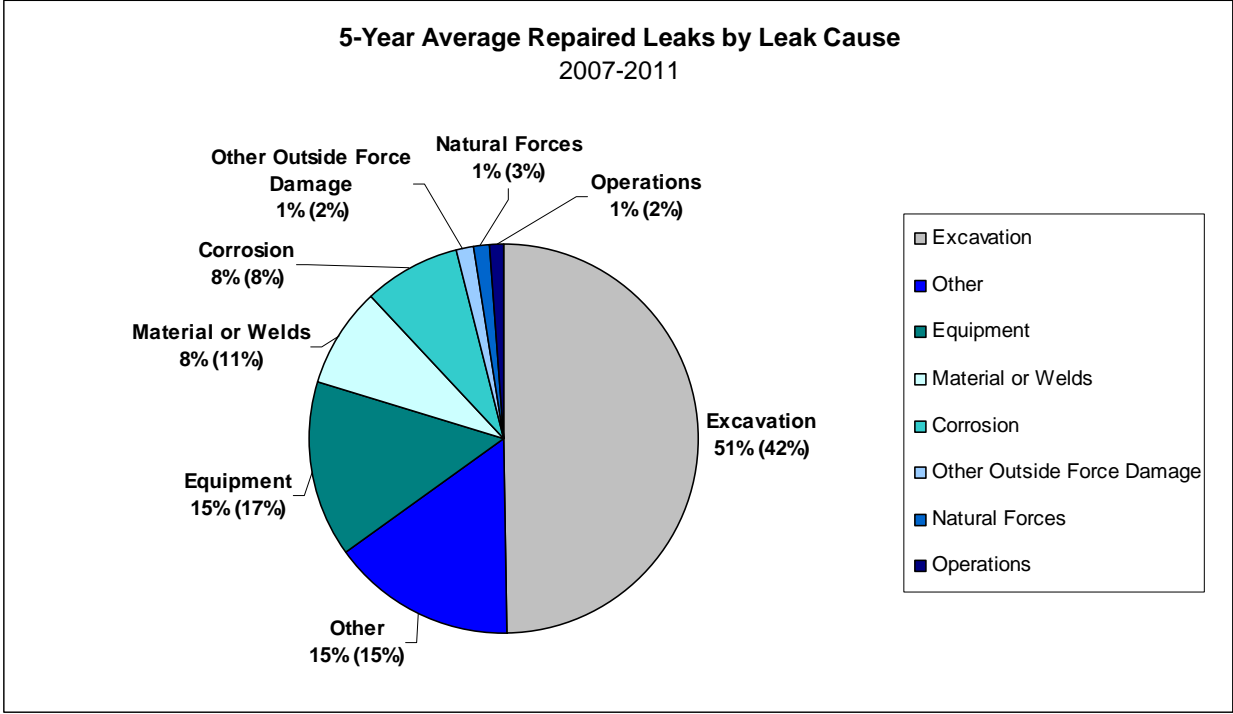
Figure 4. 5-Year Average Repaired Leaks by Leak Cause

Leak repair data indicates that Excavation Damage or third party damage remains the leading cause of leaks on the system. As shown in Figure 4, third party damage was the cause of more than half of the leaks repaired during the last 5 years. In addition, third party damage is the leading cause of federally reportable incidents. These trends related to third party damage are consistent with those experienced throughout the industry.

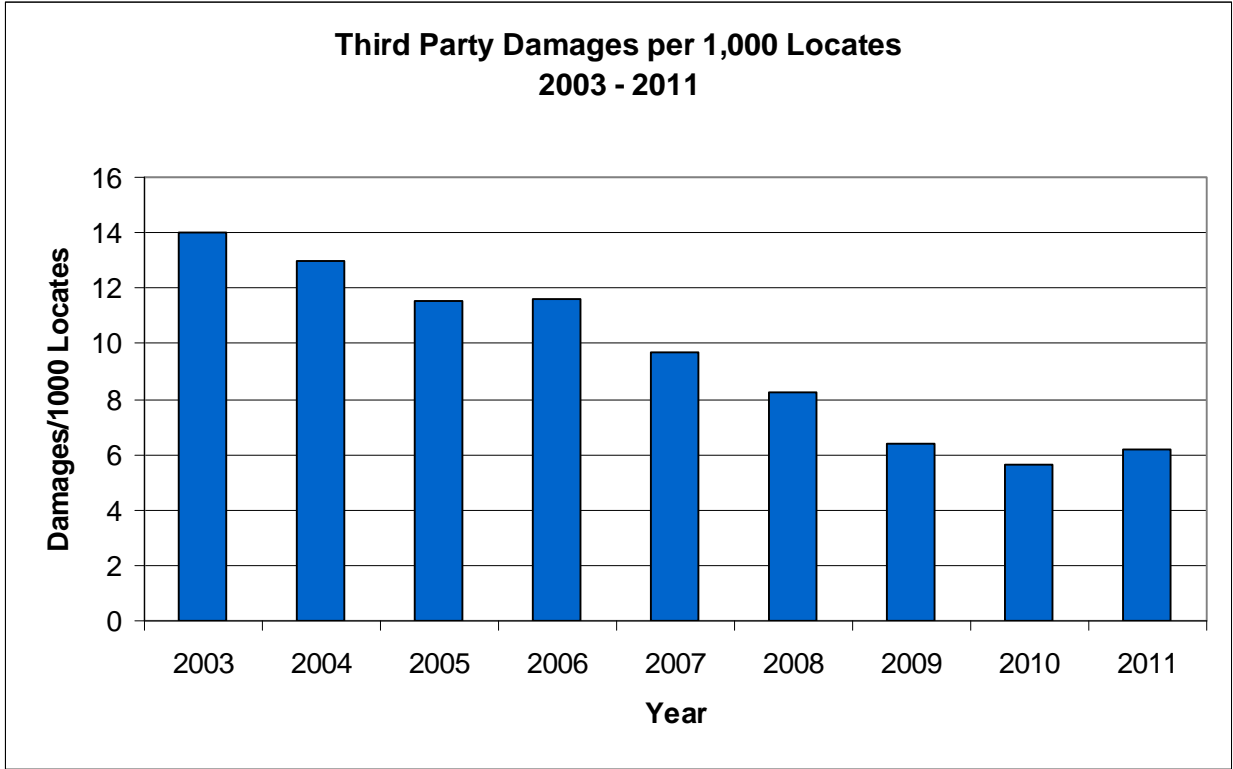
Figure 5. Third Party Damages per 1,000 Locates

Even though third party damage remains the leading cause of leaks on the system, PSE has achieved a significant reduction in third party damage since 2003. The Common Ground Alliance and industry in general has accepted representing the ratio of damages per 1,000 locates to better normalize the impact of increasing and decreasing excavation activity. As shown in Figure 5, PSE has been very successful in reducing damages per 1,000 locate requests. This positive trend has been achieved through a combination of efforts. The most significant reductions have been achieved by excavators using more careful excavation practices and increased public awareness of and adherence to the regulations that require excavators to call for locates prior to excavating.

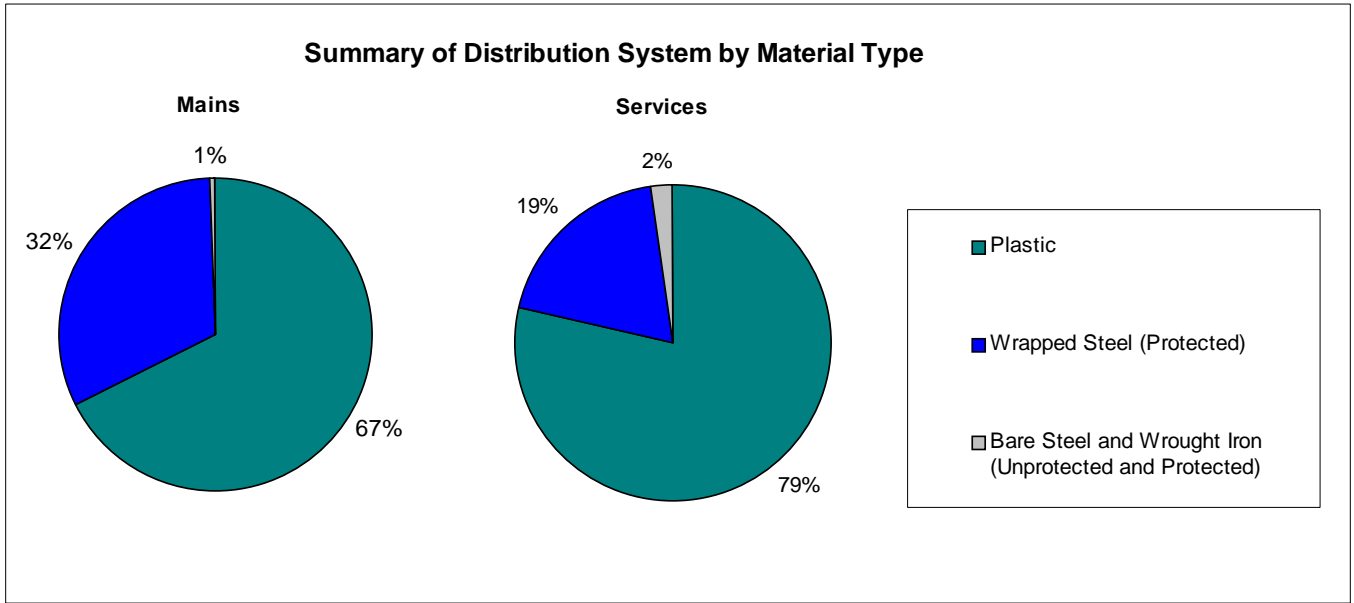
Figure 1. Summary of Distribution System by Material Type

Additional information on PSE’s Gas System Description can be found in *Section 5. Knowledge of Distribution System* in the DIM Plan as well as Gas Operating Standard (GOS) 2400.0500 Gas System Description. The following table and graph, Table 3 and Figure 1, summarizes the mains and services in PSE’s system by material type as of the beginning of 2012.

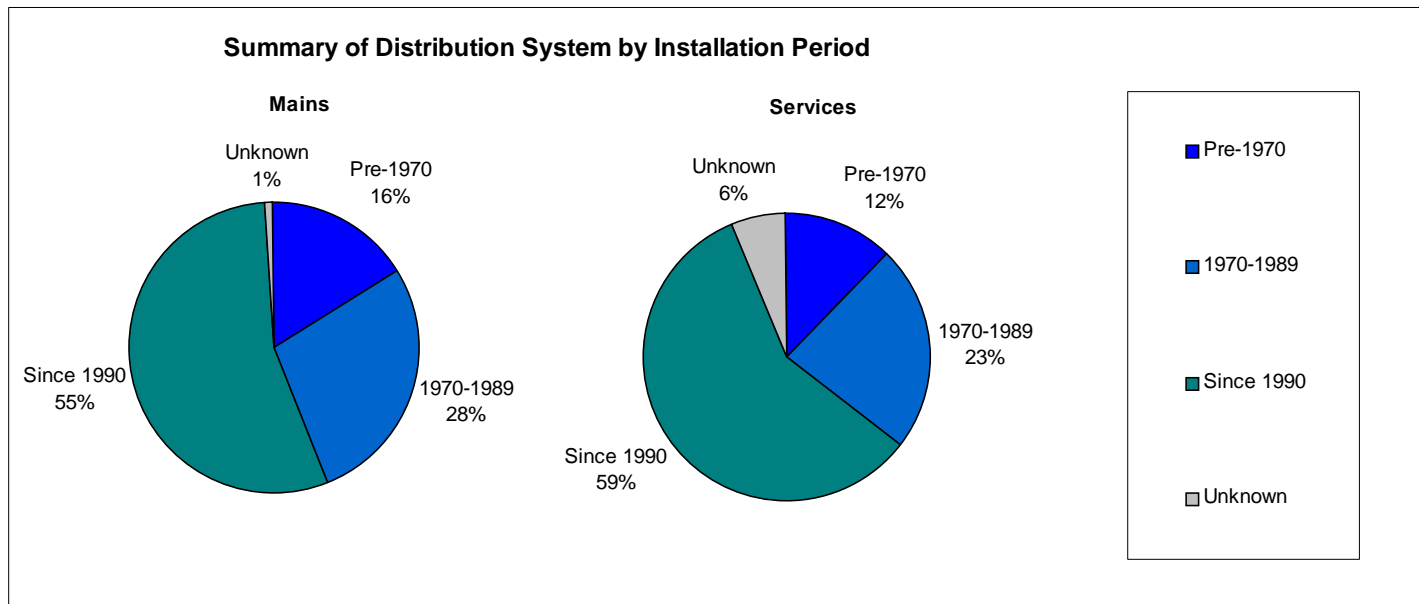
Figure 2. Summary of Distribution System by Installation Period

Table 5 and Figure 2 summarize the distribution of mains and services by installation period in PSE’s system as of the beginning of 2011.

As this information indicates, over half of PSE’s system has been installed since 1990 using newer high performance materials that are more resistant to slow crack growth and brittle-like cracking and modern construction practices including improved fusion and backfill procedures. Additionally, more than 70% of the system has been installed since 1972 when the federal regulations that govern pipeline safety were adopted.

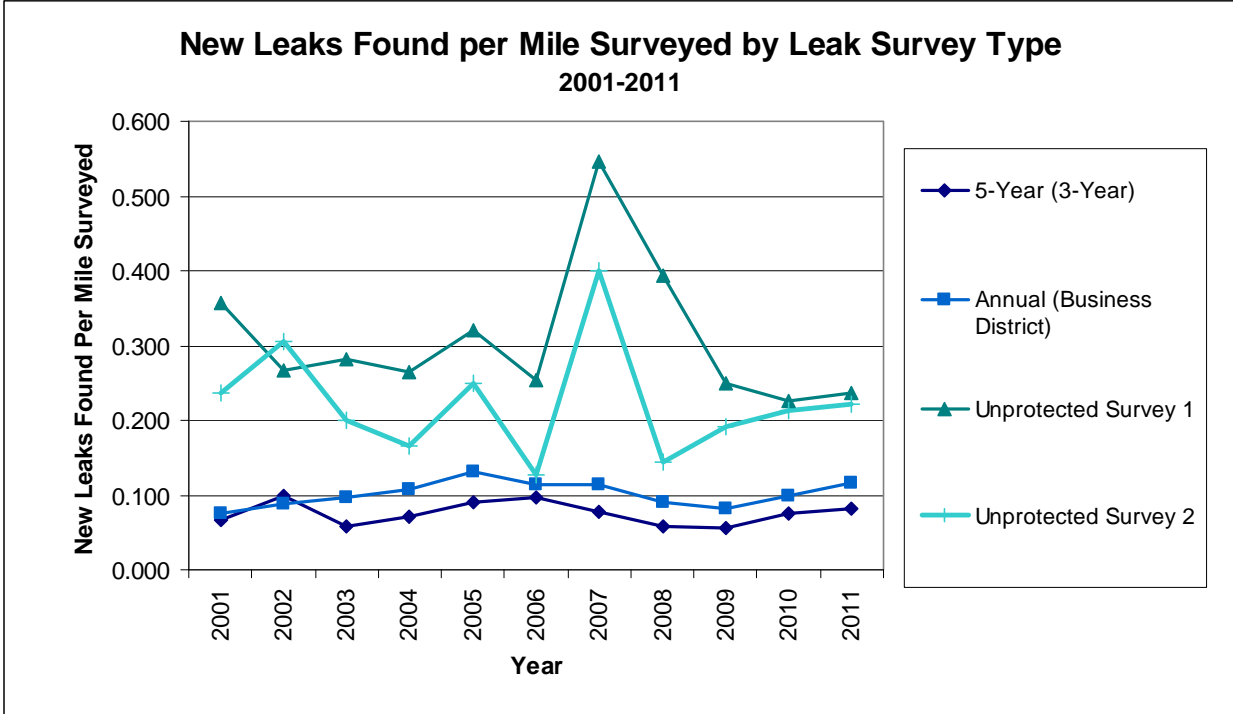
As shown in this graph, the highest concentration of new leaks is found on the facilities that are leak surveyed the most frequently and the lowest concentration of new leaks is found on those facilities that are surveyed the least frequently. This chart demonstrates that the different survey frequencies are appropriately distributed for the different types of facilities.

Figure 3. New Leaks Found Per Mile Surveyed by Leak Survey Type

PSE has an extensive leak survey program which is documented in GOS 2625.1100 Leakage Survey Program. This standard specifies the frequency of leak survey for each type of facility. Unprotected steel pipe and copper pipe is leak surveyed twice annually and the results of these surveys are depicted in Figure 3 as “Unprotected Survey 1” and “Unprotected Survey 2”, representing the first and second survey each year, respectively. Pipe within areas that are designated as business districts, high occupancy structure (HOS) or area, and supply mains operating above 250 psig are leak surveyed annually. The results of these surveys are depicted in the same graph as “Annual (Business District)”. With the exception of a few specialized leak surveys, all other surveys are required by pipeline safety regulations to be performed at least once every 5 years. In 2006, PSE began performing these surveys every 3 years and has continued to maintain this schedule due to efficiencies of combining leak survey activities with atmospheric corrosion monitoring. These surveys are depicted as “5-year (3-year)” on the graph.

In addition to demonstrating that the different survey frequencies are appropriately assigned to the different types of facilities, this graph shows a significant increase in new leaks found in 2007 on the unprotected pipe leak surveys. PSE noticed this increase in new leaks being found and took steps to ensure personnel were trained to properly identify and grade leaks as well as trained in PSE’s phantom leak procedure. Subsequently, the number of new leaks found returned to more typical values.

The graph also shows that historically, the first unprotected pipe survey of the year typically found more leaks than the second survey. PSE has explored this trend and found that the difference between the two surveys has become less significant over the past two years. This trend is likely impacted by the significant reduction in bare steel mains and services over the past several years and the significant reduction in the total number of new leaks found. For example, since 2008 the new leaks found on bare steel have decreased by more than 30%. This shows a very positive trend related to reducing leakage through the Bare Steel Replacement Program.

Since 2009, there has been a slow but steady increase in the number of new leaks found per mile of main surveyed for both the “Annual (Business District)” and “5-year (3-year)” leak surveys. This is a trend that PSE is analyzing further to better understand the factors behind this increase and what if any mitigative measures should be implemented to reverse this trend. Additional information on this analysis is provided in the *Leak Initiative* section in this report.

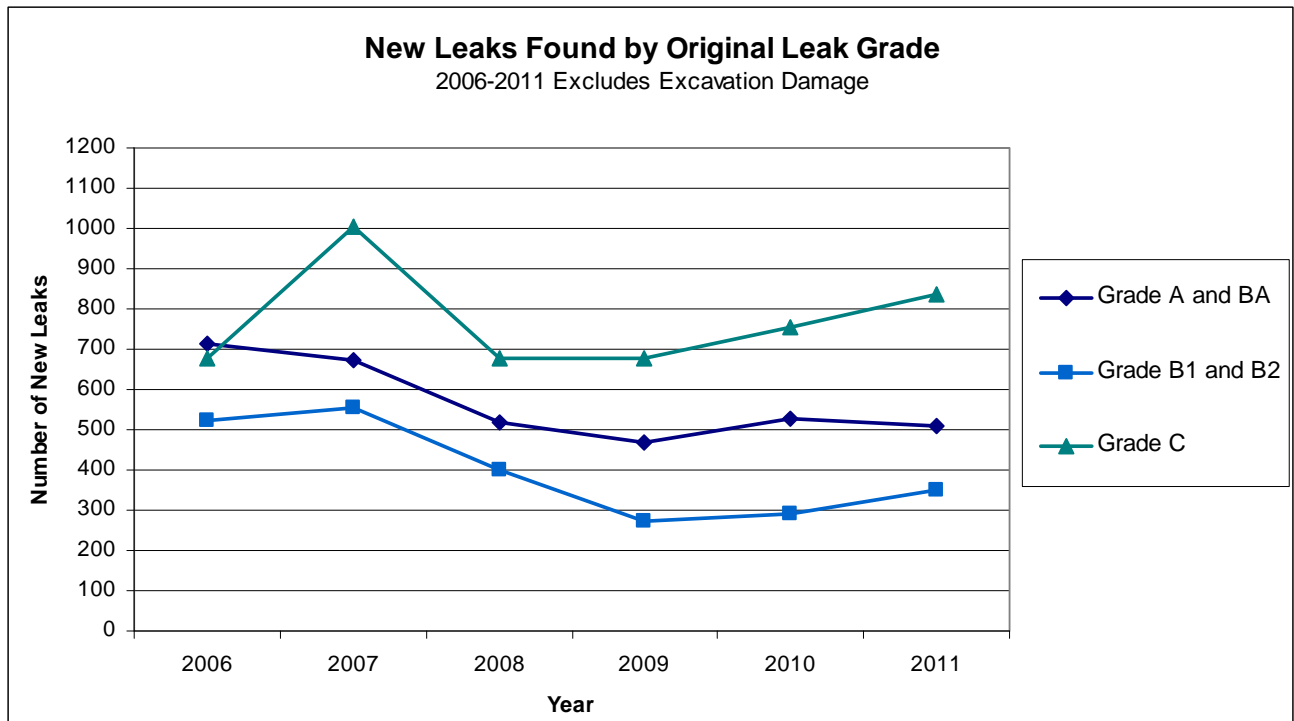
Figure 4. New Leaks Found by Leak Grade

This graph shows a similar trend in new leaks increasing since 2009 and will be included in the additional leak analysis that will be performed as described in the *Leak Initiative* section of this report.

Figure 4 shows trends over the past 6 years related to the grade of new leaks found each year. This includes leaks found by leak survey, as well as those found by company personnel or reported by the public. It excludes leaks that are due to excavation damage as these leaks are generally not indicative of system integrity and the mitigative measures for this threat are different than for other threats. As a result, third party damage trends are analyzed and discussed in the *Third Party Damage Prevention Trends* section of this report.

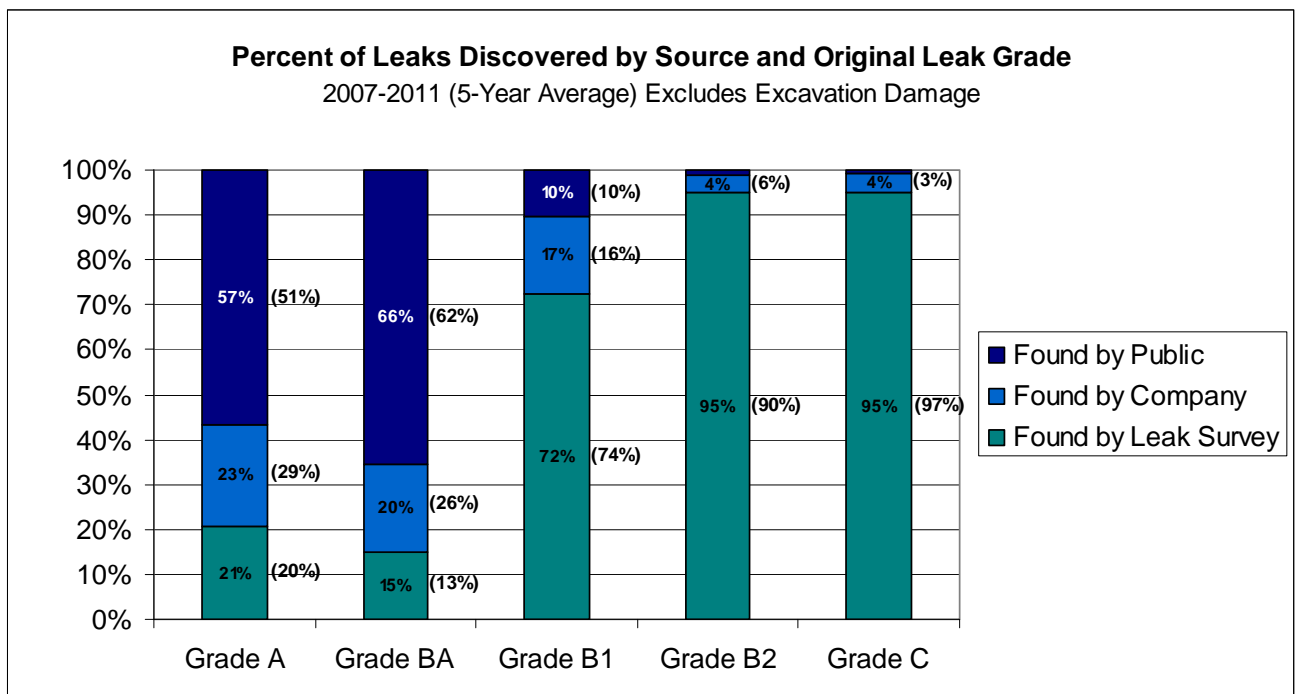
Figure 5 shows additional data that provides insight into the effectiveness of PSE’s leak survey program. As shown by this graph, over 70% of all Grade “B1” and lower grade leaks are found by leak survey. This graph also illustrates the effectiveness of PSE’s odorization program and Public Awareness Program for the higher grade leaks (Grade “A” and “BA”) that are found predominantly by the public.

Figure 5. Percent of Leaks Discovered by Source and Grade

PSE has reviewed the 2011 data and found it is consistent with the 5 year average confirming there are no new trends related to leaks reported by source and grade.

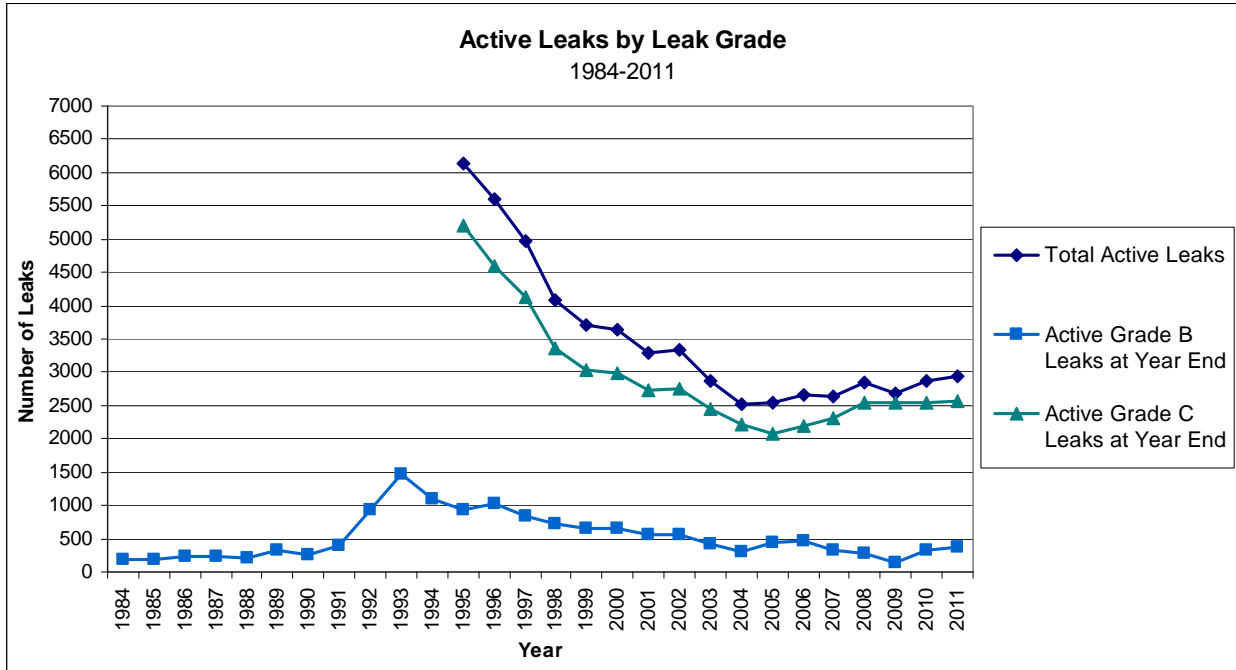
Note: Active Grade C leaks and total active leaks data prior to 1995 is not available.

Figure 6. Active Leaks per Year by Leak Grade

Figure 6 illustrates the historical active leak trends. Active leaks are leaks that are being monitored but have not yet been repaired. This graph shows the active Grade “B” leaks since 1984. It also shows the total active leaks and active Grade “C” leaks since 1995. Data on the total active leaks and active Grade “C” leaks is not available prior to 1995.

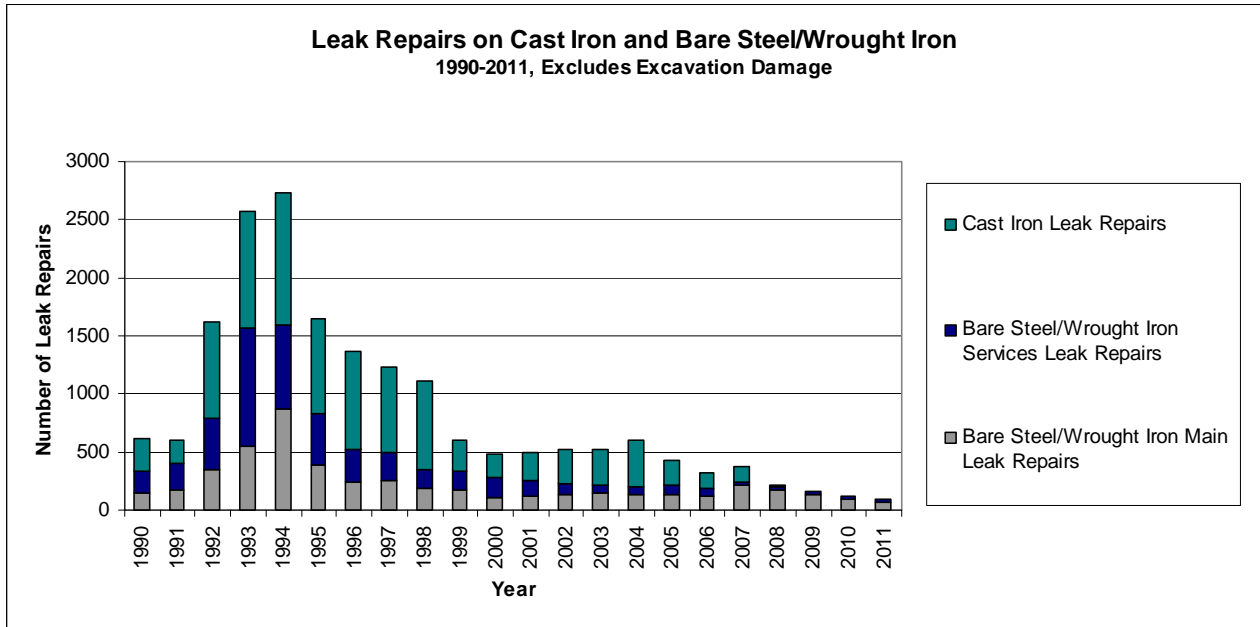
Figure 7. Leak Repairs on Cast Iron and Bare Steel/Wrought Iron

The following graph further demonstrates the impact the changes to the leak survey procedures had on leak repairs on unprotected facilities. As shown Figure 7, there was a significant increase in leak repairs on cast iron, bare steel mains, and bare steel services

beginning in 1992 and continuing over the next several years. This graph also shows that leak repairs on the remaining bare steel pipe have shown a steady decline in recent years.

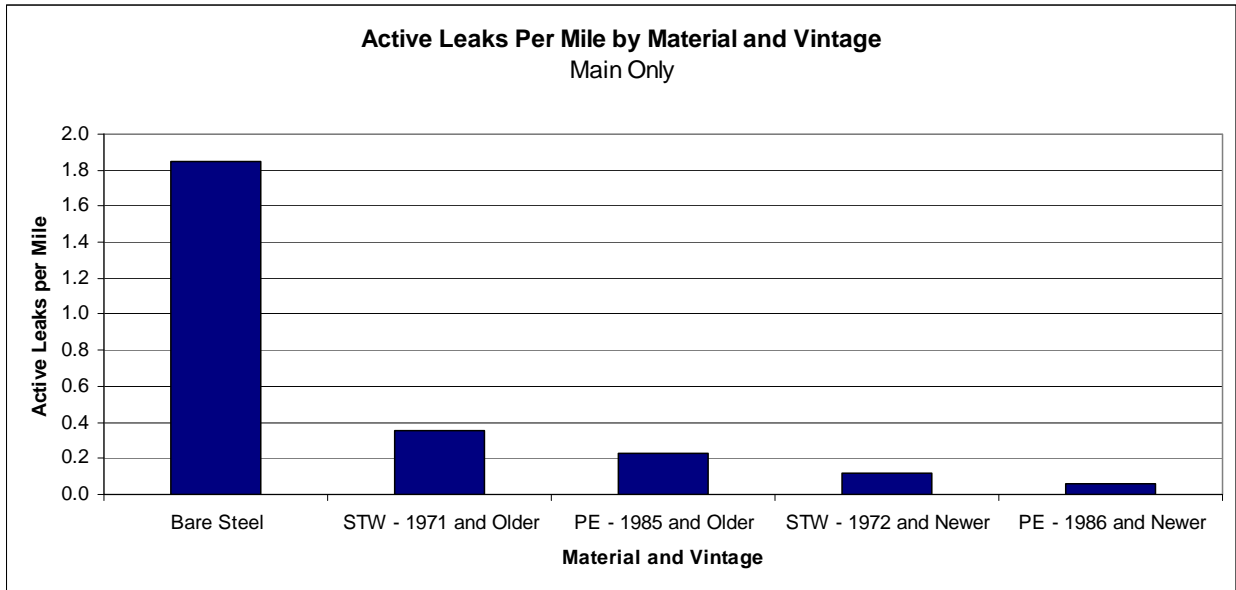
Figure 8. Active Leaks per Mile by Material and Vintage

In 2008 and 2009, PSE undertook an initiative to gain more information on the material and vintage of active leaks. This information has not historically been available on active leaks as it is typically not populated until the leak is repaired. The results of this review are presented in Figure 8 and confirm the direction PSE is headed in continuing the Bare Steel Replacement Program as well as developing and enhancing the Wrapped Steel Service Assessment Program (WSSAP), the Older Wrapped Steel Pipe Mitigation Program, and the Older Vintage PE Pipe Mitigation Program. These programs are all described in *Part 4. Mitigative Measures and Additional and Accelerated Actions* of this report.

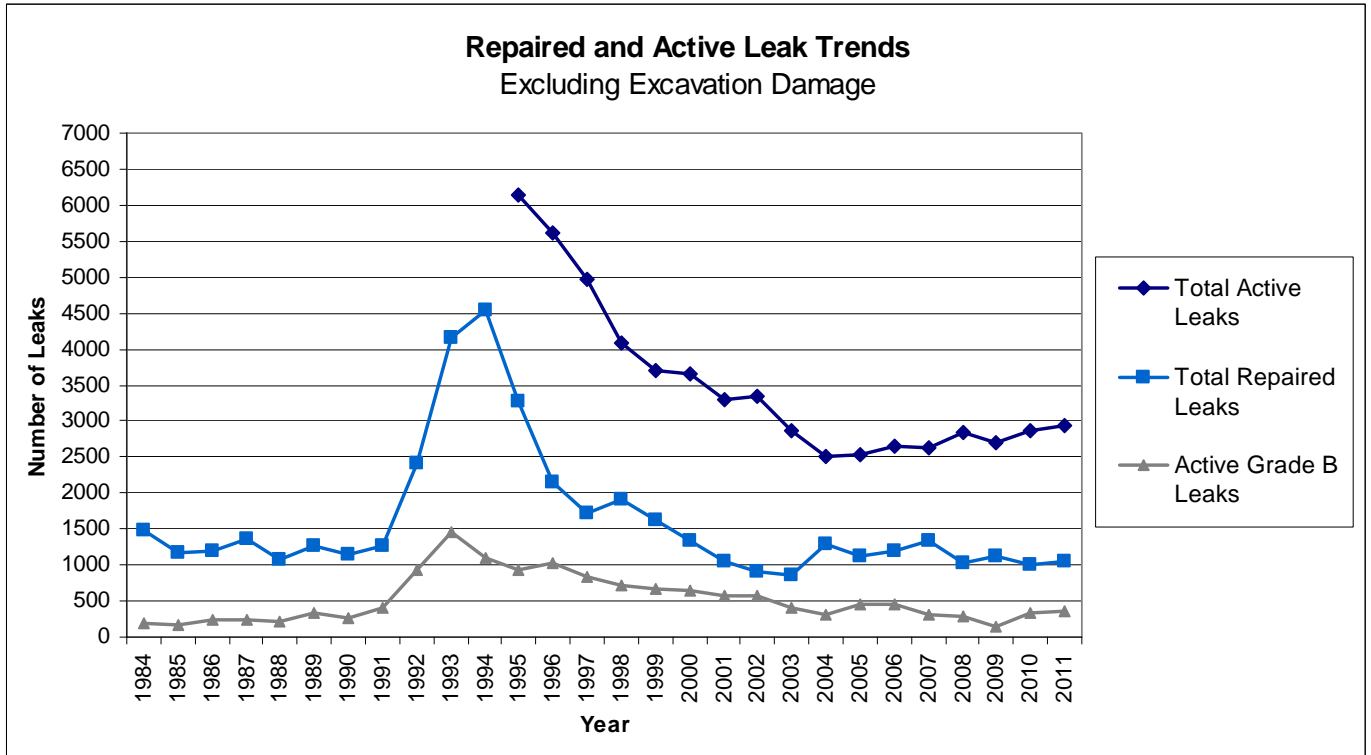
Figure 9. Repaired and Active Leak Trends

This graph shows that total repaired leaks generally follow a similar trend as active Grade “B” leaks and total active leaks. The trend is similar in that there is a significant increase in all categories for a few years beginning in 1992 and then all categories show a fairly steady decline over the next several years. As discussed in the New and Active Leak section, these historical leak trends were impacted by a change in 1992 to leak survey procedures. These changes resulted in an increase in identification of leaks on services and leaks on unprotected bare steel and cast iron. As a result, active leaks and leak repairs increased significantly subsequent to this change.

The following graph shows repaired leak trends compared to total active leak and active Grade “B” leak trends.

This graph also shows that in the past few years, total active leaks have been increasing while leak repairs have remained relatively steady. As discussed in the New and Active Leak section, PSE’s Leak Initiative is focused on performing additional analysis to gain insight into the recent increases in new and active leaks and, if appropriate, developing and implementing a plan to address this trend.

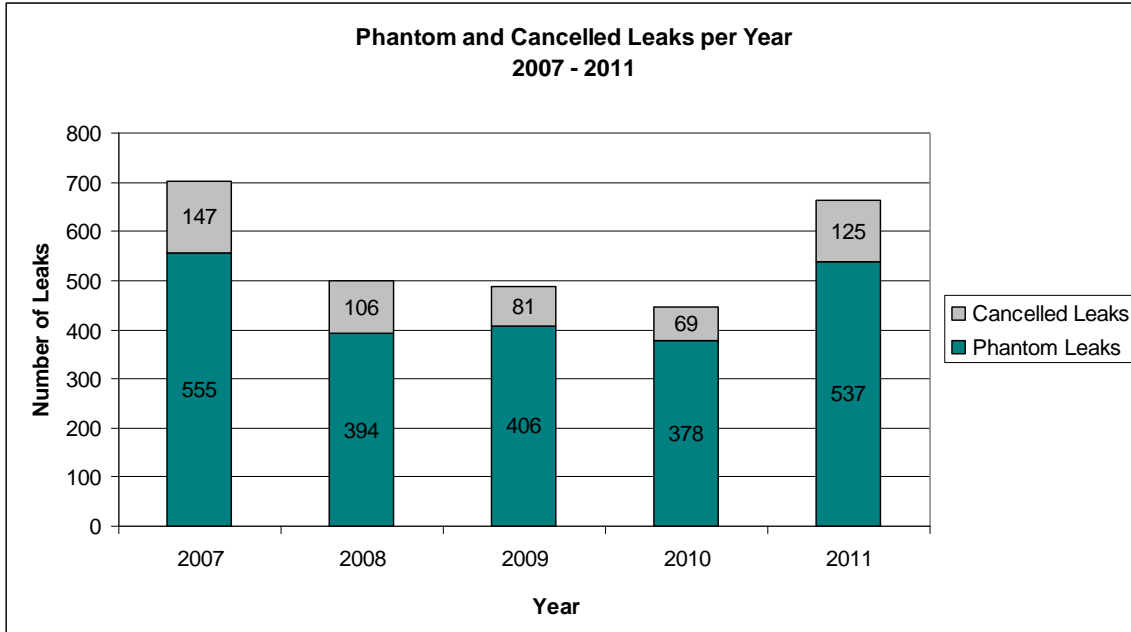
Figure 10. 2007-2010 Phantom and Cancelled Leaks per Year

Figure 10 shows that phantom and cancelled leaks had been decreasing until 2011. The decrease may have been due to improvements in the leak repair documentation process. The improvements focused on ensuring that leaks repaired by replacement were correctly identified as a leak repair rather than a phantom leak. Preliminary analysis of the phantom leaks in 2011 indicates the same issue may be driving the increase. As a result, the additional analysis of Phantom leaks will be performed as part of the Leak Initiative and if appropriate, additional process improvements may be implemented to reduce phantom leaks where a repair was performed through replacement.

While most leaks are eliminated by replacement, retirement or maintenance, leaks can also be eliminated when it is determined that there was not actually a leak present. These leaks are classified as phantom leaks. Leaks can also be eliminated by canceling the leak if the gas that was first detected was later confirmed to not be pipeline gas, the leak was confirmed to be on customer fuel line, or the leak is a duplicate. Phantom and Cancelled leak trends are shown in the following graph.

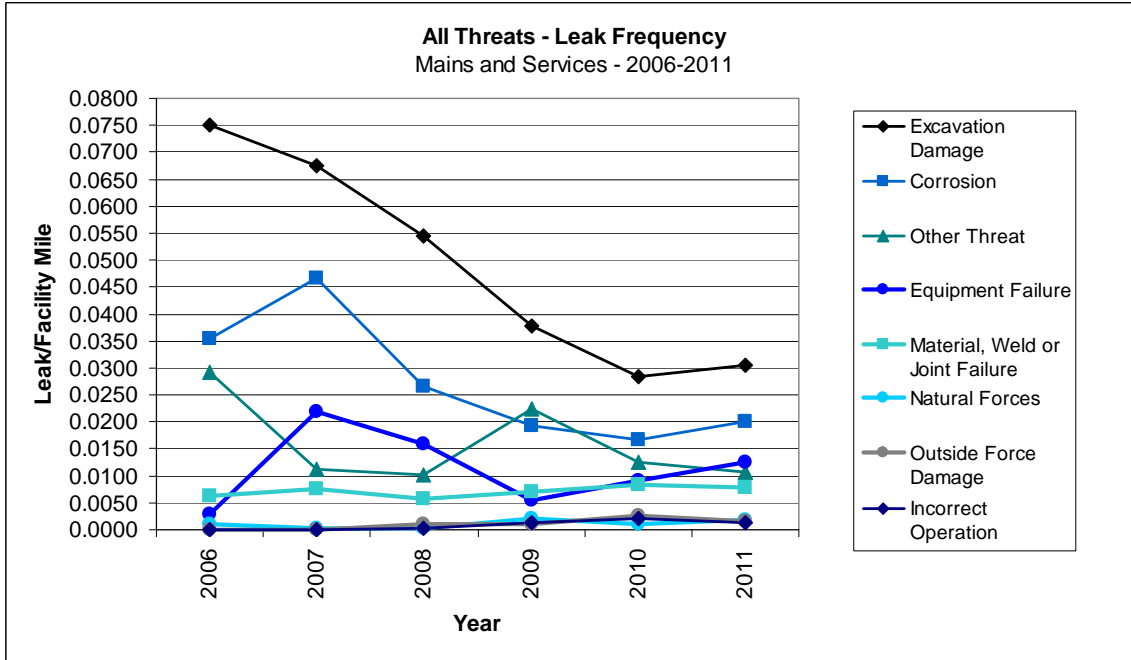
Figure 11. Leak Frequency of All Threats

Figure 11 shows the trends related to leak repairs by leak cause over the past 6 years. As shown in this graph, leaks repaired due to excavation damage and corrosion have decreased significantly over this timeframe.

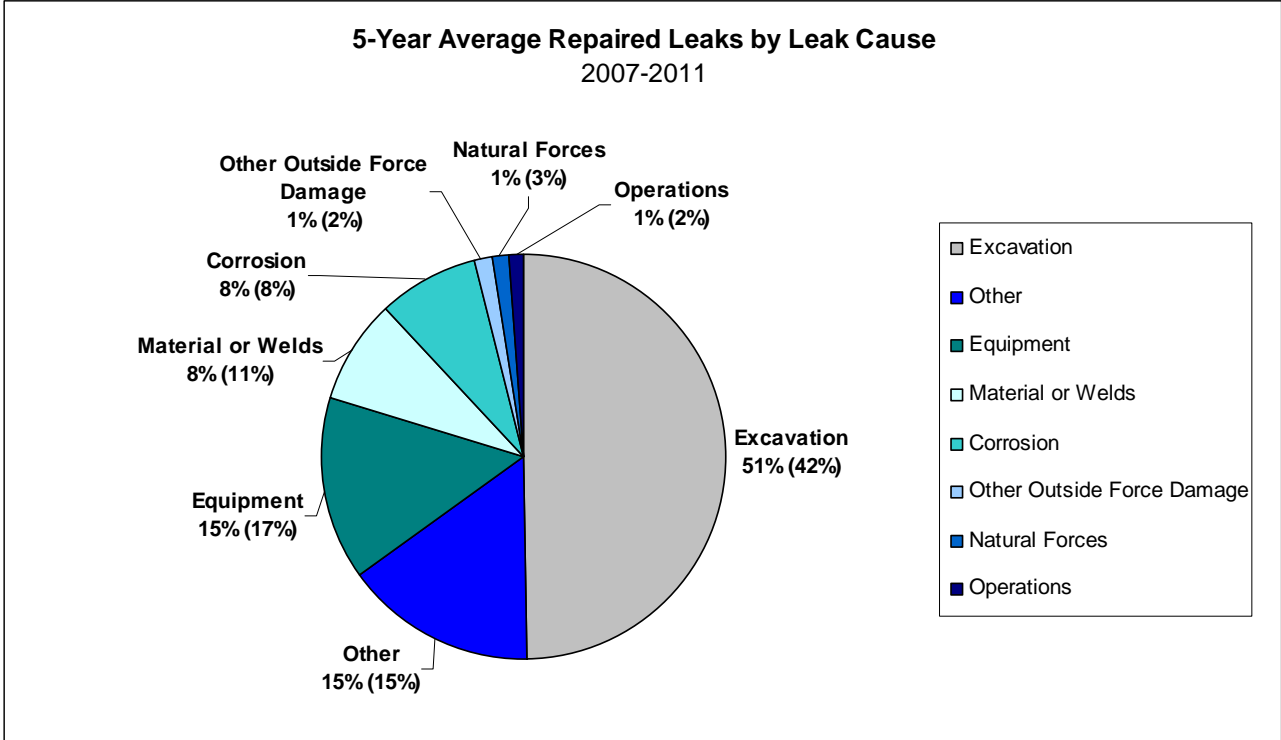
Figure 12. 5-Year Average Repaired Leaks by Leak Cause

The data on the 5 year average is provided in Figure 12 as well as the 2011 numbers. This graph also shows that excavation damage is the leading cause of leaks on the system. PSE’s third party damage data aligns with industry trends and highlights the importance of a robust Damage Prevention Program. PSE’s Damage Prevention Program is working to reduce the damage caused by excavation. There is additional data presented on these efforts in the Third Party Damage Prevention Trends section.

The second leading cause of repaired leaks on PSE’s system is from the leak cause category of “Other”. Analysis of both the 5-year average leaks and 2011 leaks in this category indicates that more than half of these leaks were on pipe that was repaired by replacement or retirement without exposing the actual leak location and identifying the actual leak cause. For 2011, approximately 7% of the total leaks were repaired without exposing the pipe with 4% on older STW services, 1% on older STW mains, and 2% on bare steel mains.

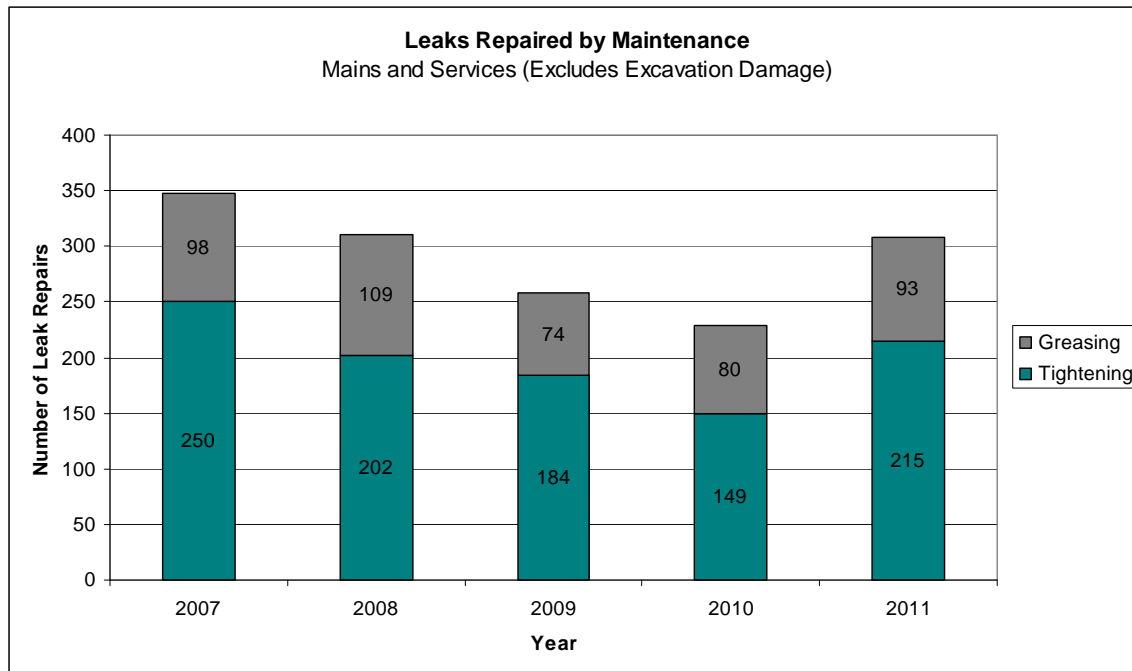
Figure 13. Number of Leaks Repaired by Greasing or Tightening

The majority of leaks in the “Equipment” category are leaks at flanged joints, mechanical joints, and on plug valves. Most of these leaks are repaired by tightening bolts on flanges, tightening both PE and STW service tee caps, and greasing plug valves. The following graph shows the trends of leaks repaired by greasing and tightening over the past 5 years.

As shown in this graph, leaks repaired by greasing and tightening show a general decline from 2007-2010 and an increase in 2011. This data will continue to be monitored in future years to determine if there is a trend that warrants additional mitigative measures related to equipment failures.

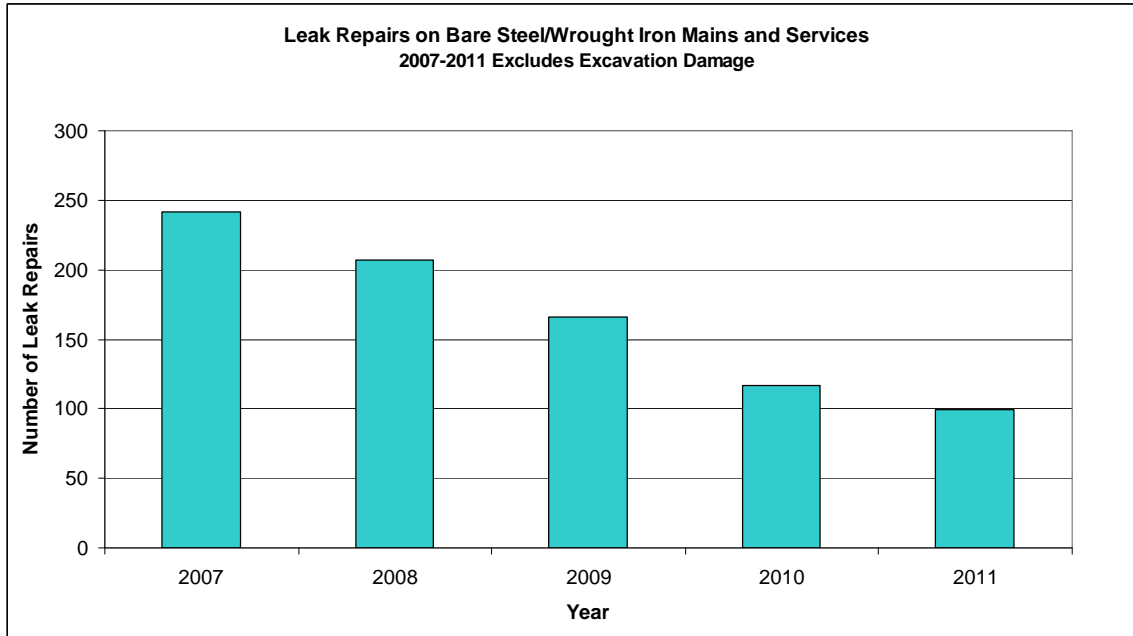
Figure 14. Number of Leak Repairs on Bare Steel Mains and Services

PSE has approximately 69 miles of bare steel and wrought iron pipe remaining in the system with the majority of which is not cathodically protected. As a result, PSE has been replacing bare steel and will have all bare steel replaced by the end of 2014. The following graph shows the impact bare steel replacement has had on decreasing the number of leak repairs over the past 5 years.

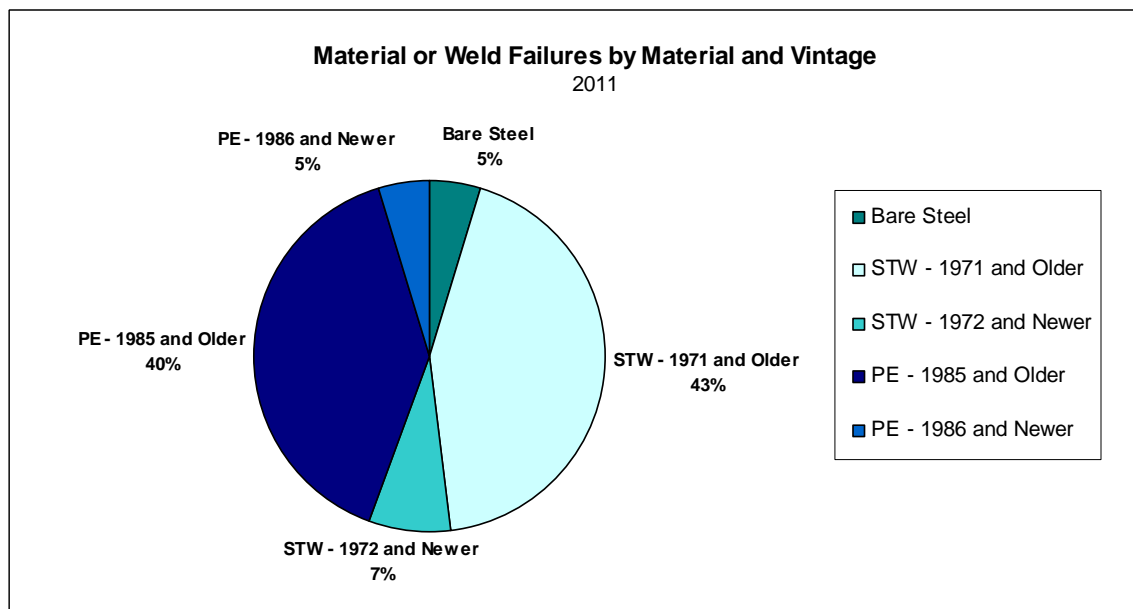
Figure 15. Material or Weld Failures by Material and Vintage

As shown in Figure 15, of the majority of leaks repaired due to material or weld failures were on older vintage PE pipe and older vintage STW pipe.

The analysis of this data shows that this trend is consistent with prior data. The Failure Analysis process provides additional information on these leaks which is discussed in the Failure Analysis Trend section.

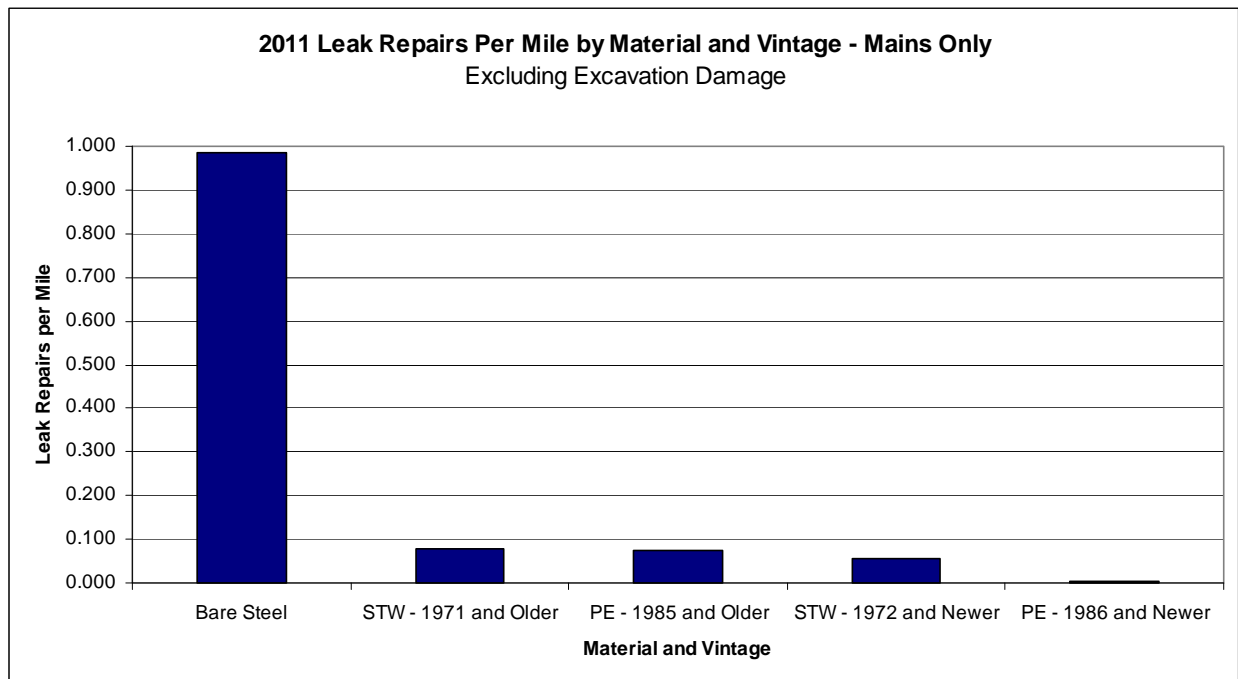
Figure 16. 2010 Repaired Leaks per Mile by Material and Vintage

In addition to looking at trends related to leak causes, PSE has looked at trends related to leak repairs by material and vintage. As shown in the following chart below, the number of leaks repaired per mile of each type of pipe material and vintage is consistent with the trend observed for active leaks per mile by material and vintage and is consistent with prior years.

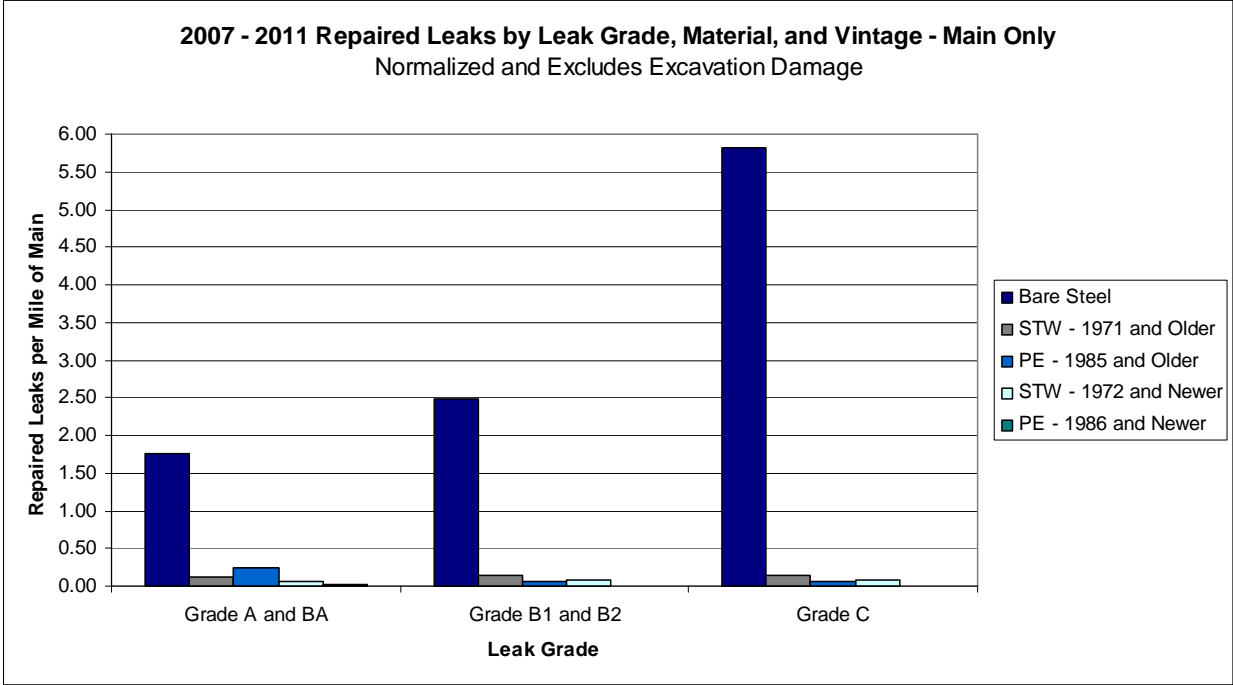
Figure 17. 2007-2011 Repaired Leaks by Leak Grade, Material, and Vintage – Mains Only

PSE has also looked at trends related to the grade of leaks repaired by pipe material and vintage. As shown in Figure 17, bare steel has the highest concentration of grade all leak grades repaired per mile.
